Ministry of  
Construction and Transport

**ANNUAL REPORT 2022**  
**Transportation Safety Bureau**  
**Hungary**

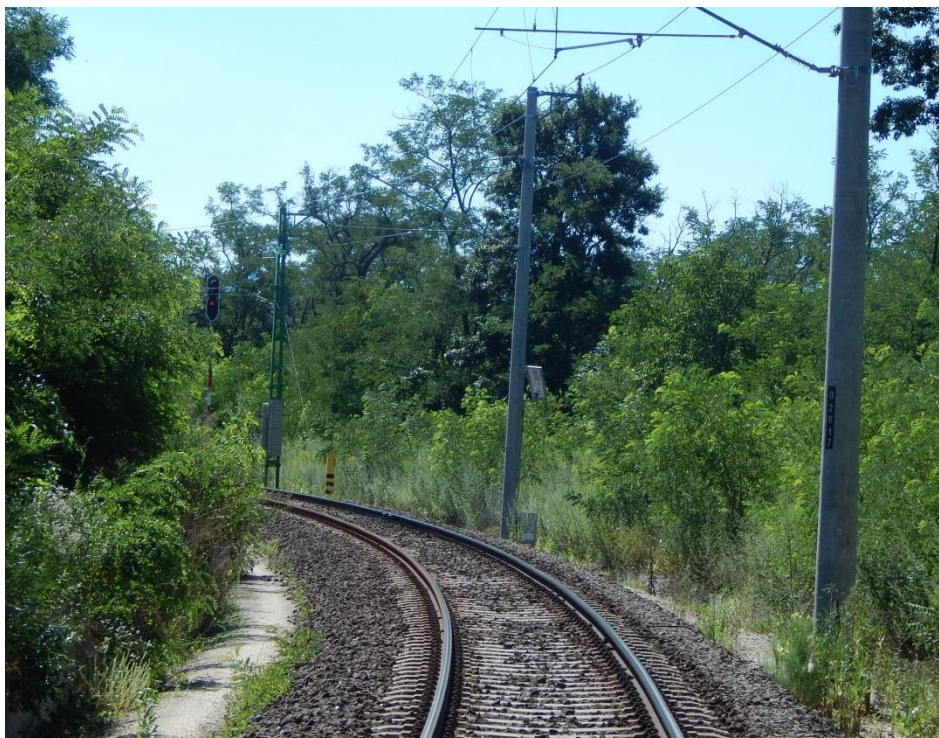
**SUMMARY OF OCCURRENCE № HU-6341**

<i>Grade:</i>	<i>Railway accident</i>
<i>Date and time:</i>	<i>16 Aug 2020 (14:10)</i>
<i>Location:</i>	<i>Szakály-Hőgyész - Kurd (line)</i>
<i>Occurrence type:</i>	<i>Train derailment</i>
<i>Movement type:</i>	<i>Freight train</i>
<i>Description:</i>	<i>The train no. 85811 derailed between Szakály-Hőgyész and Kurd stations. No one was injured.</i>
<i>Consequences:</i>	<i>0 fatality / 0 serious injury Total damage 150.000 – 2.000.000 EUR</i>
<i>Parties:</i>	<i>MÁV Zrt. (IM) RCH Zrt. (RU)</i>
<u><i>Direct cause(s):</i></u>	<ul style="list-style-type: none"><li><i>the independent track geometry errors on the short section were within different error limits, but their combined effect generated a lateral rocking motion in the vehicles of the train with a high centre of gravity, which led to the derailment of the last three wagons in the train</i></li></ul>
<u><i>Contributory factor(s):</i></u>	<ul style="list-style-type: none"><li><i>the independent track geometry errors were recorded separately and their possible combined effect was not investigated</i></li></ul>

<u><i>Underlying cause(s):</i></u>	<ul style="list-style-type: none"><li><i>the data from the mechanical track measurements are not compared with previous measurements, and therefore a continuous deterioration of the errors cannot surface until the action value is reached</i></li></ul>
<u><i>Recommendation(s):</i></u>	<i>none</i>

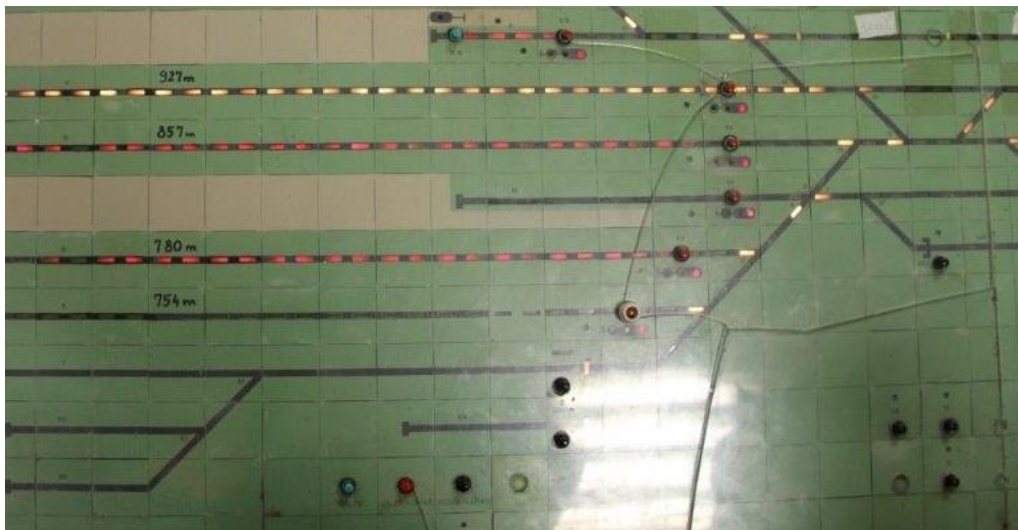
**SUMMARY OF OCCURRENCE № HU-10054**

<b>Grade:</b>	<i>Railway incident</i>
<b>Date and time:</b>	<i>17 May 2021 (11:16)</i>
<b>Location:</b>	<i>Gödöllő (station)</i>
<b>Occurrence type:</b>	<i>Signal passed at danger</i>
<b>Movement type:</b>	<i>Regional passenger train</i>
<b>Description:</b>	<i>Train no. 3135 departed from Gödöllő station without permission, passed the exit signal at danger and trailed point no. 22. No injuries occurred.</i>
<b>Consequences:</b>	<i>0 fatality / 0 serious injury No damage (0 EUR)</i>
<b>Parties:</b>	<i>MÁV Zrt. (IM) MÁV-START Zrt. (RU)</i>
<b><u>Direct cause(s):</u></b>	<ul style="list-style-type: none"> <li>the locomotive driver departed in his train without authorisation and without a signal at the exit signal to authorise the train to proceed</li> </ul>
<b><u>Contributory factor(s):</u></b>	<ul style="list-style-type: none"> <li>after a change of direction, signalling does not operate for the passing train until the route control from that track is done, therefore no emergency braking occurs when a train is passing a signal at danger</li> <li>the unintentional movements of the outer traffic controller briefly resembled a "Call" signal (green circle in the picture)</li> <li>the train crew interpreted the unintentional movements of the traffic controller as a "Call" signal (red circle in the picture)</li> </ul>

<b><u>Underlying cause(s):</u></b>	<ul style="list-style-type: none"> <li>none</li> </ul>
<b><u>Recommendation(s):</u></b>	<i>none</i>

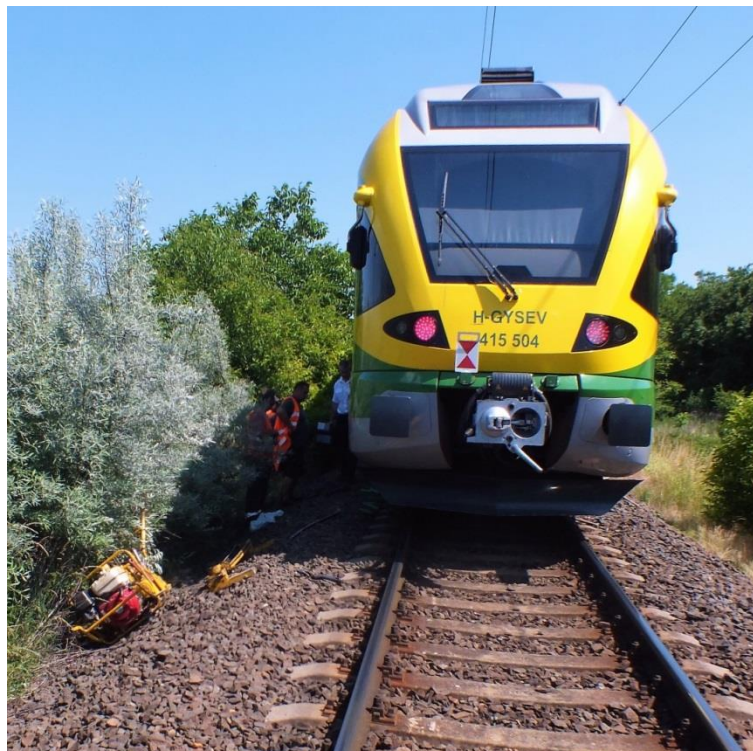
**SUMMARY OF OCCURRENCE № HU-10198**

<i>Grade:</i>	<i>Railway accident</i>
<i>Date and time:</i>	<i>25 June 2021 (18:02)</i>
<i>Location:</i>	<i>Zirc - Eplény (line)</i>
<i>Occurrence type:</i>	<i>Train derailment</i>
<i>Movement type:</i>	<i>Regional passenger train</i>
<i>Description:</i>	<i>The locomotive of train no. 39523 derailed with its front bogey's two axles between Zirc and Eplény stations. No injuries occurred.</i>
<i>Consequences:</i>	<i>0 fatality / 0 serious injury Total damage &lt; 150.000 EUR</i>
<i>Parties:</i>	<i>MÁV Zrt. (IM) MÁV-START Zrt. (RU)</i>
<u><i>Direct cause(s):</i></u>	<ul style="list-style-type: none"><li>• <i>there is a small-radius curve at the point of the derailment, causing a large amount of deflection force</i></li><li>• <i>there was a lot of friction between the rail and the wheel flange, and their contact surfaces were very rough</i></li><li>• <i>there was some track buckle due to the summer heat</i></li></ul>

<u><i>Contributory factor(s):</i></u>	<ul style="list-style-type: none"><li>• <i>the great summer heat</i></li><li>• <i>excessive rail and wheel roughness</i></li></ul>
<u><i>Underlying cause(s):</i></u>	<ul style="list-style-type: none"><li>• <i>none</i></li></ul>
<u><i>Recommendation(s):</i></u>	<b><i>NIB proposes reviewing the current track gauge system on line 11 and the combined operation of the track gauge technology for the locomotives of the series 418 and the effects of the train and locomotive rosters used, and taking technical and organisational measures as necessary.</i></b>

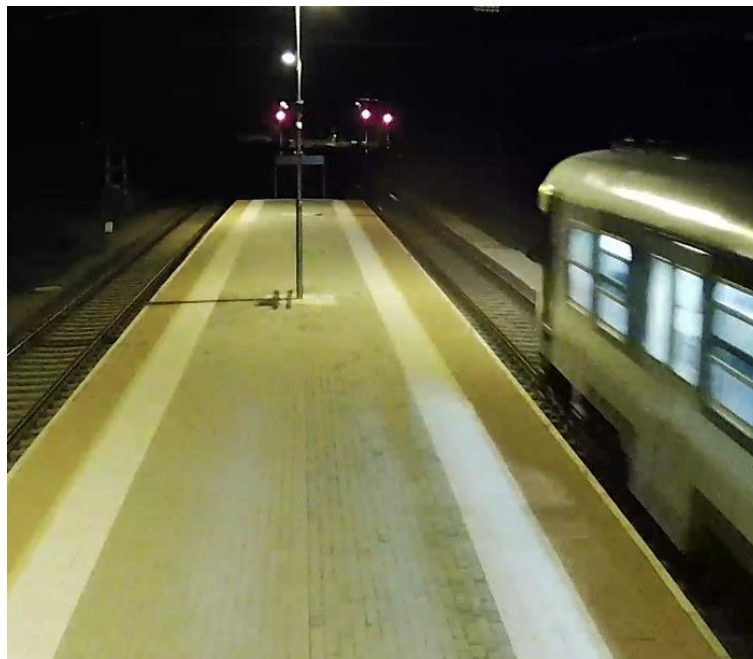
**SUMMARY OF OCCURRENCE № HU-10291**

<i><u>Contributory factor(s):</u></i>	<ul style="list-style-type: none"><li><i>the condition of the timber sleepers of siding 10 has deteriorated, resulting in increased support spacing and significantly increased stress on the rails</i></li></ul>
<i><u>Underlying cause(s):</u></i>	<ul style="list-style-type: none"><li><i>the ultrasound scan used could not detect the fault that led to the accident</i></li></ul>
<i><u>Recommendation(s):</u></i>	<i>none</i>

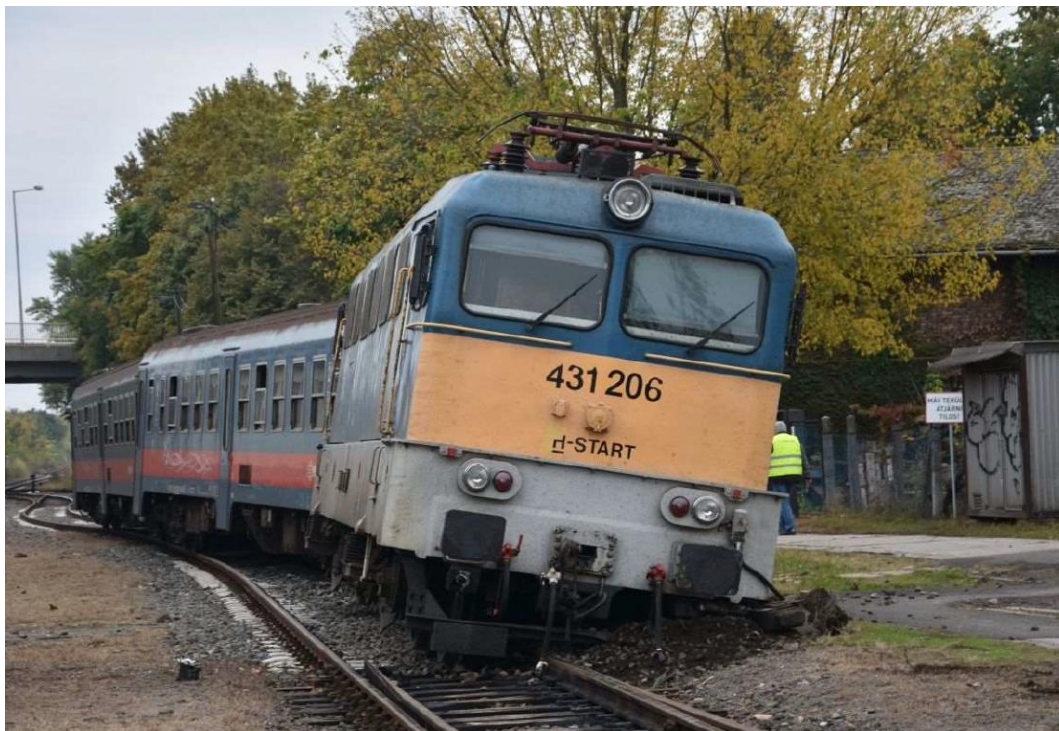
**SUMMARY OF OCCURRENCE № HU-10139**

<u><i>Contributory factor(s):</i></u>	<ul style="list-style-type: none"><li><i>the condition of the wagon and its known defects were disregarded, or repairs were not carried out or were carried out incorrectly</i></li></ul>
<u><i>Underlying cause(s):</i></u>	<ul style="list-style-type: none"><li><i>the maintenance system in place did not ensure good technical condition of the wagons</i></li><li><i>the railway company maintained the service contract with the wagon owner's partner even in the face of known risks that had existed for a long time and in large numbers</i></li></ul>
<u><i>Recommendation(s):</i></u>	<i>none</i>

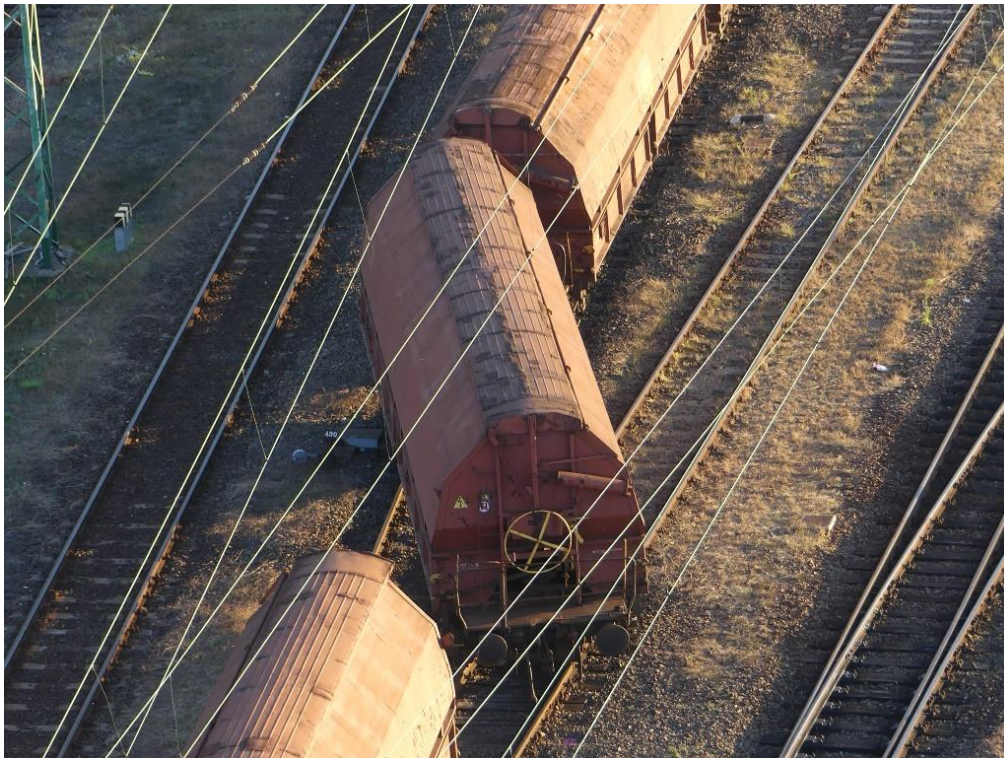
**SUMMARY OF OCCURRENCE № HU-10148**

<u><i>Underlying cause(s):</i></u>	<ul style="list-style-type: none"> <li>the infrastructure manager does not consider the shortcomings of the safety installation (resulting from its design) as a risk to be managed</li> </ul>
<u><i>Recommendation(s):</i></u>	<b>The NIB recommends MÁV Zrt. to consider reviewing the criteria used to determine the classification of station tracks as “equipped for train control”, taking into account whether those tracks perform the train control functions on which the relevant rules and instructions are based. On this basis, the necessary measures should be taken to ensure that the Station Instructions include correct information on the suitability of the tracks for continuous signalling.</b>
