*Maritime Administration of  
Latvia*

*Division for Investigation of Maritime Accidents*

***Foundering of Latvian  
f/v BEVERĪNA and loss of 6  
crew members lives in vicinity  
of port of Liepāja (Latvia).***

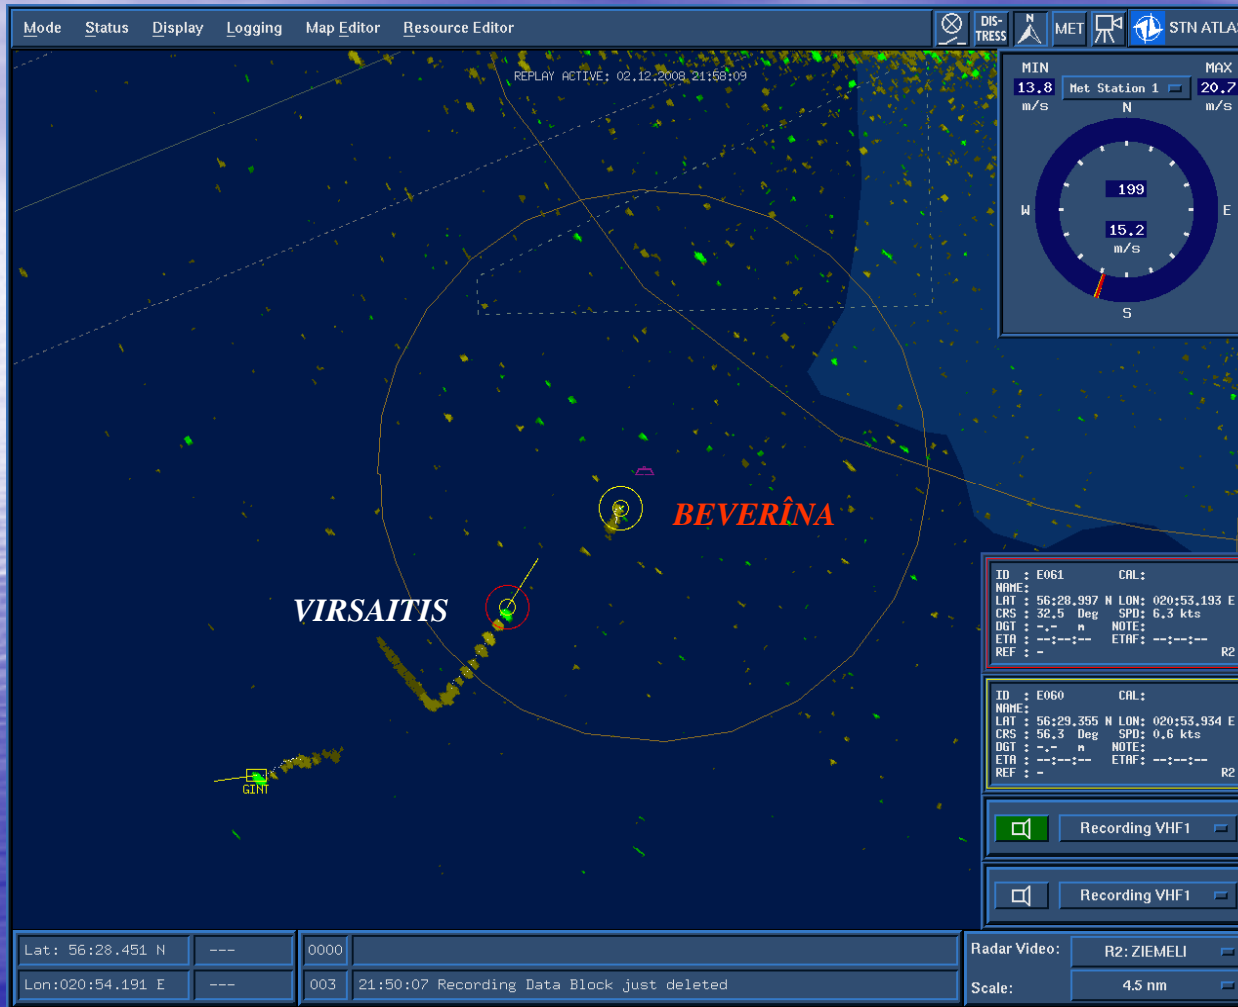
- 2200 *VIRSAITIS* was on his way to *BEVERĪNA* position (approx at a distance of 7 cables), when *BEVERĪNA* capsized.

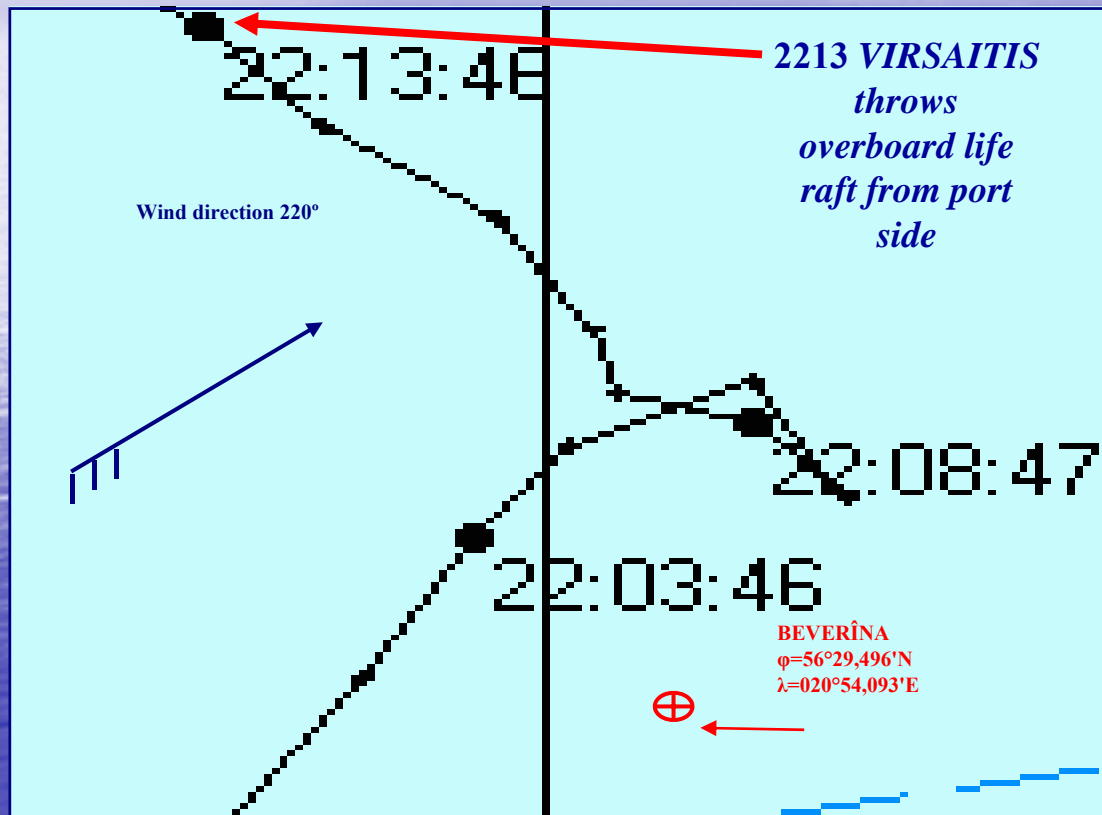
Liferaft was thrown overboard 1,5-2 kbl NW from position, where the *BEVERINA* capsized. The wind direction was SW, so the life raft was blown away.

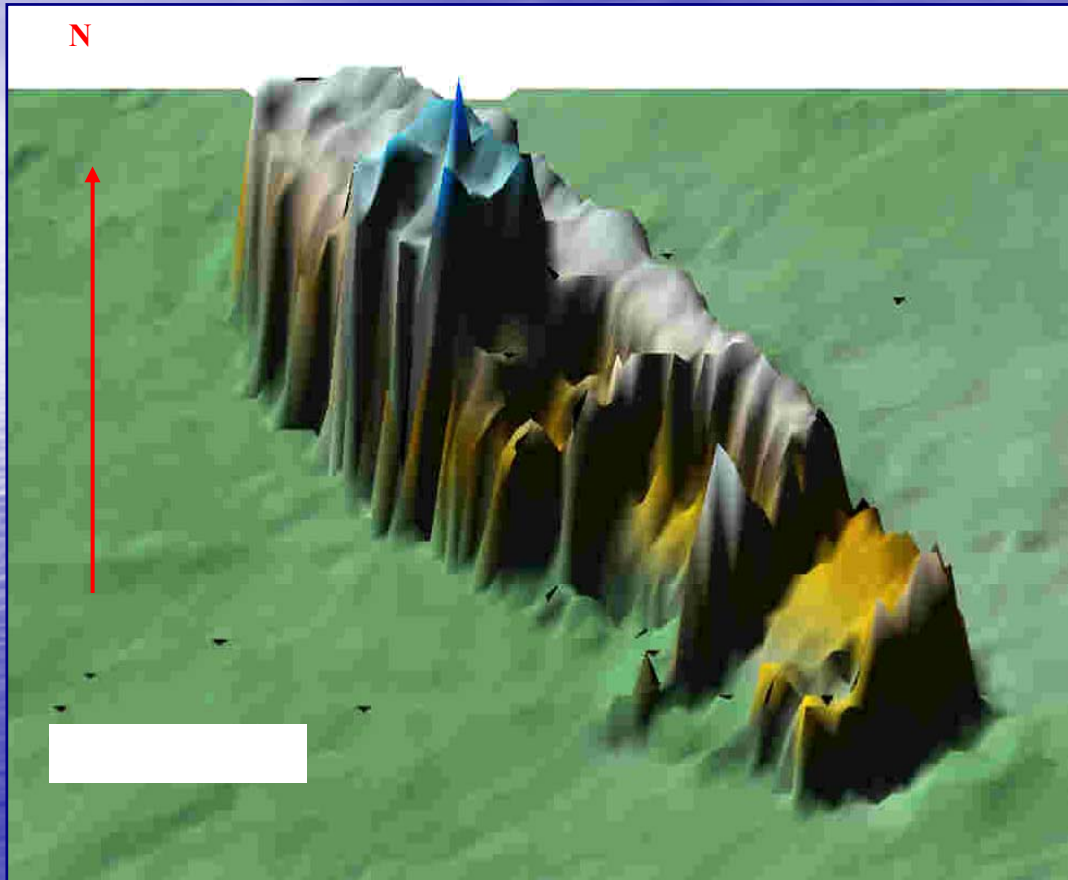
- On 5 and 6 of December 2008 the site of accident was inspected by specialized hydrographic vessel to determine the position and condition of the wreck. The wreck lies in NW direction with a list to port side and the stern submerged in sea bed.

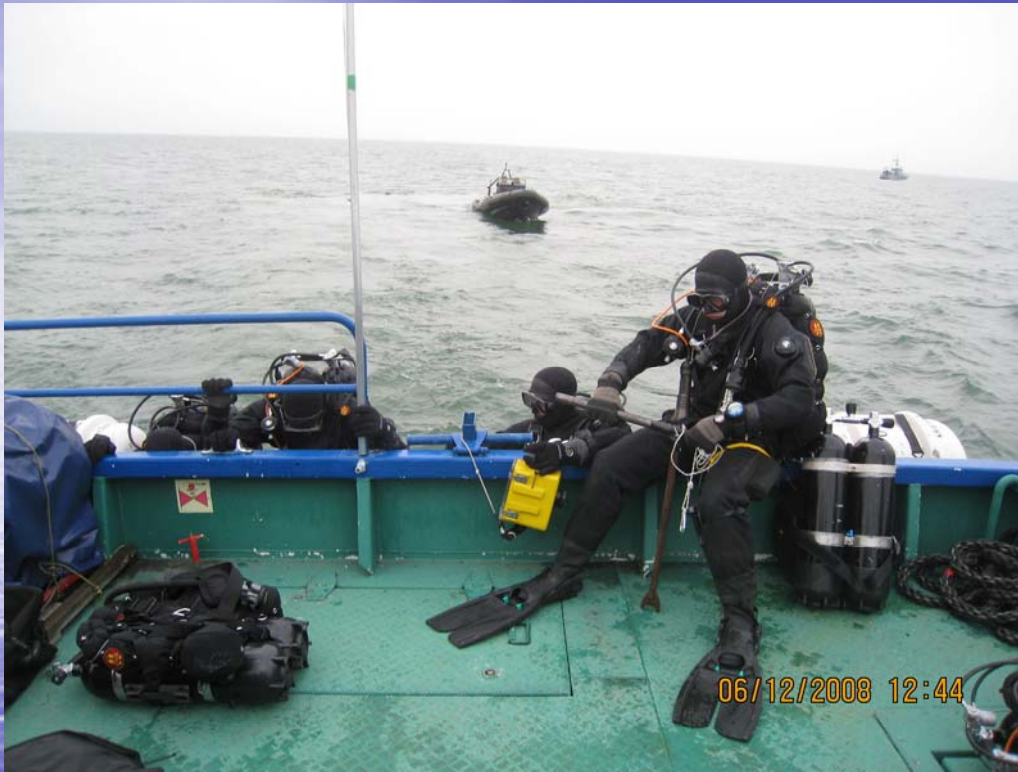
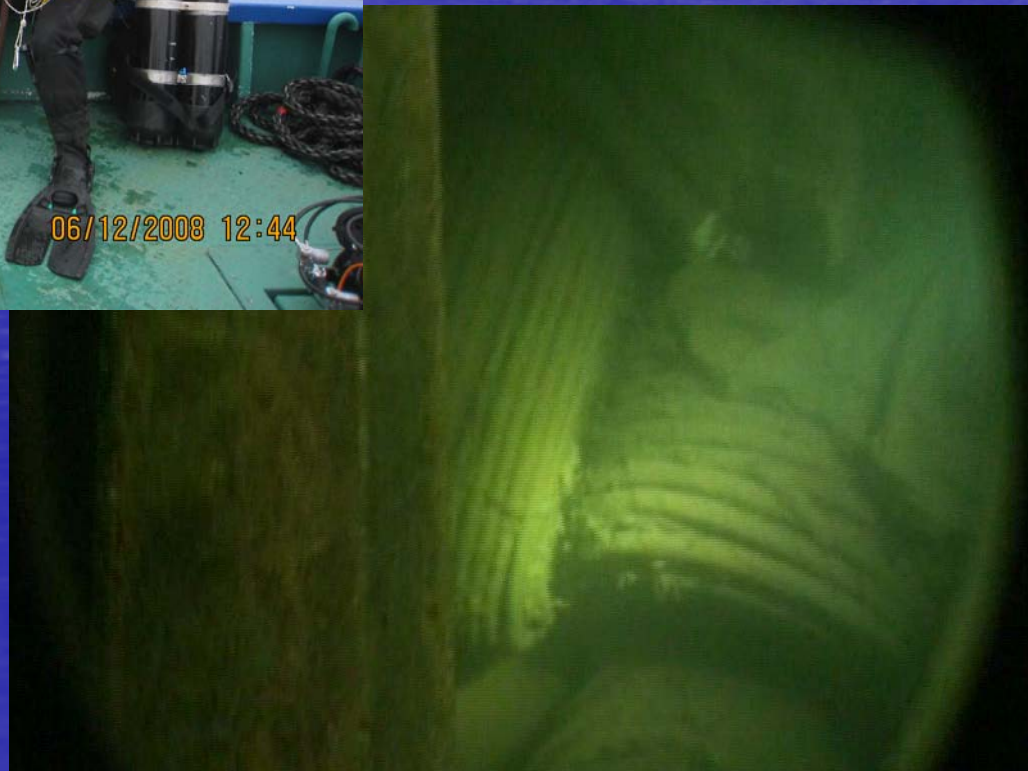
- Latvian navy divers inspected the vessel. No crew members were found inside the vessel. In cargo hold, instead of fish products, they found cooper underwater cable reels lifted from the seabed.

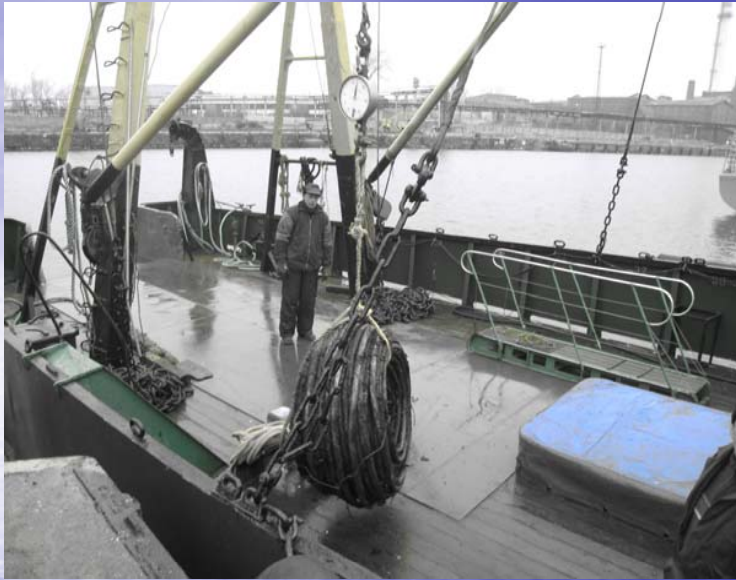
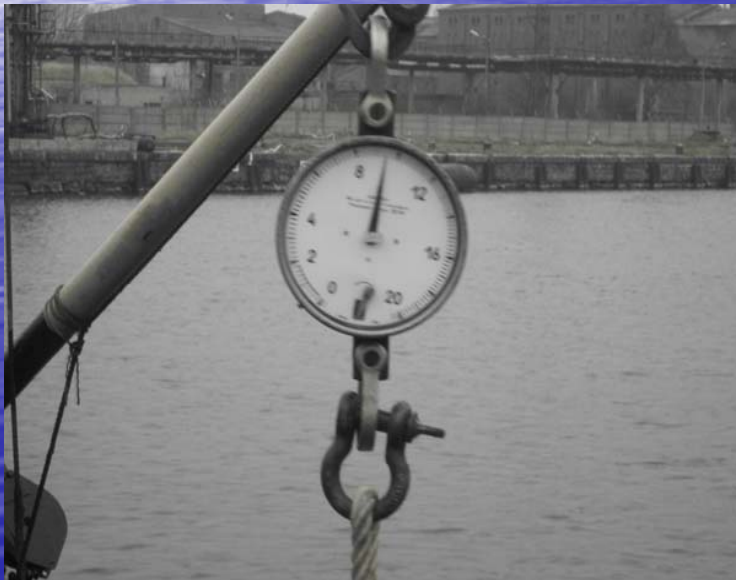
- Steering gear failure occurred due to sea water inflow in aftpeak (steering gear motors inside aftpeak), which resulted in aft draft increase.  
(approx weight of water in aftpeak: 26.4t)
- One of the cable rolls was hoisted up from *BEVERINA* hold and the weight was determined – approx 950 kg. According to the info from divers, the total possible quantity of rolls in hold could be approximately 30 pcs.  
(approx weight of cargo: 28.5 t)
- Feature of this type of f/v is that while drifting, ship's stern turns at an approx angle of 45 degrees against the direction of waves, which contributed to a situation when the water level (presuming 0.3m-minimum) on deck badly increases.  
(approx weight of water on deck: 29 t)

- Total possible extra weight on board the ship was about 60 t.
- Stability calculations were made giving a result of negative Metacentric height  
(GM) = **-1,22 m**, which resulted in a vessel's capsizing.  
All IMO determined fishing vessel stability requirements mismatched the actual stability criteria at the moment of accident.
