Investigation report

C 3/2002 L

Violation of the radar separation minima in the vicinity of Helsinki Terminal Area on 17 January 2002

HA-LMD Fokker F28 Mk0070

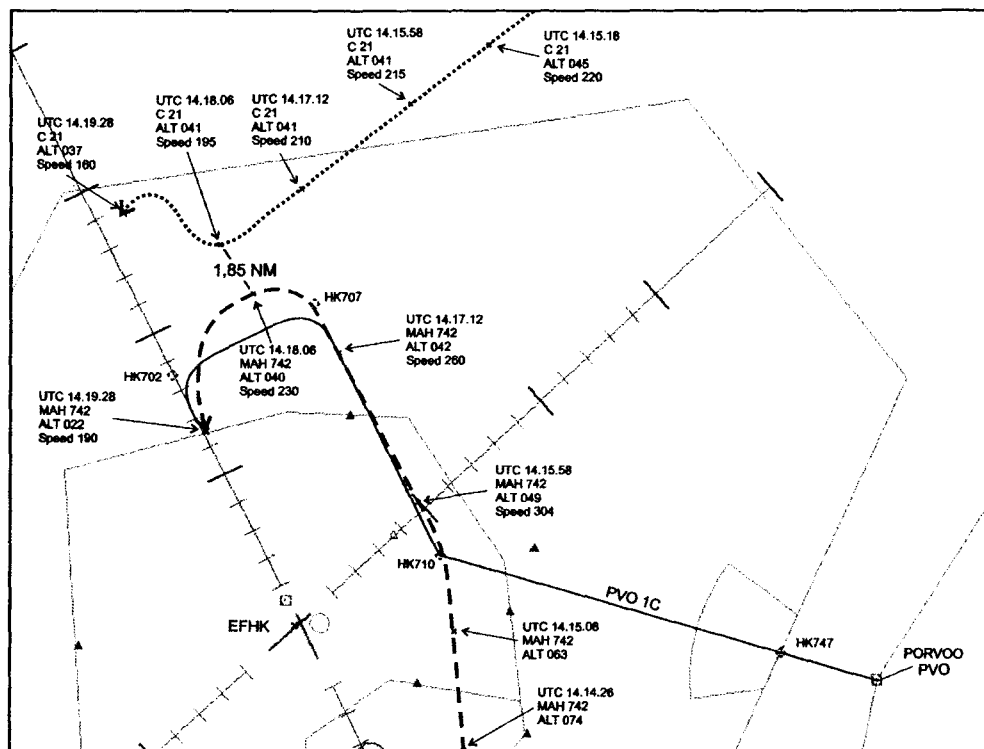
Picture 1. Flight paths of MAH742 and C21

the clouds was at about 3800 feet, and so both aircraft were above clouds in visual flight conditions. The aircraft were at the closest 1,85 nautical miles from each other.

At 14.18.13, ARR ATCO told MAH742 to fly heading 180° and cleared the aircraft for a third time for ILS approach for runway 15. Distance to touchdown was 10 NM at that moment. At 14.18.27, ARR ATCO told C21 to fly heading 180° and cleared it also for ILS approach for runway 15 when the distance to touchdown was 12 NM. ARR ATCO transferred ATC control for MAH742 to Helsinki Tower Control (TWR) at 14.19.53, when the aircraft was 5 NM from touchdown.

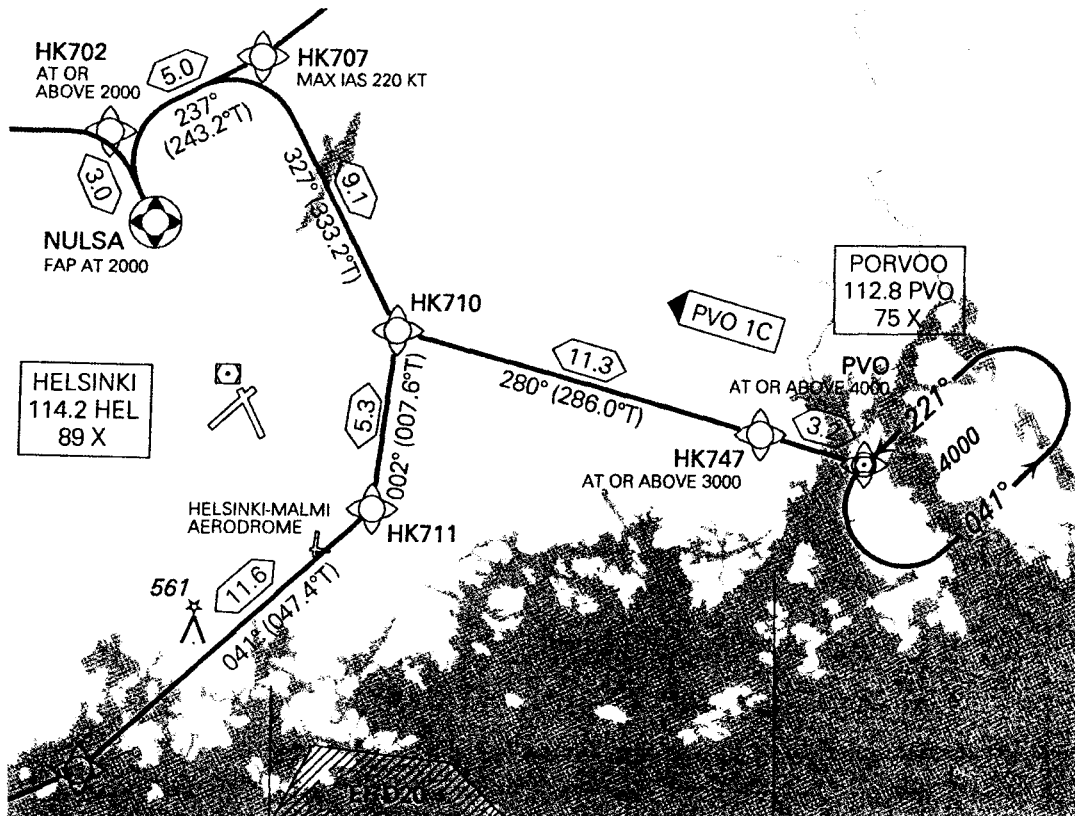
Picture 2. Short RNAV transitions for runway 15 at Helsinki-Vantaa according to AIP

Short RNAV transition routes for arriving aircraft for runway 15 have been published in the Chart EFHK AD 2.12-5 (RNAV TRANSITION 15) of VOL 2, AD 2 of the AIP. According to AIP, the PVO 1C transition route starts from Porvoo (PVO) VOR/DME and ends at the NULSA waypoint. The transition has six waypoints altogether. There is no accuracy requirement for the RNAV procedure on the chart.

Initially both long and short transition routes had been implemented for the same runway at Helsinki-Vantaa airport. After the Malev incident Helsinki-Vantaa ATC made a quick analysis of the incident on 18 January 2002, in which it was suggested to withdraw from service the long transition routes due to flight safety reasons. Long transition routes were withdrawn from service on 11 July 2002.

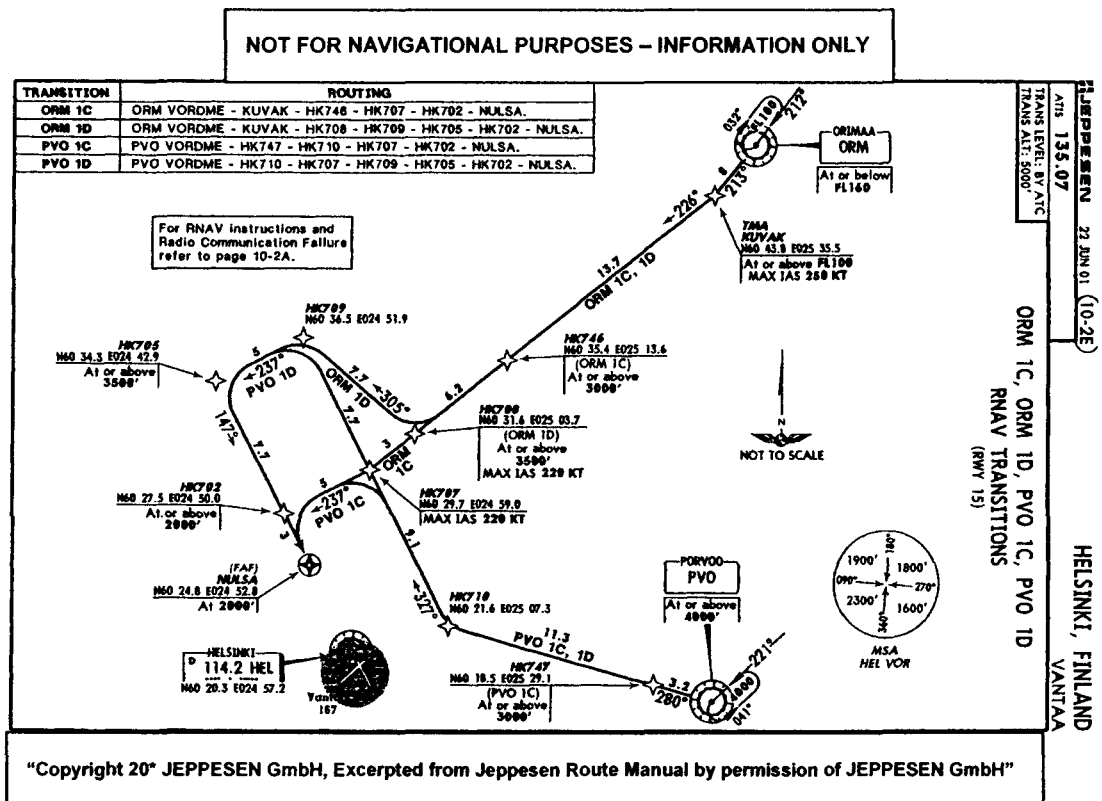
Picture 5. Extract from Jeppesen Route Manual Page 10-2E, 22 JUN 01

The cockpit crew used for navigation the Jeppesen chart shown in Picture 6, illustrating both the short transition route PVO 1C and the long route PVO 1D for runway 15. The information on the chart was in accordance with the data published by FCAA in AIP Finland. The investigators see that it could have been possible to mistake between the short and long transition routes effective at the time of the occurrence, especially because they were published on the same page of the chart. If the cockpit crew had chosen PVO 1D as their transition route, MAH742 would have flown over HK707 as it now did. However, the flight would have continued directly towards waypoint HK709. If the required navigation performance of Helsinki-Vantaa PVO 1C had been published in Jeppesen Route Manual as required in EUROCONTROL instructions, the cockpit crew of MAH742 could have noticed the accuracy requirement for the procedure and requested a new alternative arrival clearance.
