MINISTRY FOR Innovation and Technology Transportation Safety Bureau

FINAL REPORT

2014-080-4P Serious incident Sofia 8 March 2014

Beechcraft A-36 HA-ARB

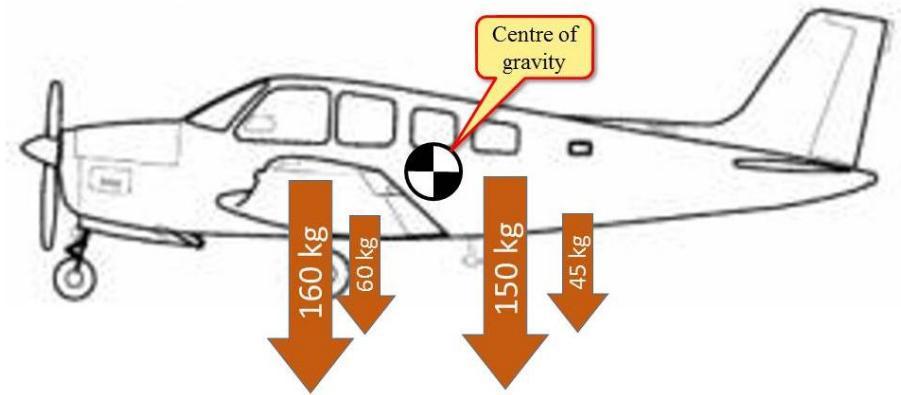
Figure 3: Payload distribution

Empty weight	1 104 kg
Fuel weight	~226 kg
Payload	415 kg
Take-off weight	1 745 kg (3 847 lb)
Maximum take-off weight	1 656 kg (3 651 lb)
Maximum landing weight	1 656 kg (3 651 lb)
Weight at the time of the occurrence	1 550 kg (3 417 lb)
Centre of gravity at take-off	219.0 cm (86.2 inch)
Centre of gravity at the time of the occur-	222.5 cm (87.6 inch)
rence	
Centre of gravity limits with max. weight	205.7 – 222.8 cm (81.0 – 87.7 inch)

At the time of the occurrence, the weight and weight distribution of the aircraft were within the relevant ranges, although the weight exceeded the maximum value at the time of take-off. The aircraft was adequately fuelled for the flight.

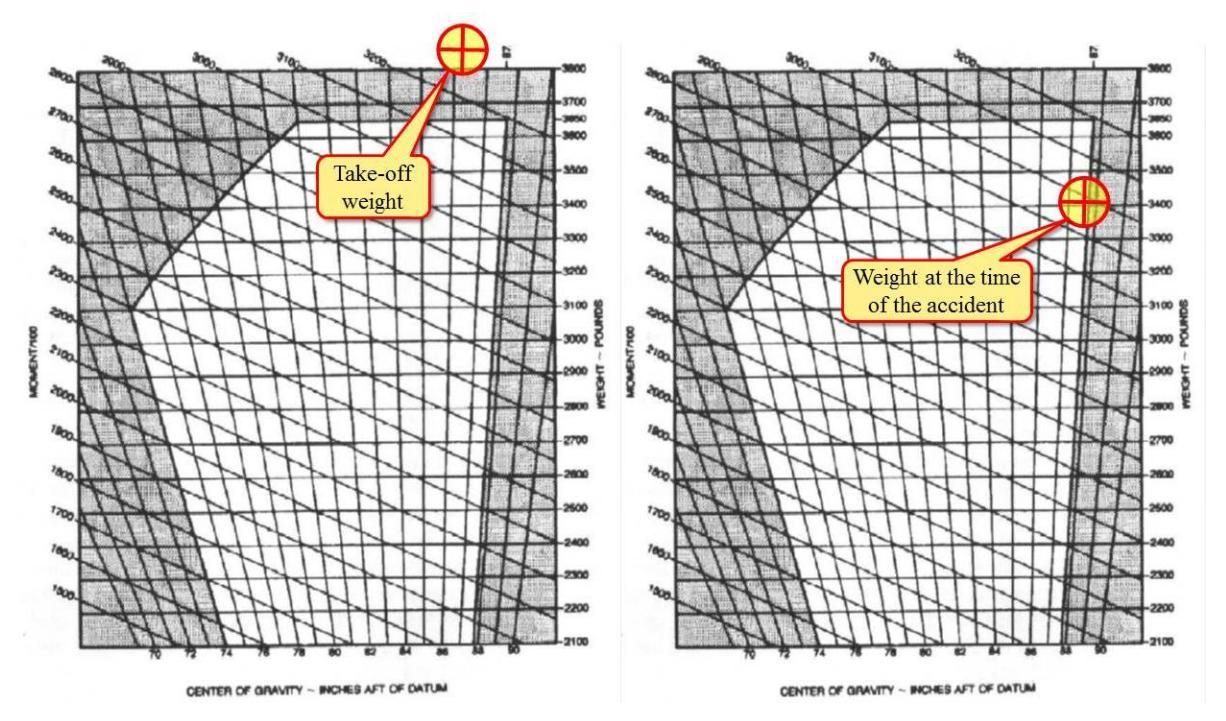
Figure 4: Respective load and centre of gravity of the aircraft at the time of take-off and at the time of the incident

Similar to the pilot's activity, the autopilot also uses the trim to adjust level flight, in such manner that first the elevator is moved by a relatively stronger electromotor, and then, in order to spare this motor from continuous load, a smaller motor moves the balancing aer-odynamic trim flap of the elevator until the force needed to provide sufficient travel of the elevator is gone. During take-off, the aircraft somewhat exceeded the maximum take-off weight, although its centre of gravity was inside the specified range (Figure 4). The fuel tanks are situated in front of the main spar inside the wings, so the mass of fuel creates a tilting torque (top heavy) during level flight, because it is situated in front of the centre of gravity of the aircraft shifted forward, due to gradual decrease of the mass of fuel. Supposing that 10 gallons of fuel was left, the location of the centre of gravity changed according to Figure 4.

The calculated centre of gravity was right in front of the rear limit position, but within the permitted range. During fuel consumption, the steering forces were in a state of constant change, which the autopilot managed by automatic trimming until the moment it was disabled. According to his report, the pilot tilted the nose of the aircraft by a resolute forward push of the elevator at the end of a cycle of rising, while, after pushing the button which disconnects the autopilot, he realised that the steering forces had changed. As a result, the aircraft trimmed almost fully forward started a vertical fall, which the pilot was able to stop (by lifting the nose of the aircraft) only at the cost of significant effort (Figure 5).

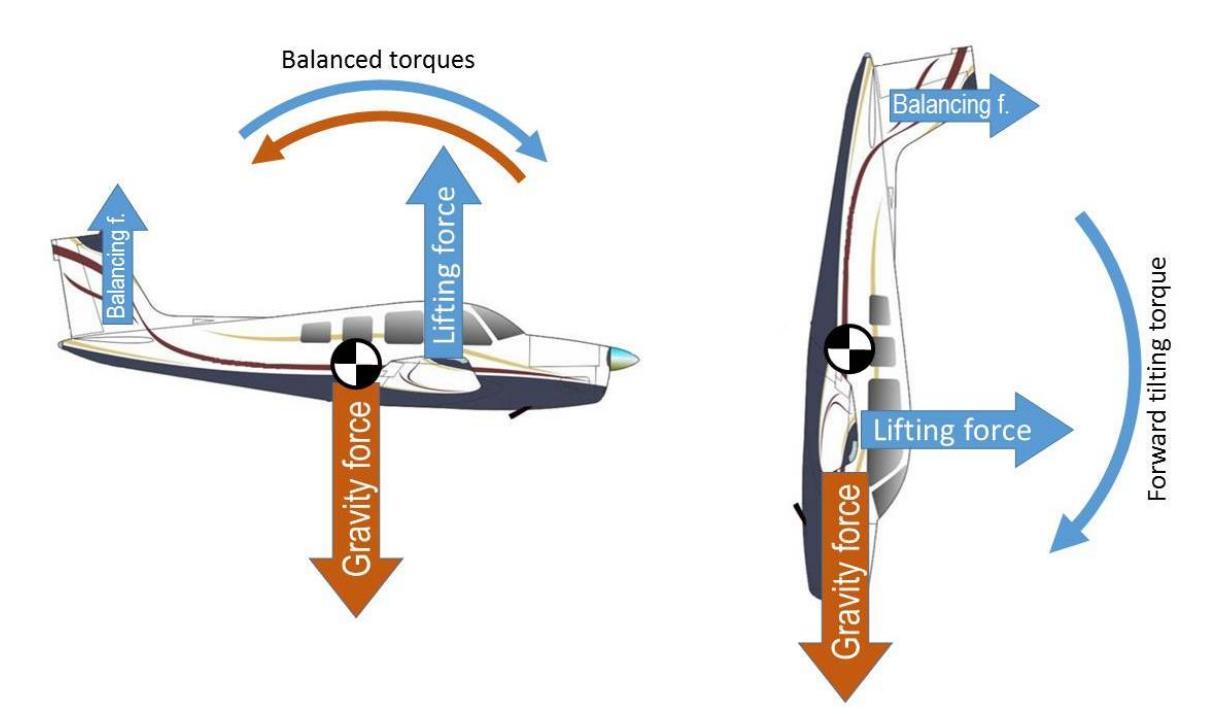
Figure 5: Forces and torques affecting the aircraft during its flight and fall

The cause of the dangerous phenomenon was an imbalance of the torques affecting the tilt movement of the aircraft. During cruise, the backward tilting torque generated by the force of gravity acting behind the fulcrum of the lifting force of the wing is balanced by the forward tilting torque of the aerodynamic force awakening upward on the forward-trimmed elevator. This situation changes significantly during a fall of the aircraft. The backward torque generated by the different fulcrums of the lifting force and the force of gravity disappears. At the same time, the balancing force of aerodynamic origin (coming from the remaining forward trim) does not decrease, but generates even greater forward torque (due to increase of velocity) which further pushes the nose of the aircraft toward the ground, or, in absence of intervention, the aircraft may even turn on its back, which almost certainly leads to disaster (Figure 5). The pilot was able to recover the aircraft from this changed attitude only by giving the elevator a drastic pull, which required a significantly greater steering force than usual. The position of the IC is that the change to the steering force was due to the situation which occurred in the manner described above, and not to malfunction of the autopilot.
