Ministry for Innovation and Technology Transportation Safety Bureau

FINAL REPORT

2014-511-4 Accident

Near Kiskunlacháza Airport 24 December 2014 Pipistrel Virus SW 14-79

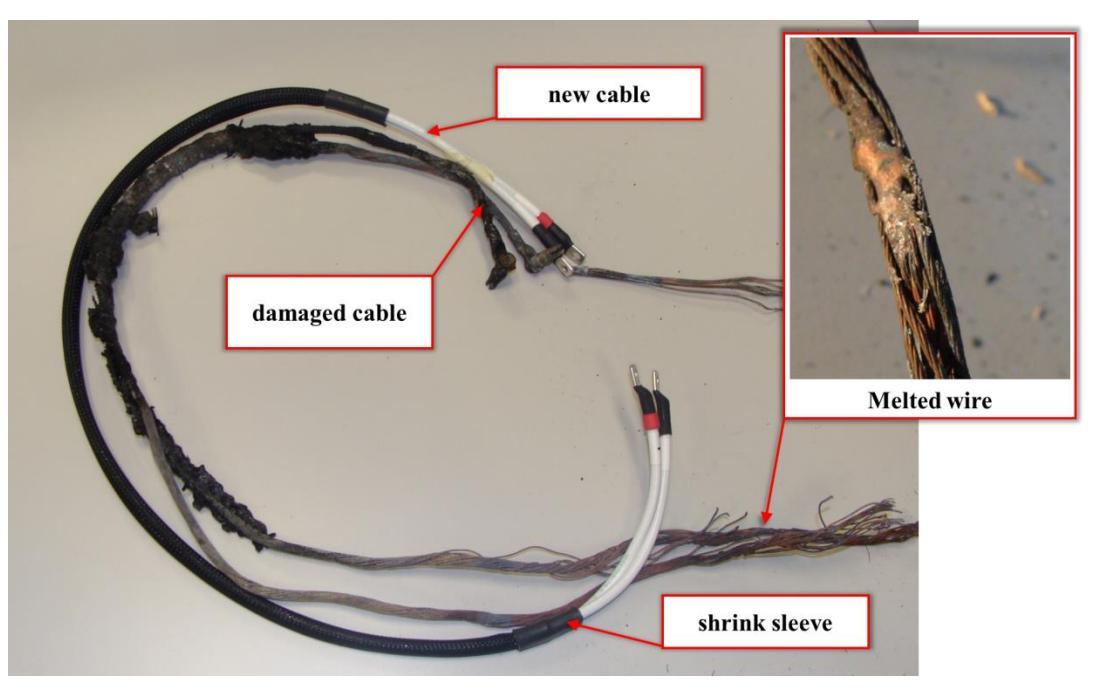
The positive and negative branches of the insulated cables of the parallel connection run along each other, placed in a common plastic protective cable sock (Figure 5). The protective cable socks and the cables were fastened together by shrink sleeves at 10 cm from the cable ends.

While examining the wreck in detail, the IC found surfaces typical of metal melting, i.e. signs of electrical short circuit, on the positive and negative branches of the wires which connect the two batteries. The marks of molten metal were located ca. 10 cm from the cable poles at the assumed place of the shrink sleeve (or in its close proximity) which fastens the protective cable sock and the positive and negative cables. The position of the IC is that the short circuit developed as a consequence of the accident.

Figure 5: The pair of cables damaged in the accident vs. a new one

- The cables connecting the batteries were heated and part of their insulation melted;
- In the case of the cables of opposite polarity running immediately along each other, the insulation, which melted at a point, lost its isolating function and allowed an electric arc to occur. That caused the damage, typically the mark of short circuit, in the pair of cables of the parallel connection (see Chapter 1.6.5).

During the investigation, the IC found electric cables which connected the two batteries, and the cable surfaces showed a molten area which was a consequence of the fire which had started before.

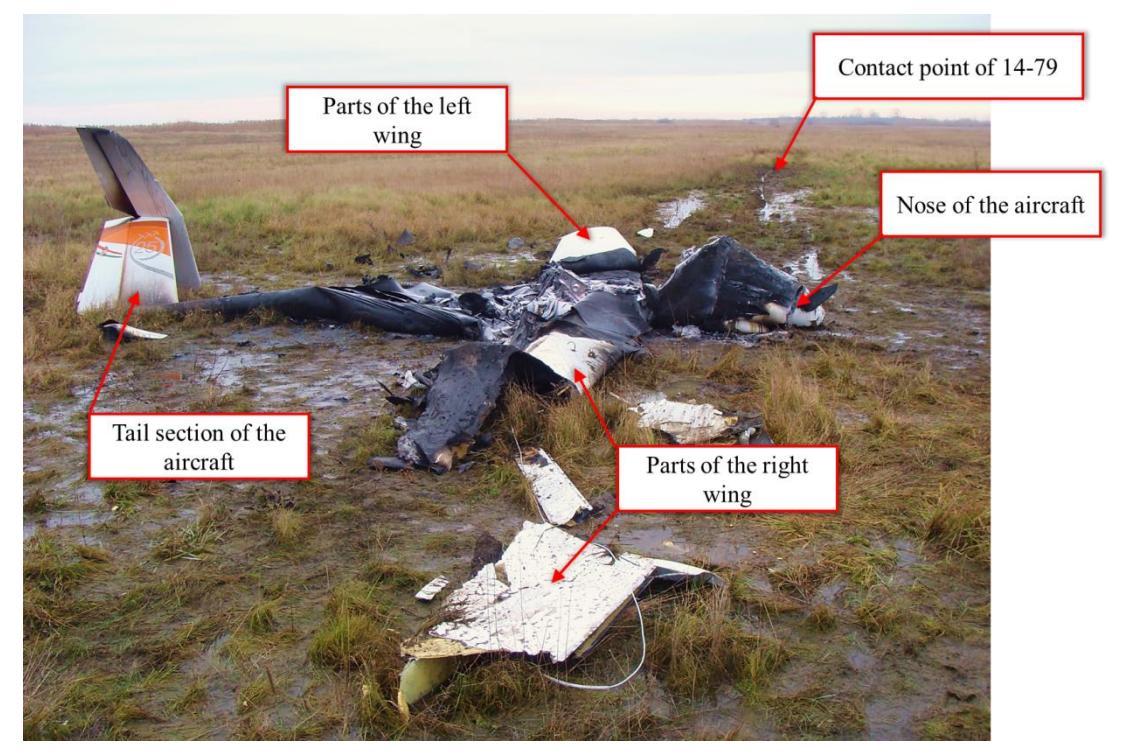
The wreck of the aircraft was found at the location with coordinates N47.16886° and E019.09895°. The area of the emergency landing is a boggy terrain with swampy surface, partly covered with water. The wreck was found in the 302° direction as seen from the point of landing, at a distance of ca. 49 metres. The marks in the terrain show that the aircraft hit the ground with high energy, which is supported by the fact that the nose gear broke out. In its still position, the direction of the aircraft deviated 90° to the left from the direction of landing (Figure 6 and Annex 1).

On the basis of the investigation of the scene and the detailed analysis of the wreck performed in January 2015, the IC found that the source of the fire was not in the engine compartment. In addition, it was also found that the area most exposed to fire was the space behind the pilot's seat.

Figure 6: The wreck and the area where it landed

The aircraft burnt out fully after landing (Figure 6).

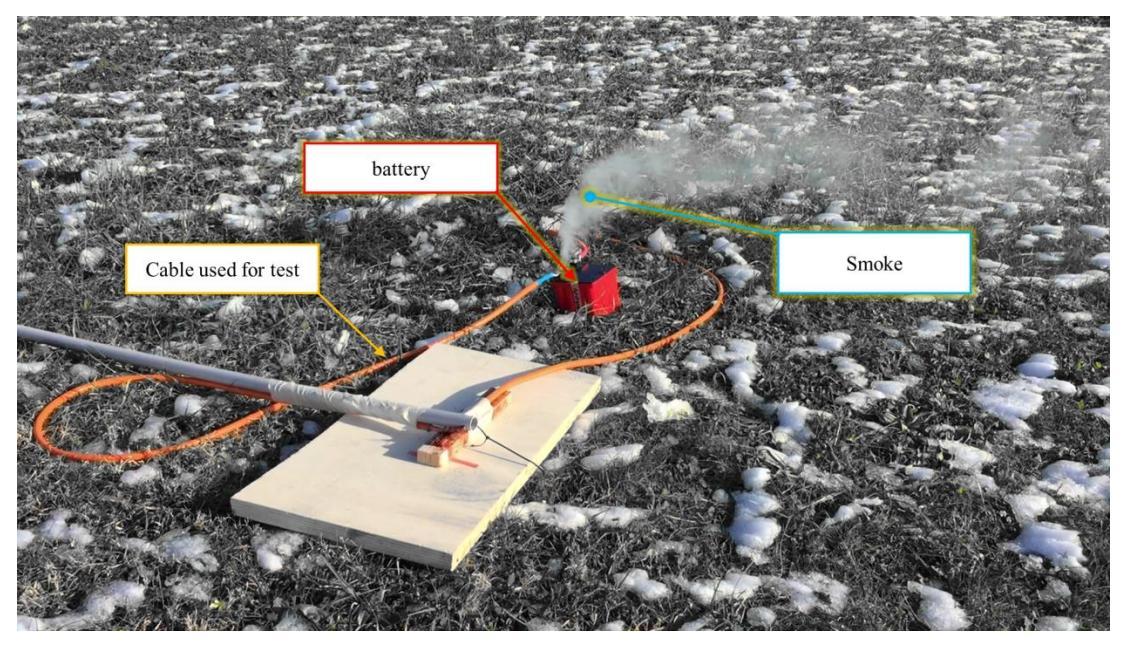
The small Lithium ion batteries of the handheld screwdriver were tested for short circuit on 5 March 2018. The test procedure was as follows: the IC created a short circuit involving one battery, and then continuously measured the terminal voltage and the temperature of the battery. The highest temperature thus measured was 96.9°C. The battery did not catch fire during the short circuit, and neither smoke nor acoustic effect was detected. The energy

stored in the battery was consumed in 1.5 to 2 minutes. During the period of load, its terminal voltage dropped so much that it could not be measured. The terminal voltage of the battery measured after the test was 0.17V, i.e. dropped largely as compared to the initial value of 3.6V.

Figure 7: Smoke was emitted by the battery after an electrical short circuit

During the investigation, the IC excluded the possibility that (in the case of a possible short circuit) the batteries of the handheld screwdriver on-board at the time of the occurrence (see Chapter 1.16) could have provided sufficient heat to damage the structure of the aircraft.

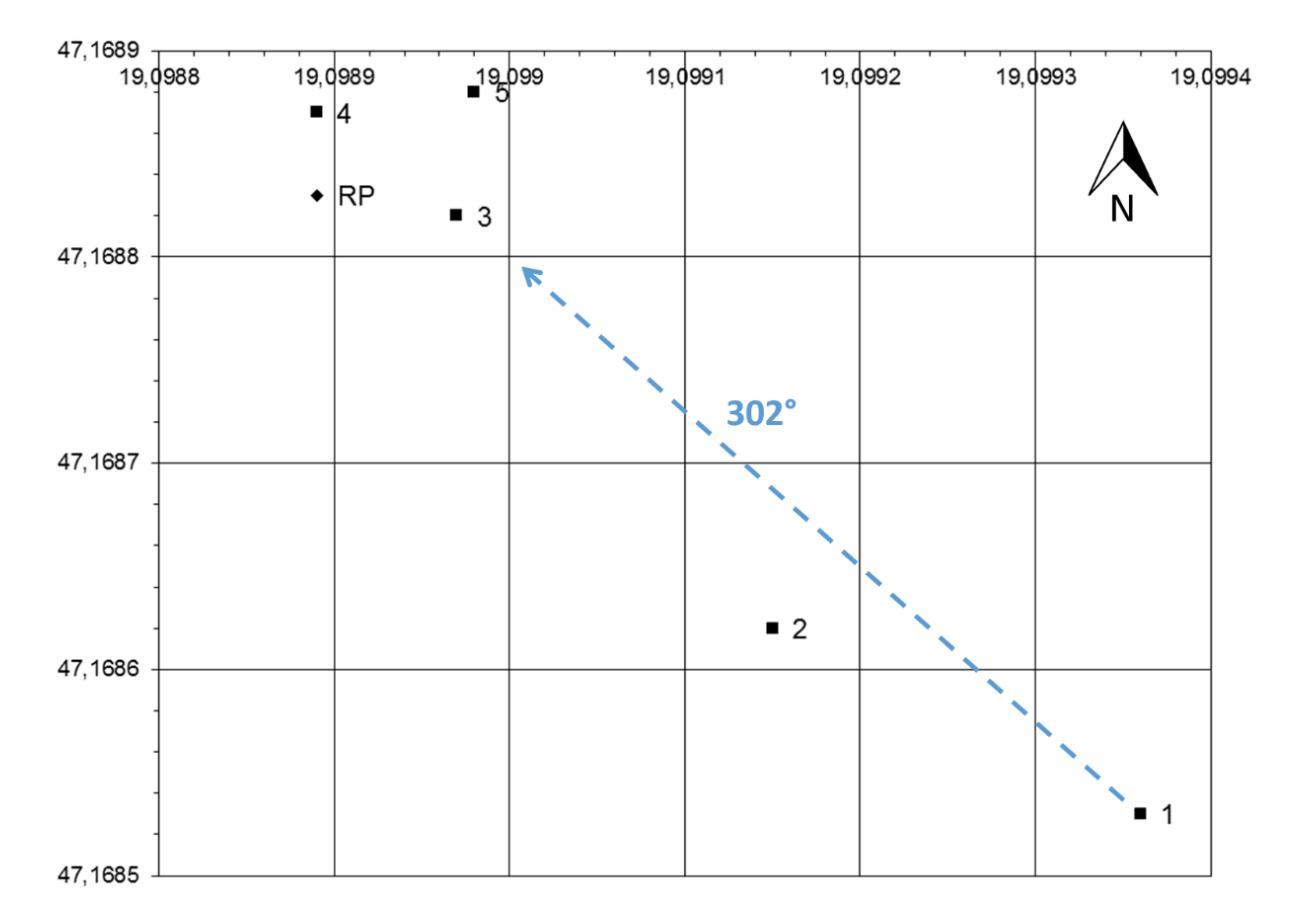
Annex 1: Diagram of the scene

(RP - aircraft heading, 1 - traces of landing, 2 - spot where nose gear was found, 3 - left wing tip, 4 - right wing tip, 5 - tail piece)

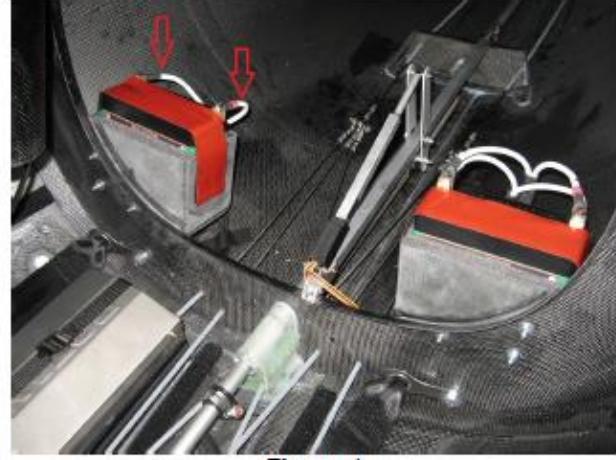
Figure 1

Concern has been raised about the use of two LiFePO4 batteries on Pipistrel aircraft. Instances of abnormal behavior and testing indicate that short circuits can occur and cause potentially dangerous current surges, if any of the batteries individual cells selfdischarge to sufficiently low levels.

To prevent any potentially dangerous battery failures, immediate disconnection of the second LiFePO4 battery is required.

In those aircraft that have both batteries located in the luggage compartment, the positive and negative cables need to be disconnected from the second battery (see Figure 1). Once disconnected, they must be fastened to something with tape or plastic ties, to prevent them from shifting and/or moving around during aircraft operation. More importantly, the cable terminals, as well as the battery terminals, must be thoroughly insulated/protected to prevent them from touching components/installations nearby. After the cable is disconnected, the second battery can either be left where it is or removed. Only the later requires redetermining the aircraft's weight and balance.
