MINISTRY FOR Innovation and Technology Transportation Safety Bureau

FINAL REPORT

2015-229-4P SERIOUS INCIDENT

DHC-8-400 / Schleicher Ka-8B SP-EQG / HA-4007

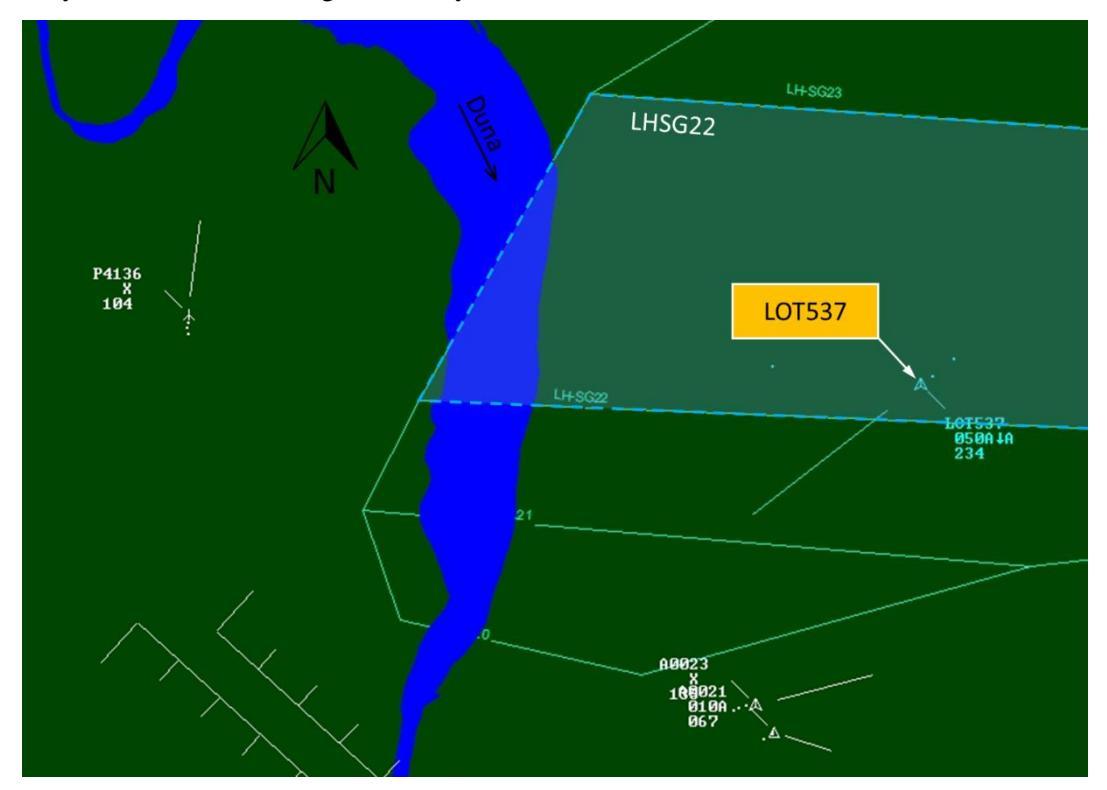
Figure 3: Approximate position of the LOT537 flight at the time of the occurrence

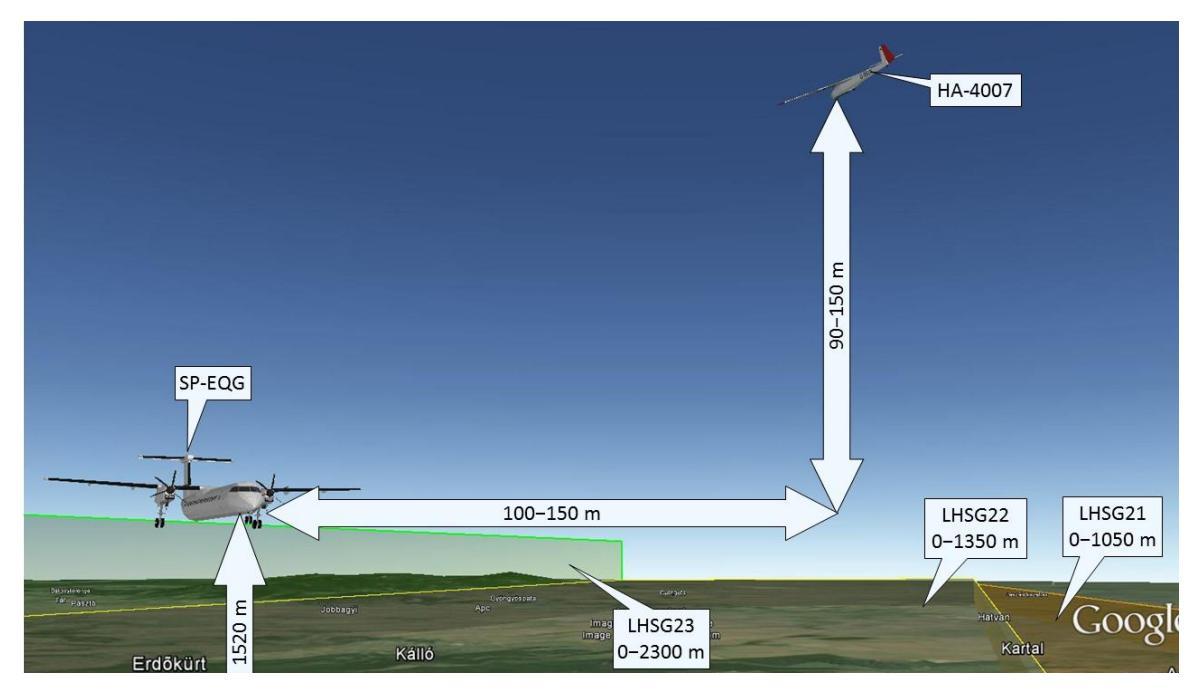
Figure 5: The positions of the two aircraft relative to each other as depicted according to the report of the crew of the LOT537

The ATC was notified of the infringement of separation minima from the crew of the LOT537 only because the glider had no responder, so its position was only detected but its altitude was not (*Figure 5*).

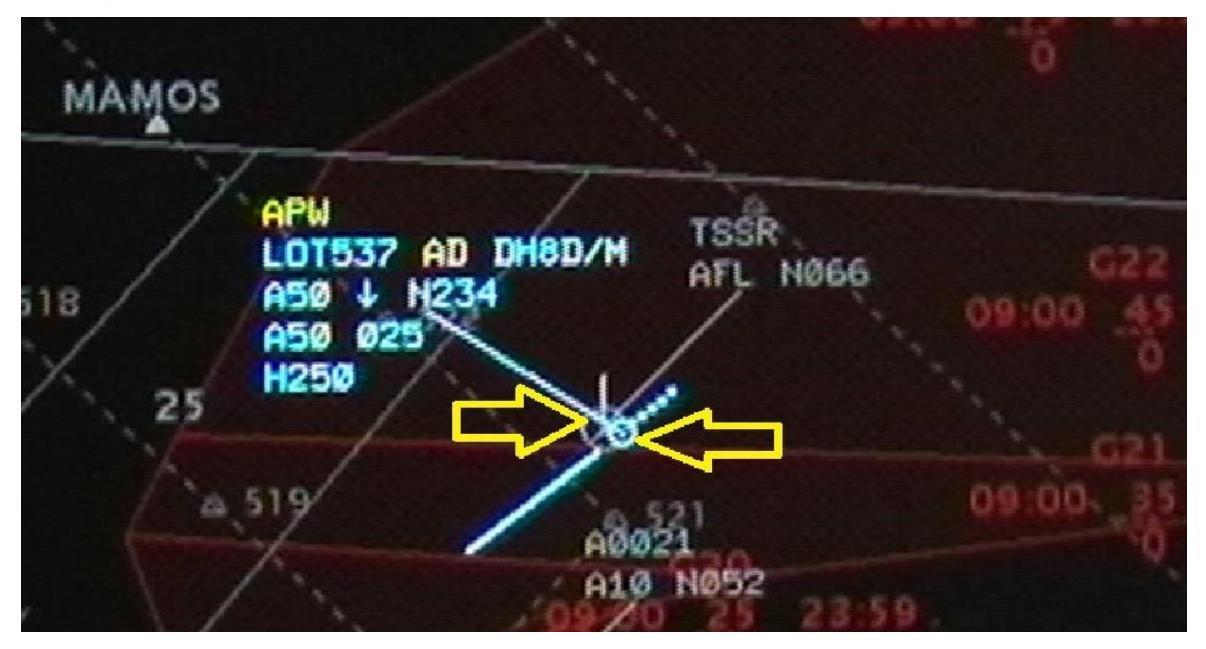
Figure 6: A primary radar signal can be seen in the vicinity of the LOT537 aircraft around the time of the event
