MINISTRY FOR Innovation and Technology Transportation Safety Bureau

FINAL REPORT

2016-082-4 accident

Tecnam P2002 JF HA-VOE

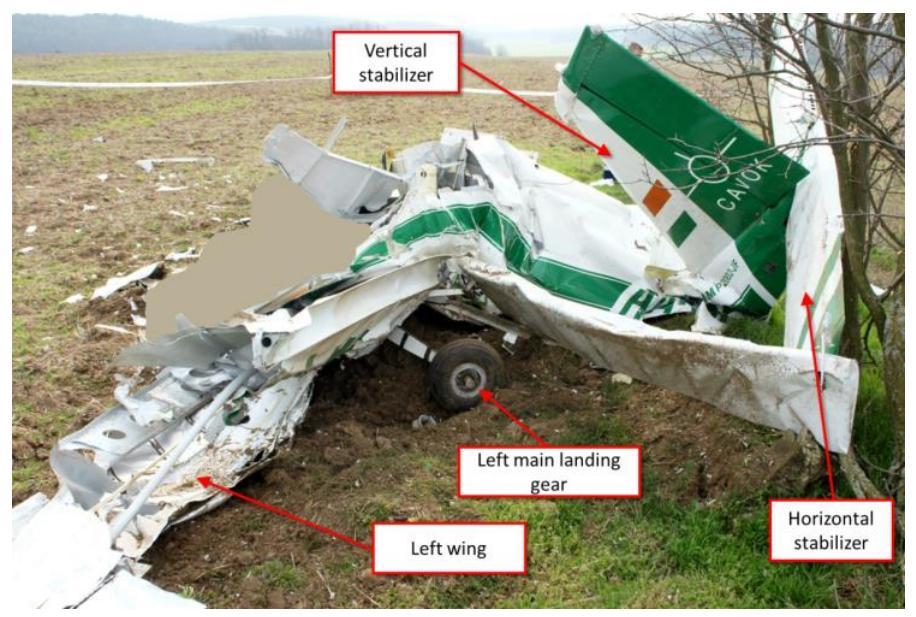
Figure 5: Damage to the airframe

The aircraft was destroyed in the accident. Upon ground impact, the nose part of the fuselage crumpled up as far as the seats.

The main landing gears were found almost intact, fastened to the fuselage. The fuselage buckled behind the trailing edge of the wings and right in front of the stabilisers. The stabilizers suffered

minor damage but stayed in place (Figure 5); the flap broke off the left wing and collided hit the horizontal stabilizer. The frame of the canopy separated from the fuselage and fell over the right wing tip. Each major structural element and spoiler of the aircraft was found in the vicinity of the impact.

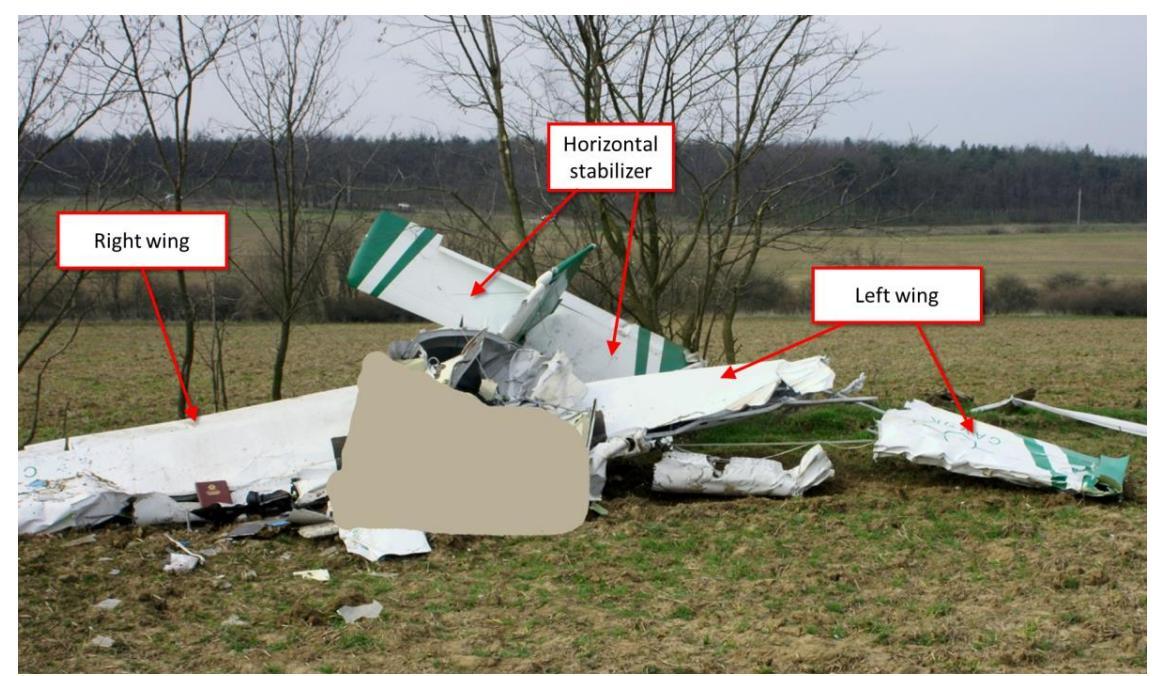
Figure 6: Damage to the wings

The left wing of the aircraft broke into two, and a significant part of the leading edge (from the wing tip towards the fuselage) showed the marks of ground impact. The right wing was damaged all along its leading edge, and it was moved forward slightly (Figure 6).

The aileron and the flap were separated from the left wing; the joints of these control surfaces remained intact on the right wing. The connections between the two wings and the aircraft were intact. The flaps were retracted at the moment of ground impact.

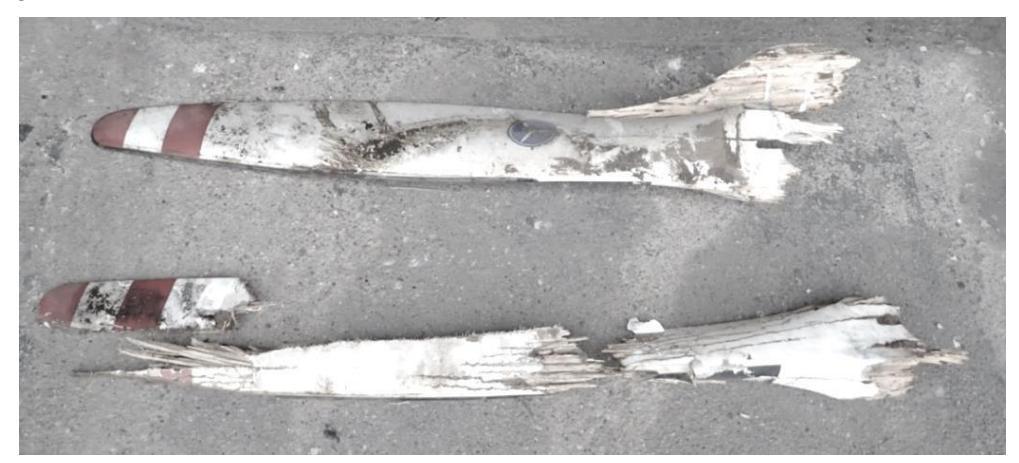
Figure 7: Damage to the propeller

The engine and the propeller got stuck into the ground to a depth of 60 to 70 cm. One of the rotor blades broke into smaller pieces, while the other broke off the hub and remained almost whole (Figure 7). The nose landing gear broke off due to the impact, and gut trapped under the fuselage.

The marks suggest that all the damages of the aircraft occurred during ground impact.

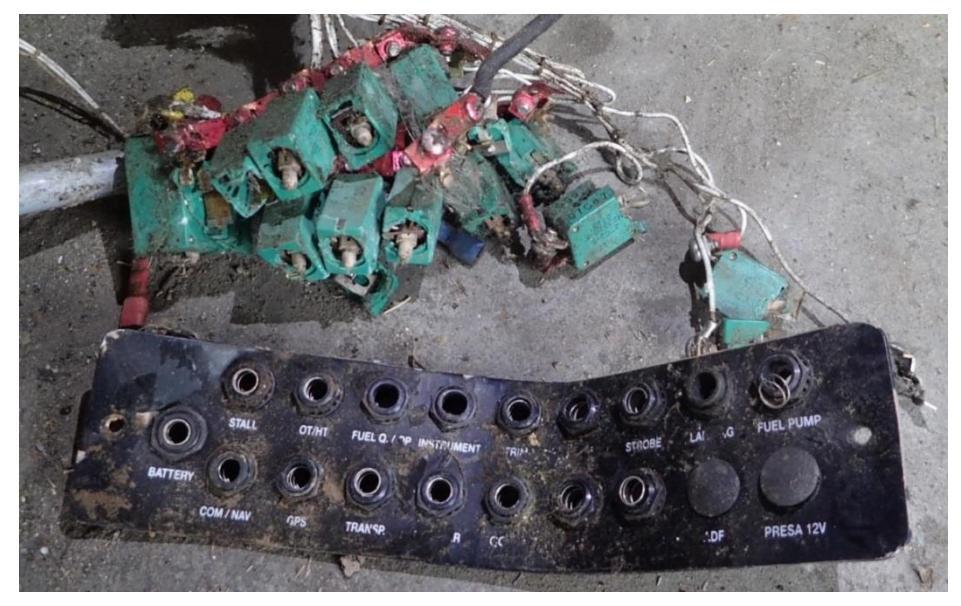
Figure 8: The damaged CB panel

The IC found the panels of the automatic circuit breakers (CB) of the aircraft, but the components installed in them broke out during the crash (Figure 8). Due to the damage caused to the panels by ground impact, it was impossible to check the pre-crash positions of the circuit breakers.

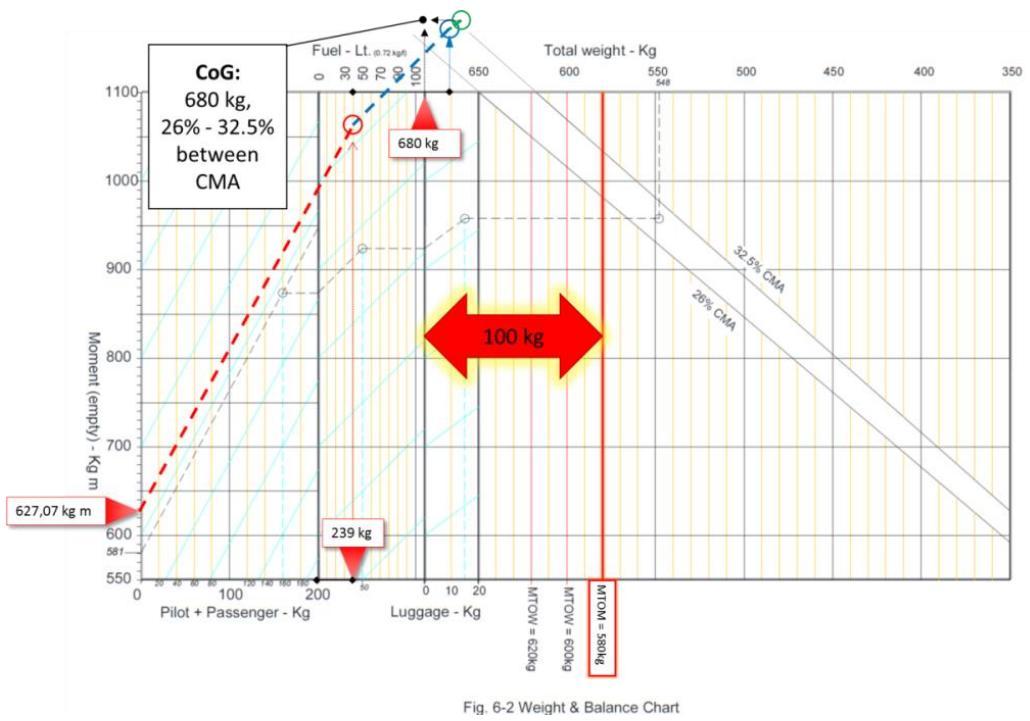
Figure 9: calculation of the mass and CoG at the time of the accident

At the time of the engine start before the flight ending up in accident, the mass of the HA-VOE aircraft exceeded the maximum limit by 104 kg; its centre of gravity was within the specified limits. In order to determine the mass and centre of gravity at the time of the accident, the IC calculated the centre of gravity according to the flight manual of the HA-VOE aircraft (Figure 9). The calculation results show that that the centre of gravity was within the specified limits, and the total mass of the aircraft exceeded the specified upper limit by 100 kg. The IC did not find any document, neither on-board nor at the airport of take-off, which would have proven that the pilot had performed pre-flight checks of the aircraft or calculations of the mass and CoG.

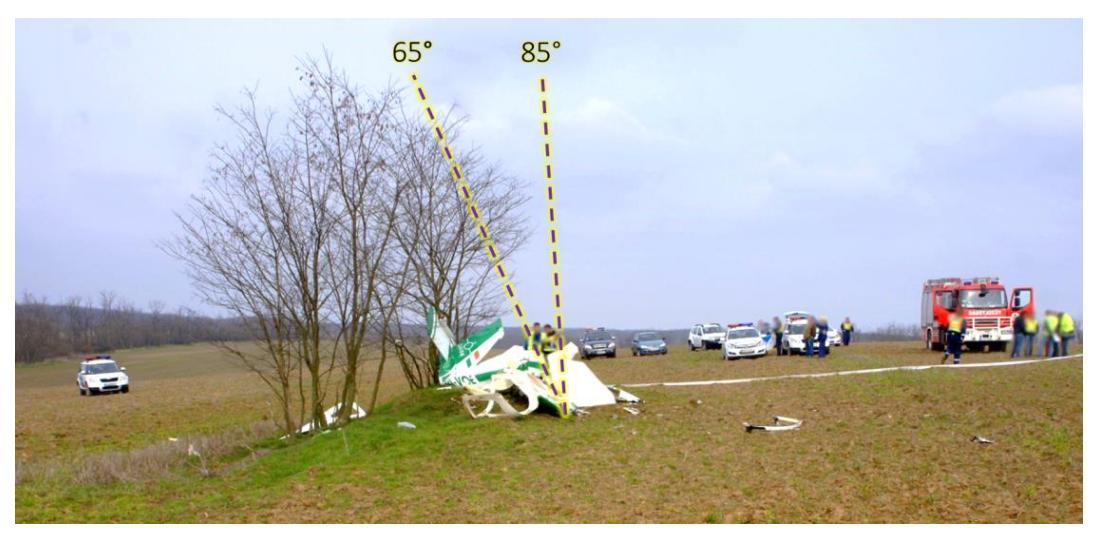
Figure 11: Determining the angle of impact

On the basis of the damages to the aircraft, the on-board instruments, the impact marks and the fractures of the tree branches, the IC concluded that the aircraft had impacted the ground from a steep fall, along a path with an angle of 65° to 85° to the ground, in a steep tilt angle (with its nose pointing downward) (Figure 11).

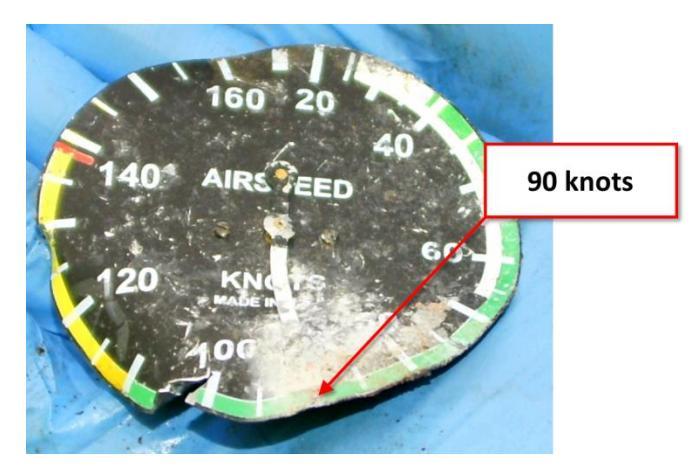
Figure 12: The airspeed indicator with its hand fixed

Due to the impact, the airspeed indicator of the aircraft suffered damages such extent that its indicator preserved the value displayed at the moment if the impact (Figure 12). The instrument reading was 90 knots (166.68 km/h).

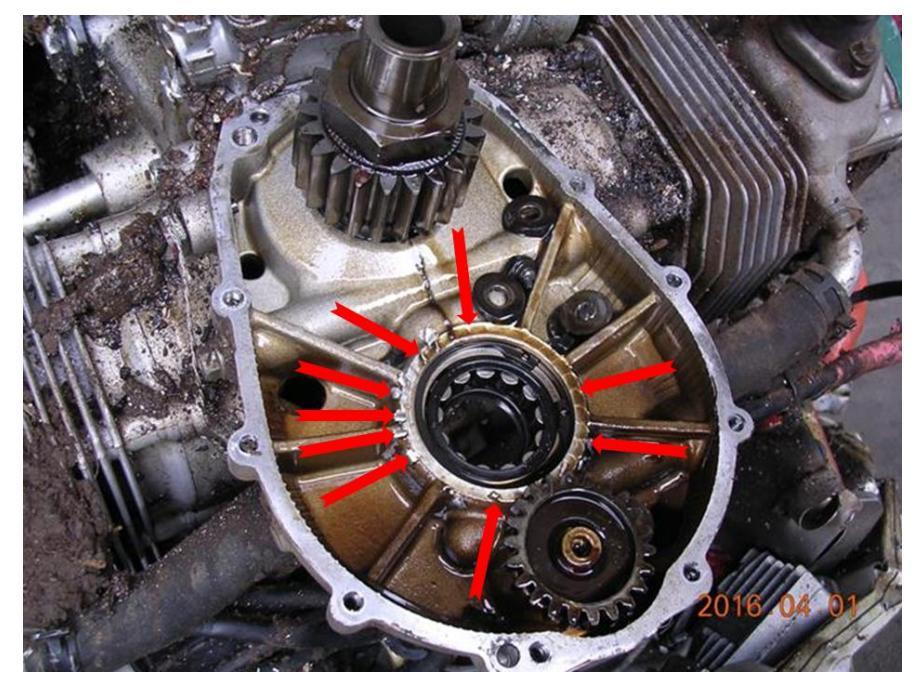
Figure 15: The cogwheel of the crankshaft of the engine and the engine-side surface of the propeller gearbox

During ground impact with the nose in front, the gearbox of the propeller got deformed, as a consequence of which the cogwheel of the propeller deeply scratched the surface of the gearbox at the engine side.

The red arrows in Figure 14 point to aluminium chips scratched out of the propeller gear house by the cogwheel of the propeller shaft.

The red arrows in Figure 15 show the points where the cogwheel of the propeller shaft contacted the engine-side surface of the gearbox.

Multiple fracture of one of the propeller blades and damages to the gearbox suggest that the engine and the propeller were rotating at the moment of ground impact, and then, after the gearbox was deformed, the cogwheel of the propeller shaft got pushed to the engine-side surface of the gearbox, and both the engine crankshaft and the propeller shaft stopped rotating.

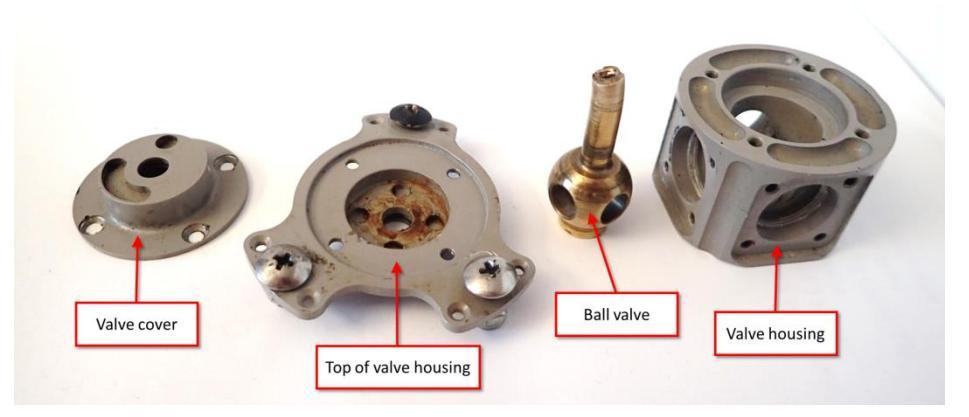
Figure 17: Parts of the damaged fuel ball valve

The setting mechanism of the fuel ball valve broke and the cover of the valve housing was significantly deformed due to the forces generated by the impact.

On 18 May 2016, the IC, ANSV and experts from Tecnam viewed the wreck in a joint effort. The engineer of Tecnam found the damaged fuel ball valve in OFF position.

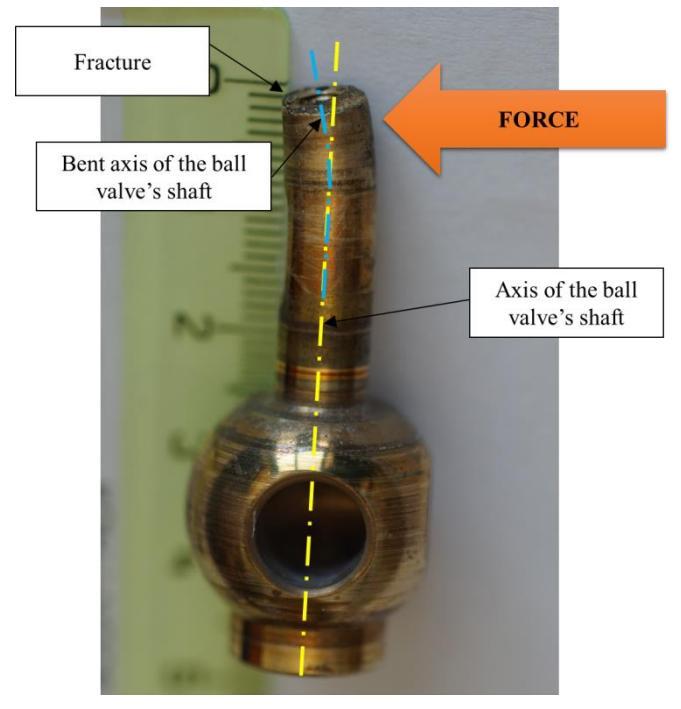
Figure 18: The damaged ball valve

The IC inspected the fuel ball valve in detail in order to determine its position at the moment of the ground impact (Figure 17). The opinion of the IC is that the deformations of the shaft of the ball valve (Figure 18) and of the valve housing (Figure 19) were consequences of the forces generated by the ground impact. The IC assembled the ball valve, taking into account the direction of the force and the deformations caused. On the basis of the inspection, it may be stated that the fuel ball valve was in open position at the moment of the ground impact, in such manner that the fuel system supplied the engine from the left hand side tank.

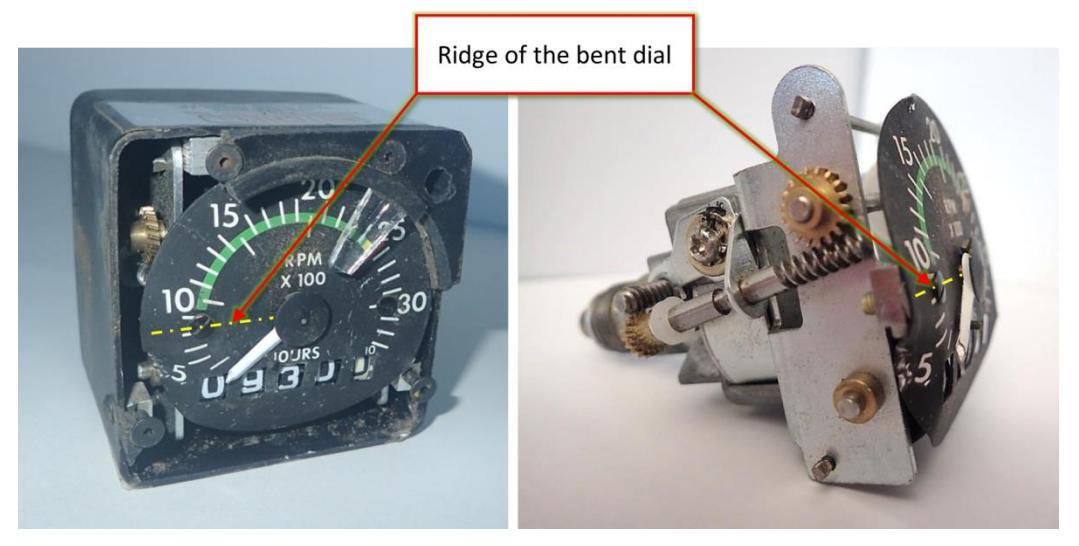
Figure 20: Damages to the dial and hand of the revolution meter of the propeller

The IC dismounted the propeller revolution meter from the wreck, and subjected it to further inspection. Prior to opening of the instrument, its glass cover had been found in broken state (Figure 20). The dial was dusty and showed signs of scratches as well. The IC found no signs of a punch mark caused by the hand of the instrument hitting the dial, which would have showed the RPM value at the moment of the ground impact.

At the time of the inspection, the hand showed 0 RPM and it moved freely within the range from it baseline position and the 800 RPM value (which was at the ridge of the bent dial). After removal of the hand and the dial, the rest of the instrument was found intact.

It may be concluded from the shape of the bent dial of the instrument that if the hand of the instrument had been in a position exceeding the 800 RPM value at the moment of the ground impact then the hand would have got into resting position at the other side of the ridge of the dial, somewhere around 900 RPM.

Based on damages to the dial and hand of the revolution meter of the propeller, the IC concluded that the hand of the instrument had been in the 0 to 800 RPM range at the moment of the ground impact. The transmission ratio between the engine and the propeller is 2.4286 (according to data in page 1-9, AFM), on the basis of which, the IC gives the engine rpm values associated to the given propeller rpm values in the following table:
