FINAL REPORT

2016-548-4 Incident

29 December 2016 Békásmegyer Area, Budapest

> OY-NAY / TB20 and HA-SJM / Cessna 172

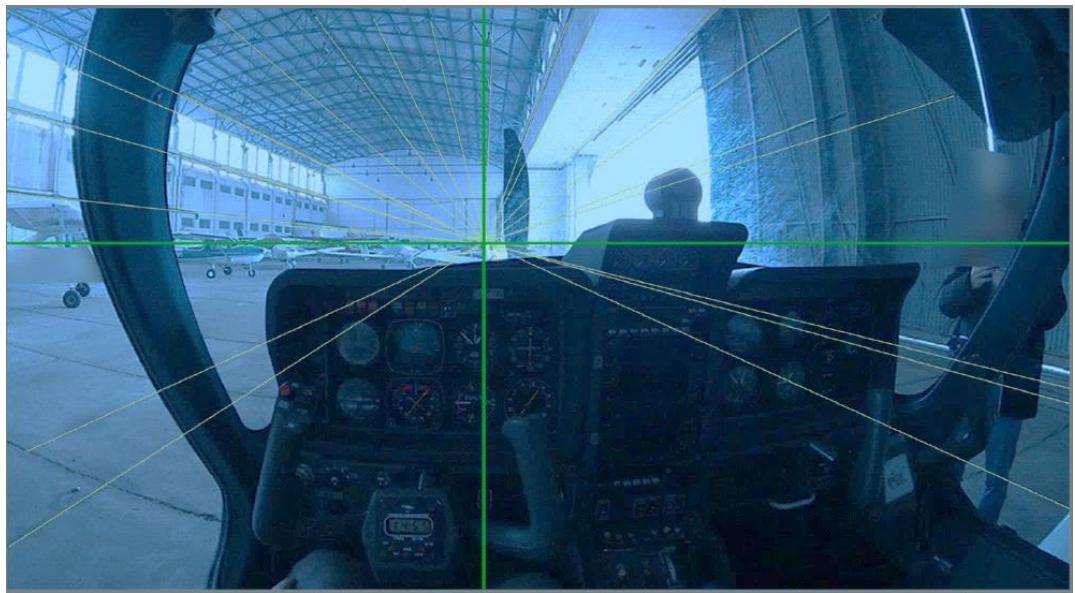
Figure 2: The view out of the LH side seat of the aircraft type TB20 Socata.

From the eye level of the pilot in the normal seating position, the angular subtense is less than 2° below the horizon between 8° and 30° to the right, from where the aircraft with reg. mark HA-SJM was approaching (*Figure 4*). At a later stage, the blind spot was also examined from camera angles higher than the normal seating position.

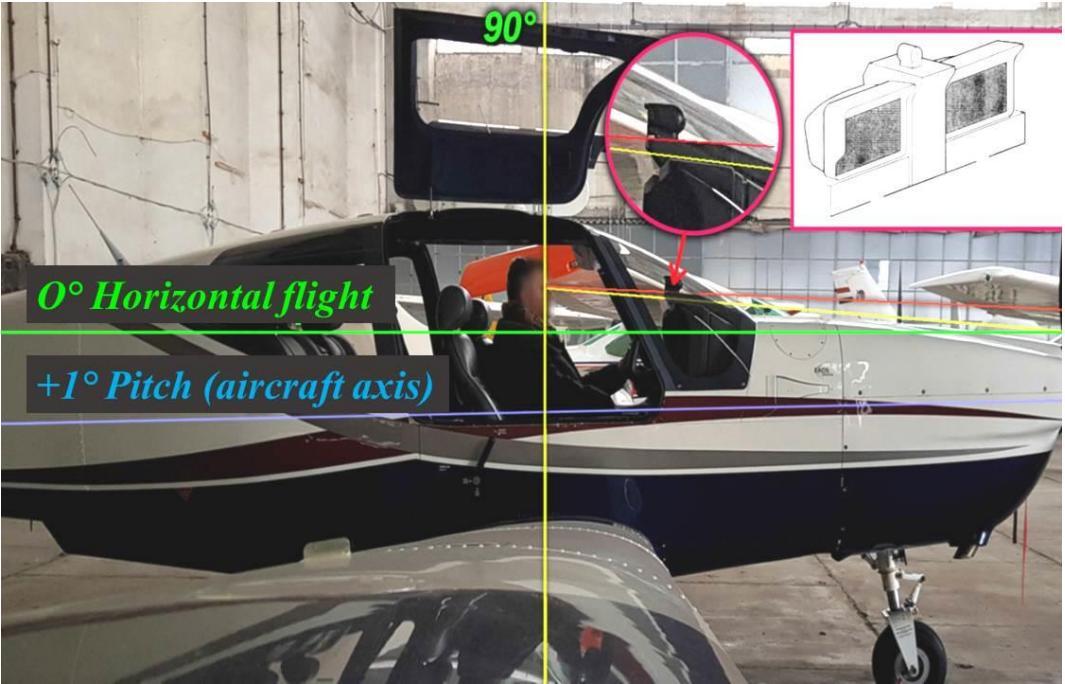
2. Figure 2: Measuring the Pilot's angle of view

The measurement experts measured the angle between the eyes of the pilot of the aircraft with reg. mark OY-NAY and the engine casing (*Figure 3*), as well as the distance of visibility straight ahead and in several different directions to the right, as the aircraft with reg. mark HA-SJM had come from there (*Figure 3* and *Annex 3*). It was found that the pilot of the aircraft with registration mark OY-NAY had had a visibility of only less than 5 km in the forward direction i.e. on the flight path (which was 300 feet lower) of the aircraft with reg. mark HA-SJM.

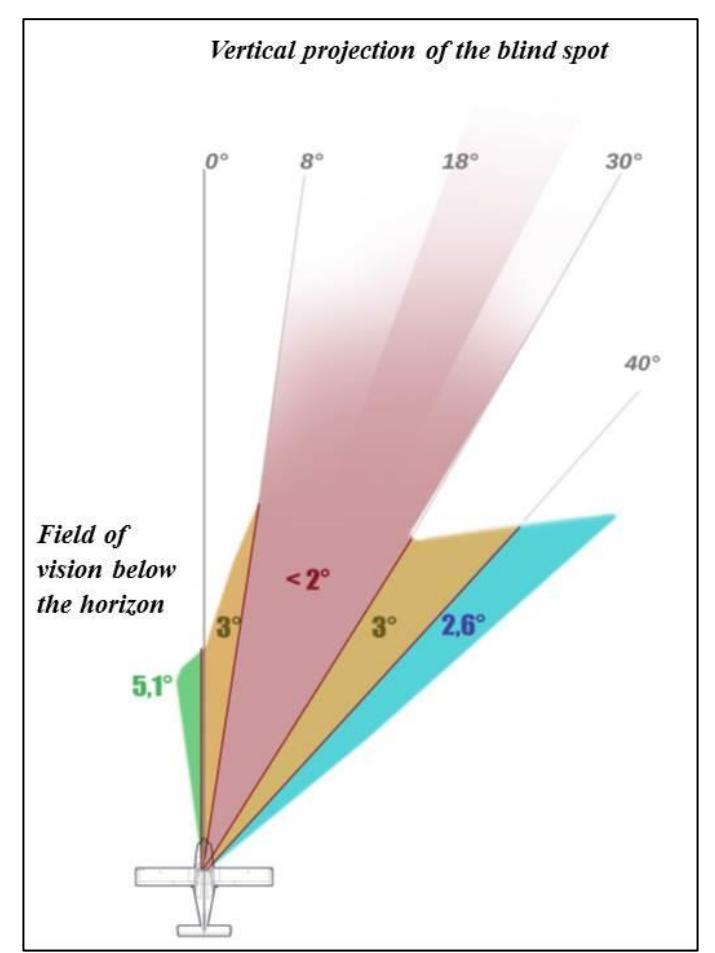
Figure 3: Results of the measurements of the blind spots of the type TB20 aircraft

The speeds and the trajectories of the flight paths show that the two aircraft were approaching each other with 180 to 200 knots. The MATIAS radar image shows that the aircraft with registration mark HA-SJM climbed for 27 seconds before the conflict, having started such climb from a 120-metres-lower altitude (and from a spot 2.7 km back) before becoming visible from the left seat of the type TB20 aircraft.

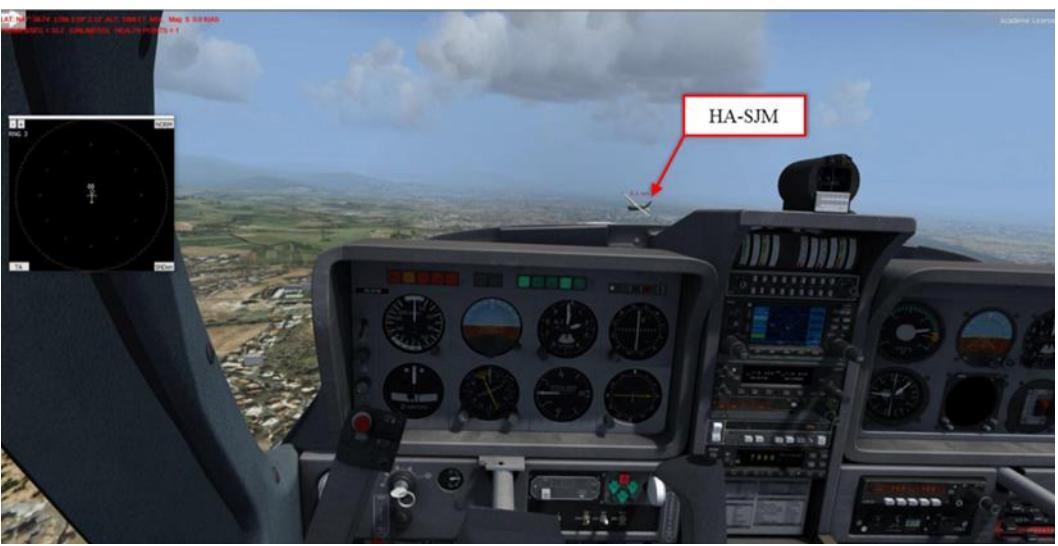
Figure 5: The HA-SJM enters the field of vision of the pilot of the OY-NAY

The result of the simulation was that, during the critical period, the aircraft with registration mark HA-SJM was flying within the blind spot of the aircraft with registration mark OY-NAY. The pilot of the aircraft with register mark OY-NAY had the chance to detect the other aircraft when it was only about 0.1 nautical miles (185 metres) ahead, almost at the same altitude, and was moving along an almost opposite route (*Figure 5*).

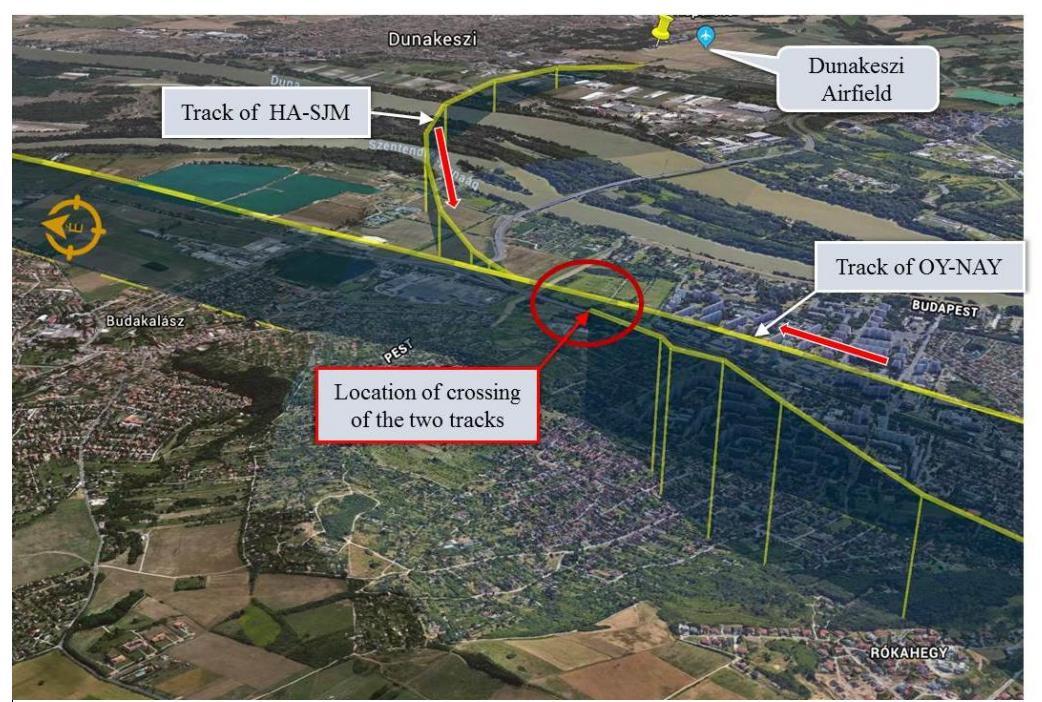
Figure 9: The crossing of the tracks of the two aircraft

After its take-off from Dunakeszi airfield, the aircraft with registration mark HA-SJM flew with a continuous left turn above District 3, climbing to a height of 1600 ft (Figure 9), without any flight plan being submitted, according to the information given by the pilot at the time of his check-in with the FIC. On the basis of the signals emitted by the aircraft, that altitude was reached and maintained for some time, but then the aircraft climbed to a height of 2000 ft. The signal of the transponder in the HA-SJM proved to be rather uncertain during the flight, which led to the absence of visibility on the flight information service radar screen at the time of the occurrence. On the basis of the MATIAS radar data recovered later, the flight path was traceable, but a lot of altitude data of the aircraft is missing. According to radar data, the radar signals of the aircraft with registration mark HA-SJM were just "thrown" intermittently between 11:46:26 and 11:46:46, actually due to the uncertain operation of its transponder and the proximity of the two aircraft, which resulted in giving inappropriate position data (Figure 10). Immediately before the conflict, the radar signals of the aircraft with registration mark HA-SJM did not represent the actual position, so the IC is of the opinion that it had flown with a continuous deviation from its intended track, to the left.

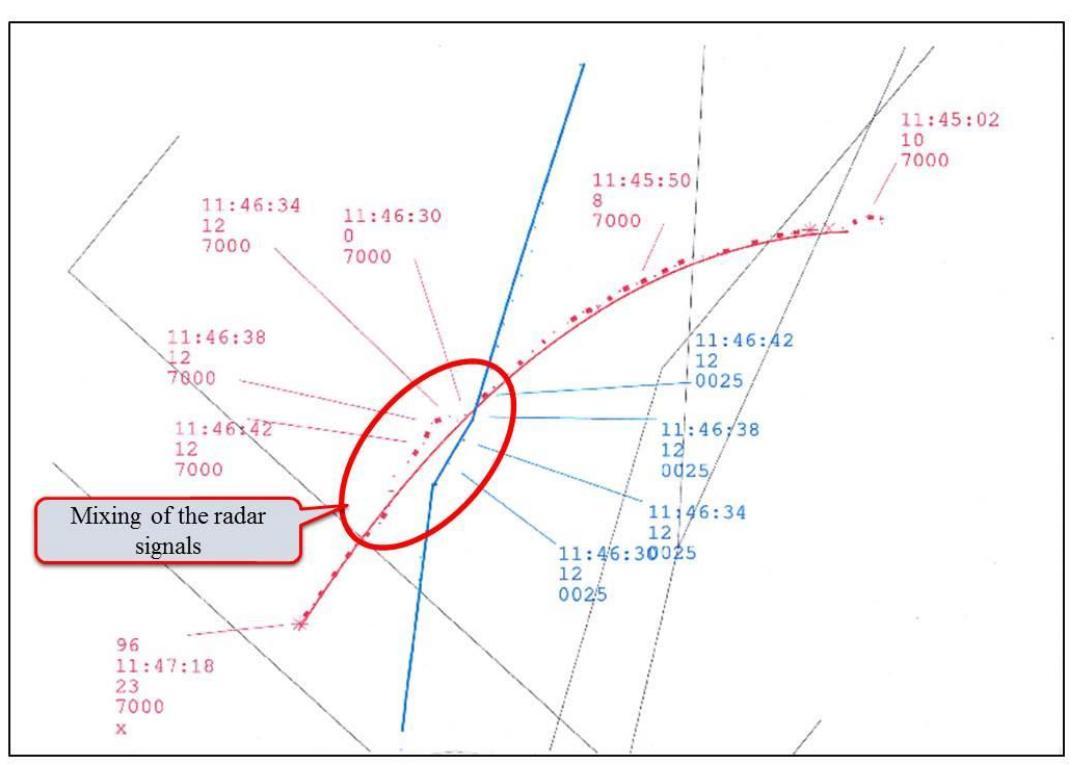
Figure 10: The dots represent the signals, and the solid lines represent the actual flight paths (red - HA-SJM, blue - OY-NAY).

On the basis of radar signals, it cannot be established that any of the pilots involved performed an evasive action during the conflict.
