# FINAL REPORT

# 2017-307-4 Accident

Pirtó 245° 2800 m 13 July 2017

> ASW 27-18E D-KRIB

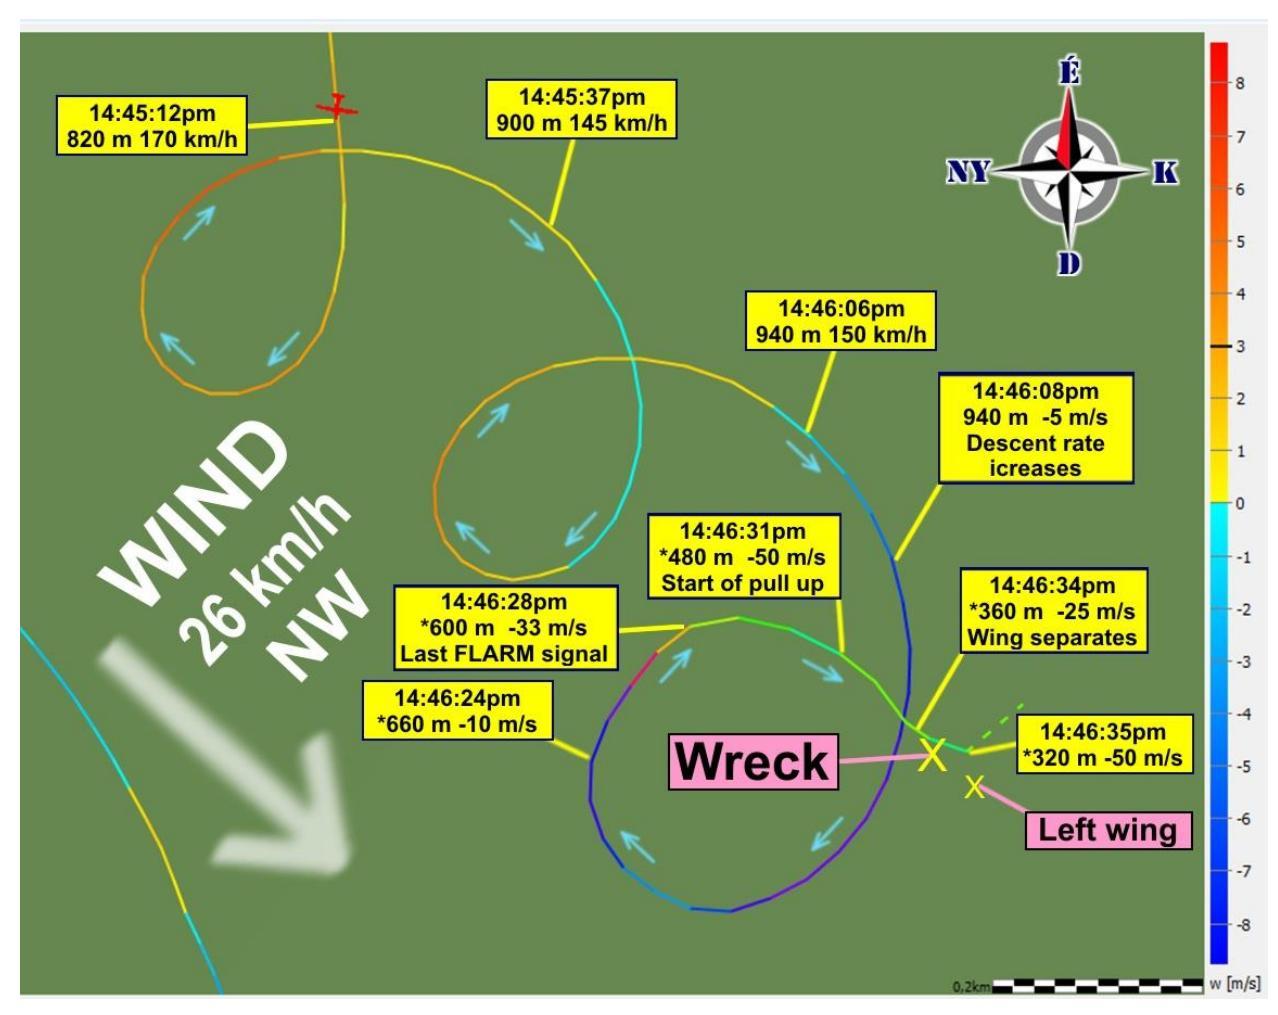
Figure 3: Last minutes of the flight. The colour of the flight path changes according to the vertical speed scale. (The values of the last 10 seconds are out of scale.) (\*altitude above ground level)

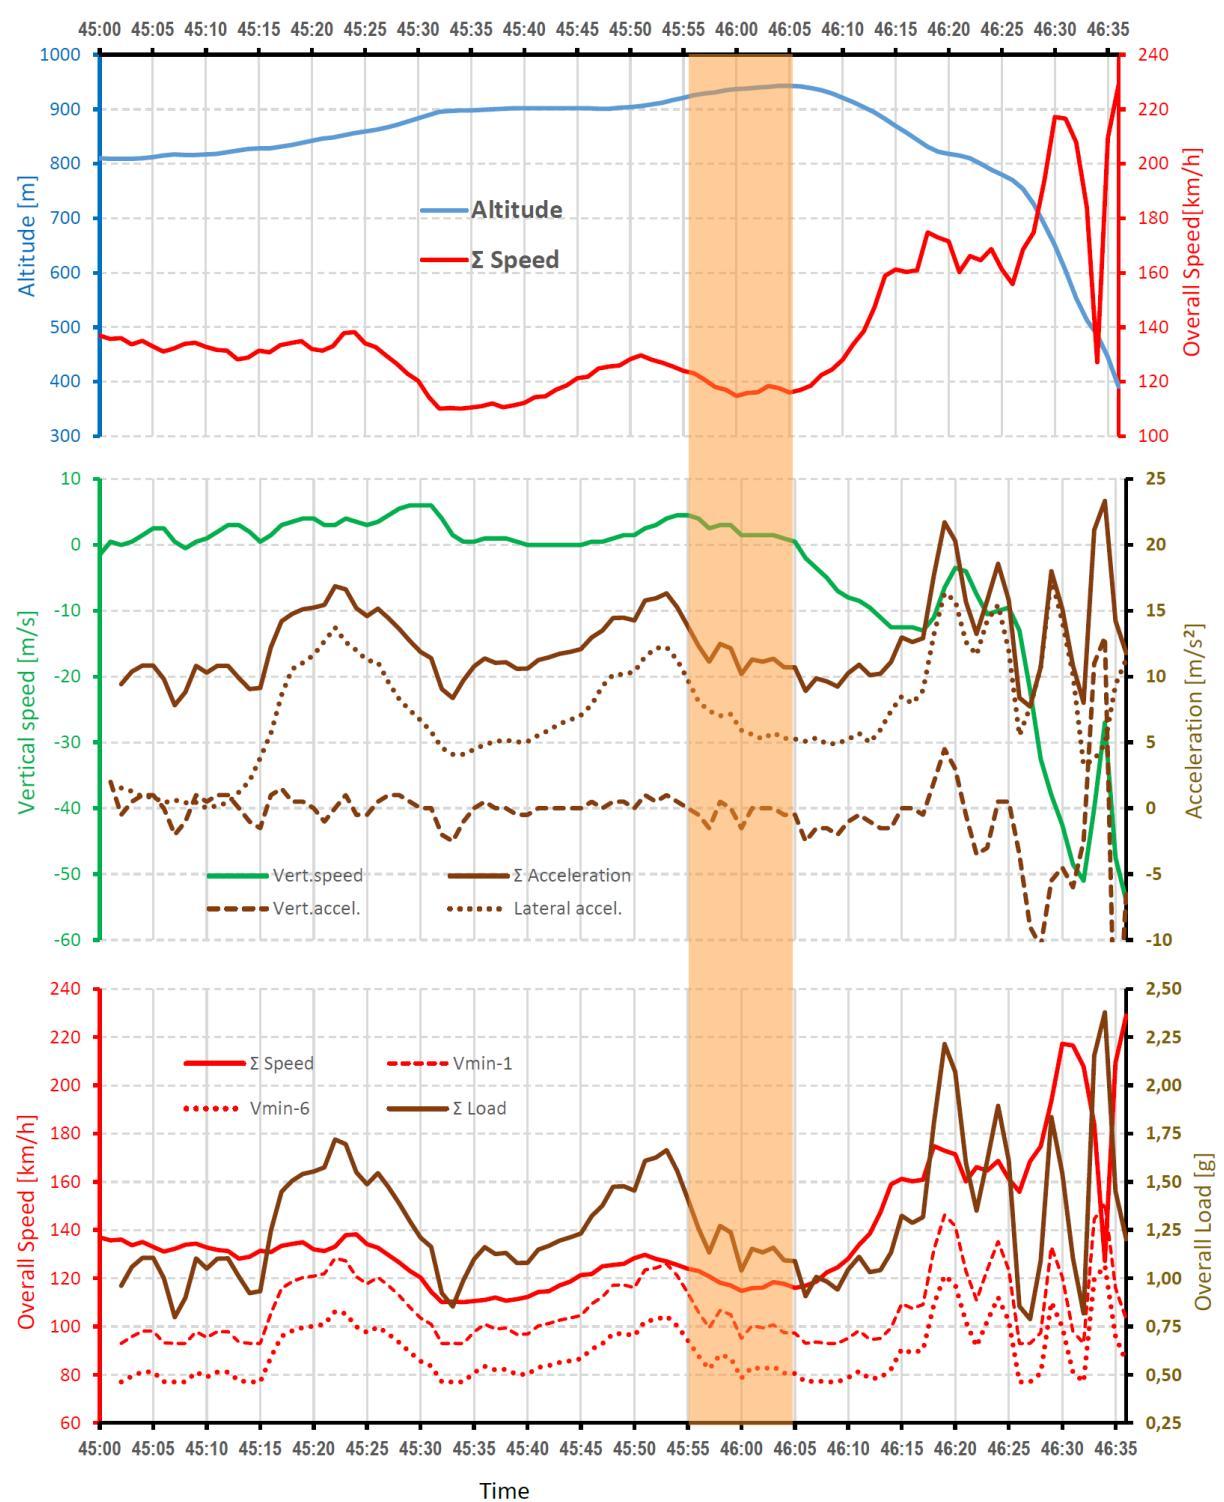
Figure 6: Data of the last 1.5 minutes of the flight, calculated from data measured by the LX8000 device

In the third circle of an attempt to climb in the thermal near Pirtó village, at 14:45:50-55, the speed of the sailplane exceeded the stalling speed value only by 10-17 km/h (depending on the flap setting), according to data recorded by and read out of the data recorder. In a situation like that, a more violent wind gust (which occurred quite often on that day) could have caused stalling of one or both wings. Possible closure of the flap (setting 1) may lead to stalling even without a wind gust. This is suggested by the unusually intensive and continuously accelerating loss of altitude which started a few seconds later (Figure 6).

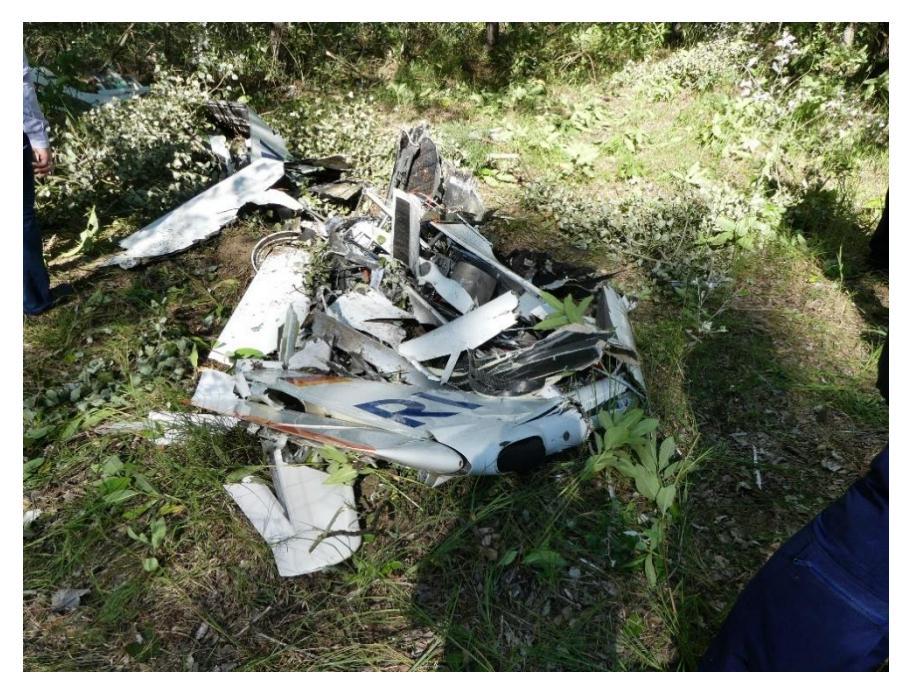
The fuselage of the aircraft and the unseparated right wing were found within a relatively small area but in extremely damaged state. It is a sign of vertical impact that most of the fuselage as well as the stabilizers and the ripped-off engine were found within a circle with a diameter of 3 metres (Figure 8). The nose part of the fuselage (with the body of the pilot) stuck in the sandy forest soil, in a depth of ca. 70 cm. No significant damage to nearby trees was found. Minor pieces of wreckage and other items from the aircraft were scattered around the wreck within a circle with a diameter of ca. 10 metres.

Figures 8: The fuselage with the stabilizers after the vertical impact

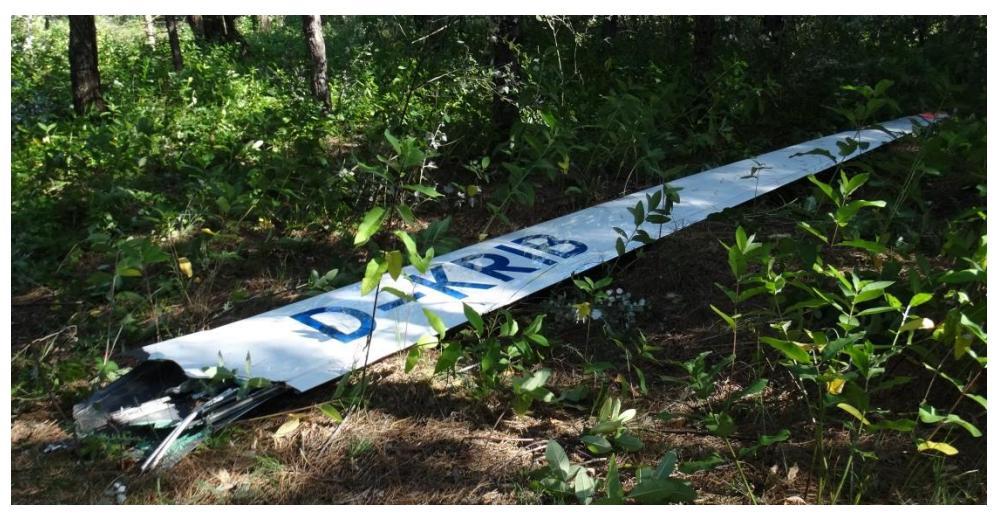
A 8,4-metre-long outer piece of the left wing was found lying, in relatively intact state, 58 metres southeast of the fuselage (Figure 9). Its aerodynamic elements (spoiler and flap) moved freely, but their actuator rod connections were torn, and their position at the moment of the accident could not be determined. Despite its fracture, the ballast water tank in the wing still contained a significant quantity of water.

Figure 9: The left wing which was ripped off in-flight

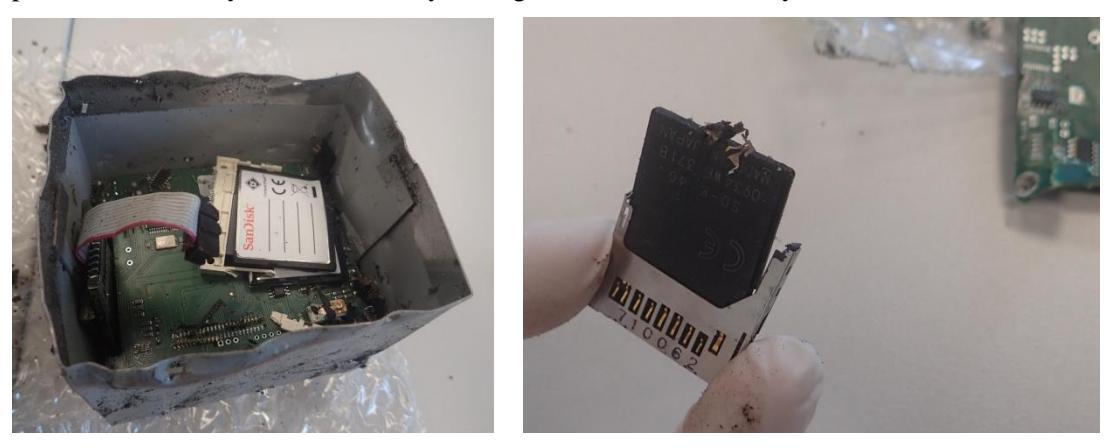
TSB sent the navigation equipment found in seriously damaged and deformed state at the scene of the accident to the manufacturer LXNav in Celje, Slovenia, for inspection and possible data recovery. Subsequently, the IC sent the removed memory cards (Figure 11) to a company specialised in data recovery. The inspection and data recovery effort brought partial success only, due to seriously damaged state of the memory cards.

Figure 11: LX8000 navigation equipment and the damaged memory cards found in it

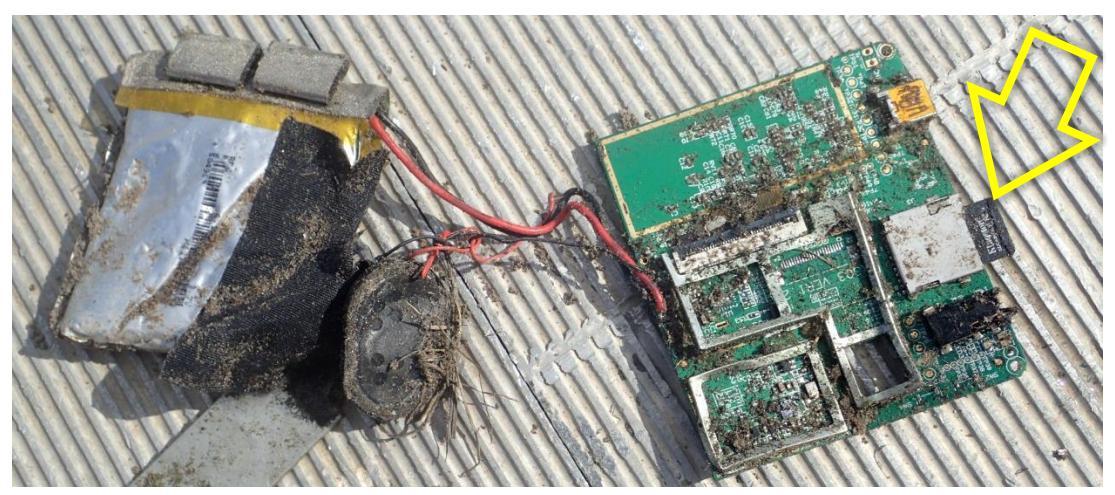
During the visit, representatives of TSB and other authorities inspected the scene of the accident and the wrecks of the aircraft involved. It was found that the landing gear, the canopy, the harnesses of the pilot's seat, as well as the discharge valves of the ballast water were in closed position. It was not possible to determine the positions of the controls (situated at the left hand side of the flight cabin) of the brake paddles and flaps at the time of the accident. During inspection of the site, an electronic device was found (Figure 12), which contained a type Kingston memory card which was taken to TSB for further inspection (1.16.3).

Figure 12: The damaged Colibri II device with its serviceable memory card as found during the additional visit

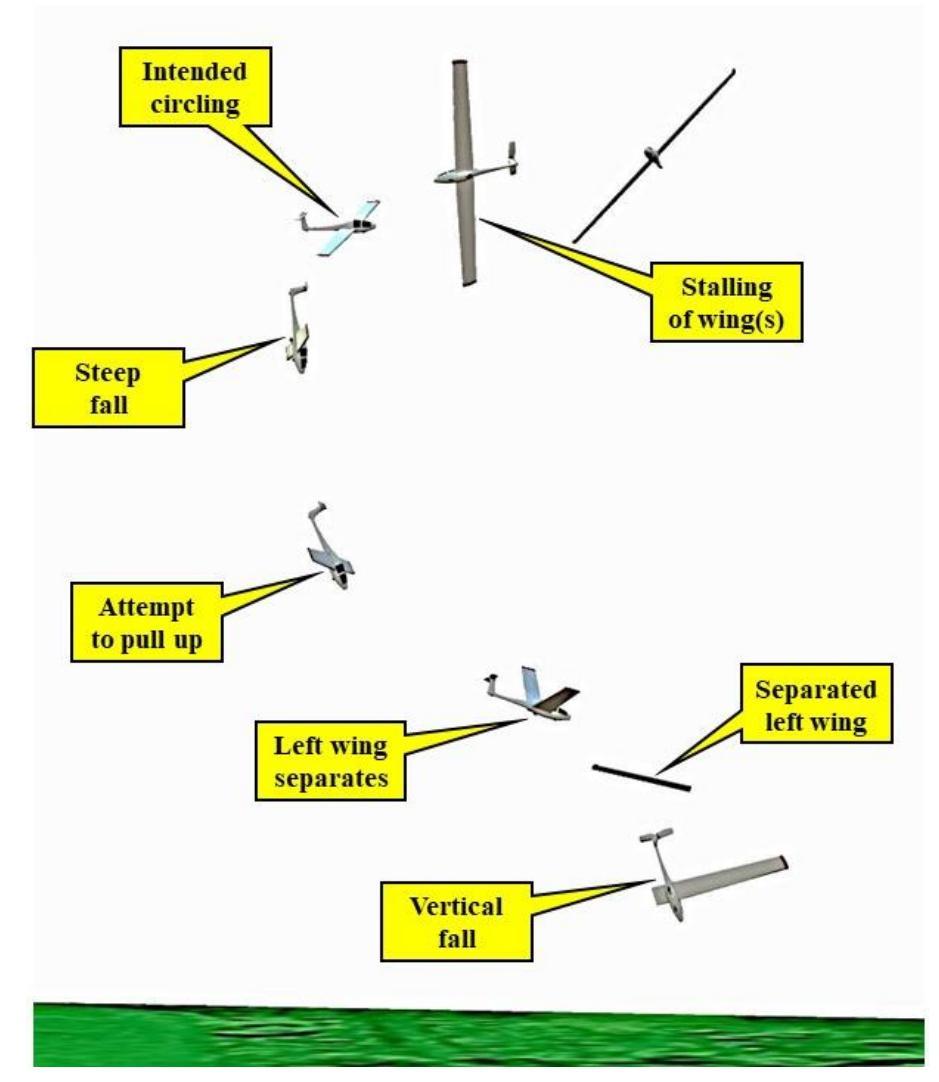
After the wing drop following the stall, the aircraft was rotating around its longitudinal axis, and lost altitude fast. After a few seconds, the pilot managed to stop rotation of the aircraft, and then she pulled the elevator lever firmly back in order to stop dive. The descent rate began to decrease. However, by that time, the speed of the aircraft loaded with water ballast had exceeded that value over which gross control manoeuvres may hazardously overload the structure of the aircraft. That did actually happen, and, as a result of overload, the wing spar fractured, and the left wing separated from the aircraft. The Flight Manual mentions (Section 1.18.1) that the airframe may be overloaded as a result of a stronger wind gust arriving at an unfavourable moment while the pilot is performing a permitted manoeuvre.

The process of pulling out of dive was disrupted, and the descent rate began to increase quickly again. As an effect of the unbalanced lift still acting on the right wing, the aircraft began to rotate to the left, which went on, together with the dive, until the aircraft crashed into the ground. The separated left wing fell at a significantly lower speed, owing to its higher drag relative to its mass, so it was damaged less than other parts of the aircraft, and it was drifted further away in the wind.

Figure 20: Assumed process of the accident

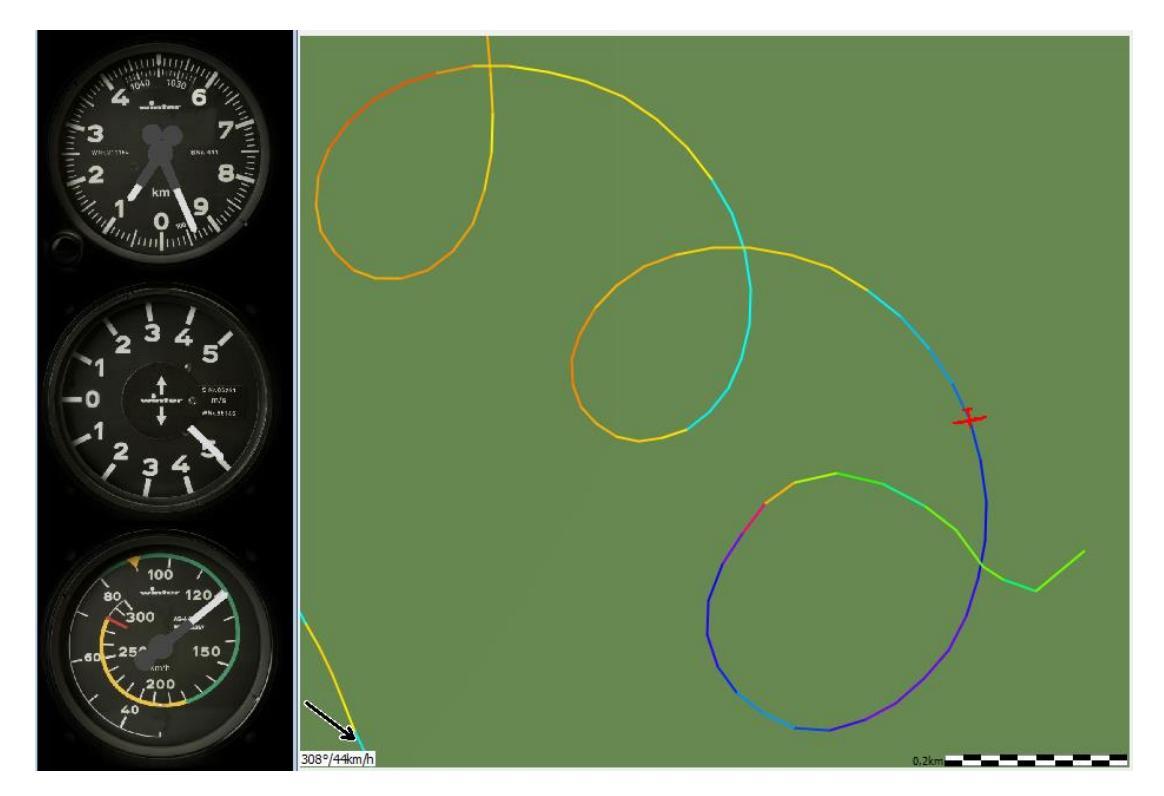
Figure 1/d: (Second -32) Start of dramatic loss of altitude.

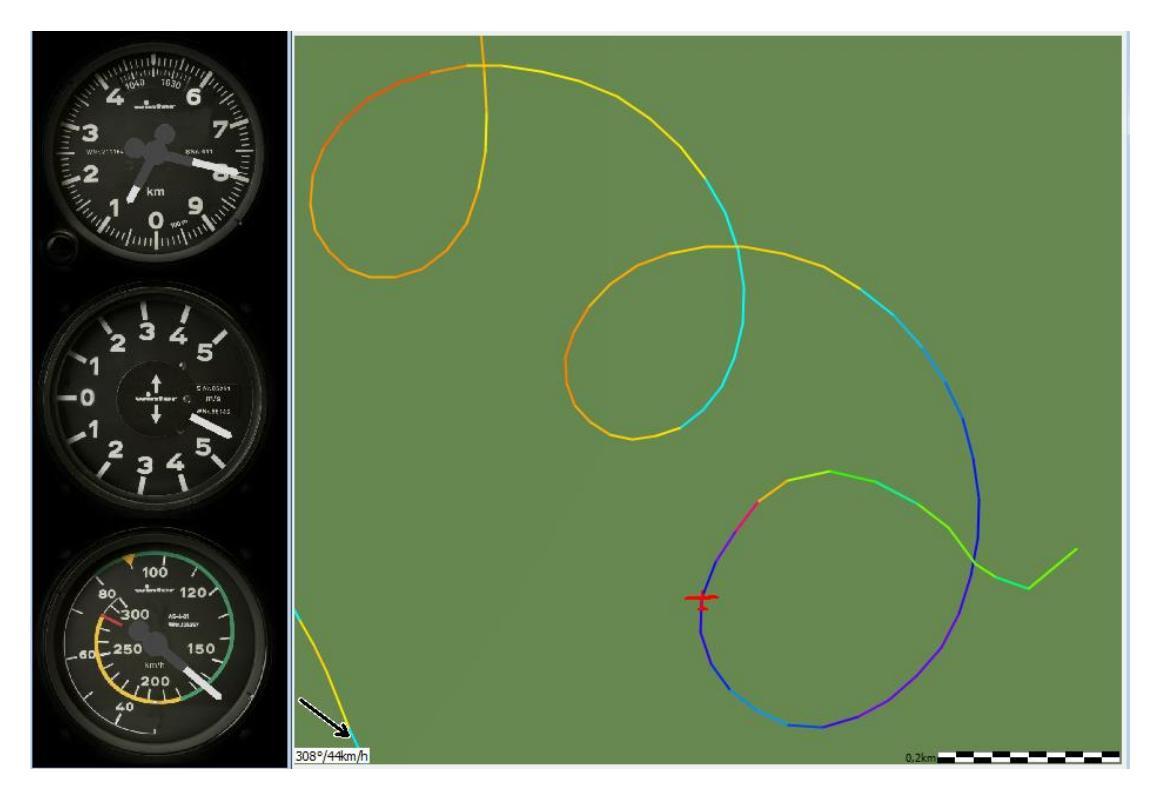
Figure 1/e: (Second -16) The rate of descent exceeds the 10 m/s value.

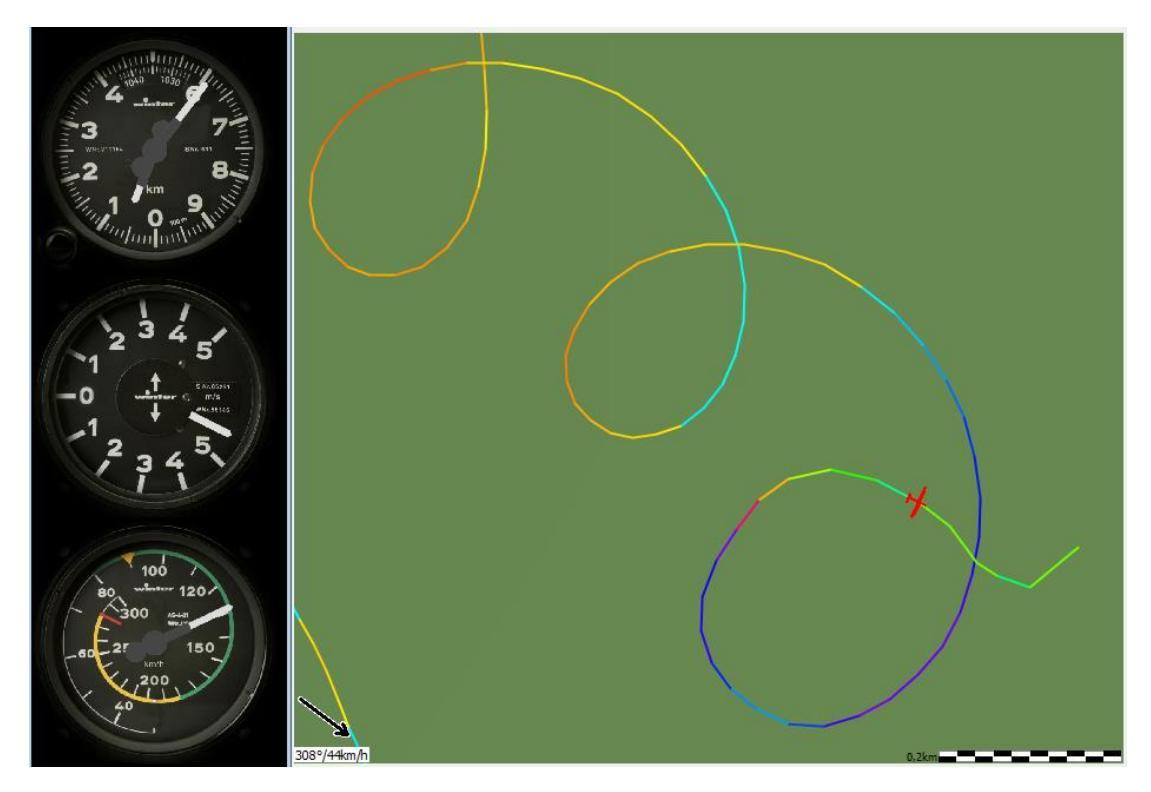
Figure 1/f: (Second -9) The rate of descent is 50 m/s, circling stops.

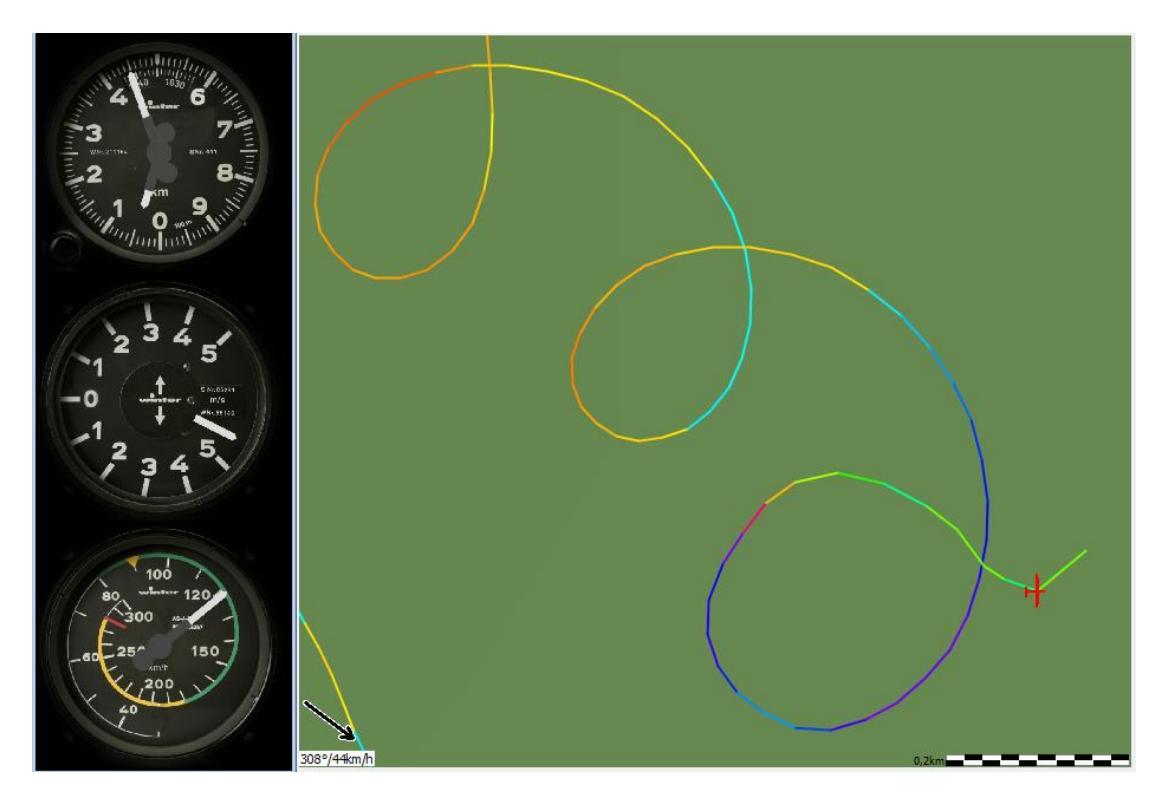
Figure 1/g: (Second -5) The rate of descent is 50 m/s, circling starts in the opposite direction, after supposed separation of the left wing; altitude above ground level is 320 metres.
