MINISTRY FOR Innovation and Technology Transportation Safety Bureau

# FINAL REPORT

2018-548-4

Cirrus Standard OK-7077 SZD-41 Jantar Standard HA-4361

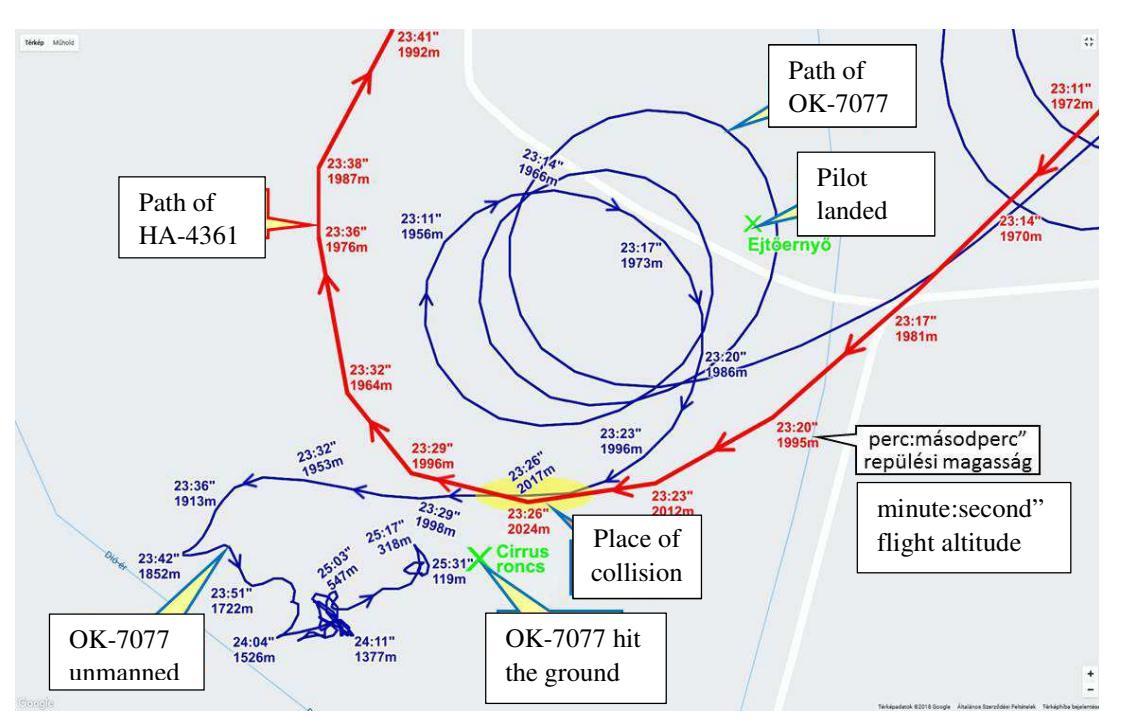
Figure 5: Movement of the aircraft involved, right before and after the collision

7077, running outside of it (Figure 5). However, the pilot of the OK-7077 reduced the bank of his aircraft, thus increasing the radius of its turn, so its path got closer to that of the HA-4361 aircraft which was outside of his primary visual field and the altitude of which was gradually nearing his own altitude. Due to the banking orientation, the altitudes of the wingtips were 4 to 5 metres different from those of the centres of gravity (Figure 6).

Prior to the collision, the fuselage and the right wing of the HA-4361 approached the left wing of the OK-7077 from behind and below. The impact force lifted the left wing of the OK-7077, and the aircraft tipped to the right along its longitudinal axis. The pilot of the OK-7077 jettisoned the canopy of the plane, unfastened the harness system, and, relying on the force of gravity, dropped out of the plane which was turning on its back. He deployed his parachute by pulling the rip cord handle, and landed safely after a temporary uplift in the thermal. Due to shift of its centre of gravity, his sailplane crashed in a spin on its back.

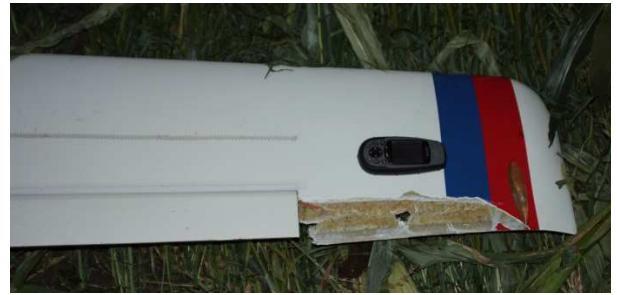
<u>**OK-7077**</u>: During investigation of the site, a continuous, red skid mark of 1.5 metres length was seen, running from the wing root towards the wing tip on the bottom part of the left wing of the aircraft found lying on its back. The structure of the wing was not damaged in this section. The trailing edge of the left wing was damaged in the section between the left aileron and the wingtip. Part of the lower surface of the wing was torn off in this section.

Figure 11: Lower part of left wing with the damaged trailing edge

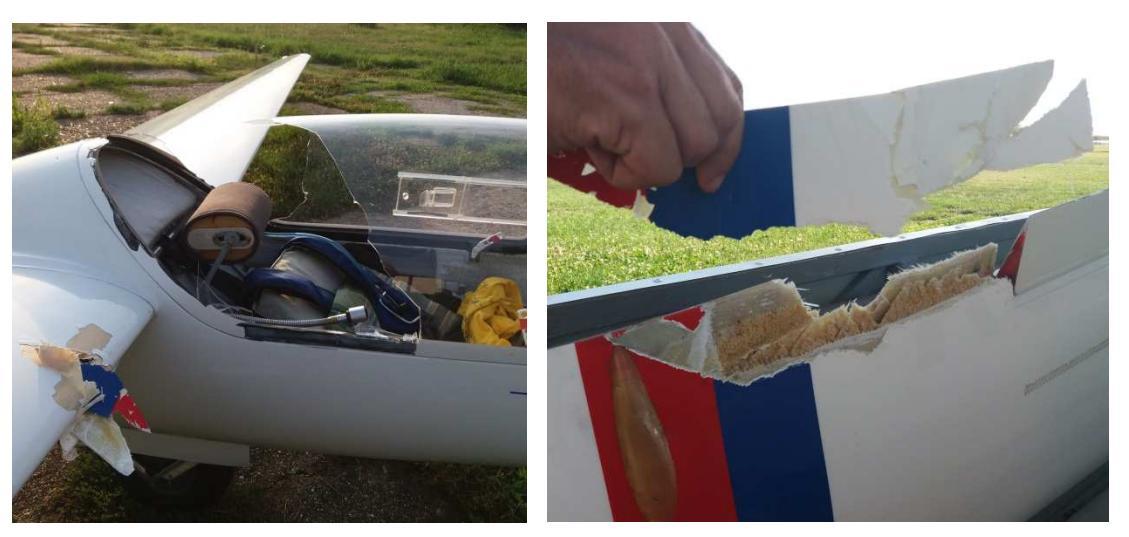
<u>**HA-4361</u>**: The rear 1/3 part of the Plexiglas of the rear part of the canopy broke and misses, some of its debris was found scattered inside the cabin. A longitudinal, gradually deepening scratch runs along the centreline of the canopy backwards as far as the edge of the fracture. At a distance of 25 cm from the fuselage, the leading edge of the right wing cracked to a depth of 15 cm. A piece of a trailing edge (made of composite and painted blue and red) broken off another aircraft (OK-7077) was wedged in the crack. Non-continuous abrasion and paint damages can be seen on the leading edge of the right wing. The red paint on the top front section of the right wingtip was completely rubbed off.</u>

Figure 12: The damaged canopy and the piece of trailing edge (from the OK-7077) which wedged into the wing

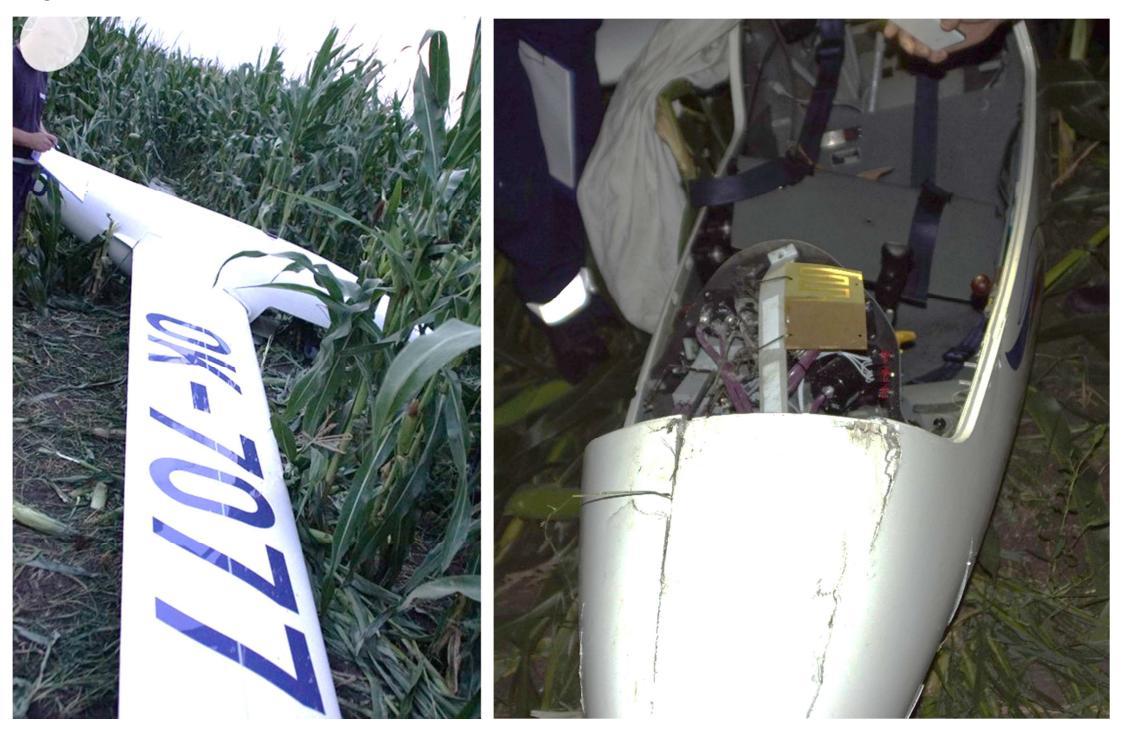
<u>**OK-7077**</u>: The aircraft touched down 5 kilometres west of Vésztő town; coordinates:  $46.92986^{\circ}N \ 021.18897^{\circ}E$ . The state of the surrounding vegetation and the wreck suggests that the aircraft hit the ground on its back, moving almost in vertical direction, at not very high speed. During the site investigation, a continuous, red skid mark of 1.5 metres length was seen, running from the wing root towards the wing tip on the bottom part of the left wing of the aircraft found lying on its back (Figure 18). This section of the wing structure was not damaged.

The trailing edge of the left wing was damaged between the aileron and the wing tip. A piece of the lower surface of the wing was torn off in this section. The right wingtip showed scratches and paint damages parallel to the longitudinal axis of the aircraft. The canopy fractured, and the cover on the nose of the aircraft cracked and broke in several places. (Figure 19). The inlet tube of the airspeed meter broke off. The trailing edge of the rudder at the side of the tail fin split apart along the trailing edge. Inside the cabin, the instrument console, which is a plate, was bent. As regards instruments, the display of the navigation system cracked, but proved to be serviceable, notwithstanding. That part of the trailing edge of the left wing which is between the aileron and the wing tip split apart in the width of a man's palm and its lower surface was torn off. The jettisoned canopy was not found in the vegetation which was as tall as a man.

Figure 18: Aircraft and vegetation

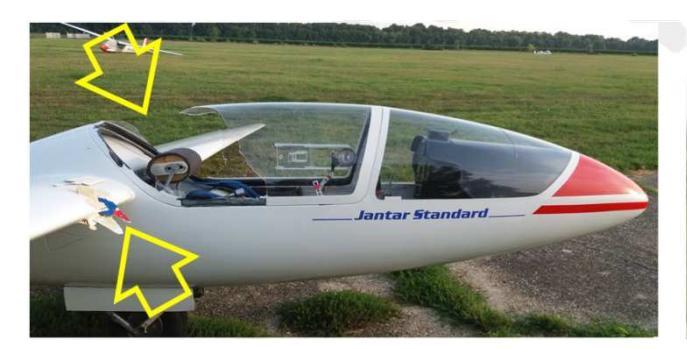
**HA-4361**: The damaged aircraft was able to fly as far as Békéscsaba Airport where it landed successfully. The rear 1/3 part of the plexiglas of the rear part of the canopy broke and misses, some of its debris was found scattered inside the cabin (Figure 20). A longitudinal, gradually deepening scratch runs along the centreline of the canopy backwards as far as the edge of the fracture. At a distance of 25 cm from the fuselage, the leading edge of the right wing cracked to a depth of 15 cm. A piece of a trailing edge (made of composite and painted blue and red) broken off another aircraft (OK-7077) was wedged in the crack (Figure 21). Non-continuous abrasion and paint damages can be seen on the leading edge of the right wing. The red paint on the top front section of the right wingtip was completely rubbed off.

Figure 20: The aircraft with reg. mark HA-4361 after landing

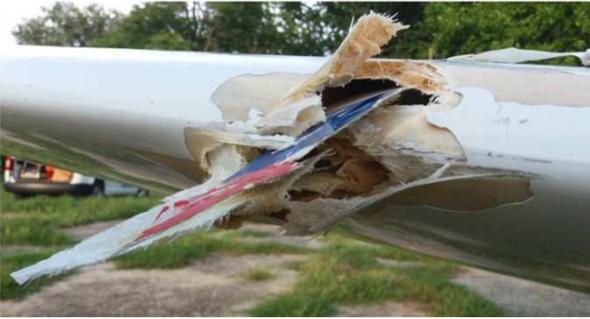
Figure 21: piece of trailing edge wedged in the wing

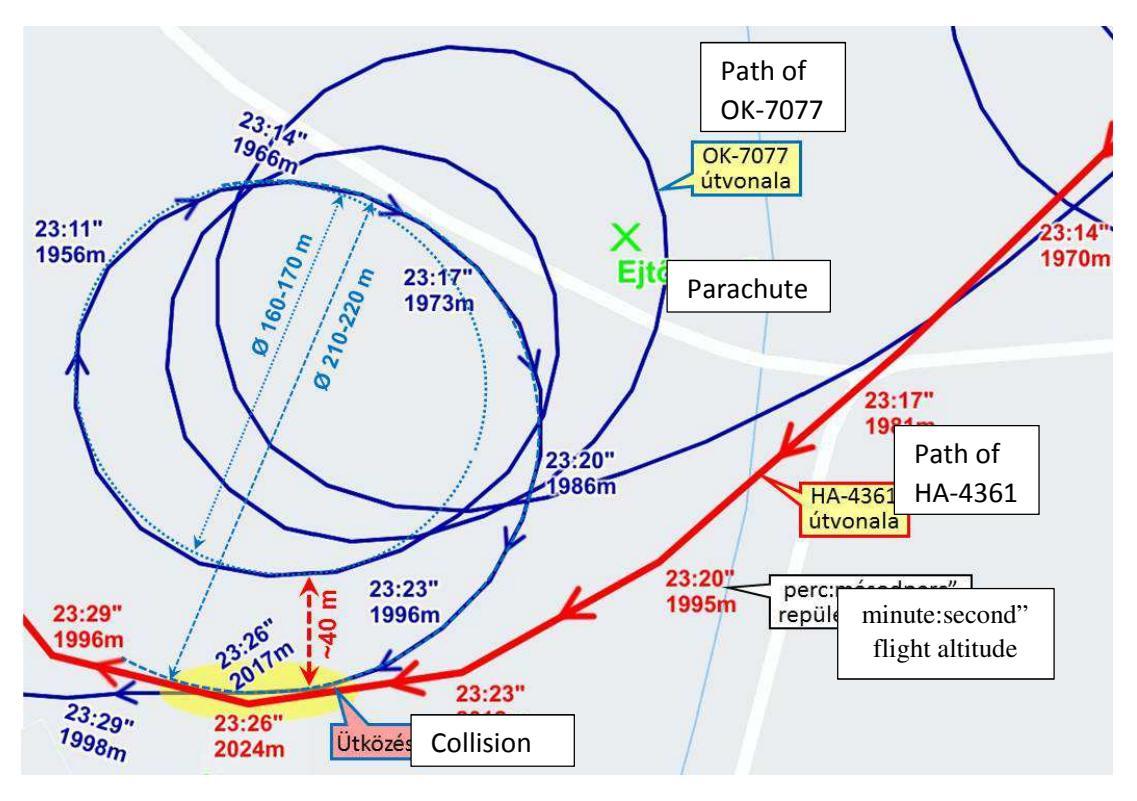
- <u>15:23:14</u>: The bank of the aircraft with reg. mark OK-7077 has decreased from ca.  $40^{\circ}$  to ca.  $35^{\circ}$ , and the diameter of its circle has increased to 210 to 220 metres. It may be assumed that, looking for the "core" of the thermal, the pilot was trying to shift the centre point of his circling more to southwest.

- <u>15:23:17</u>: The aircraft with reg. mark OK-7077 is gradually getting farther, outward, from its initial circular path. The aircraft with reg. mark HA-4361 is not changing its course.

Figure 22: Temporo-spatial visualisation of the pre-collision movements of the aircraft involved

- <u>15:23:20</u>: The OK-7077 follows the arc with increased diameter (dashed line). Banking gradually to the right, the HA-4361 starts a turn in the direction of the path of the OK-7077.
- <u>15:23:23</u>: The HA-4361 is turning right, with a bank of ca.  $35^{\circ}$ , in the direction of the OK-7077.

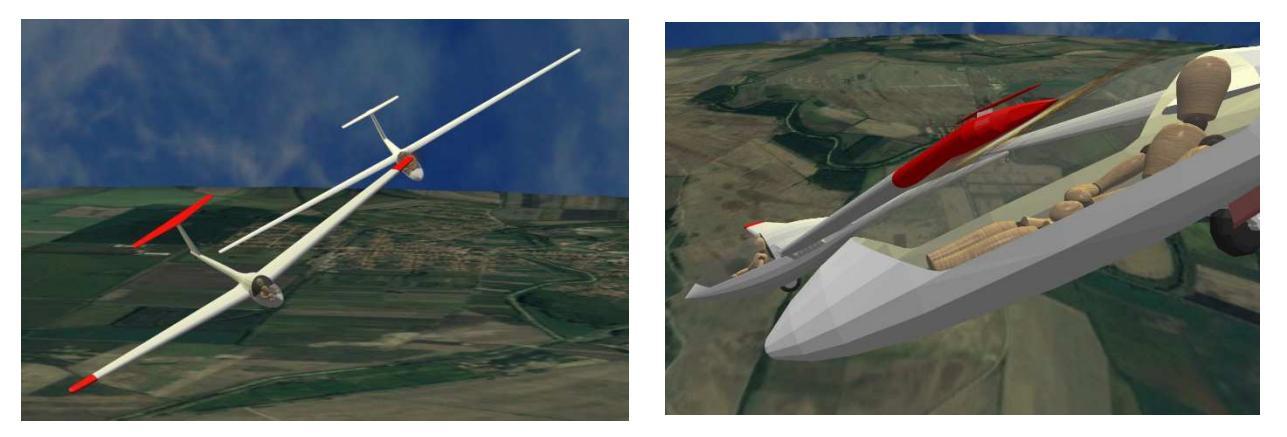
Figure 26: The left wingtip of the OK-7077 hits the canopy of the HA-4361.

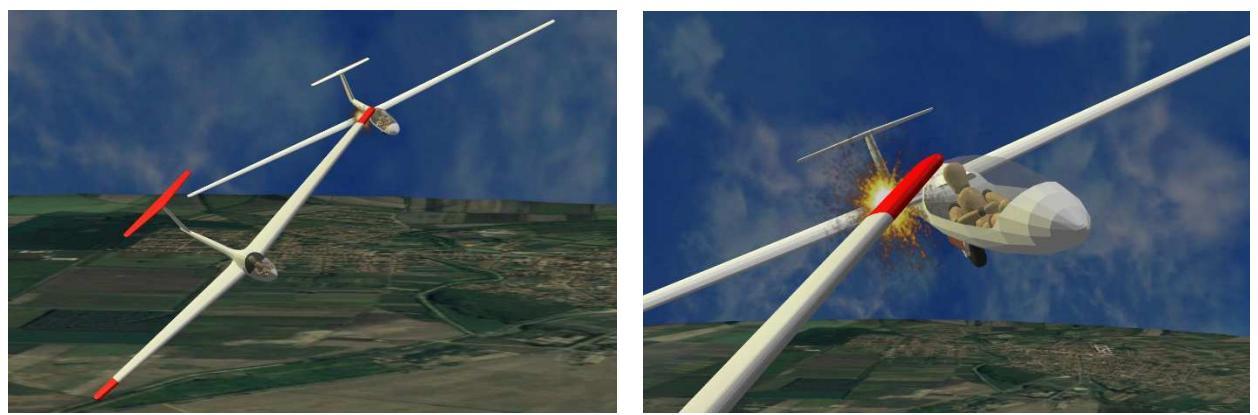
Figure 27: The left wingtip of the OK-7077 hits the leading edge of the HA-4361.

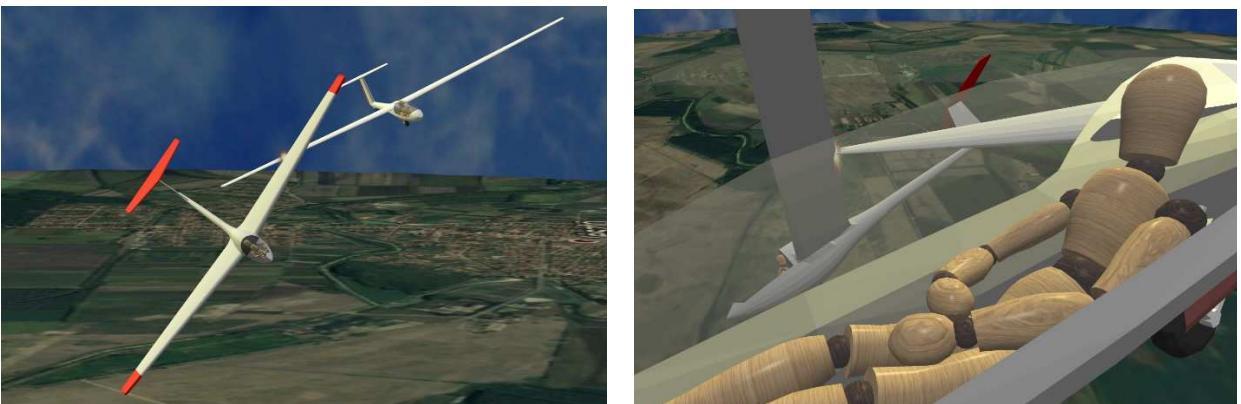
Figure 28: The trailing edge of the left wing of the OK-7077 slides on the leading edge of the HA-4361.

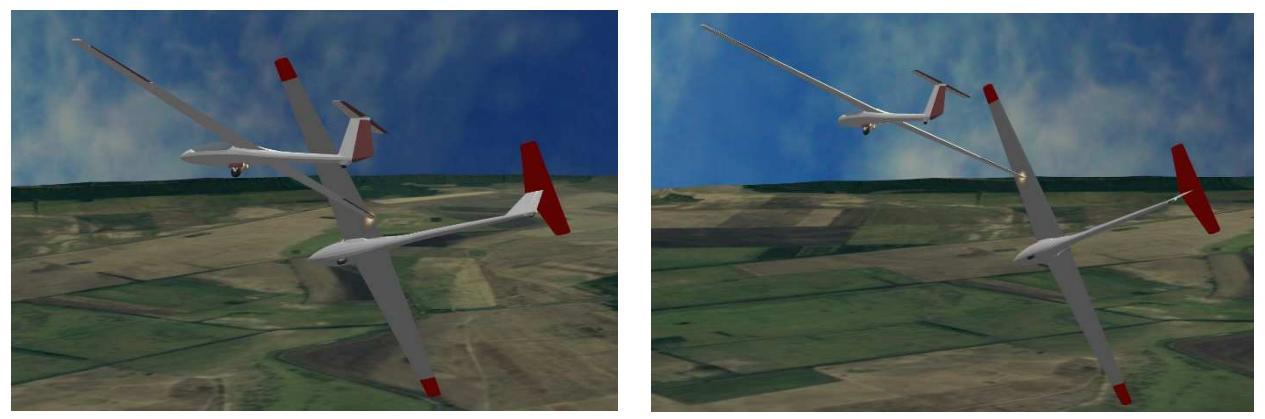
Figure 29: The right wingtip of the HA-4361 slides under the left wing of the OK-7077, and tips it upside down.

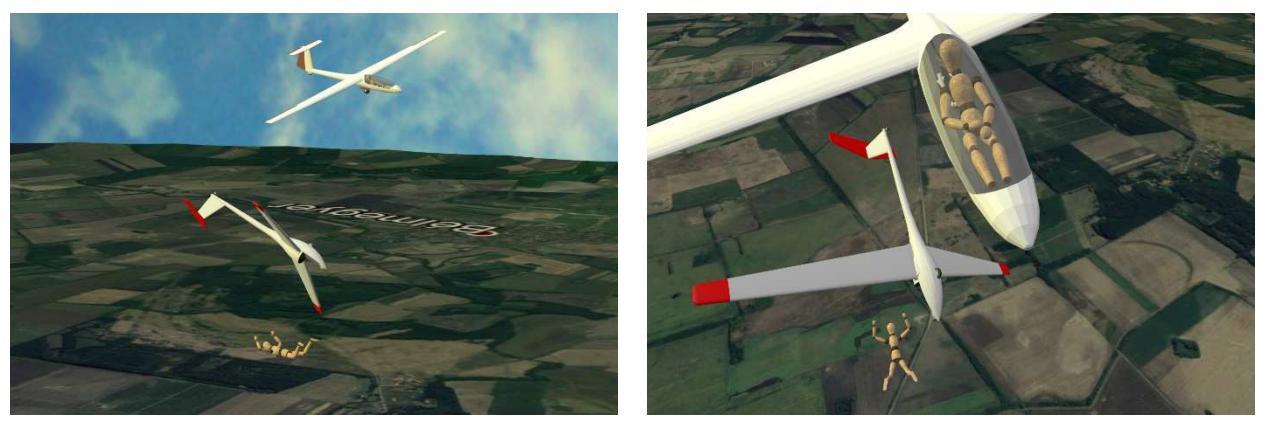
Figure 30: The pilot of the OK-7077 leaves the tipped aircraft; the HA-4361 continues flying.
