# FINAL REPORT

Fly-Coop Kft., Schweizer 269C, HA-HBQ Vicinity of Páty, 23 February 2023

Accident 2023-0195-4

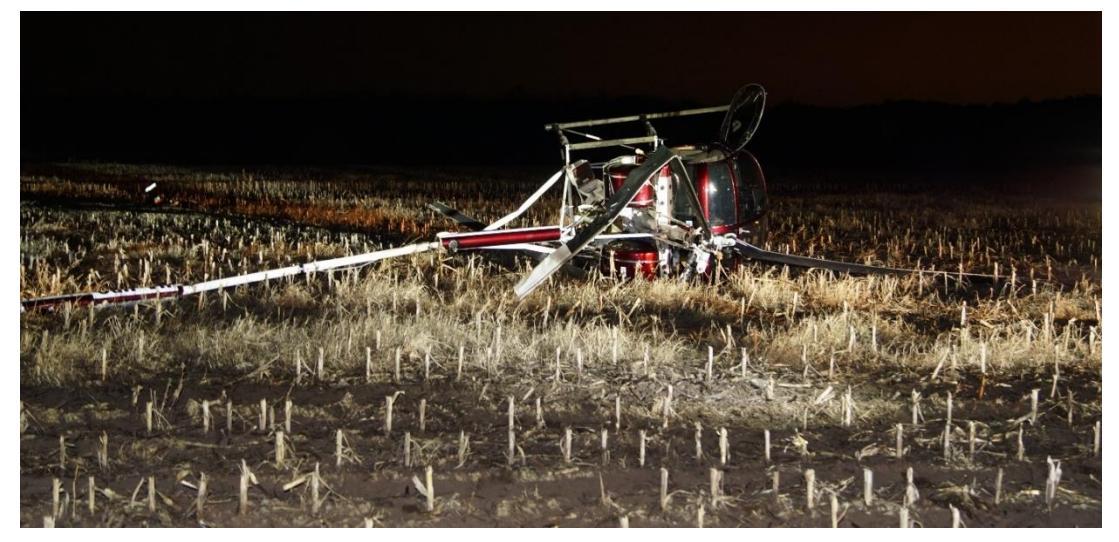
Figure 1. The helicopter after the emergency landing

- The main rotor blades knocked out the tail boom and spinned the helicopter around, which came to rest on its right side with its nose pointing backward.
