FINAL REPORT

2007-432-4

FARKASHEGY 4 October 2007

PH-WIM Piper PA-38 Tomahawk

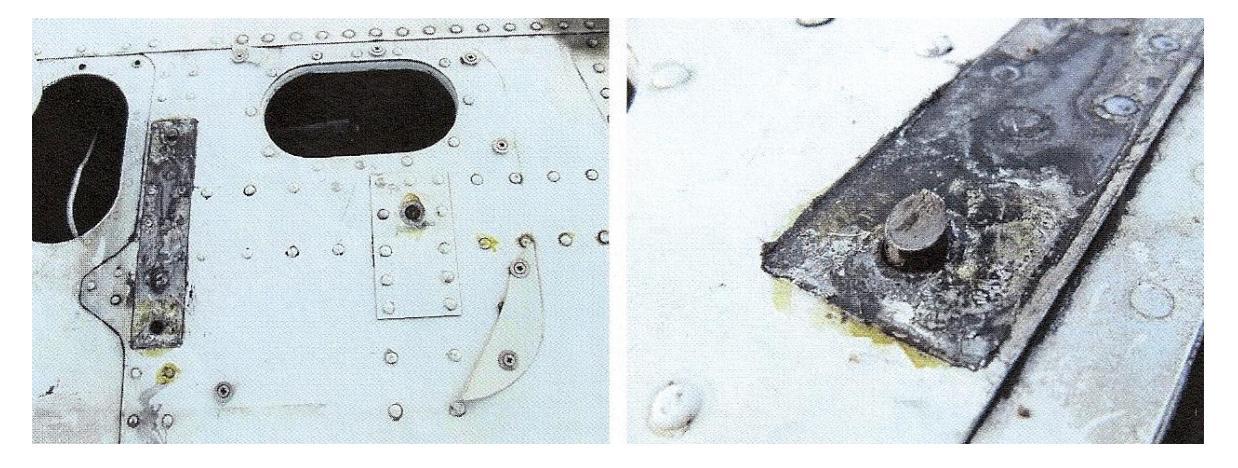
Two (2) bolt heads with cca. 6...8-mm-long stems remaining and one (1) bolt stem from the left main landing gear mount,

Two (2) bolts (both slightly bent) from the right main landing gear mount,

Two (2) main landing gear mounting clamps, one of which had a bent end at one side.

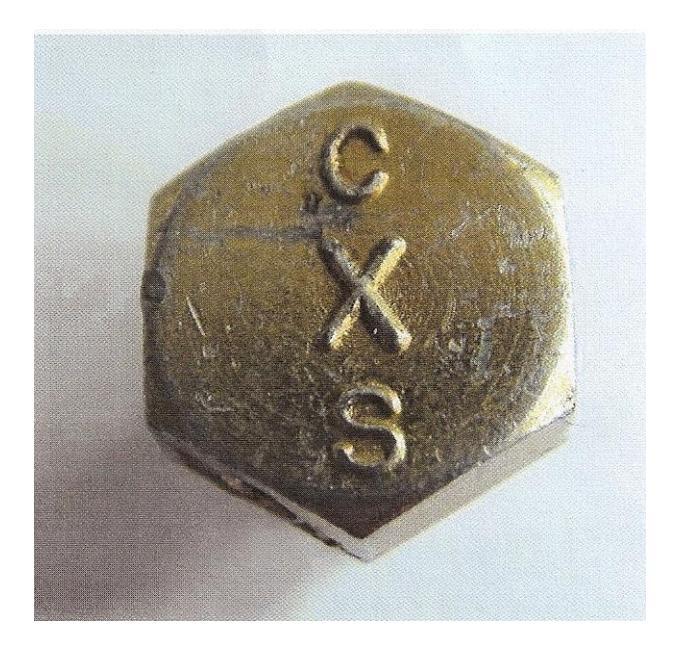
Fig. 2.

Bolt length 45 mm, stem diameter 9 mm, head size 14 mm, thread pitch 1 mm. The head is marked with letters "CXS" in vertical arrangement.

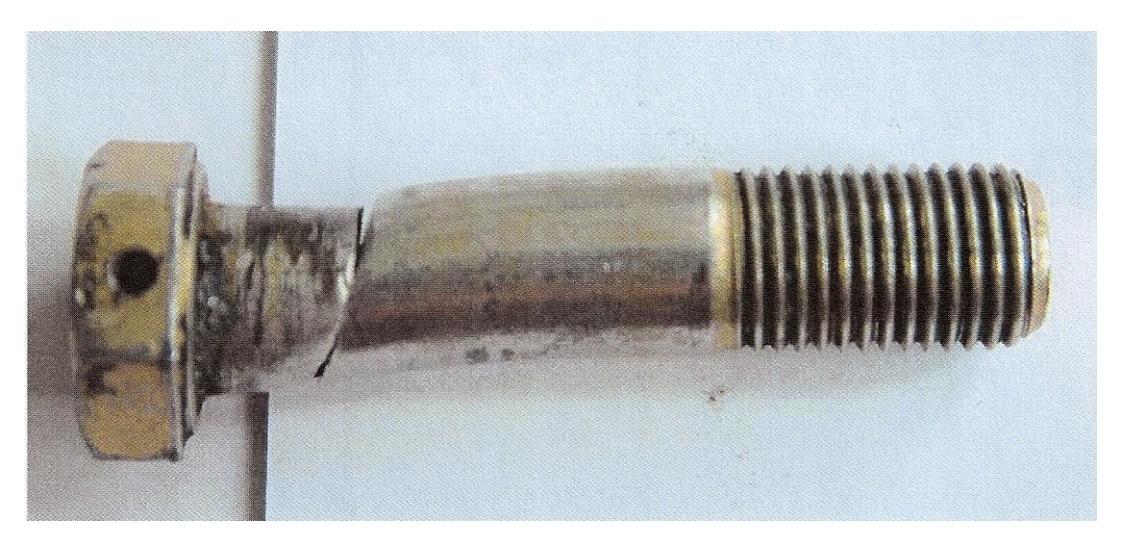
Fig. 3.

The bolts have galvanic cadmium coating. Deformations visible on the sides of the heads demonstrate multiple screw-ons/screw-offs, tightenings and loosenings. The threads are undamaged.

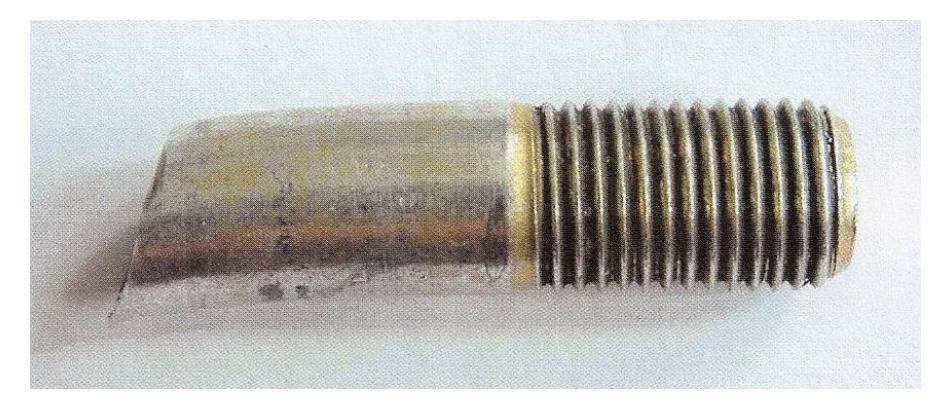
Fig. 4.

The cylindrical surface of the bolts of the right main landing gear show superficial scratches but these bolts are otherwise intact. The stems are bent almost identically, the bending angle is about 5 degrees.

The 2 mounting bolts of the left main landing gear have been bent and their stems sheared aslope at a distance of 6...8 mm from the plane of the bolt head bottom.

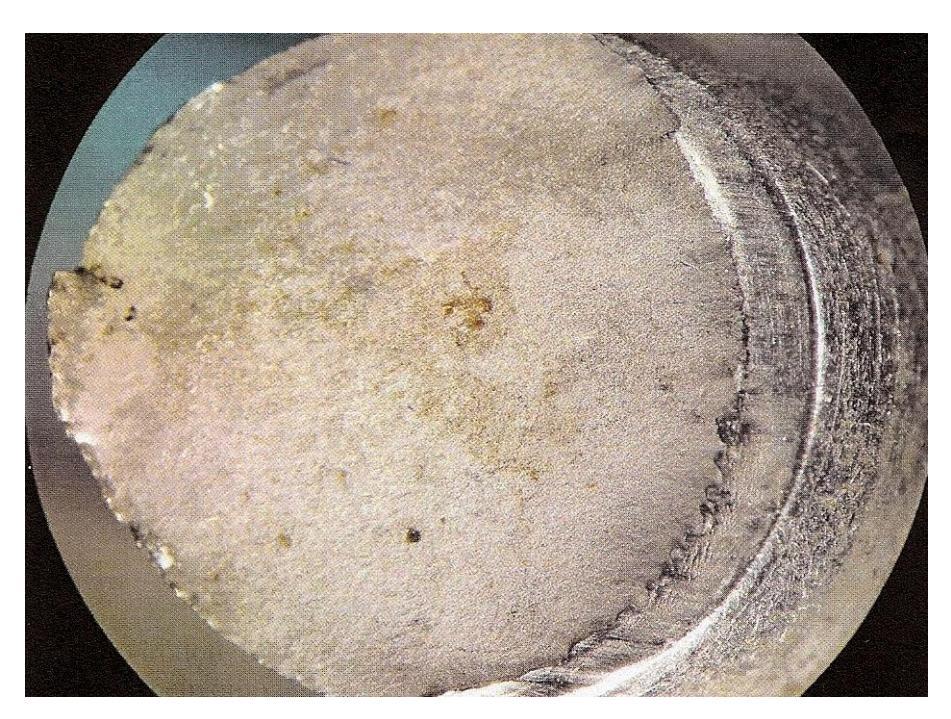
Fig. 5.

One of the bolts shows an approx. 0.8-mm-deep dent at the edge of the sheared surface. It is most possible that this dent was the trigger for the shear that cut the whole cross-section of the bolt stem.

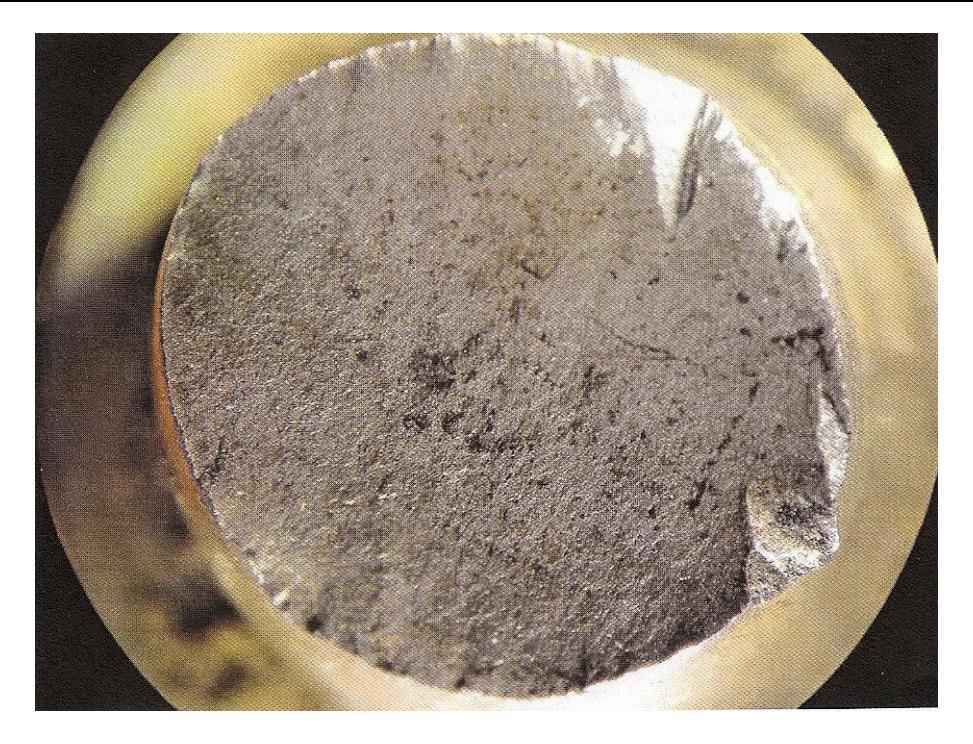
Fig. 6.

The sheared surfaces are smooth, the skid traces are clearly visible even with a naked eye.
