# **FINAL REPORT**

2009-207-4 SERIOUS INCIDENT

Romanian airspace 6 August 2009

> Boeing 757 G-LSAC

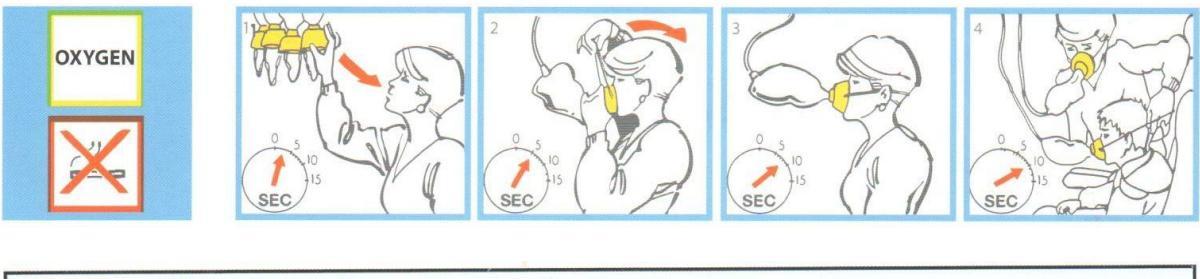
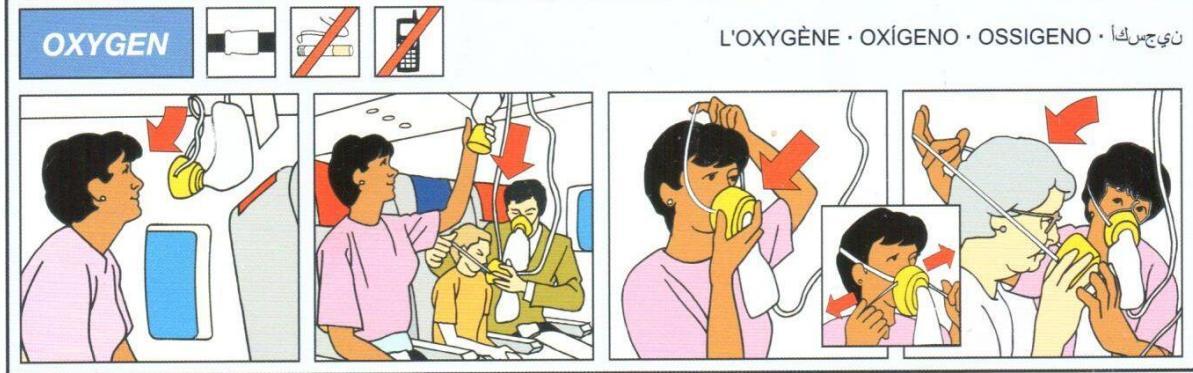
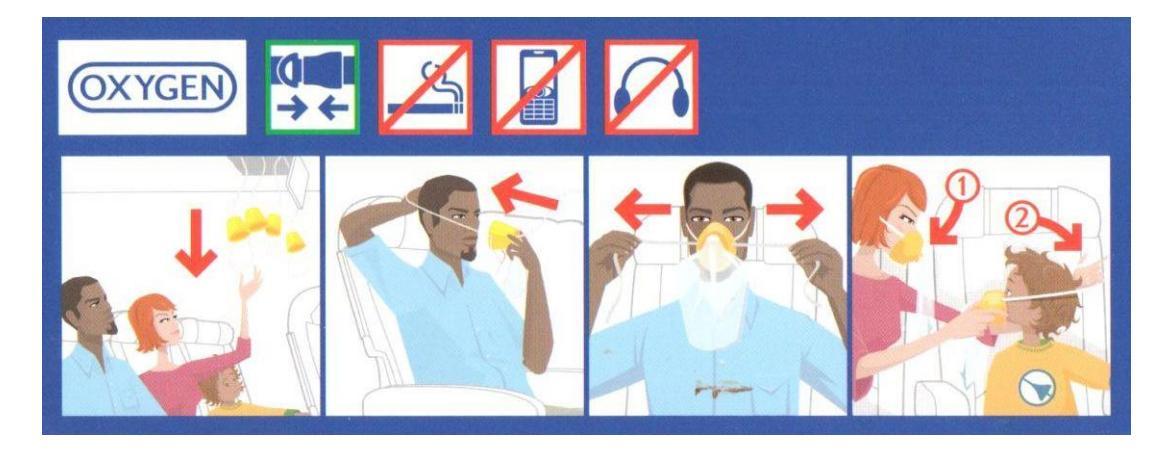
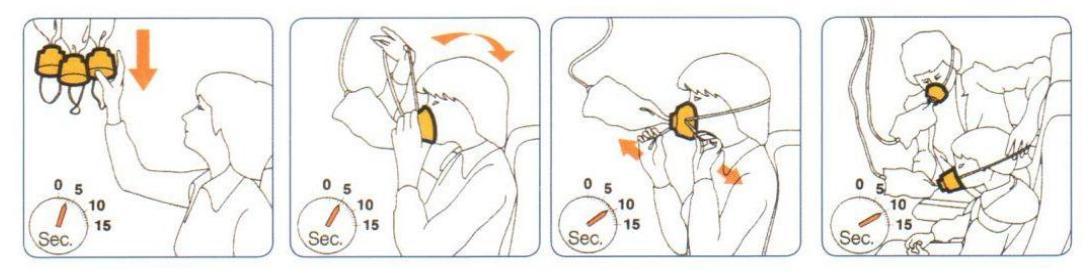
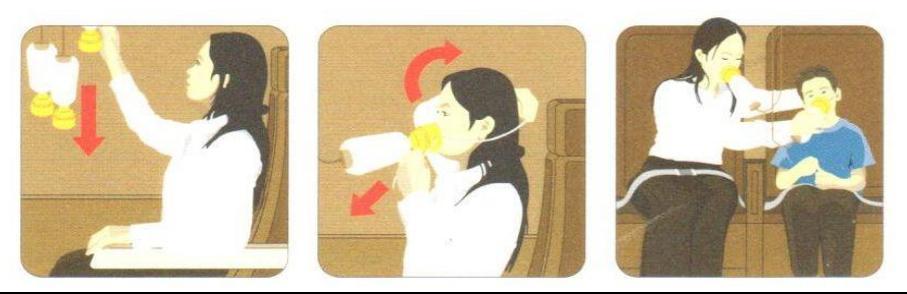
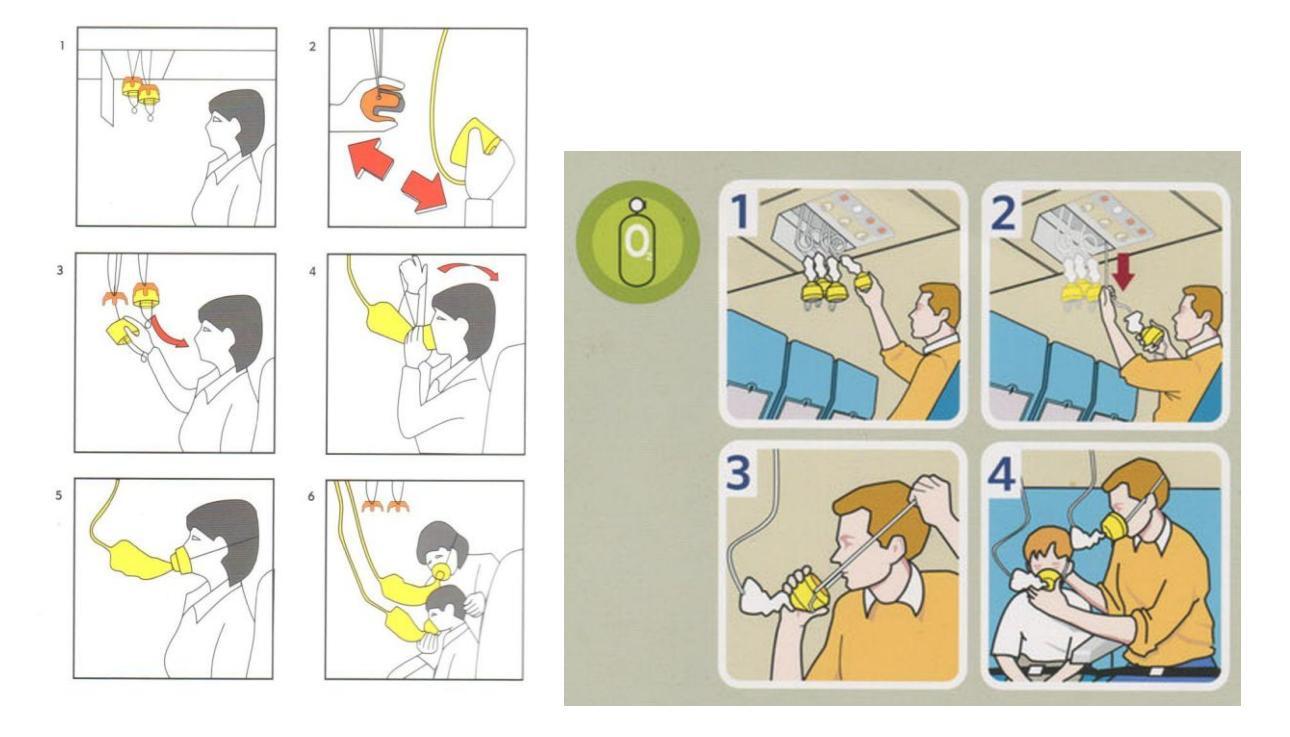
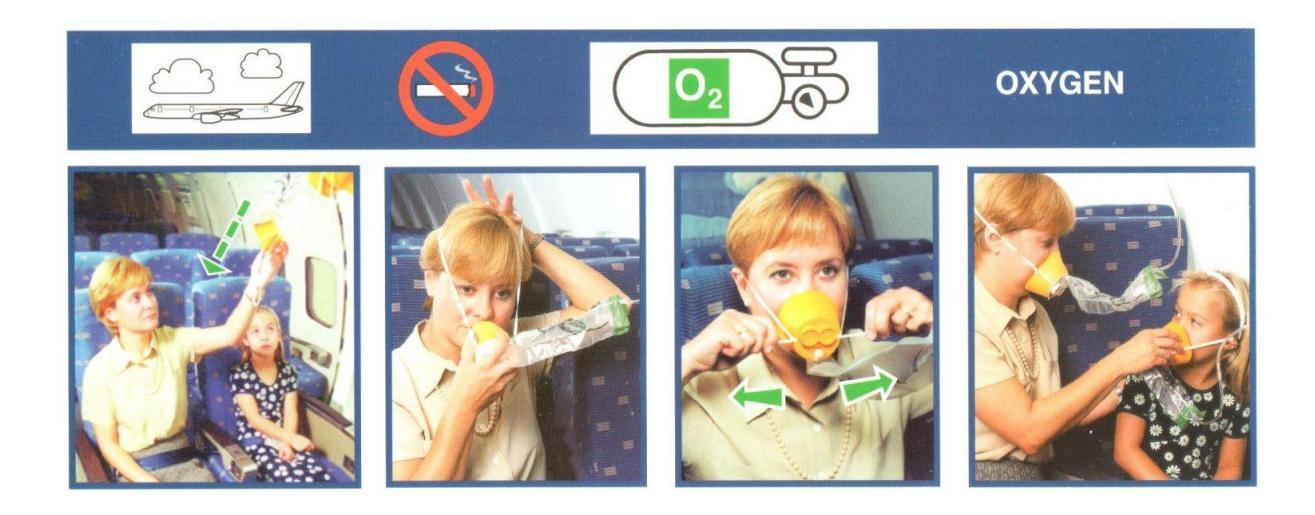
Examples of on-board safety information cards concerning the use of emergency oxygen masks

The above mentioned sections of the safety information cards can be found in **Appendix 1.** The IC believes that most of the illustrations show the plastic bag of the mask in an inflated rather than flat state. The only exception is the very last example where the use of the mask is illustrated with photographs instead of drawings.

Since the activation of the mask is not necessarily accompanied by the inflation of the attached clear plastic bag this kind of illustration can be misleading especially because the oxygen does not have a specific smell or colour. Therefore the passengers have absolutely no feedback whether their bag is operating.

In order to prevent similar cases the Transportation Safety Bureau recommends to the ICAO to direct the attention of signatory countries to the unambiguity of the in-flight safety demonstration concerning the use of oxygen masks with special attention to the function and status of the clear plastic bag while in operation.
