# **FINAL REPORT**

2011-120-4P SERIOUS INCIDENT

> BUDAPEST 17 JUNE 2011

ATR42-500 YR-ATG

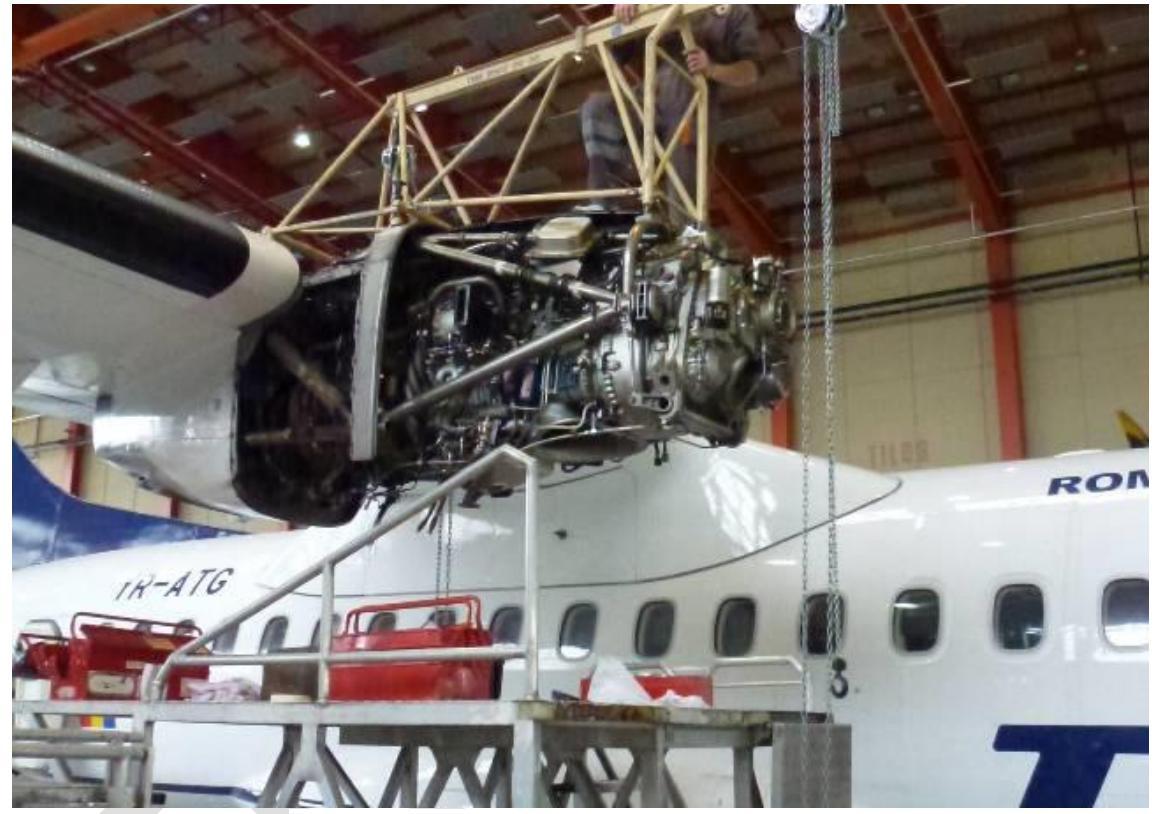
Fig. 1: Engine removal from the aircraft

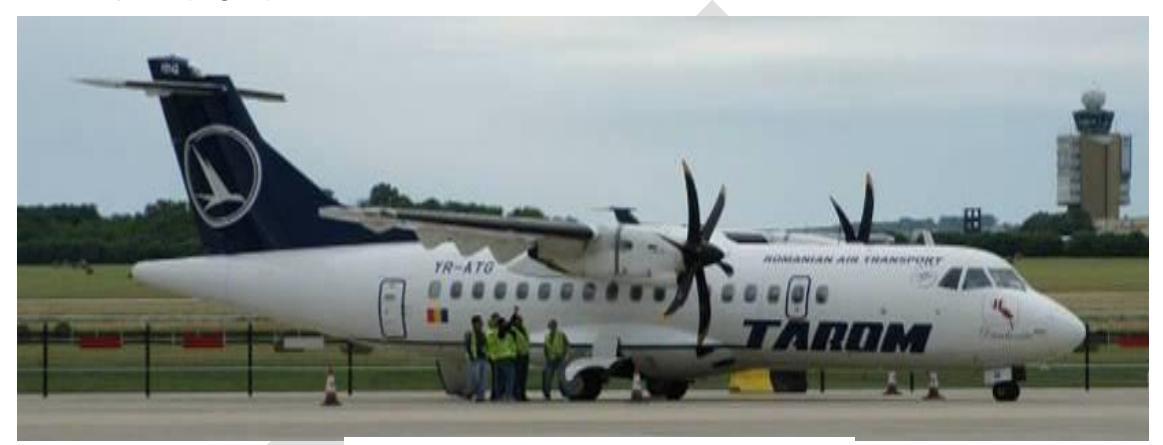
Fig. 2: The aircraft on the apron

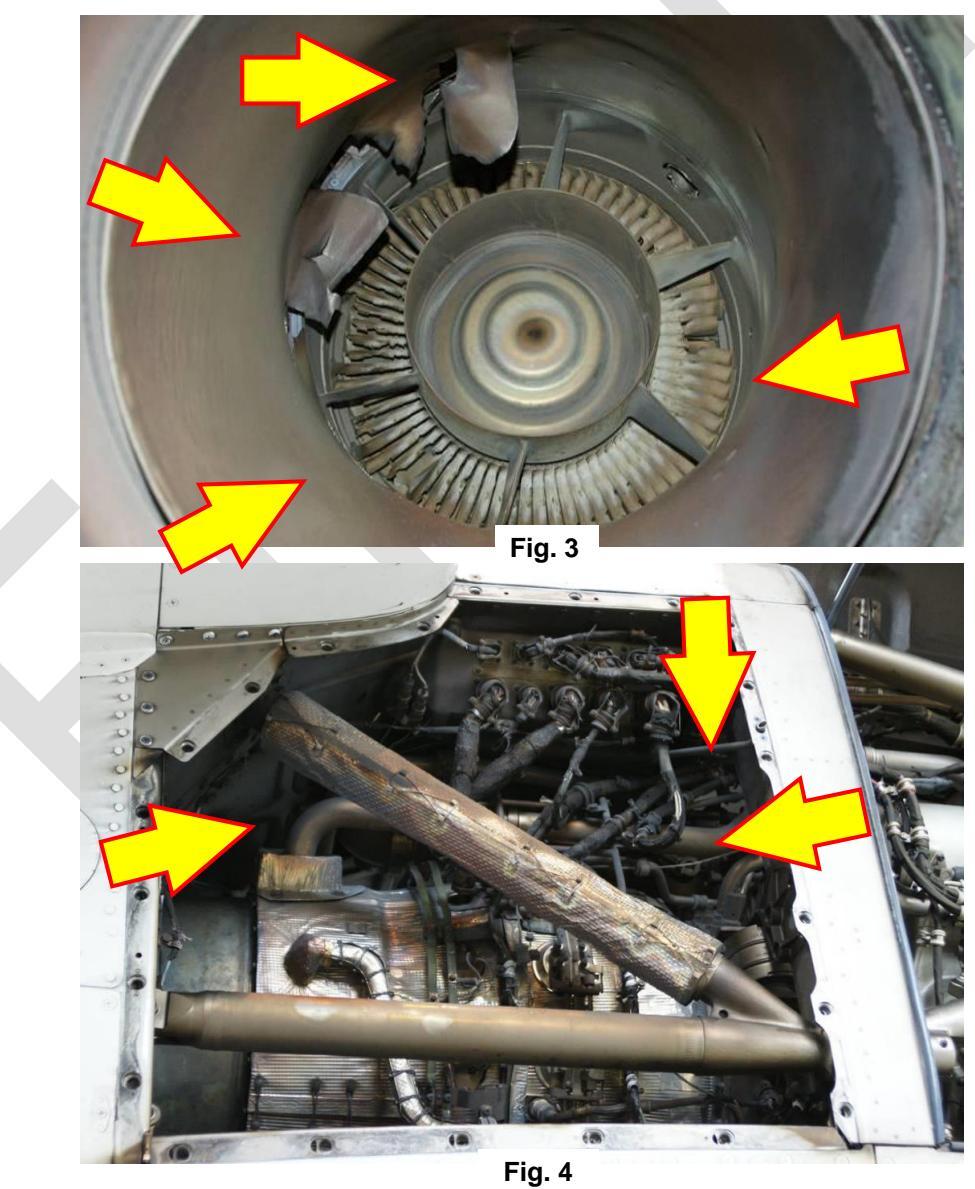
The Power Turbine of the RH engine (engine No.2) (Fig. 3), the exhaust pipe and the engine nacelle (Fig. 4) sustained heavy damage.

As a result of major failure of engine No.2 a fire developed in the engine nacelle. The fire protection system triggered a fire warning to which the flight crew responded and successfully put out the fire with the built-in fire extinguishing system. The fire caused considerable damage near the turbine section but was confined to the inside of the nacelle (see Fig. 3 and 4).
