FINAL REPORT

2012-159-4P SERIOUS INCIDENT

Budapest FIR – Bugac area 11 June 2012

Bombardier CRJ900 / Airbus A320 D-ACKC / OE-LEU

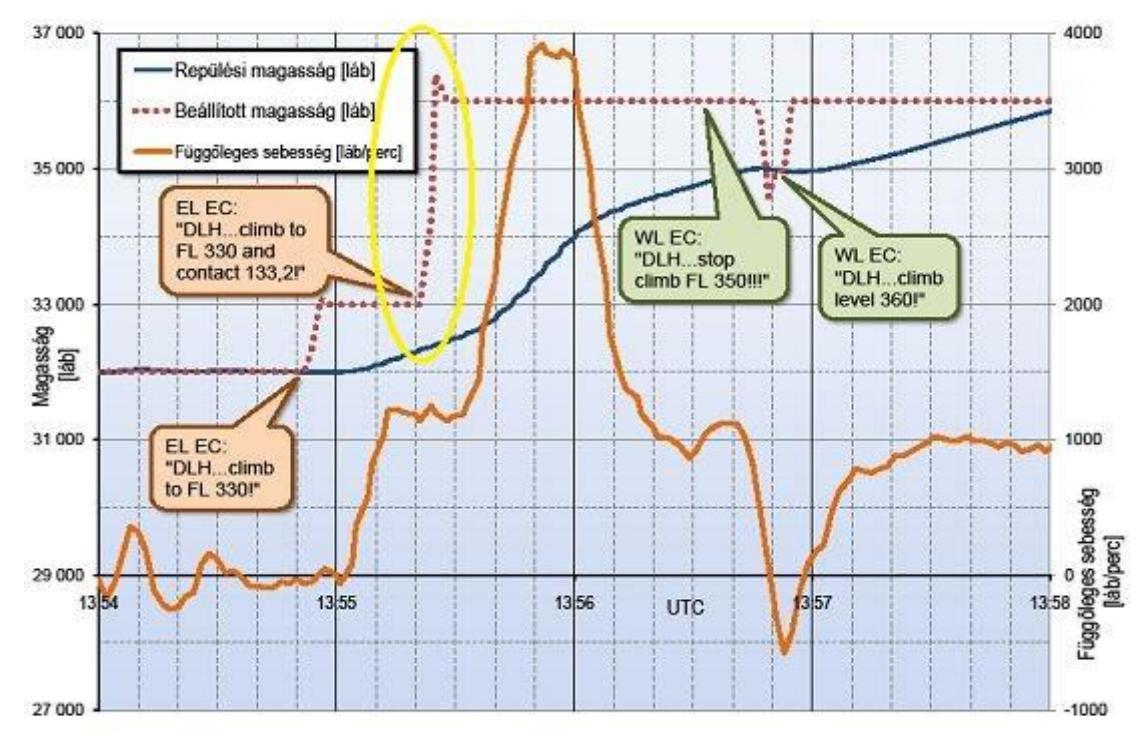
At the time of the frequency switch (E-39 sec) the Pilot Flying of DLH9949 set FL360 on the Autopilot Control Panel. \checkmark

DLH9949 FDR data: Setting FL360 on Autopilot Control Panel

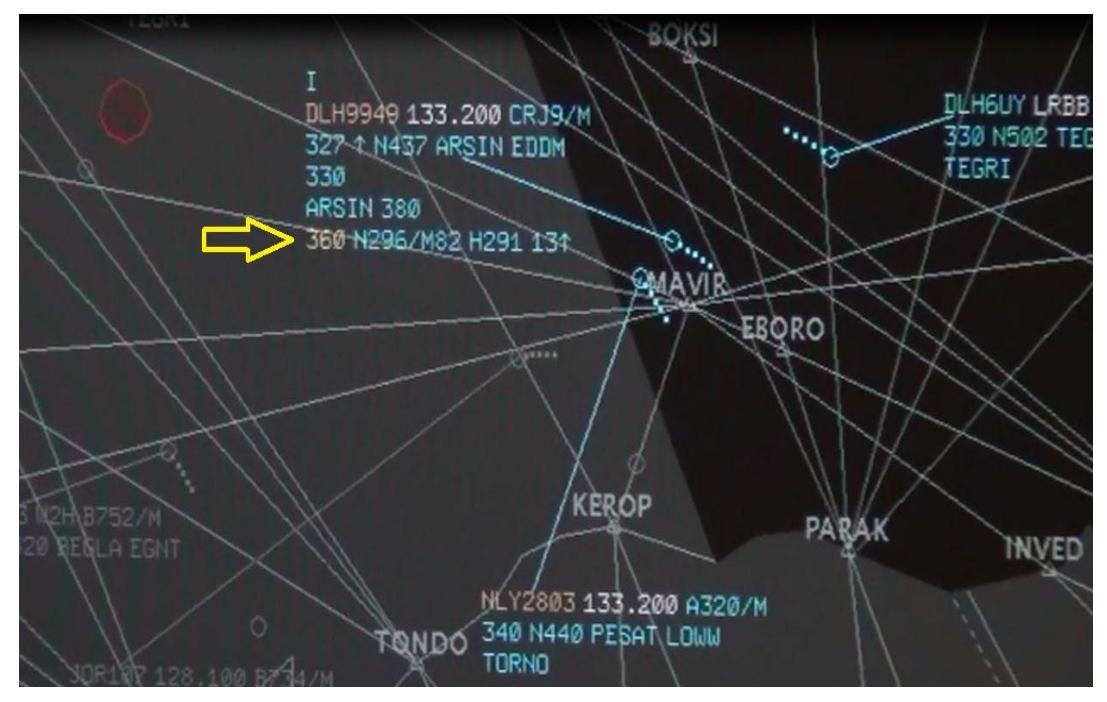
At 13:55:38 (E-22 sec) a warning appeared on the EL EC radar screen indicating that the pilot set an altitude (FL360) different from the altitude approved by ground control (FL330). \checkmark

EL EC screen: S mode set altitude difference warning

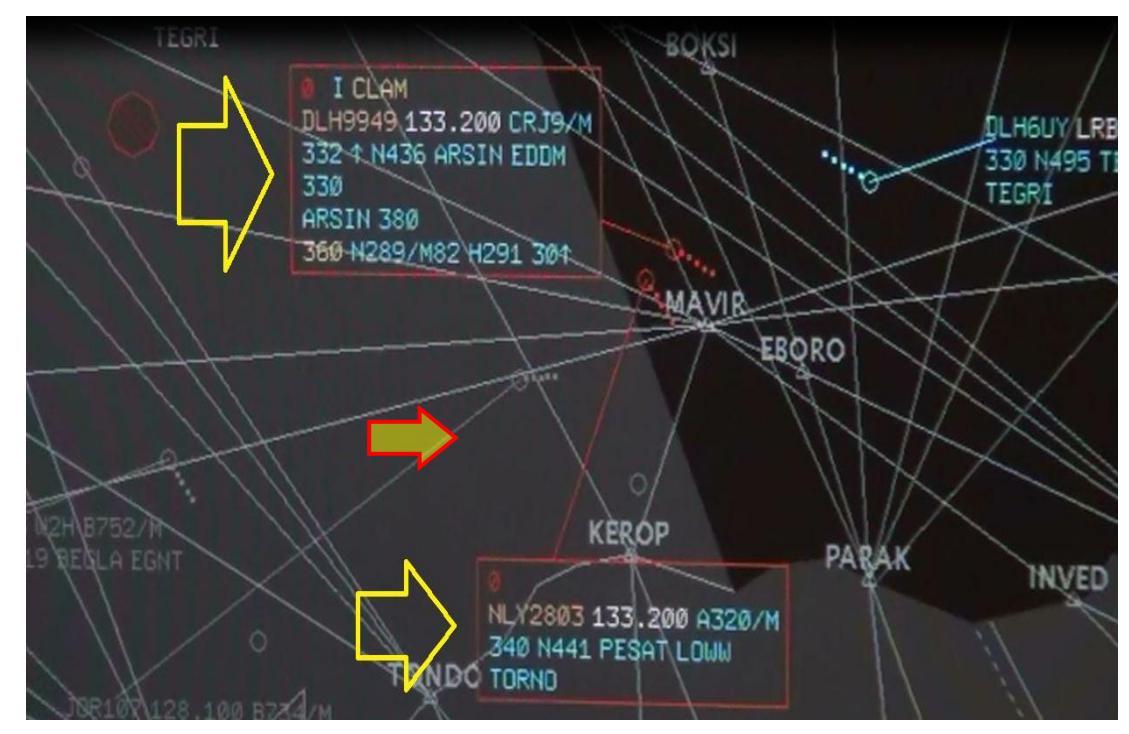
STCA and CLAM alerts appeared on EL EC and WL EC radar screens at 13:55:48 (E-12 sec) when DLH9949 overshoot her approved altitude. The computer-calculated separation between DLH9949 and NLY2803 was less than 1 NM. \checkmark

EL EC screen: STCA and CLAM alert related to relative position of DLH9949 and NLY2803

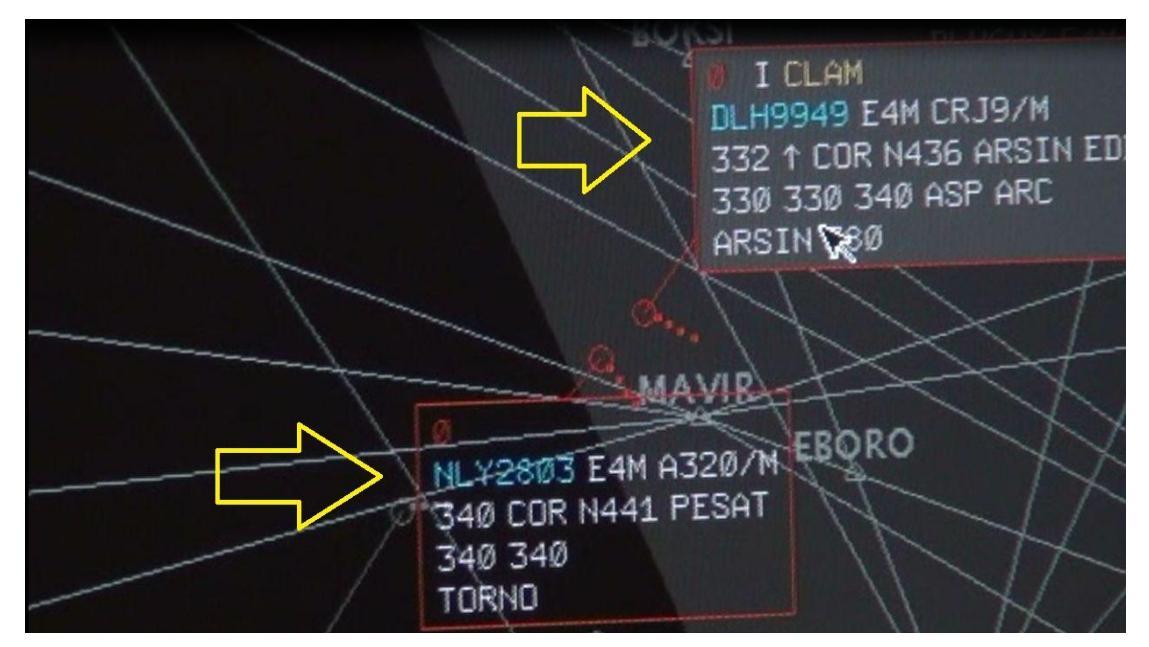
WL EC screen: STCA and CLAM alert related to relative position of DLH9949 and NLY2803

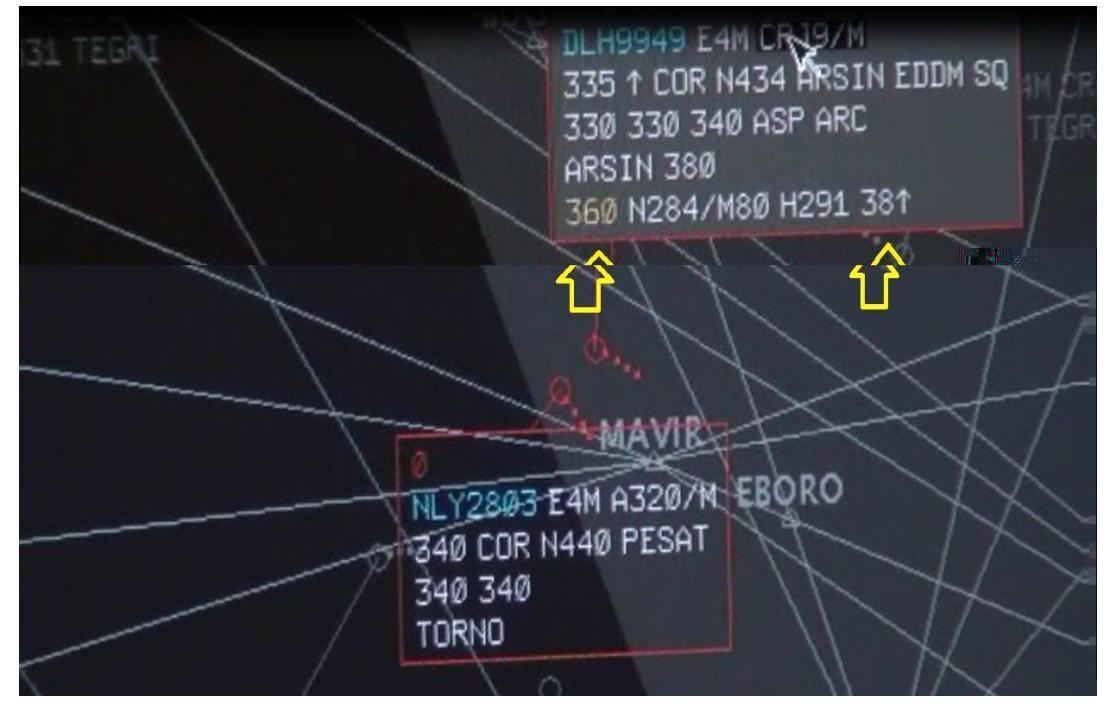
The set altitude difference warning (triggered by the DLH9949 radar working in S mode) appeared on the WL EC radar screen only after the STCA alert, at 13:55:51 and just for a short time. It reappeared later at 13:56:40.

The vertical speed of DLH9949 at the moment of same flight level crossing was +3.800 feet/min.

WL EC screen: S mode set altitude difference warning for DLH9949/FL360. Vertical speed of +3.800 feet/min is also indicated

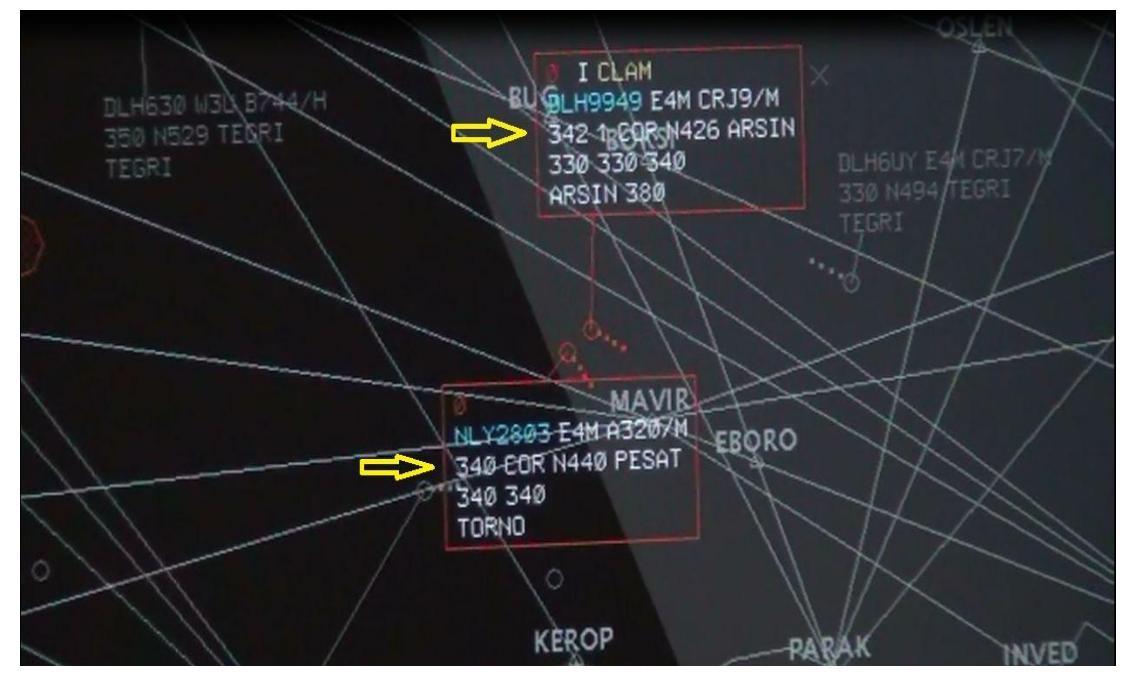
DLH9949 crossed the altitude (FL340) of NLY2803 at 13:56:00 (E-0). ↓

WL EC screen: DLH9949 crosses altitude of NLY2803. At the time of the snapshot DLH9949's altitude was already FL342, horizontal separation 1.8-1.9 NM, decreasing

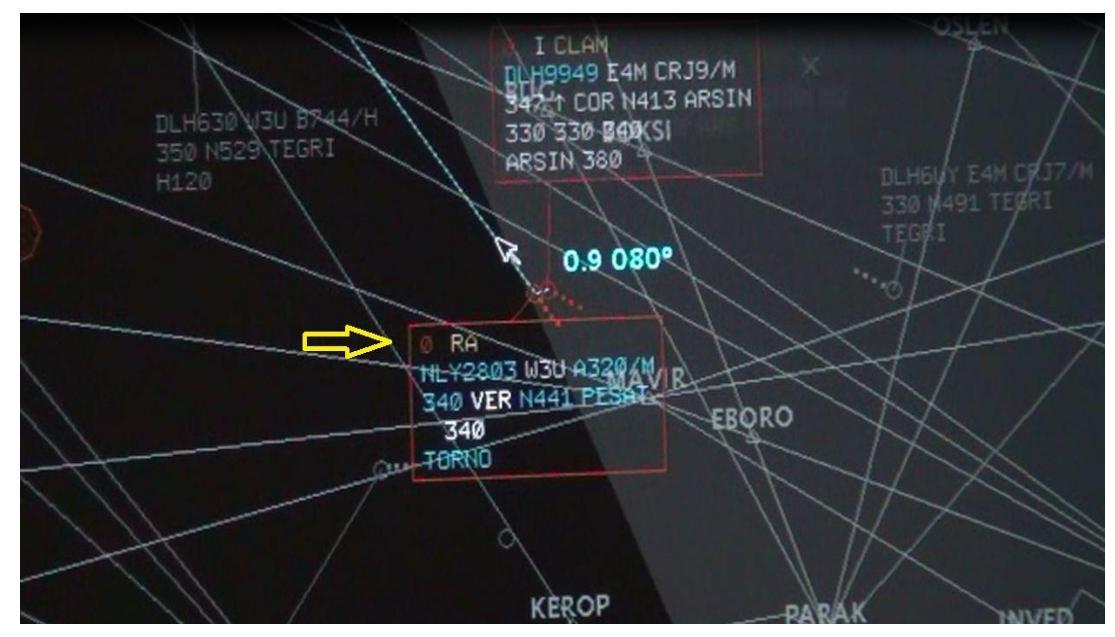
At 13:56:27 (E+27 sec) the TCAS of NLY2803 issued an RA warning. NLY2803 continued the level flight, in accordance with the TCAS advisory. The captain was not able to report the warning to the controller because the frequency was occupied by DLH9949. The TCAS RA warning, however, appeared on the WL EC radar screen, thanks to the S mode operation. \checkmark

WL EC screen: S mode TCAS RA warning related to NLY2803

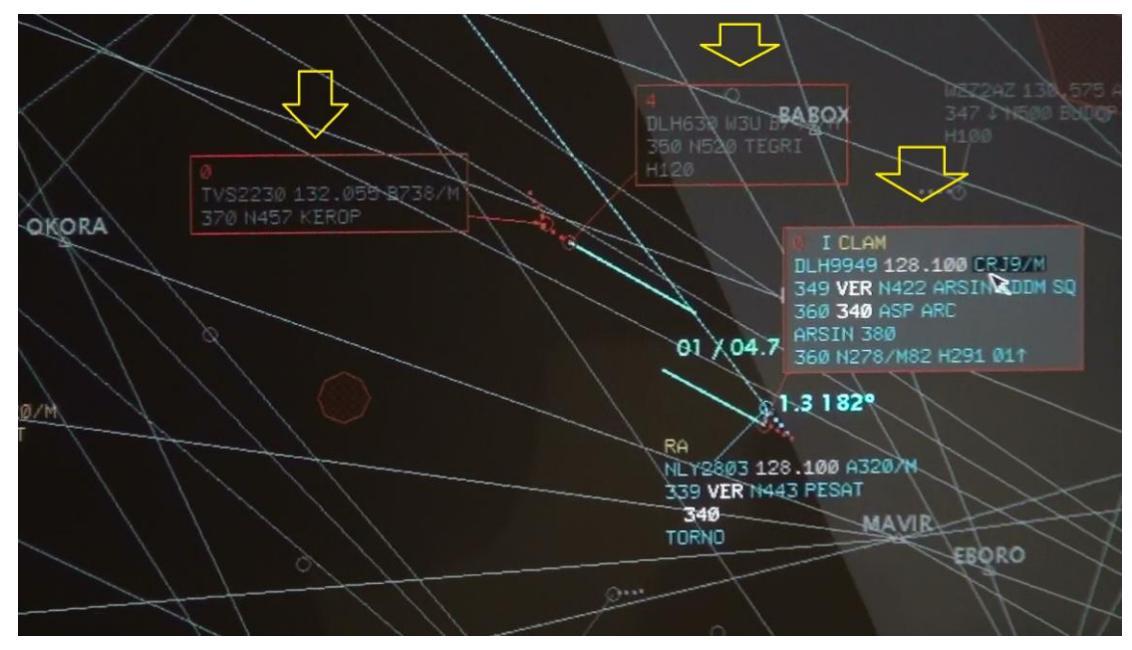
DLH9949 was already above NLY2803 and communicated on WL frequency while flying in WU-controlled airspace. Here she got into conflict with two other aircraft, one of them is DLH630 at FL350, under WU control, and the other one is TVL2230 at FL370, under WT control, both heading towards DLH9949. The latter conflict was generated due to the fact that the computer was unable to estimate the target altitude of DLH9949. The MATIAS system generated STCA alerts.

WL EC screen: STCA warning related to DLH9949, DLH630 and TVL2230

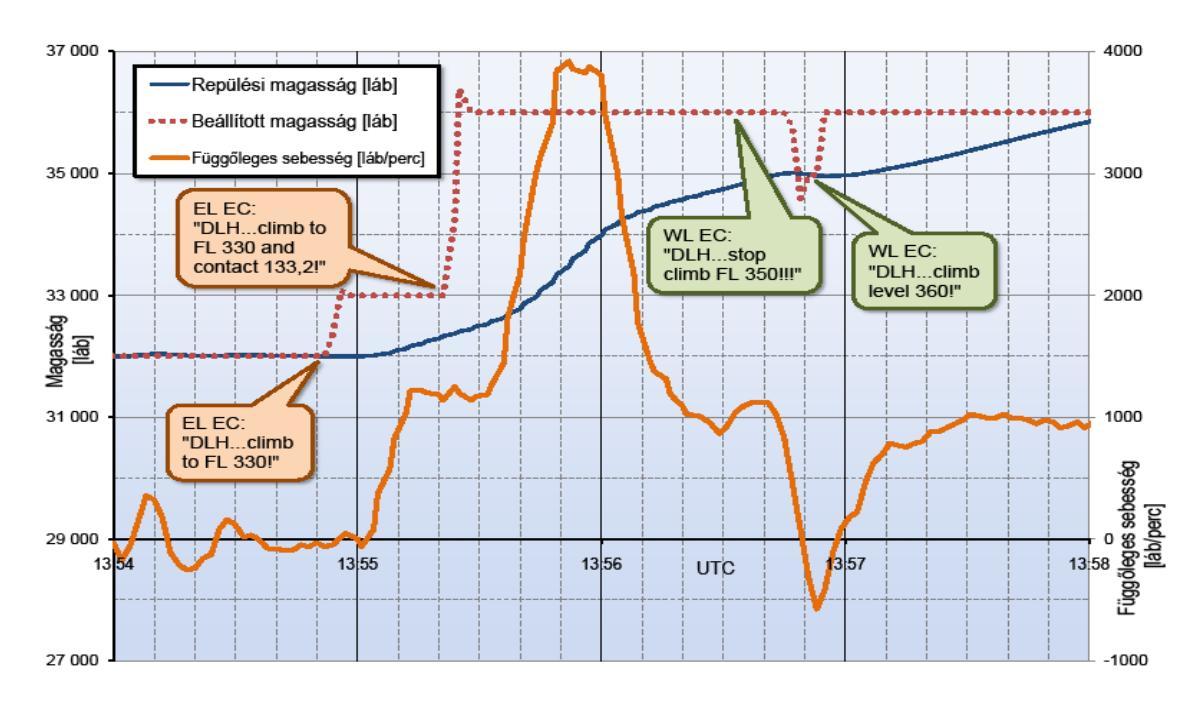
DLH9949 FDR data and transcript of radio traffic Legend: Blue continuous- Altitude (feet), Orange dotted- Set altitude (feet), Orange continuous-Vertical speed (feet per minute)

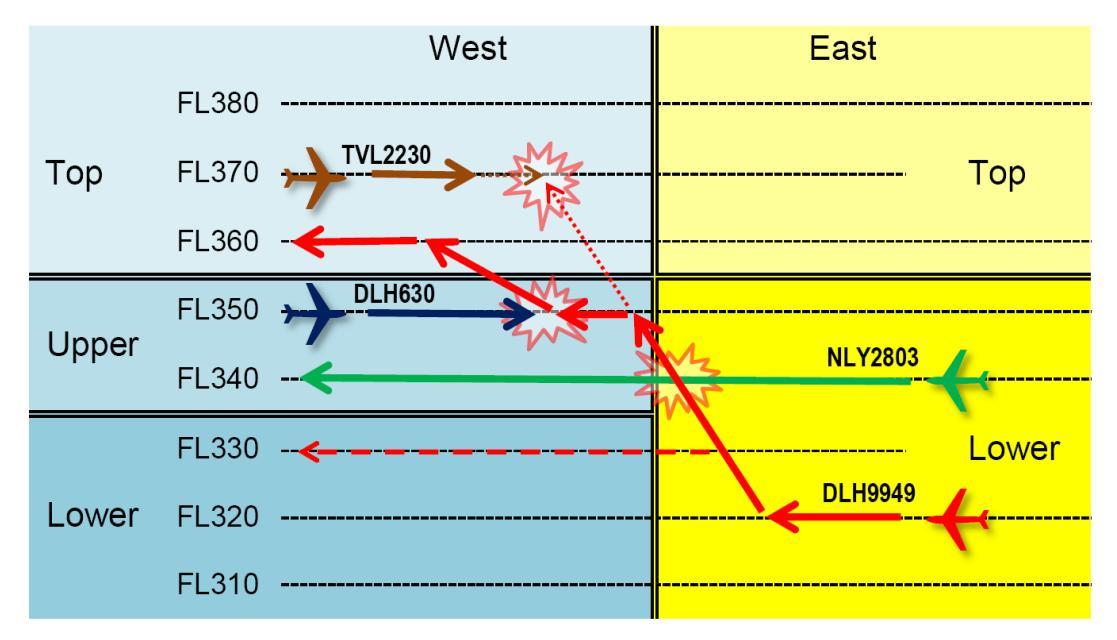
Since they had no TCAS, the pilots of DLH9949 did not have information on the nearby traffic. In fact, they had NLY2803 in the immediate vicinity, and their desired altitude brought them in conflict with two more aircraft (see below). Eventually the separation minima concerning these two aircraft were not breached thanks to the actions of the ATC personnel.

The occurrence and the conflicts generated in the affected airspaces

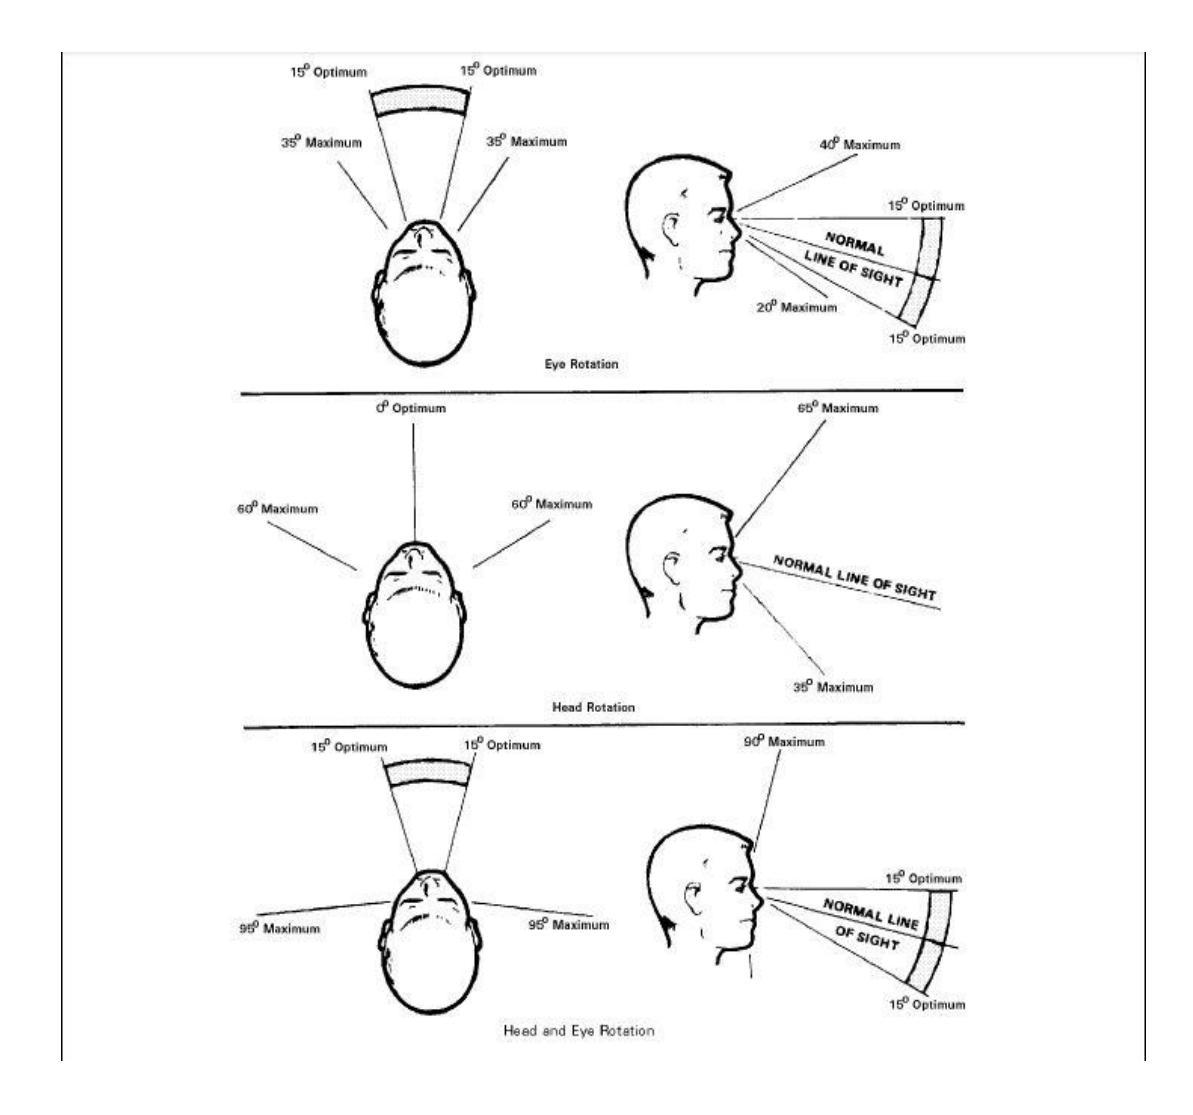
Fields of sight according to FAA Human Factors Design Guide. HungaroControl uses this guide as main reference

The IC examined how the visible alerts could go unnoticed. After transferring DLH9949 and NLY2803 to another sector, the EL EC was working with traffic on the upper third as well as on upper right quadrant of his screen. The STCA alert appeared in the lower left quadrant, approximately 20-25 degrees below his normal plane of sight.

BA2012-159-4P-1: It was found that the STCA alert was displayed near or beyond the edge of the EL EC operator's field of vision resulting in a long reaction time.

The approval and implementation of the recommendation would ensure that the ATC operators get timely notification on STCA warnings and alerts displayed on their screen outside their field of vision.
