MINISTRY OF NATIONAL DEVELOPMENT TRANSPORTATION SAFETY BUREAU OF HUNGARY

FINAL REPORT

2014-102-4P Serious Incident

Piper PA-38-112 Tomahawk HA-APW

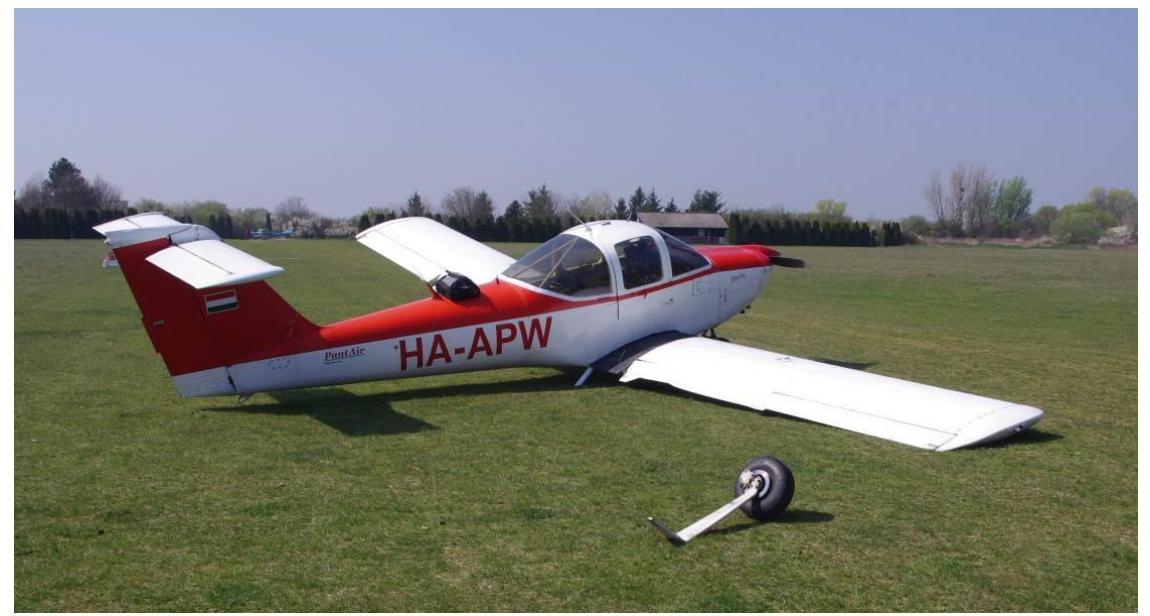
Following a short taxi at low speed, the airplane suddenly leaned to the right, the right wingtip touched the ground, then the airplane turned around the right wingtip, and then came to a full stop (Figure 1).

Figure 1: Position of the airplane after it stopped

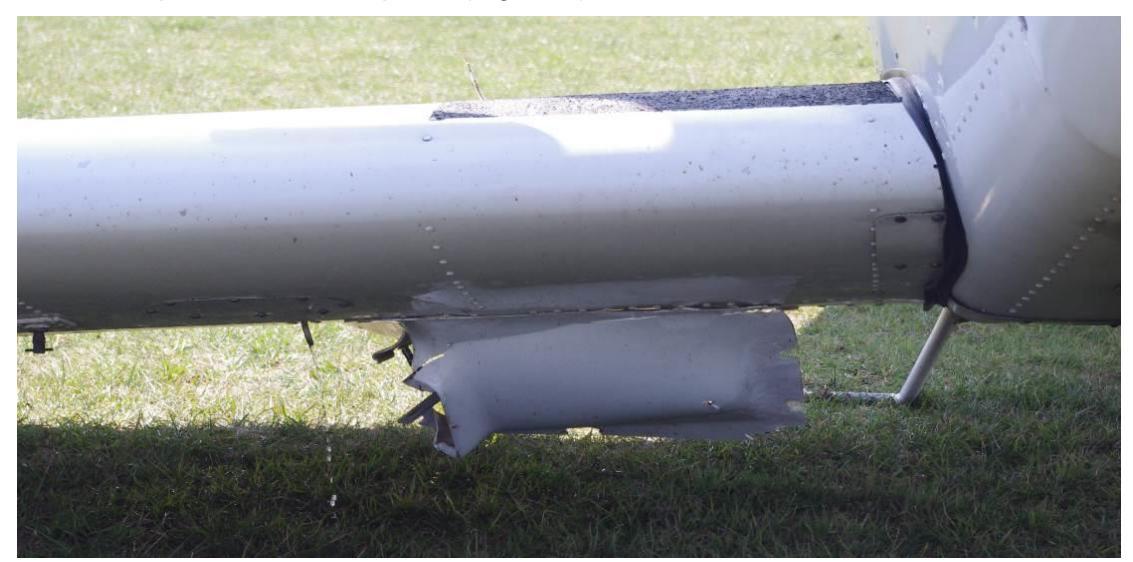
The fuel began to leak on the ground through the overflow hose of the right fuel tank due to the lateral tilt position of the airplane (Figure 2).

Figure 2: Fuel tank overflow hose at the bottom of the right wing

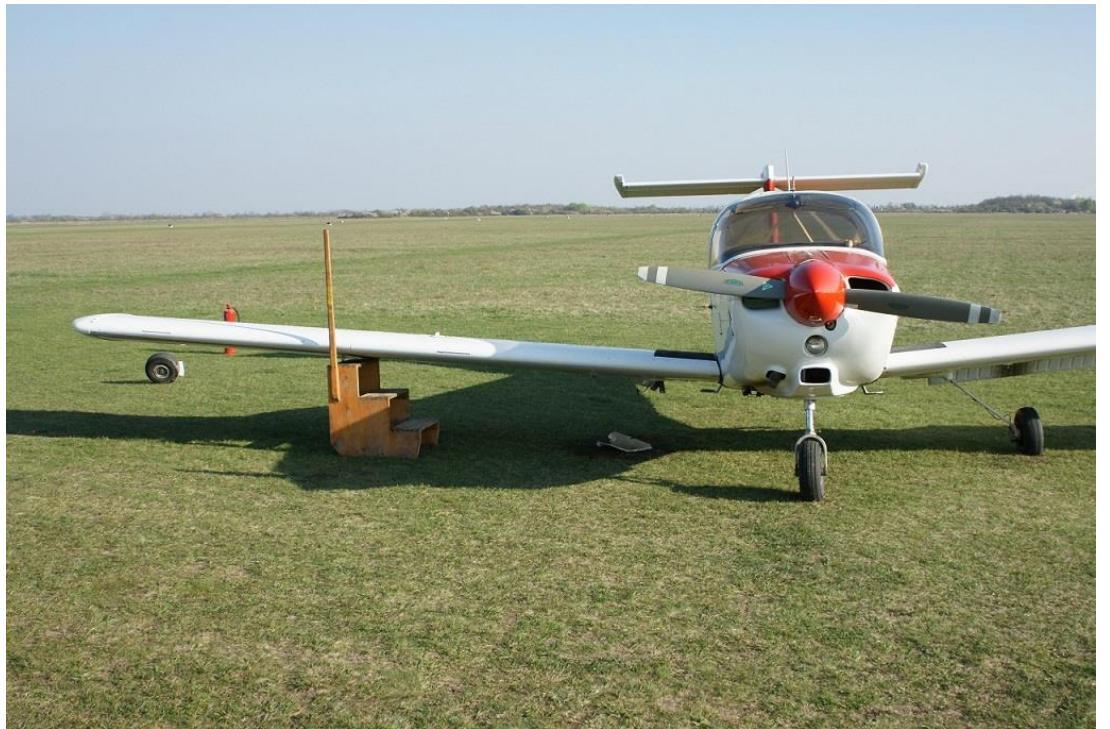
Assisted by the people at the airfield, the pilot lifted the right wing of the airplane, almost to the level of the left wing, and supported it (Figure 3). The pilot disconnected the battery power cable from the battery.

Figure 3: Airplane position with the right wing supported

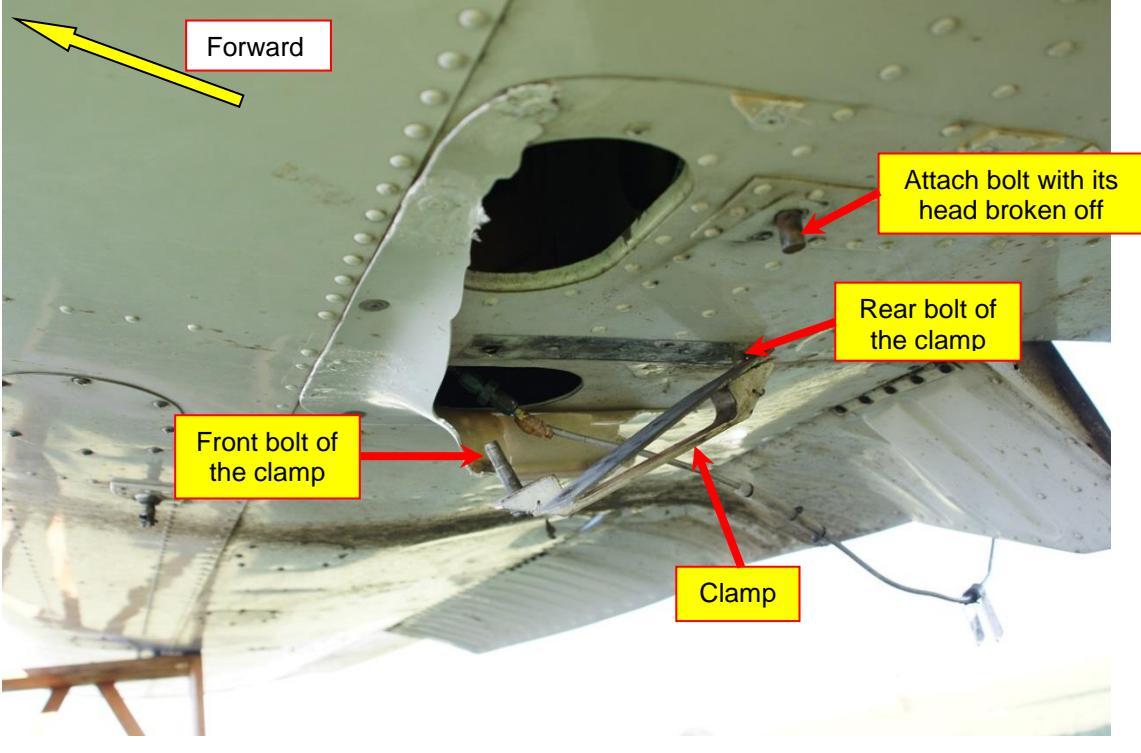
The leaf spring of the right landing gear is fastened to the right wing of the airplane using 3 bolts, in such manner that two bolts fasten the landing gear to the wing through a clamp, and the third bolt presses the end of the leaf spring to the wing (Figure 4).

During the event, the head of the bolt fixing the end of the leaf spring of the right main landing gear ripped off, and the right main landing gear wheel moved in the direction of the wing, i.e. upwards relative to the aircraft, due to the weight of the airplane loaded on it. The bent end of the leaf spring of the right main landing gear situated at the wing moved downward, gave a push to the clamp, ripping out its front bolt. The clamp moved away from the wing, and allowed the right main landing gear to twist backward and detach from the aircraft. During such detachment, the composite fairing piece of the linkage of the main landing gear broke off, and the brake tube of the wheel of the main landing gear broke.

Figure 4: Fixing points of the right main landing gear of the airplane

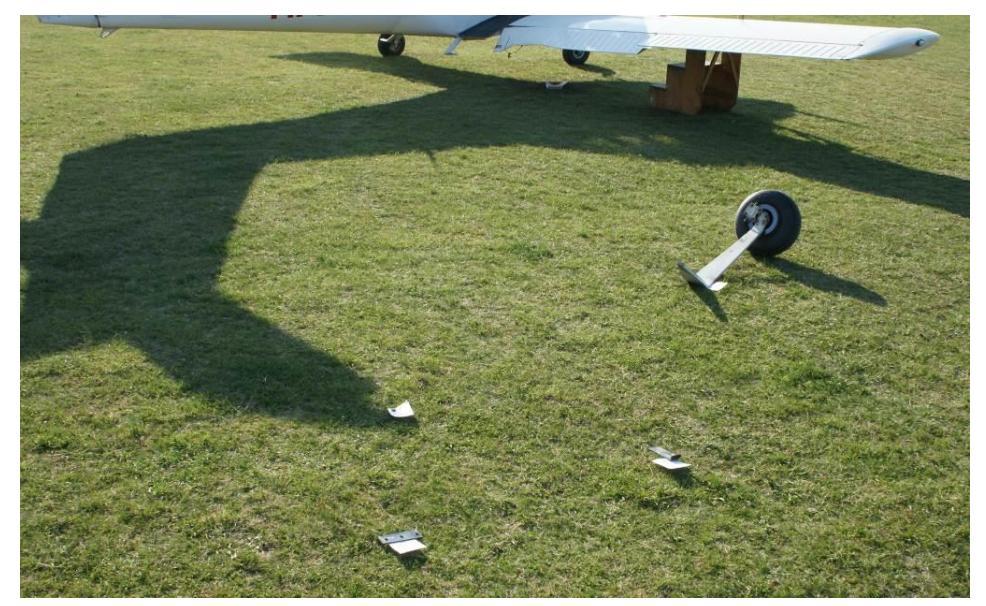
The main parts of the airplane remained together during the event, only the right main landing gear and its fasteners were detached from the airplane (Figure 5).

Figure 5: Detached parts of the airplane as found after the event

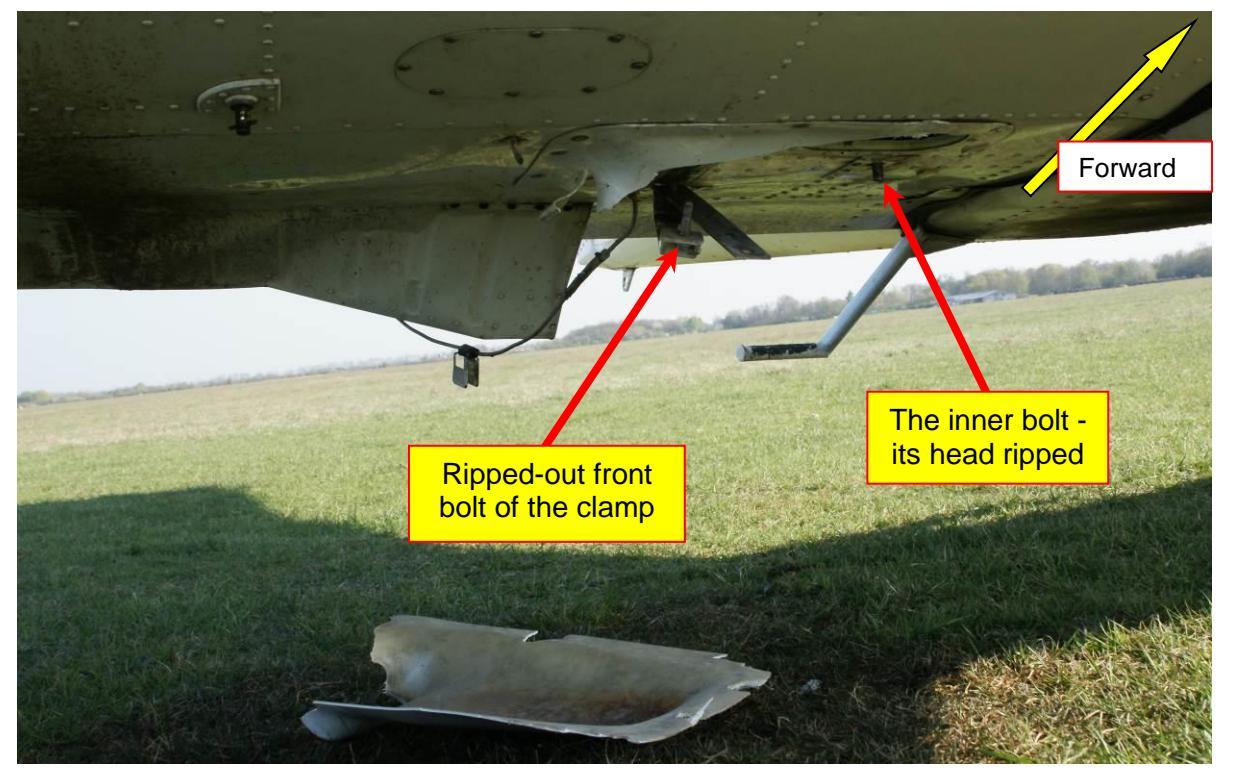
Figure 6 shows that one of the two bolts of the aforesaid clamp has ripped out, while the head of the inner bolt is missing.

The IC inspected the attach hole for the right main landing gear, but it showed no sign of irregular wear or damage.

Figure 6: Bolt joints of the right main gear after the event (as viewed backward from the leading edge of the wing)

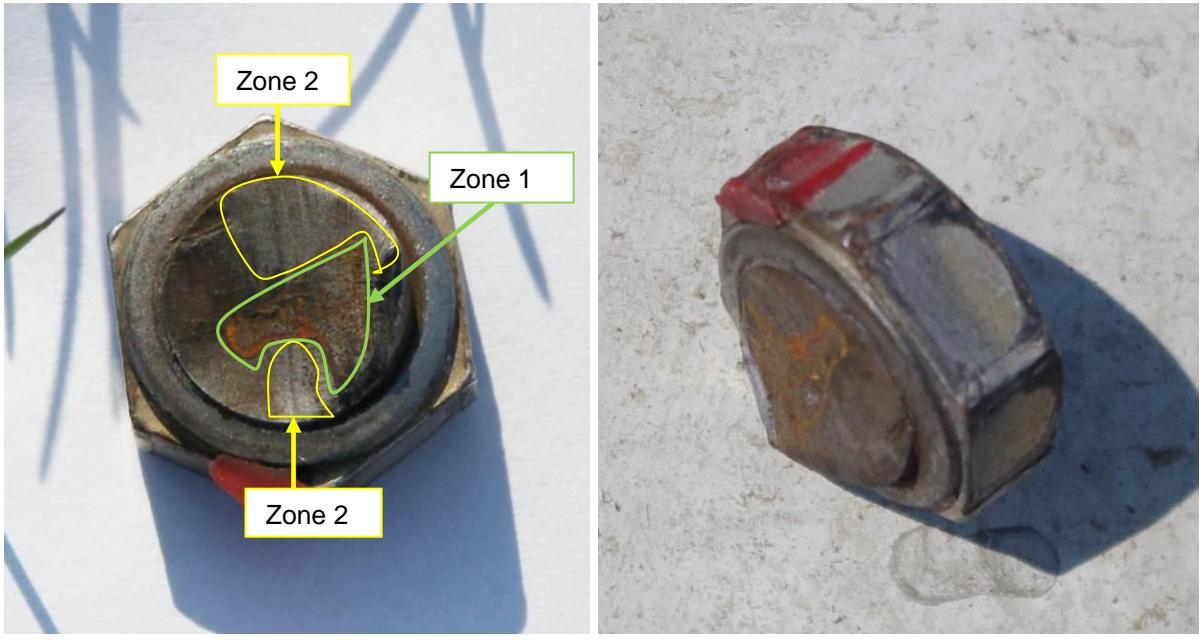
Figures 7 & 8 show the broken head of the damaged bolt. Corrosion marks can be seen in the central part of the broken surface (Zone 1). The right part of the broken surface in Figure 7 is bright, which indicates fatigue fracture (Zone 2).

Figures 7 & 8: The broken-off head of the attach bolt of the right main gear

- The head of the inner attach bolt of the right main landing gear fractured while the airplane was moving on ground, and the broken surface showed the signs of fatigue of the material.
- The bent end of the leaf spring of the right main landing gear situated at the wing moved downward, gave a push to the clamp, ripping out its front bolt.
- The clamp moved away from the wing, which allowed the right main landing gear to twist backward and detach from the airplane.

Ministry of National Development Transportation Safety Bureau of Hungary, recommends Federal Aviation Authority (FAA) to consider the possibility of application of the fasteners specified in Service Bulletin No.1200 instead of those specified in Service Bulletin No.673B relating to the landing gear of the type Piper PA-38-112 airplane, based on experiences gained from operation. In the case that the landing gear of the type Piper PA-38-112 airplane is judged more reliable with the parts specified in Service Bulletin No.1200 than the earlier solution, then FAA is proposed to consider the possibility to modify Airworthiness Directive No. 90-19-03 in accordance with Service Bulletin No.1200.

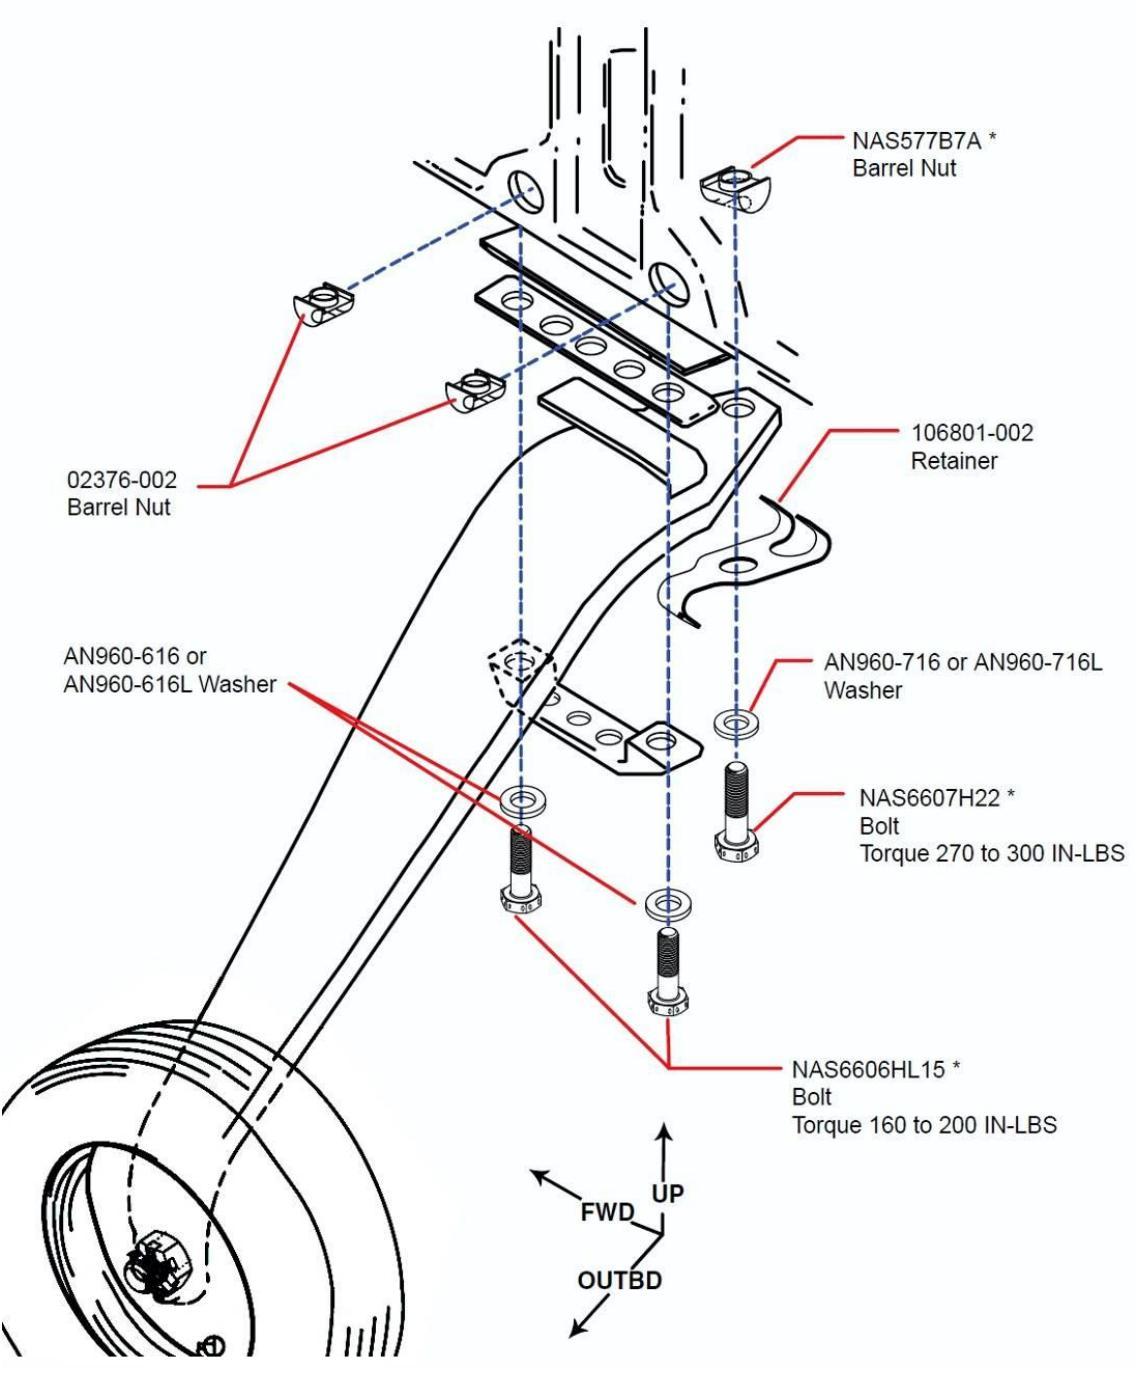
Figure 9: Fixing of the landing gear according to the Piper 1200 Service Bulletin

Inspecting the broken-off bolt head, the IC found that it had no holes for the safety wire, i.e. the attach bolt incorporated in the airplane was surely not the one shown with Item No. NAS6607H22 in Figure 9.

On 29 May 2009, the manufacturer of the airplane issued its Service Bulletin No. 1200 relating to strengthening of the landing gear of the airplane type Piper PA-38-112 Tomahawk (See attached in Annex 1). Such SB modifies the bolt joints of the landing gear of the airplane by ordering and incorporating of the Piper 88455-002 KIT as follows (Figure 9):

- Replace the barrel nuts by NAS577B7A (P/N: 506-561) and 02376-002 barrel nuts;
- Replace the bolts by NAS6606HL15 (P/N: 693-245) and NAS6607H22 (P/N: 693-246) bolts;
- Install AN960-716 or AN960-716L washers under the bolt heads;
- Install a 106801-002 retainer under the NAS6607H22 bolt;
- Tighten the bolts using appropriate torque, and then secure the bolt heads using the MS20995C41 safety wire.
