# **ANNUAL REPORT 2021**

# Transportation Safety Bureau Hungary

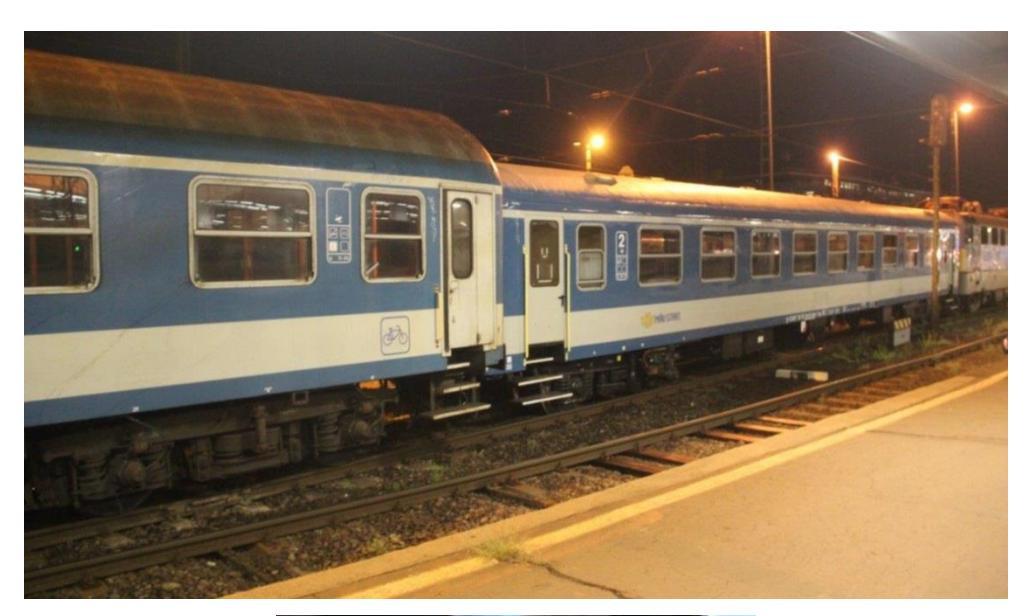
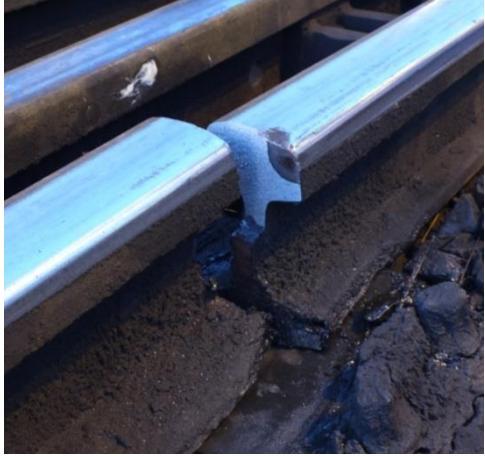
Grade:	Railway accident
Date and time:	10 September 2019
Location:	Budapest-Nyugati (station)
Occurrence type:	Train derailment
Movement type:	Passenger train
Description:	The second bogie of the first wagon of the arriving train no. 22629 derailed on the switch no. 19/a at Budapest-Nyugati station.
Consequences:	0 fatality / 0 serious injury Total damage < EUR 150,000
Parties:	MÁV Zrt. (IM) MÁV-START Zrt. (RU)
<u>Direct cause(s):</u>	• one of the tongue rails of the switch fractured under the incoming train, causing the derailment of second bogie of the first wagon
Contributory factor(s):	• due to poor prop up of the track, the rail was exposed to loads that led to fatigue fractures in the long term
<u>Underlying cause(s):</u>	• the railway track in the area of Budapest Nyugati station is in a significantly degraded condition, the track maintenance system is not able to reduce the degradation process

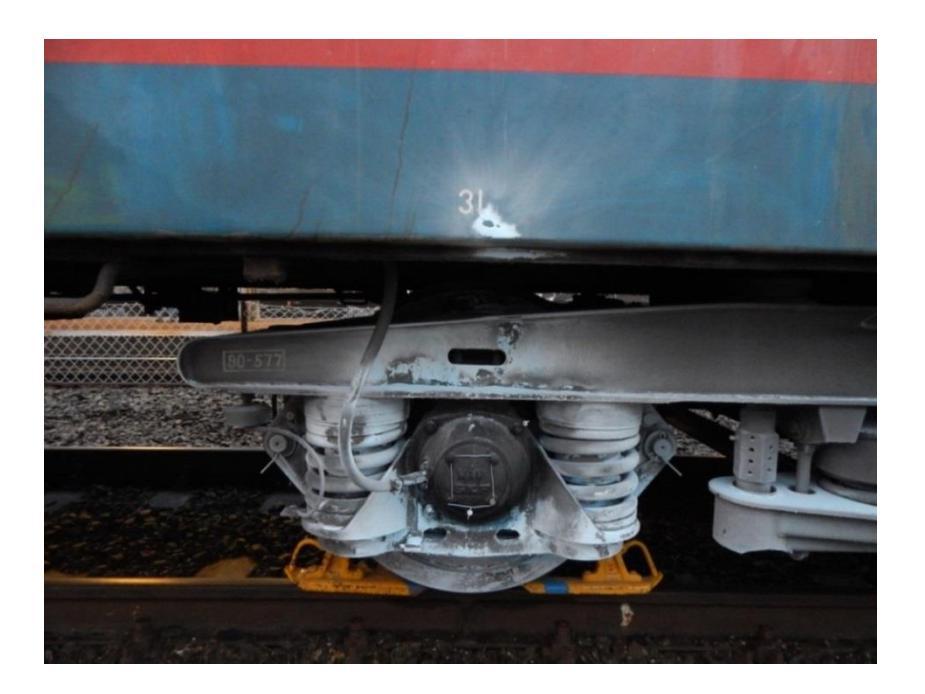
Grade:	Railway accident
Date and time:	15 January 2020
Location:	Mende (station)
Occurrence type:	Fire in rolling stock
Movement type:	Regional passenger train
Description:	A bearing of a wagon of passenger train no. 3330 caught fire, then the train was stopped at Mende station and the fire was extinguished with a fire-extinguisher.
Consequences:	0 fatality / 0 serious injury Total damage HUF 522,011 ( < EUR 150,000)
Parties:	MÁV Zrt. (IM) MÁV-START Zrt. (RU)
<u>Direct cause(s):</u>	• the bearing was stucked, probably due to mechanical damage from fatigue fracture; the rolling elements and the inner ring have stopped rotating, the withdrawal sleeve rotated on the shaft journal and on the inner ring of the bearing
<u>Contributory factor(s):</u>	<ul> <li>due to high friction, the heat generated ignition of the lubricant (grease)</li> <li>the bearing had already reached the end of its fatigue lifetime, but this was not detectable due to the nature of the maintenance system</li> <li>there is a manufacturer's recommendation for the lifetime of the bearing, but the maintenance system does not adapted it to the operating conditions and does not specify an expected lifetime period, so there is not a known maintenance requirement to replace the bearing before the end of its life</li> </ul>

<u>Underlying cause(s):</u>	<ul> <li>none</li> </ul>
<u>Recommendation(s):</u>	Transportation Safety Bureau recommends to MÁV-START Zrt. to consider introducing a procedure in its passenger car maintenance system that takes into account the manufacturer's recommendations on bearing lifetime and requires bearings to be replaced before the end of their expected lifetimes.

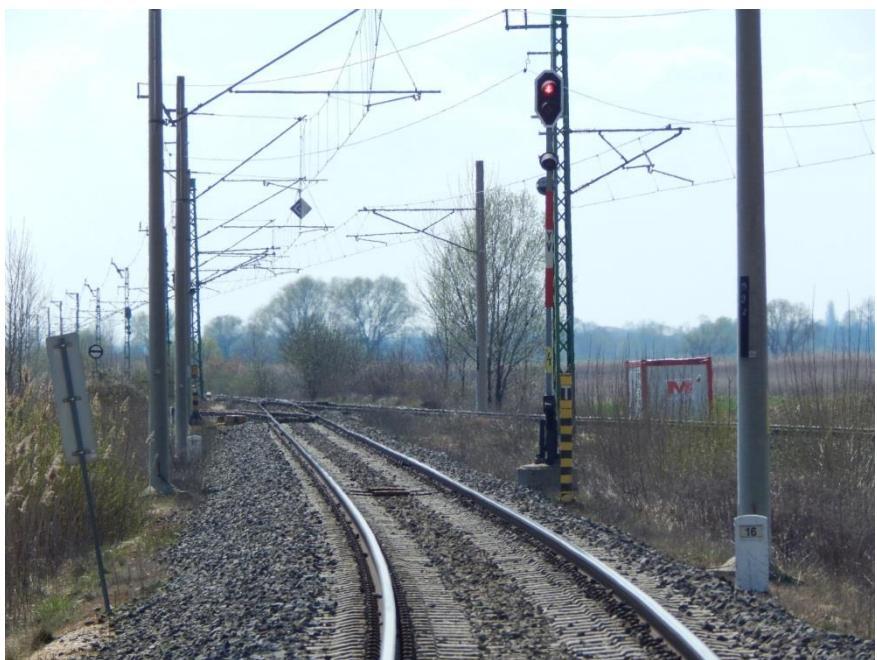
Grade:	Railway incident
Date and time:	28 January 2020
Location:	Jánosháza elágazás (junction)
Occurrence type:	Signal passed at danger
Movement type:	Long distance passenger train
Description:	The passenger train no. IC952 passed the signal of Jánosháza-elágazás at danger. The train was stopped by the engineer 149 metres behind the signal.
Consequences:	0 fatality / 0 serious injury No damage (EUR 0)
Parties:	MÁV Zrt. (IM) MÁV-START Zrt. (RU)
Direct cause(s):	• the driver did not check the aspect of the warning signal and did not expect a "Danger" aspect on the "YV" signal and therefore did not apply the brakes in time
<u>Contributory factor(s):</u>	<ul> <li>the driver's attention was distracted from checking the pre-indication signal by making the necessary switches to cross the phase boundary located in front of the signal</li> <li>the line-side of this section of the railway is not equipped for continuous train</li> </ul>

control system operation
<u>Underlying cause(s):</u>	• during the training of locomotive drivers, it is possible that they acquire certificate of knowledge of a line section without having actually travelled on certain parts of it

• within the infrastructure managing entity, the incident was not initially handled in accordance with its real safety risk and the relevant legislation and instructions, and therefore its immediate reporting to the TSB was delayed and the scene of the accident was disrupted without authorisation
<u>Recommendation(s):</u>	none

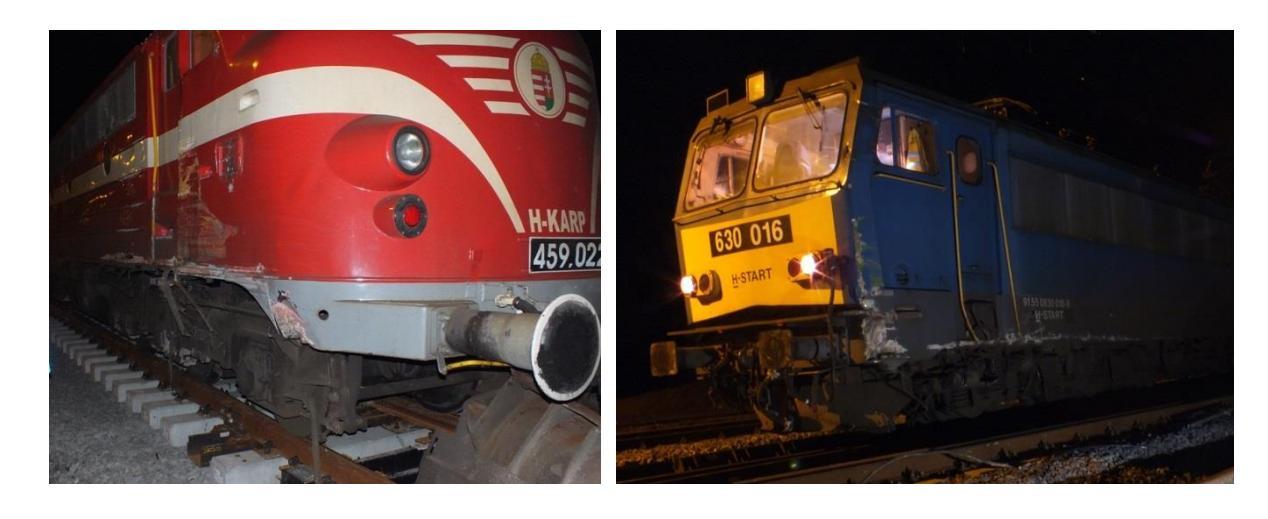
Grade:	Railway accident/incident
Date and time:	3 February 2020
Location:	Pusztaszabolcs (station)
Occurrence type:	Trains collision
Movement type:	Shunting operation
Description:	A shunting train crossed the route of an overpassing freight train no. 82901 and collided with it side to side at Pusztaszabolcs station.
Consequences:	0 fatality / 0 serious injury Total damage HUF 10,984,875 ( < EUR 150,000)
Parties:	MÁV Zrt. (IM) Kárpát Vasút Kft. (RU) Rail Cargo Hungaria Zrt. (RU)
<u>Direct cause(s):</u>	<ul> <li>the safety installation did not detect the occupation of the № 14 switch, so the route of the passing freight train could be locked and "green" light could appear on the signal</li> <li>the traffic controller gave authorisation to start the shunting movement without having information about the actual position of the train, without having competence over the tracks where the train was located (in the construction site) and without the presence of a forman shunter at the shounting site</li> <li>the train making the shunting movement stopped on the № 14 in a position of violating the structure gauge (clearance) of the route of the ongoing freight train</li> <li>the transition points between the station area in use and the construction area and the way of managing the movements crossing them were not clearly defined</li> </ul>

<u>Contributory factor(s):</u>	• limited information was available to the traffic controller on the processes in progress at the construction site
	<ul> <li>snuming movement was performed without a forman snunter being present in the construction area</li> </ul>
<u>Underlying cause(s):</u>	<ul> <li>no implementing instructions had been drawn up on the traffic management procedures applicable at the time of the reconstruction works</li> <li>the staff were only allowed to work under instructions which did not indicate a person authorising the shunting operations in the work area</li> </ul>
Recommendation(s):	none

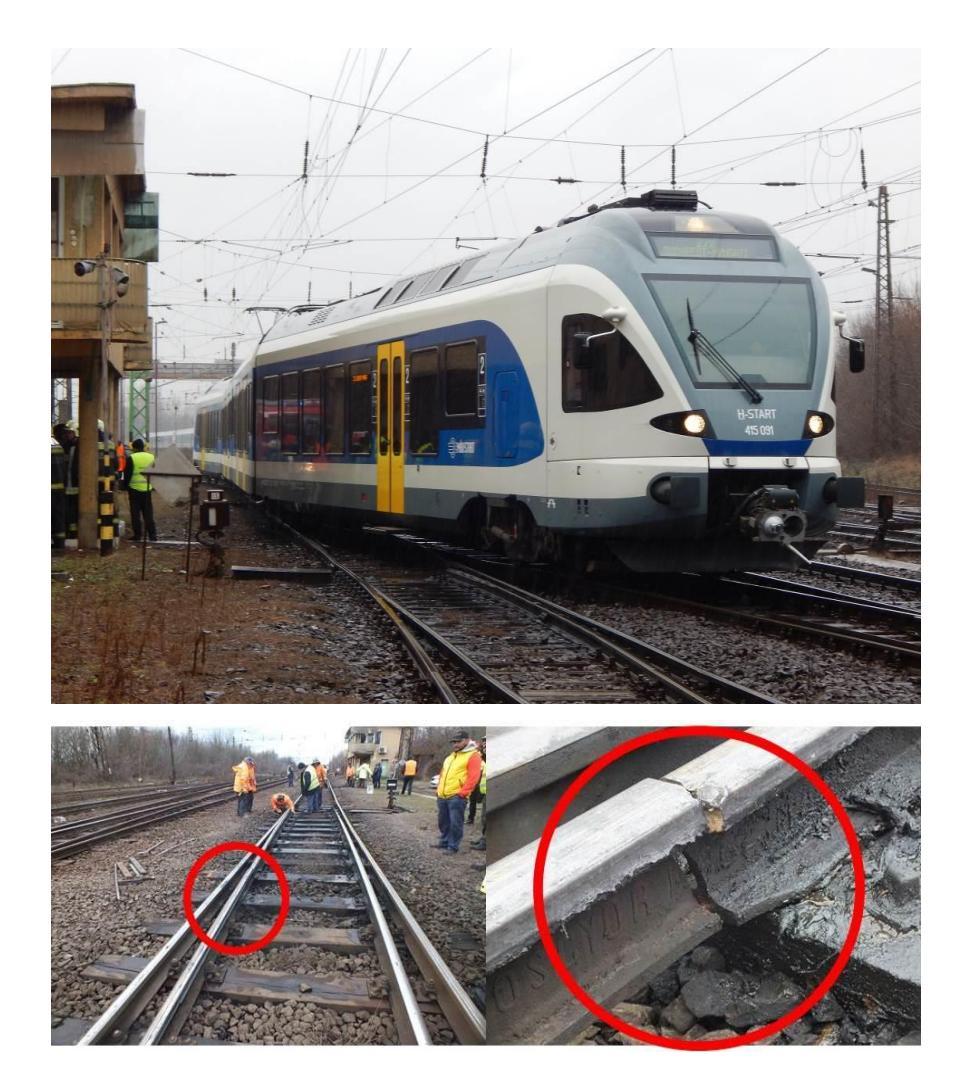
Grade:	Railway accident
Date and time:	4 February 2020
Location:	Rákosrendező (station)
Occurrence type:	Train derailment
Movement type:	Commuter train
Description:	The passenger train no. 2067 derailed on the switch no. 11 at Rákosrendező station.
Consequences:	0 fatality / 0 serious injury Total damage HUF 37,430,000 ( < EUR 150,000)
Parties:	MÁV Zrt. (IM) MÁV-START Zrt. (RU)
Direct cause(s):	• during the train's approach, the switch tongue in the diverging direction fractured, causing the derailment of the leading bogie of the train
Contributory factor(s):	• none
<u>Underlying cause(s):</u>	• the cycle time for ultrasound rail testing (which can detect hairline cracks in the web and the foot of the rail) is much longer than the time needed by the processes leading to similar fractures (from the formation of detectable hairline cracks to the final fracture), therefore fractures cannot always be prevented

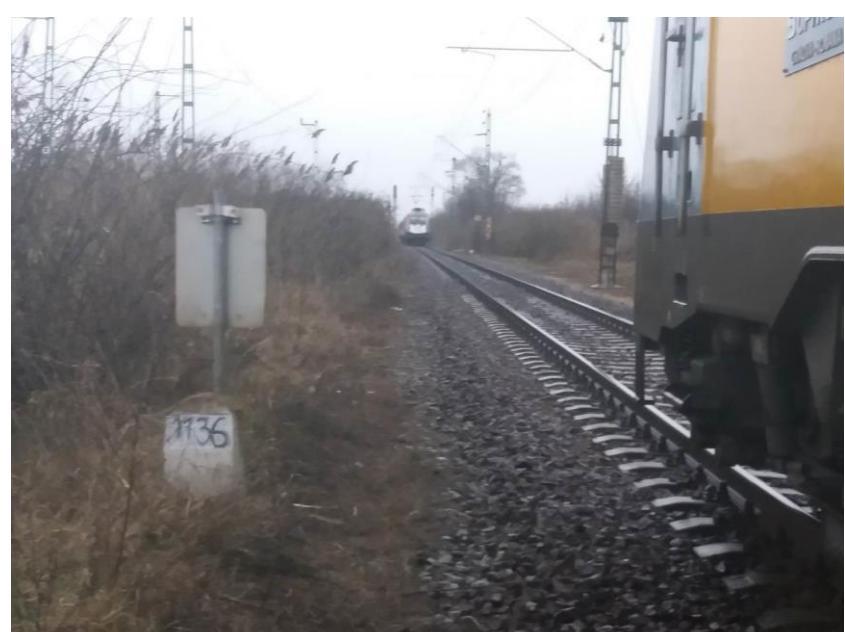
Grade:	Railway incident
Date and time:	21 February 2020
Location:	Lőkösháza (station)
Occurrence type:	Signal passed at danger
Movement type:	Locomotive running solo
Description:	The train no. 27355 passed the signal of Lőkösháza station at danger. Eventually the train was stopped by the engine driver before leaving the station. The passenger train what was coming from the opposite direction (no. 7504), stopped before reaching the entry signal of the station.
Consequences:	0 fatality / 0 serious injury No damage (EUR 0)
Parties:	MÁV Zrt. (IM) CER Hungary Zrt. (RU) MÁV-START Zrt. (RU)
Direct cause(s):	<ul> <li>the driver remembered incorrectly the aspect of the entrance signal which also gave pre-indication for the exit signal</li> <li>the locomotive driver was late in checking the aspect of the "K2" exit signal</li> <li>the driver's work was interrupted by a telephone conversation with the dispatcher of the railway company and then by the receive of the journey documents</li> </ul>

<u>Contributory factor(s):</u>	<ul> <li>the driver was also distracted by the fact that, after a phone call with the dispatcher, he was already planning the rest of the work to be done at Szolnok station when he got back on the locomotive and departed</li> <li>the locomotie driver's concentration may have been reduced by the fact that he has had to leave home quite early, about four hours before the start of the service</li> </ul>
<u>Underlying cause(s):</u>	• none
<u>Recommendation(s):</u>	none

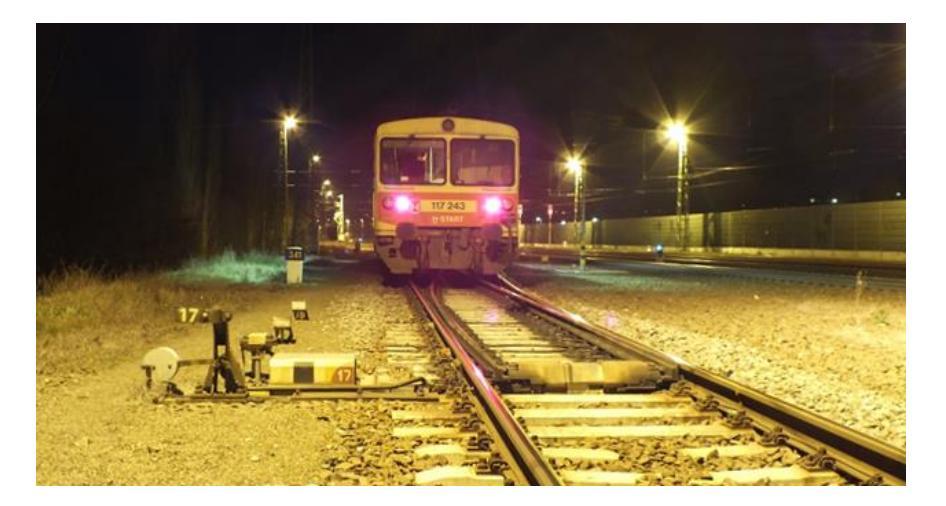
Grade:	Railway incident
Date and time:	15 March 2020
Location:	Vác (station)
Occurrence type:	Signal passed at danger
Movement type:	Regional passenger train
Description:	For the passenger train no. 32228 the route was set incorrectly by the signaller from track no. 4b instead from track no. 3b at Vác station. The train left the station this way: passed a signal at danger and opened up a switch.
Consequences:	0 fatality / 0 serious injury No damage (EUR 0)
Parties:	MÁV Zrt. (IM) MÁV-START Zrt. (RU)
<u>Direct cause(s):</u>	<ul> <li>the traffic controller in the computer did not lock the proper track route for the train that was actually departing, and then gave instructions to his coworker to authorise the train driver verbally, without ensuring that the track route had actually been formed, because he was not staying at his place of work</li> <li>the external traffic controller, on the basis of receiving an incorrect verbal instruction, authorised the locomotive driver without checking the aspect of the exit signal</li> <li>under the influence of the authorisation and the signal from the exit signal of the adjacent track allowing the train to proceed, the driver started his train without checking the signal concerning his train, and did not check the signal either while moving towards it</li> </ul>

<u>Contributory factor(s):</u>	<ul> <li>after a change of direction, continuous train controlling does not work on the train until the new track route setting is made, so the more frequently given vigilance alert does not help the driver detect the situation, nor does the emergency brake apply when passing a signal at danger</li> <li>because of the spatial position of the signals, their apparent order due to the curve in the track causes problems when checking them</li> </ul>

• the movement inspector on the platform was accustomed to the fact that in daylight the signals were not clearly visible, so he did not even attempt to check them by stepping back from the train in the dark, nor did he ask about the aspect of the exit signal by radio
<u>Underlying cause(s):</u>	• none
Recommendation(s):	none

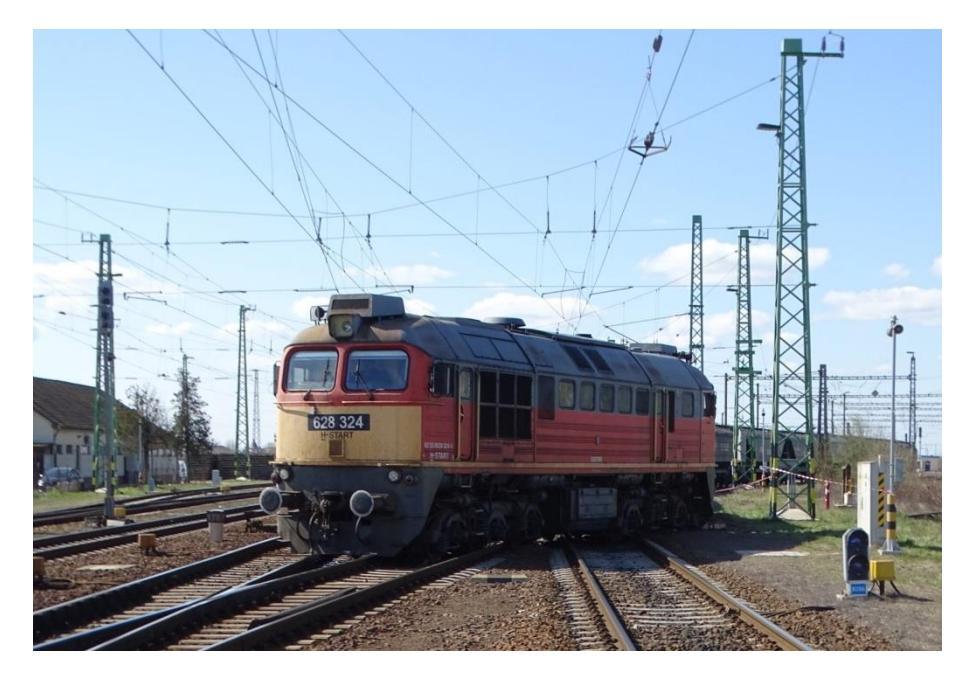
Grade:	Railway incident
Date and time:	21 March 2020
Location:	Isaszeg (station)
Occurrence type:	Signal passed at danger
Movement type:	Freight train
Description:	The freight train no. 55907 passed the signal of Isaszeg station at danger. The train was stopped by the train control system.
Consequences:	0 fatality / 0 serious injury No damage (EUR 0)
Parties:	MÁV Zrt. (IM) MMV Zrt. (RU)
<u>Direct cause(s):</u>	<ul> <li>neither the trainee driver nor the instructor checked the aspect of the home signal, and they cheked the aspect of the exit signal too late</li> <li>in addition, the trainee driver based his driving style on the signals coming from the train control system and therefore he started braking too late, while the instructor had not recognised this driving style and did not wean the trainee off it – this became dangerous because the information provided by the train control system was insufficient to support a stopping before the signal, because of the short signal evaluation distance given at the station</li> </ul>

<u>Contributory factor(s):</u> <u>Underlying cause(s):</u>	<ul> <li>the instructor had only administrative but not real knowledge of the line</li> <li>the rule relating to the layout of continuous signalling of the train control system does not ensure that signalling is capable of supporting driving or even just preventing driver errors</li> <li>the regulation and the practice of railway undertakings do not take account of the inevitable situation where drivers do not have professional knowledge on the route, and the training system does not solve this problem by using the training methods already available or, in their absence, by requiring other risk mitigation measures</li> <li>the training and examination of practical railway instructors is based to a large extent on knowledge of rules and regulations, not on the issue and capability of knowledge transfer and the supervision of that</li> </ul>

<u>Recommendation(s):</u>	Transportation Safety Bureau recommends the Railway Aurthority Division, Ministry of Technology and Industry (as National Safety Authority) to consider requiring the development of procedures in the safety management systems of railway companies to identify and manage driving situations where drivers do not have up-to-date route knowledge (e.g. lines under reconstruction, infrequently travelled lines), and analyse the risks and apply risk mitigation procedures as a result.
	The TSB recommends the Railway Training and Methodology Centre, Institute for Transport Sciences to consider investigating the applicability of simulators and virtual reality in order to ensure drivers' route knowledge, and based on the results of the investigation, take measures – by drafting proposals for amending legislation if necessary – to establish and introduce simulator training in the Hungarian railway industry.

Transportation Safety Bureau recommends the Railway Aurthority Division, Ministry of Technology and Industry (as National Safety Authority) to consider examining the maximum length of the track to which signalling of the used train control system is suitable to support safe driving and accordingly, requiring the application of the rules for no signals on tracks that are too short for continuous signalling.

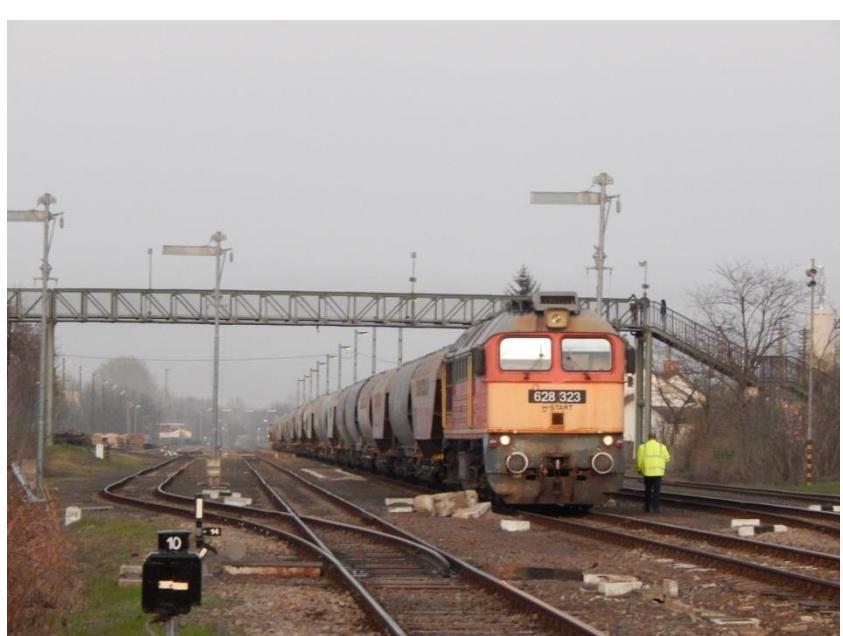
Grade:	Railway incident
Date and time:	7 April 2020
Location:	Nyírbátor (station)
Occurrence type:	Signal passed at danger
Movement type:	Freight train
Description:	The freight train no. 68001 passed the signal of Nyírbátor station at danger. Eventually the train was stopped by the engine driver before leaving the station. The passenger train what was coming from the opposite direction (no. 6316), stopped before reaching the entry signal of the station.
Consequences:	0 fatality / 0 serious injury No damage (EUR 0)
Parties:	MÁV Zrt. (IM) Rail Cargo Hungaria Zrt. (RU)
<u>Direct cause(s):</u>	• the locomotive driver did not stop his train at the shunting limit signal at the station, contrary to the train's timetable
<u>Contributory factor(s):</u>	<ul> <li>the exit signal "K3" involved in the route had not been repaired in six months following a previous accidental damage and was not standing in place at the time of the incident</li> <li>the man-portable 'Stop' sign previously placed in place of the "K3" sign was removed within a short time</li> </ul>

<ul> <li>the permanently changed traffic conditions at the station have not been modified in the Station Instructions, nor in the Route Book</li> </ul>
<u>Underlying cause(s):</u>	• the replacement of the signal was not seen as a safety issue but as a financial one

• the station staff and area managers, who were uncertain about the applicable procedures, received only informal guidance on the interpretation of the applicable rules from the management
<u>Recommendation(s):</u>	none

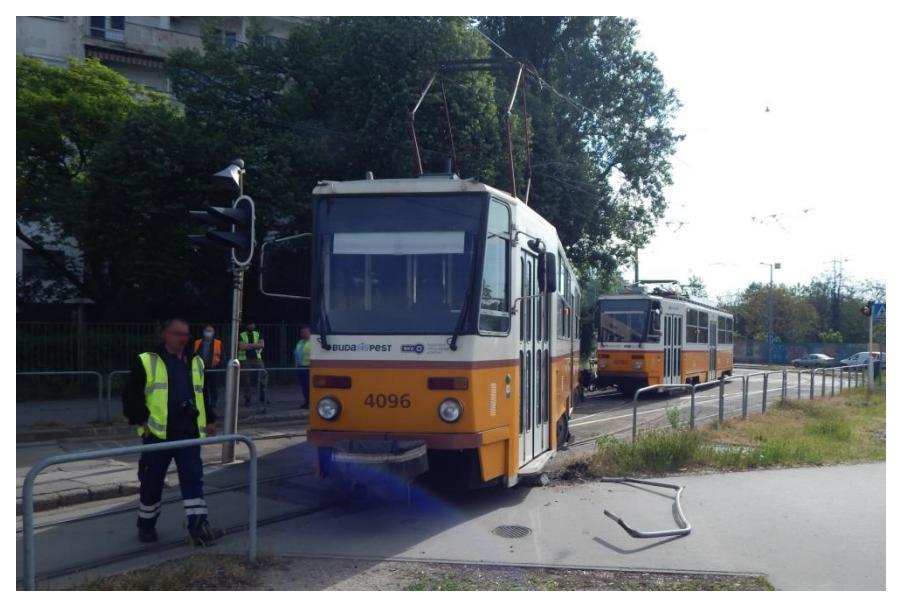
Grade:	Tramway accident
Date and time:	27 April 2020
Location:	Budapest, Lehel tér (station)
Occurrence type:	Train derailment
Movement type:	Tramway
Description:	The tram no. 14 derailed on the switch of the terminus Budapest, Lehel tér.
Consequences:	0 fatality / 0 serious injury Total damage HUF 149,400 ( < EUR 150,000)
Parties:	BKV Zrt. (IM) BKV Zrt. (RU)
<u>Direct cause(s):</u>	• the control panel operator initiated a shift on the signalling equipment while a vehicle was on the set of points

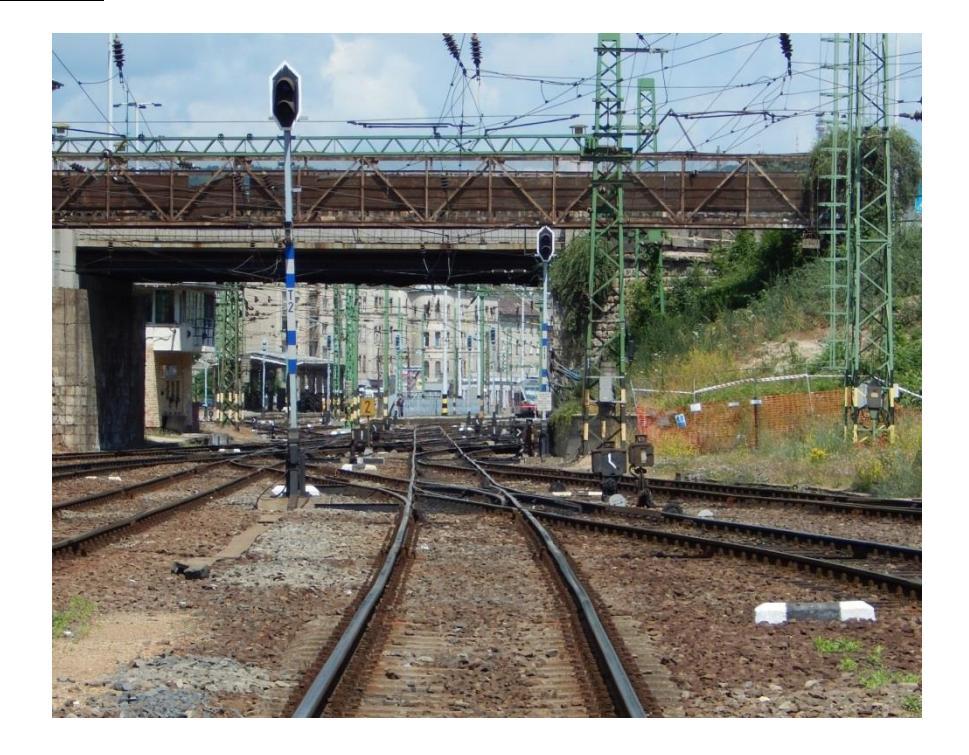
Grade:	Railway incident
Date and time:	29 April 2020
Location:	Budapest-Déli (station)
Occurrence type:	Signal passed at danger
Movement type:	Locomotive running solo
Description:	The train no. 20348-1 passed the signal at danger at Budapest-Déli station and opened up a switch. Eventually the train was stopped by the engineer.
Consequences:	0 fatality / 0 serious injury No damage (EUR 0)
Parties:	MÁV Zrt. (IM) MÁV-START Zrt. (RU)
<u>Direct cause(s):</u>	<ul> <li>the locomotive driver did not stop at the shunting limit signal at the end of the 'T4' track</li> <li>the yard foreman did not meet the train in front of the signal box 'B' and did not give the train the 'Slow down!' and 'Stop!' handsignals as it is required by the Station Instructions</li> </ul>
Contributory factor(s):	<ul> <li>the driver did not have a professional, substantive route knowledge relating to the station's storage sidings and tracks</li> <li>the driver was busy with a protracted operational telephone call</li> </ul>

<u>Underlying cause(s):</u>	<ul> <li>the volume of work load concerning for staff working as yard foremen at the station may mean that they are not always able to carry out their duties fully</li> <li>having a legally valid route knowledge licence for locomotive drivers does not guarantee that their real knowledge is in fact adequate and up-to-date, and the associated risk is not managed by the safety management system</li> </ul>
Recommendation(s):	none

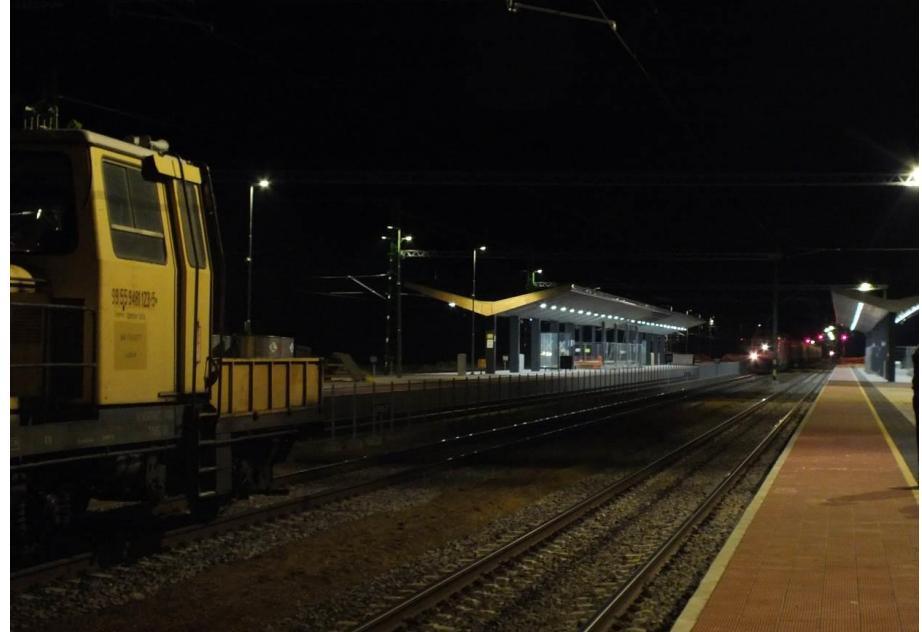
Grade:	Railway incident
Date and time:	27 May 2020
Location:	Kaba (station)
Occurrence type:	Signal passed at danger
Movement type:	Locomotive running solo
Description:	The train no. 14566 (work train) passed the signal of Kaba station at danger and moved on towards the oncoming freight train no. 48911. Eventually the two trains stopped 200 metres away from each other.
Consequences:	0 fatality / 0 serious injury No damage (EUR 0)
Parties:	MÁV Zrt. (IM) MÁV FKG Kft. (RU) Rail Cargo Hungaria Zrt. (RU)
Direct cause(s):	• both the driver (who is presumed to have fallen asleep) and the second attendant failed to detect the 'Danger' aspect of the second entry signal 'C' and neither of them stopped the vehicle before the signal
<u>Contributory factor(s):</u>	<ul> <li>the driver and the second employee on watch had spent a large part of their time on night duty, which led to long-term fatigue</li> <li>the vehicle with registration number 99 55 9481 123-5 was not fitted with vigilance equipment that would have stopped the train if the driver had failed to react</li> </ul>

Underlying cause(s):	• the employees' need for resting periods was not taken into account in the scheduling of their working hours
<u>Recommendation(s):</u>	none

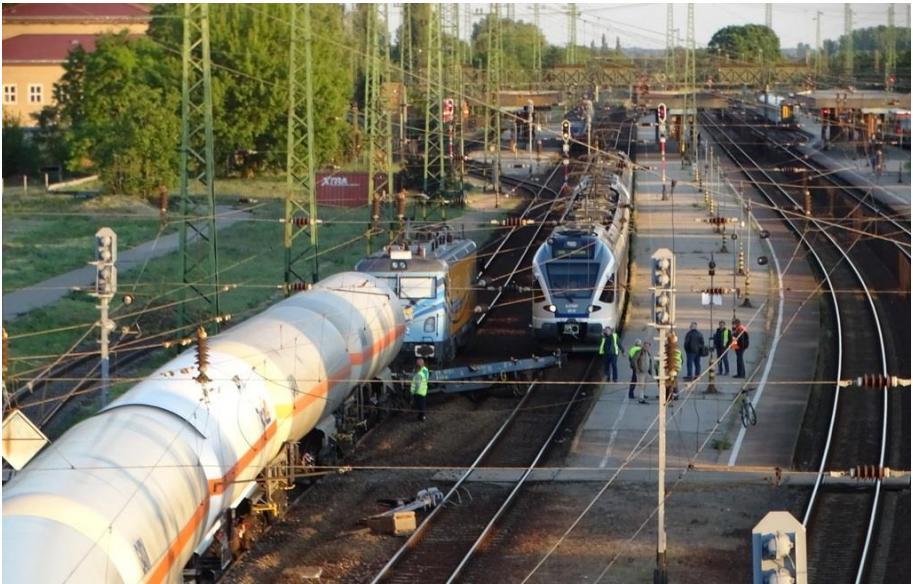
Grade:	Railway accident
Date and time:	2 June 2020
Location:	Hatvan (station)
Occurrence type:	Train derailment
Movement type:	Freight train
Description:	The freight train no. 45290-1 derailed on the switch no. 33 at Hatvan station.
Consequences:	0 fatality / 0 serious injury Total damage HUF 6,600,000 ( < EUR 150,000)
Parties:	MÁV Zrt. (IM) CER Hungary Zrt. (RU)
<u>Direct cause(s):</u>	<ul> <li>there was a rapid loss of gauge in the curve of № 33 set of points, which was not detected by the track supervision system and therefore was not corrected</li> <li>at the front of the train, a light wagon was inserted as a guard wagon, which was more sensitive for the trajectory error</li> <li>the causes implied by the technical condition of the derailed wagon could not be investigated, but could not be excluded either</li> </ul>
<u>Contributory factor(s):</u>	<ul> <li>the fault of a rapid loss of gauge in the curve of the set of points cannot be detected by following the track inspection rules</li> <li>the amendment to the rules on guard vehicles, scheduled for April 2020, has been postponed until August 2020 due to external circumstances</li> </ul>

<u>Underlying cause(s):</u>	<ul> <li>the infrastructure manager does not fulfill the safety management task to take immediate corrective action to prevent the recurrence of accidents involving known safety risks</li> </ul>
<u>Recommendation(s):</u>	The TSB recommends the Railway Aurthority Division, Ministry of Technology and Industry (as National Safety Authority) considering to review the safety management system and operation of MÁV Zrt. to ensure that it adequately provides for immediate corrective action to be taken in response to identified risks and that the company operates its safety management system accordingly.

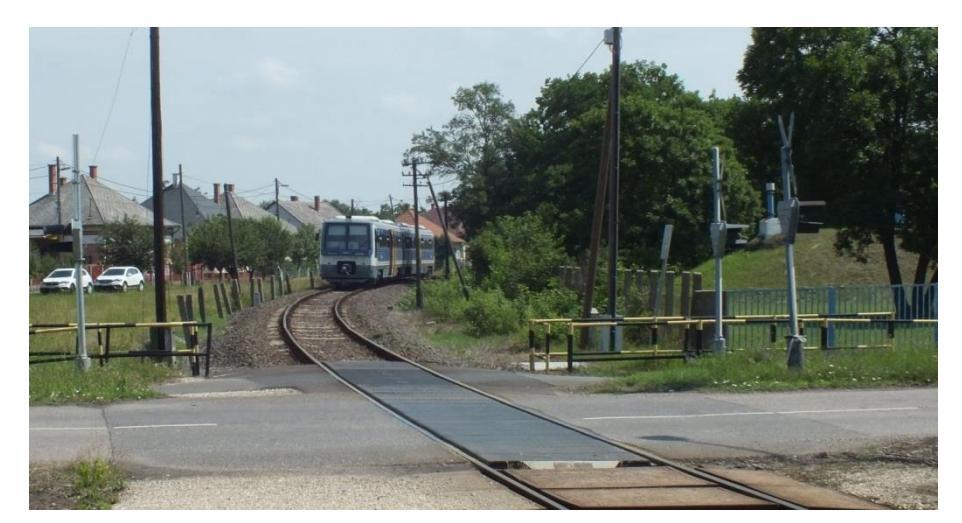
Grade:	Railway incident
Date and time:	14 June 2020
Location:	Püspökladány (station)
Occurrence type:	Signal passed at danger
Movement type:	Regional passenger train
Description:	The passenger train no. 6417 could not stop thus passed the signal of Püspökladány station at danger. Eventually the train could stop 2,6 kilometres away from the station.
Consequences:	0 fatality / 0 serious injury No damage (EUR 0)
Parties:	MÁV Zrt. (IM) MÁV-START Zrt. (RU)
<u>Direct cause(s):</u>	<ul> <li>a glide on an electrical cable has slipped off the electro-pneumatic brake valve connector on side A, causing the brake valve to fail</li> <li>the driver did not recognise the brake valve failure during troubleshooting and therefore did not apply the relevant rules</li> <li>the locomotive driver started the train after manual release of the brakes, despite the main pipeline pressure was 0 bar</li> <li>the locomotive driver had severe deficiencies in his knowledge of the type of locomotive and was therefore unable to activate the independent braking devices</li> </ul>

Contributory factor(s):	<ul> <li>the glides of the electrical wires connected to the brake valve were not the fixing lock type and were able to slip off the connector and cause the electro-pneumatic brake valve to fail</li> <li>the DMU train set does not have a main line pressure switch to prevent traction when the main brake line is empty</li> <li>the driver did not use the direct engine brake, even in an emergency, because he thought that it could lead to a technical failure</li> </ul>
<u>Unaertying cause(s):</u>	<ul> <li>locomotive drivers' current knowledge of the type and decades of driving experience do not necessarily reflect their confidence in handling vehicles, and their knowledge is not always at a skill level</li> <li>the DMU train set was not overhauled within the required time</li> </ul>

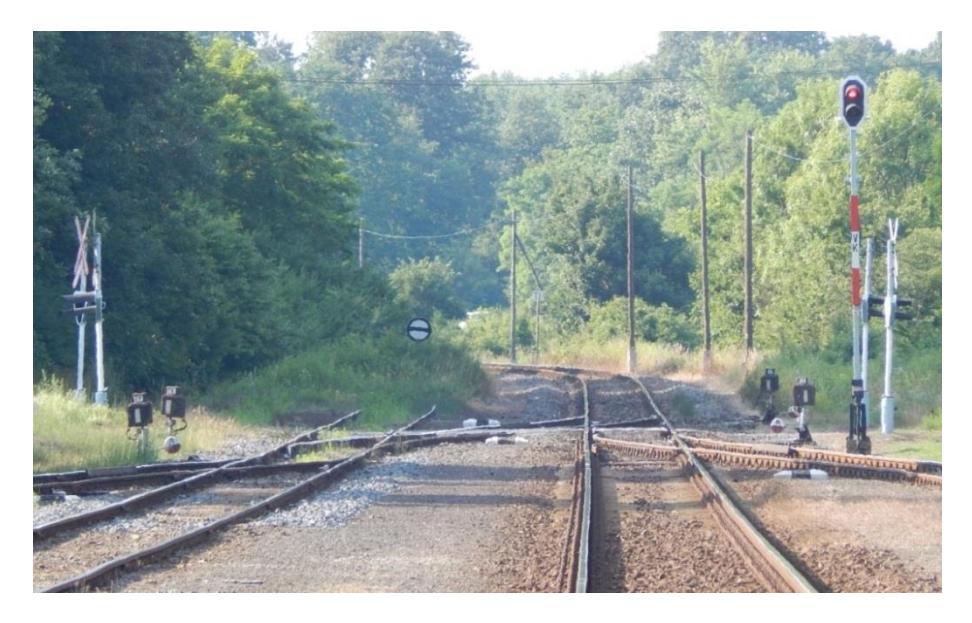
Grade:	Railway incident
Date and time:	27 June 2020
Location:	Uzsa (station)
Occurrence type:	Signal passed at danger
Movement type:	Regional passenger train
Description:	The train no. 9694 passed the signal of Uzsa station at danger. Eventually the train was stopped by the engine driver.
Consequences:	0 fatality / 0 serious injury No damage (EUR 0)
Parties:	MÁV Zrt. (IM) MÁV-START Zrt. (RU)
<u>Direct cause(s):</u>	<ul> <li>instead of passing through, as it was in the timetable of the train, the signaller wanted the train to stop at the station, but the locomotive driver did not intend to stop at the station and therefore did not apply the brakes in time</li> <li>the locomotive driver did not check the aspect of the level crossing protecting signal at the other end of the station and did not miss the authority (hand signal) to pass the station from the signaller</li> <li>the signaller did not meet the train at the trackside and did not give the "Slow down" hand signal because he was on the phone with the line traffic controller</li> </ul>

<u>Contributory factor(s):</u>	<ul> <li>the chief ticket inspector was staying in the driver's cabin</li> <li>the pintsman did not stop the train at the entry signal</li> <li>the signaller prioritised his tasks incorrectly</li> <li>the line traffic cotroller changed the trains' meeting point several times and issued his last order too late</li> </ul>
<u>Underlying cause(s):</u>	• the audit by the station master did not take action to address the poor practices identified after a previous similar incident at the station what are also relevant to this incident

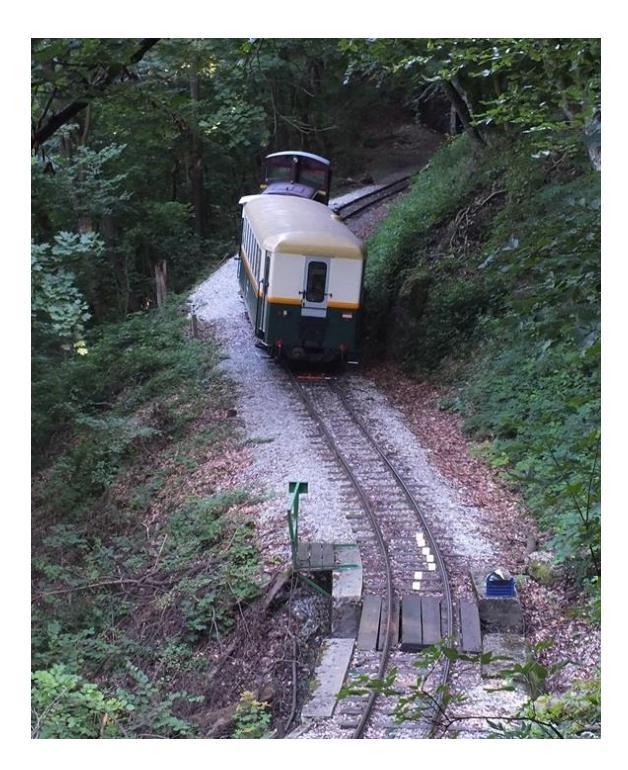
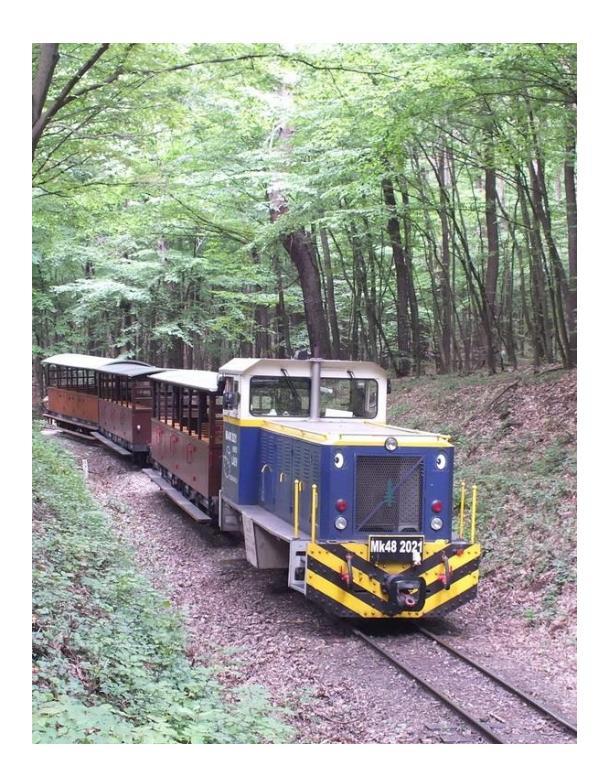
Grade:	Heritage railway accidents		
Date and time:	24 June 2020 / 10 July 2020 / 14 July 2020		
Location:	Papírgyár - Puskaporos, km 4,3 (line) / Lillafüred - Fazolakohó, km 7,7 (line) / Papírgyár - Puskaporos, km 4,3 (line)		
Occurrence type:	Train derailment		
Movement type:	Heritage passenger trains		
Description:	Three passenger trains derailed on the network of $L \acute{A} EV$ narrow-gauge railway.		
Consequences:	0 fatality / 0 serious injury Total damage < EUR 150,000		
Parties:	Északerdő Zrt. (IM) Északerdő Zrt. (RU)		
Direct cause(s):	<ul> <li>direct technical causes:         <ul> <li>low wheel flange angles of derailed vehicles, which is a normal consequence of the overhaul</li> <li>high friction between the wheel and the rail, which can be traced back to</li></ul></li></ul>		
Contributory factor(s):	<ul> <li>track supervision is carried out by a railway manager who is also burdened with managerial duties, due to the absence of a company or staff member available for this purpose, since no measures have been taken to involve the necessary company or to increase the staff headcount</li> <li>on the refurbisher side, the controllability of quality assurance processes is</li> </ul>

<ul> <li>weak, with shortcomings of documentation of work processes and vehicle characteristics</li> <li>there is no professional staff or company available for vehicle supervision or maintenance</li> </ul>		
<u>Underlying cause(s):</u>	<ul> <li>in project management:         <ul> <li>in the case of public procurement, the tasks concerning different types of vehicles were not split into separate tenders</li> <li>the project was not managed professionally, including the absence of a designated engineer organization, and the role of the engineers was not clearly defined among the actors</li> <li>in vehicle maintenance:</li> </ul> </li> </ul>

<u>Recommendation(s):</u> The TSB recommends to Északerdő Zrt. to develop standards for coupling devices for all (applicable) types used, ensuring safe coupling and/or imposing application restrictions, with the involvement of similar railway companies.

The TSB recommends to Északerdő Zrt. to clearly identify the person responsible for making technical decisions in the ongoing vehicle renewal (and the planned track renewal) project.

The TSB recommends the Rail Technical Committee to develop technical rules for narrow gauge railways with the meaningful involvement of the narrow gauge rail industry, with regulatory requirements proportionate to the risks and opportunities of these railways.

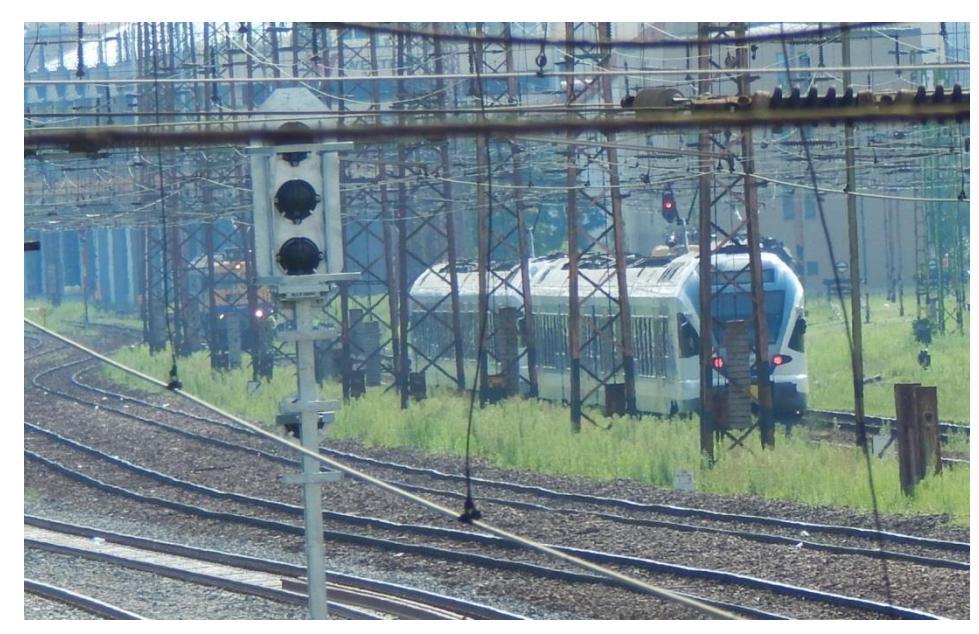
Grade:	Railway incident		
Date and time:	23 July 2020		
Location:	Budapest-Nyugati (station)		
Occurrence type:	Signal passed at danger		
Movement type:	Locomotive running solo		
Description:	The train no. 22425 passed the signal "G" of Budapest-Nyugati station at danger and moved on towards the oncoming passenger train no. 2346. Eventually the two trains stopped 288 metres away from each other.		
Consequences:	0 fatality / 0 serious injury No damage (EUR 0)		
Parties:	MÁV Zrt. (IM) MÁV-START Zrt. (RU)		
<u>Direct cause(s):</u>	• after the train № 2036 (moving in the opposite direction) had passed, the locomotive driver of train № 22425 departed without authorisation and without observing (or after not observing it carefully enough) the aspect of signal "G" which was in 'Danger'		
<u>Contributory factor(s):</u>	• the 75 Hz continuous signal transmission for train control systems is not installed at the location of the occurrence, so active train control is not available there

• the personnel of the traffic-regulating signal box $N_{2}$ 2 did not notice that train $N_{2}$ 22425, which had been waiting in their area, started to move without authorisation, passed the area of the train-regulating signal box $N_{2}$ 2 and then entered the track which lead towards signal box $N_{2}$ 1, and so did not take any action to stop the dangerous movement(s)		
Underlying cause(s):	• the train protection system based on 75 Hz track-circuit signals is not suitable to prevent head-on traffic when it is only partially installed		
Recommendation(s):	none

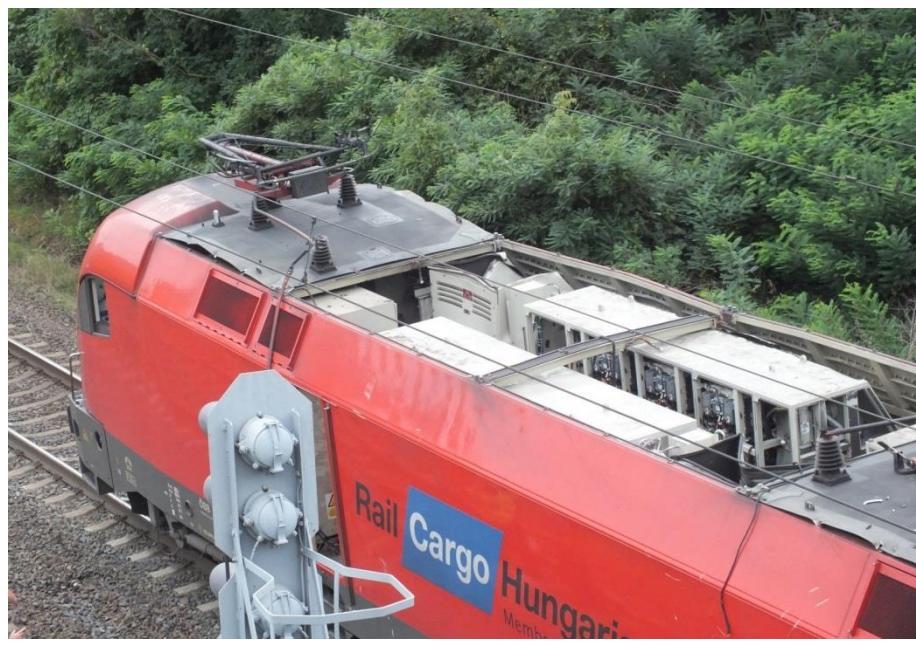
Grade:	Railway accident	
Date and time:	14 August 2020	
Location:	Biatorbágy (station)	
Occurrence type:	Fire in rolling stock	
Movement type:	Freight train	
Description:	There was an explosion inside the electric-engine of the freight train no. 92905 and the roof of the engine fell down onto the second track, where the oncoming passenger train no. IC910 collided with the pieces of it.	
Consequences:	0 fatality / 0 serious injury Total damage EUR 150,000 – 2,000,000	
Parties:	MÁV Zrt. (IM) Rail Cargo Hungaria Zrt. (RU) MÁV-START Zrt. (RU)	
<u>Direct cause(s):</u> Contributory factor(s):	<ul> <li>one capacitor of the locomotive was overheated, and produced a combustible gas which inflamed, because         <ul> <li>the materials of the capacitor decompose as a result of heat and</li> <li>the detection and venting of such gases is not ensured</li> </ul> </li> <li>the failure can be traced back to the capacitor's manufacturing de-fect, or possible overvoltage</li> <li>the locomotive driver did not respond adequately to the fire alarm that had</li> </ul>

<u>contributory juctor(s).</u>	appeared, because sometimes false fire alarms do occur	
<u>Underlying cause(s):</u>	• the failure of the capacitors had been a known phenomenon, but its safety risks were underestimated	
<u>Recommendation(s):</u>	none

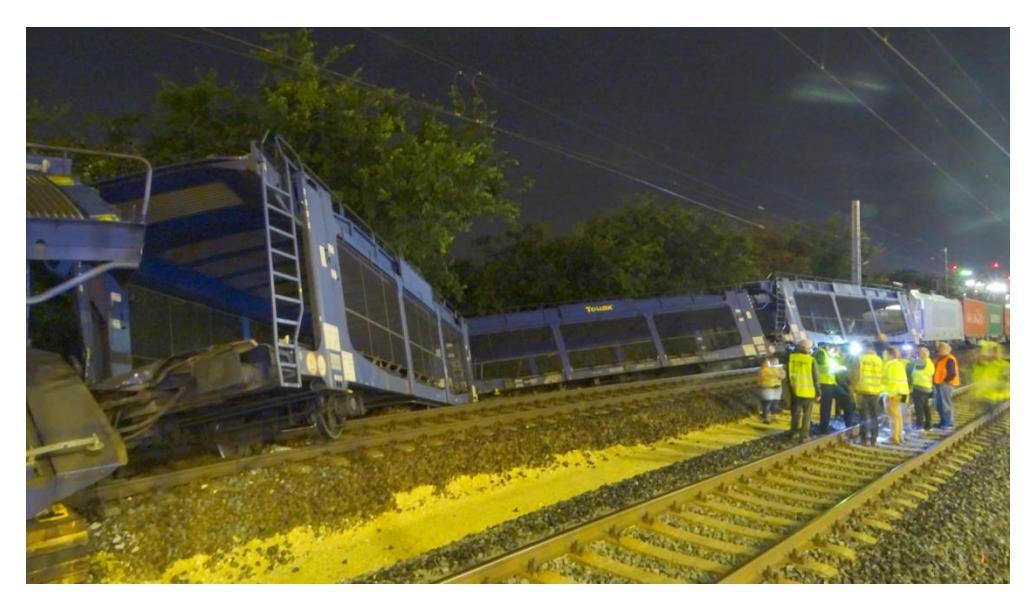
Grade:	Railway accident	
Date and time:	7 October 2020	
Location:	Ferencváros - Kelenföld, km 8,2 (line)	
Occurrence type:	Trains collision	
Movement type:	Freight train	
Description:	The freight train no. 42000-1 passed the section signal '83a' at danger and collidied with the end of the freight train no. 47141 which was standing 21 metres behind the signal. The last 2 twin-wagons of the train no. 47141 derailed, the engine of the train no. 42000-1 was damaged.	
Consequences:	0 fatality / 0 serious injury Total damage HUF 15,000,000 ( < EUR 150,000)	
Parties:	MÁV Zrt. (IM) METRANS Danubia Kft. (RU) LTE Hungária Kft. (RU)	
<u>Direct cause(s):</u>	<ul> <li>the locomotive driver did not apply the brake in time because he did not scan the 'Danger' signal he was approaching</li> <li>the locomotive driver was occupied by handling an error message which had appeared on the display when he ought to have been prepared for stopping the train</li> <li>the train control system in use at the time of the occurrence is not suitable for avoiding similar cases</li> </ul>

<u>Contributory factor(s):</u>	<ul> <li>while the vehicle was in motion, the locomotive driver opened a description of tasks to do at standstill, related to the error message</li> <li>the description was unprofessional</li> <li>this error message occurs frequently, and if it is handled inappropriately, it may be necessary to restart the locomotive, which is a time-consuming process; the locomotive driver was aware of it, which resulted in him a stressful situation</li> <li>the use of short blocks increases the risk of collision in cases of signal overrun</li> </ul>	
<u>Underlying cause(s):</u>	• none	
<u>Recommendation(s):</u>	none

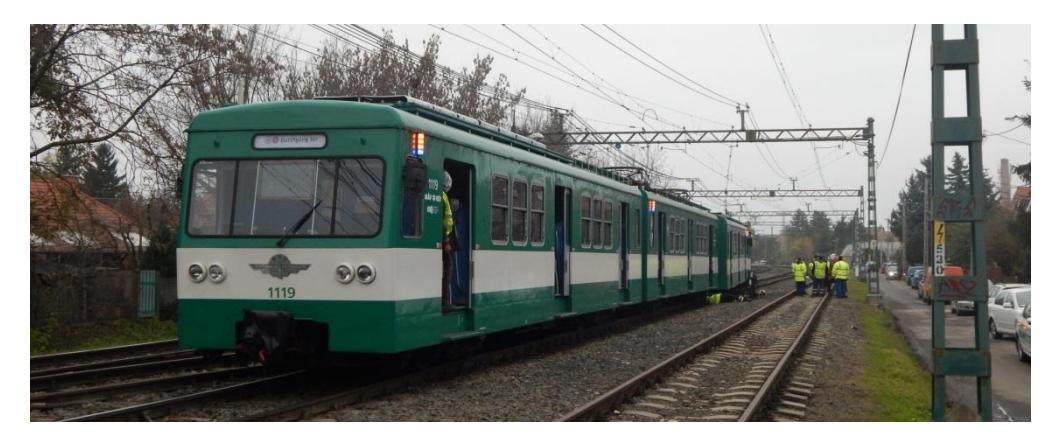
Grade:	Railway accident	
Date and time:	14 November 2020	
Location:	Budakalász (station)	
Occurrence type:	Train derailment	
Movement type:	Commuter train	
Description:	The suburban train no. 4015 derailed at Budakalász station.	
Consequences:	0 fatality / 0 serious injury Total damage HUF 1,400,000 HUF ( < EUR 150,000)	
Parties:	MÁV-HÉV Zrt. (IM) MÁV-HÉV Zrt. (RU)	
<u>Direct cause(s):</u>	• there was a plane distortion of the track exceeding the dimension limit "D" at the location of the derailment, but the track was not excluded from traffic and speed limit was not introduced either

• sleepers were replaced and adjusted in the turnouts linked to the track, which increased the plane distortion of the linked track section as a side effect, but it was not detected because the linked track was not measured and adjusted after the sleeper replacement

• the vehicle's wheel load difference exceeded the limit	
	• the vehicle had novel wheel flanges	
Underlying cause(s):	• the track maintenance rules do not require inspection of the track geometry in cases where the track itself was not disassembled but its geometry changed	
<u>Recommendation(s):</u> <u>Transport Safety Bureau of Hungary recommends MÁV-HÉV Z</u> reviewing the requirements for the frequency of track measurement supervision rules applicable to the MÁV-HÉV railway infrastructur provide sufficient frequency of the assessment of tracks used le attention to the definitions of the terms used relating to the tracks.		
	Transport Safety Bureau of Hungary recommends adjustment of the track supervision rules and practice on the MÁV-HÉV railway infrastructure in such manner that the follow-up measurements carried out on completion of track repairs should also cover an appropriate length of such adjacent track sections which were not worked on but may have related geometric changes due to such works.
