# **ANNUAL REPORT 2021**

# Transportation Safety Bureau Hungary

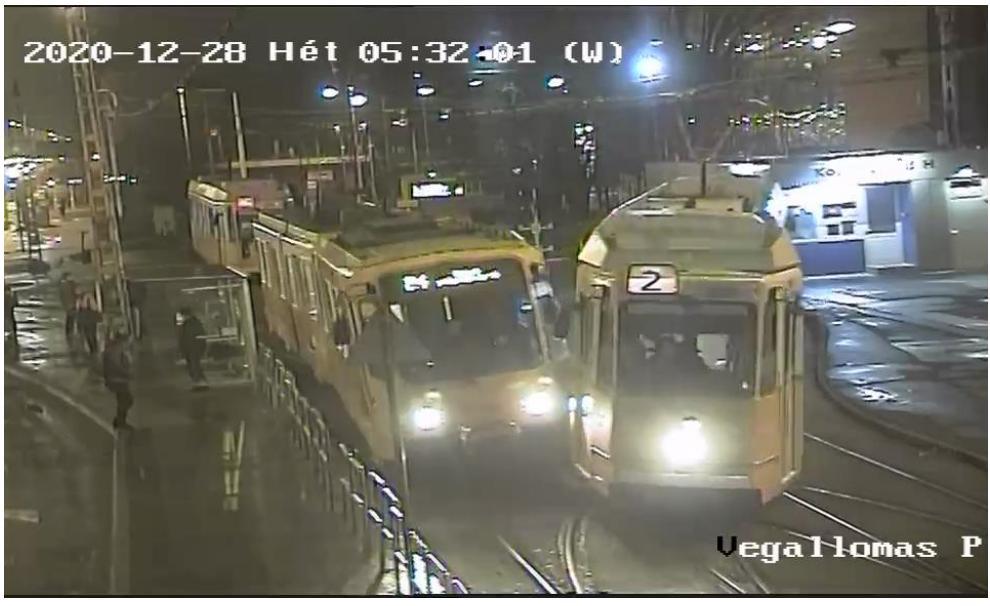
Grade:	Tramway accident	
Date and time:	28 December 2020	
Location:	Budapest, Közvágóhíd (station)	
Occurrence type:	Trains collision	
Movement type:	Tramway	
Description:	Two trams were leaving the terminus of Budapest, Közvágóhíd (one from the track no. 1 and one from the track no. 2) towards the same direction at the same time and they collided side to side at the switch.	
Consequences:	0 fatality / 0 serious injury Total damage HUF 431,216 ( < EUR 150,000)	
Parties:	BKV Zrt. (IM) BKV Zrt. (RU)	
Direct cause(s):	• the driver of the № 24 tram departed despite the "Danger" aspect of signal "C"	
<u>Contributory factor(s):</u>	<ul> <li>while departing (with 'Proceed' signal), the driver of the № 2 tram did not realise that the № 24 tram had also started its journey and got in the way</li> <li>the time pressures inherent in tramway operations (which are most pronounced on return departures at terminals) can, in unfavourable circumstances, facilitate distraction of drivers' attention from rail safety</li> </ul>

<u>Underlying cause(s):</u>	<ul> <li>psychological testing is not a compulsory part of the periodic medical evaluation of drivers, therefore any changes in the employees' circumstances that may preclude or limit their fitness and competence can remain hidden</li> </ul>	
<u>Recommendation(s):</u>	none

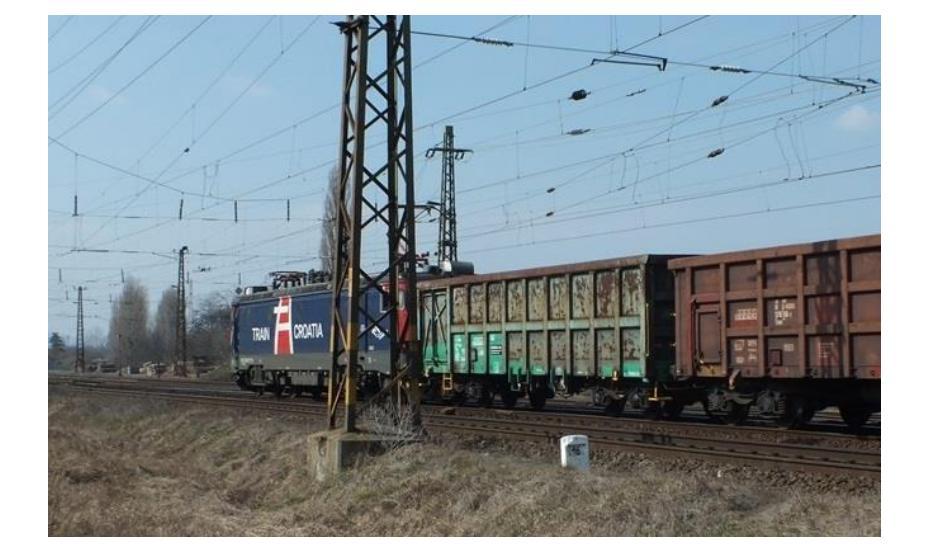
Grade:	Railway incident	
Date and time:	10 March 2021	
Location:	Rákos (station)	
Occurrence type:	Signal passed at danger	
Movement type:	Freight train	
Description:	The train no. 44290-1 passed the entry signal of Rákos station at danger.	
Consequences:	0 fatality / 0 serious injury No damage (EUR 0)	
Parties:	MÁV Zrt. (IM) Train Hungary Kft. (RU)	
Direct cause(s):	• the locomotive driver did not prepare for stopping in front of the home signal of the station at danger

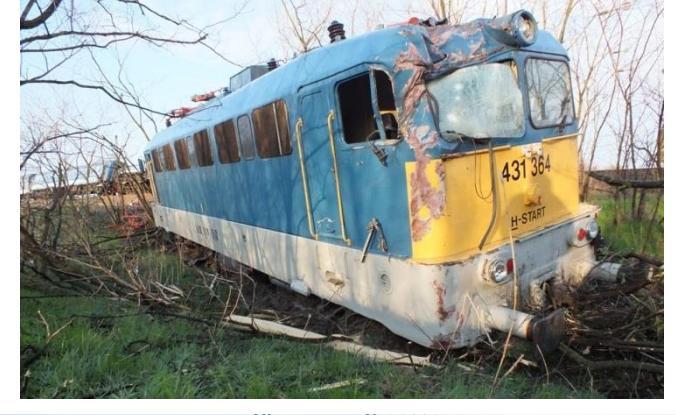
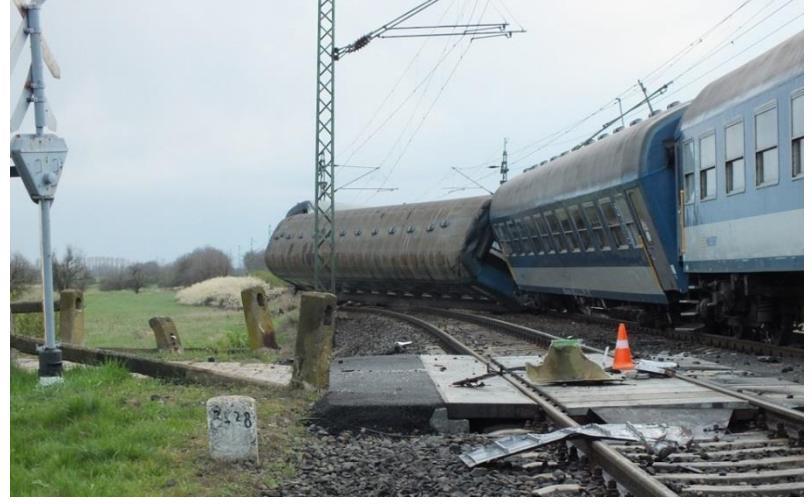
Grade:	Railway accident	
Date and time:	20 April 2021	
Location:	Hajdúhadház - Újfehértó, km 252,7 (line)	
Occurrence type:	Level crossing accident	
Movement type:	Regional passenger train	
Description:	Between Hajdúhadház and Újfehértó stations at a level crossing (equipped with active level crossing protection) the train no. 6254 collided with a tractor what was thrown onto the second track where the oncoming train no. 6203 collided with the wreck. The train no. 6203 derailed – in the derailment one wagon was overturned.	
Consequences:	1 fatality / 0 serious injury Total damage HUF 272,000,000 (EUR 150,000 – 2,000,000)	
Parties:	MÁV Zrt. (IM) MÁV-START Zrt. (RU)	
<u>Direct cause(s):</u>	• the road vehicle (agricultural tractor) failed to stop at the "Beginning of railway crossing" sign and entered the level crossing despite the red light signal of the active level crossing protection system	
<u>Contributory factor(s):</u>	• the severity of the consequences was considerably increased by the fact that the wheel of the tractor, which had come off the tractor, was thrown onto the left-hand track, where it was hit by the train coming from the opposite direction, and caused it to derail

Underlying cause(s):	• none	
Recommendation(s):	none

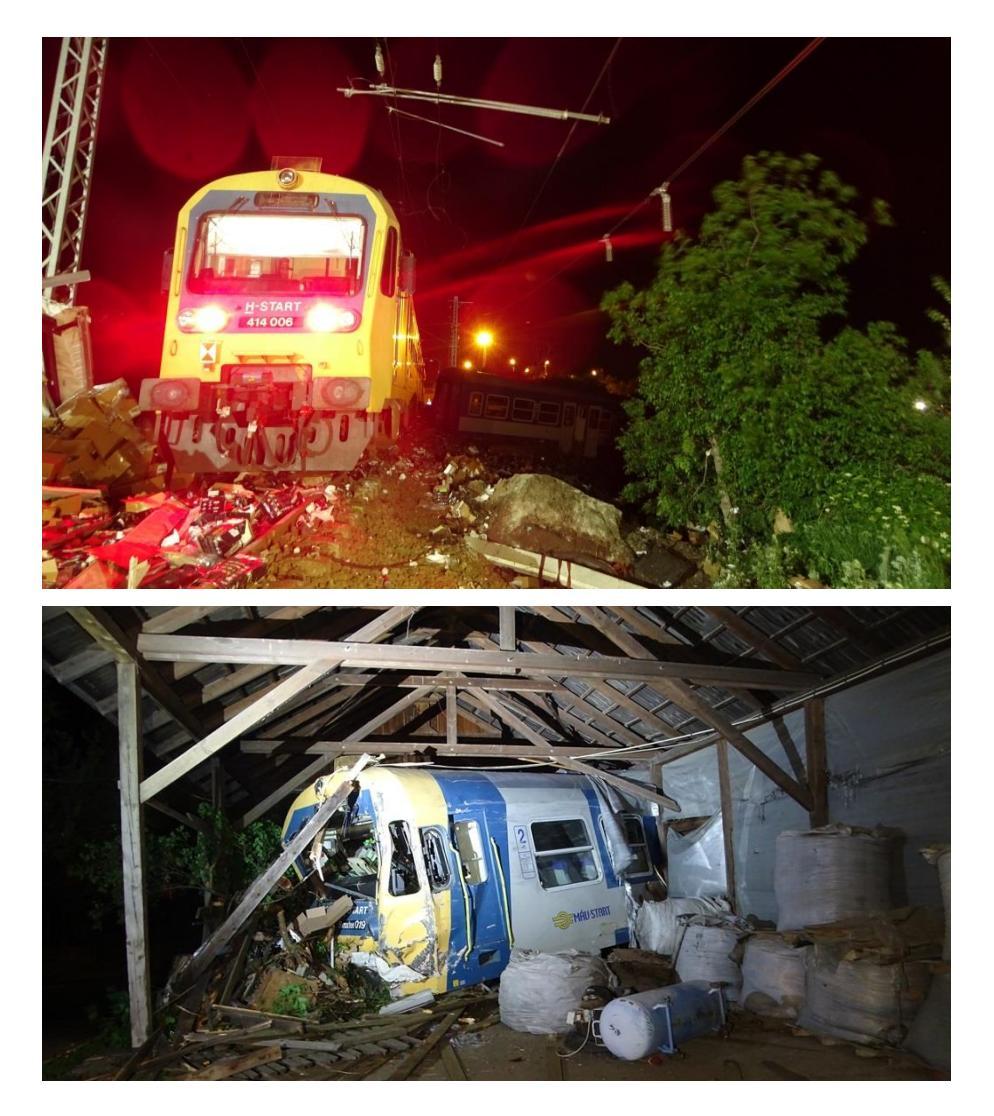
SUMMARY	OF	OCCURRENCE № HU-10056

Grade:	Railway accident	
Date and time:	31 May 2021	
Location:	Sátoraljaújhely (station)	
Occurrence type:	Level crossing accident	
Movement type:	Regional passenger train	
Description:	At the level crossing of Sátoraljaújhely station (equipped with active level crossing protection) the train no. 5228 collided with a truck what caused the derailment of the train.	
Consequences:	0 fatality / 2 serious injury Total damage HUF 71,100,000 (EUR 150,000 – 2,000,000)	
Parties:	MÁV Zrt. (IM) MÁV-START Zrt. (RU)	
Direct cause(s):	• the truck driver entered the level crossing despite the blinking red warning lights of the active level crossing protection system	
Contributory factor(s):	• none	
Underlying cause(s):	• none	
<u>Recommendation(s):</u>	none

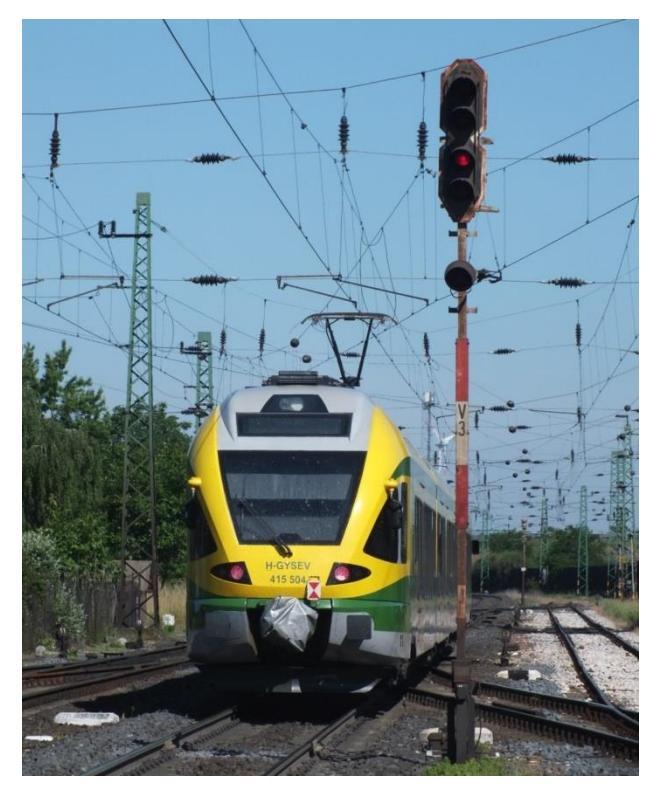
Grade:	Railway incident	
Date and time:	16 June 2021	
Location:	Mosonmagyaróvár (station)	
Occurrence type:	Signal passed at danger	
Movement type:	Regional passenger train	
Description:	At Mosonmagyaróvár station after passengers got off/on, the train no. 9412 departed to continue its journey, upon the signal "Ready to start" given by the chief ticket inspector, passing the exit signal at danger, finally stopped in the switching zone upon (too late) brake use by the locomotive driver. As a result, the entry signal ahead of the train no. 9467 arriving from the opposite direction dropped back to 'Danger!' aspect automatically and the locomotive driver stopped the train (using the brake) before the signal.	
Consequences:	0 fatality / 0 serious injury No damage (EUR 0)	
Parties:	MÁV Zrt. (IM) MÁV-START Zrt. (RU)	
Direct cause(s):	<ul> <li>neither the locomotive driver nor the chief ticket inspector checked the 'Danger' aspect of the exit signal before the departure</li> <li>although the moderner train control system, which could have prevented the occurrence was available and in service, but following a decision of the railway undertaking, it was not used, but they used the older system which cannot prevent similar occurrences</li> </ul>

Contributory factor(s):	• the train control system in use does not meet the safety requirements set for it as regards speed limits of up to 160 km/h	
Underlying cause(s):	• the railway undertaking let their train go with the train control system that provided the lower level of the two available safety levels and assigned a locomotive driver for that configuration	
<u>Recommendation(s):</u>	none
