KÖZLEKEDÉSBIZTONSÁGI
SZERVEZET

FINAL REPORT

2006-020-6

MARINE INCIDENT

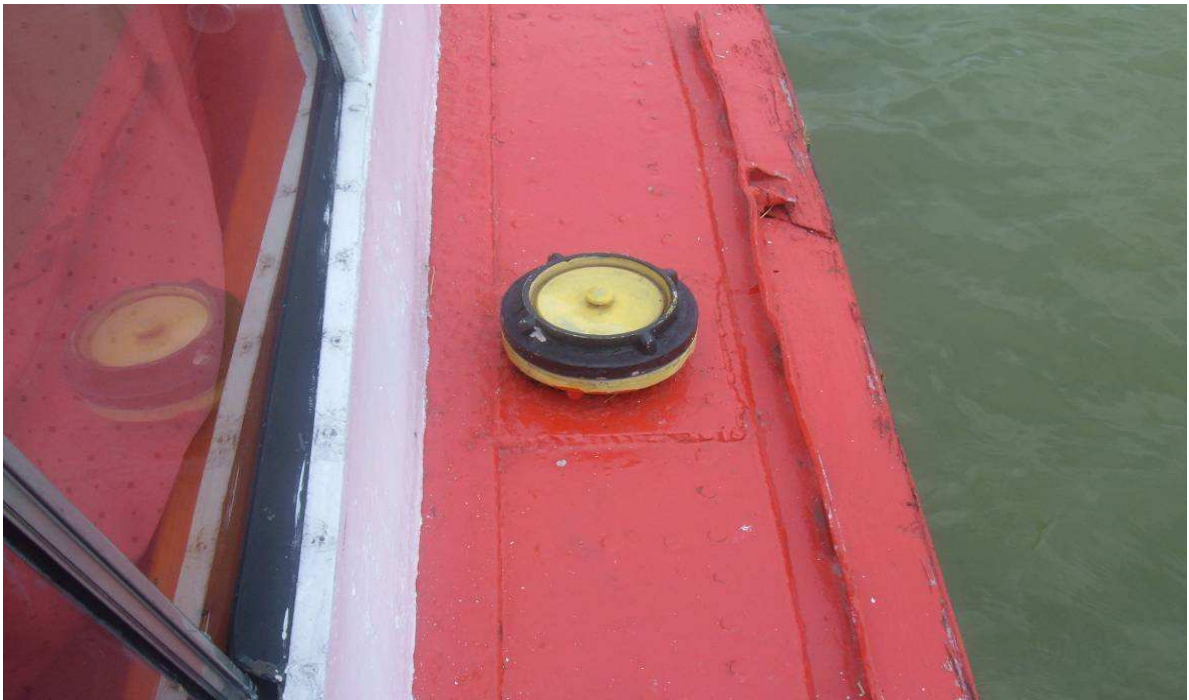
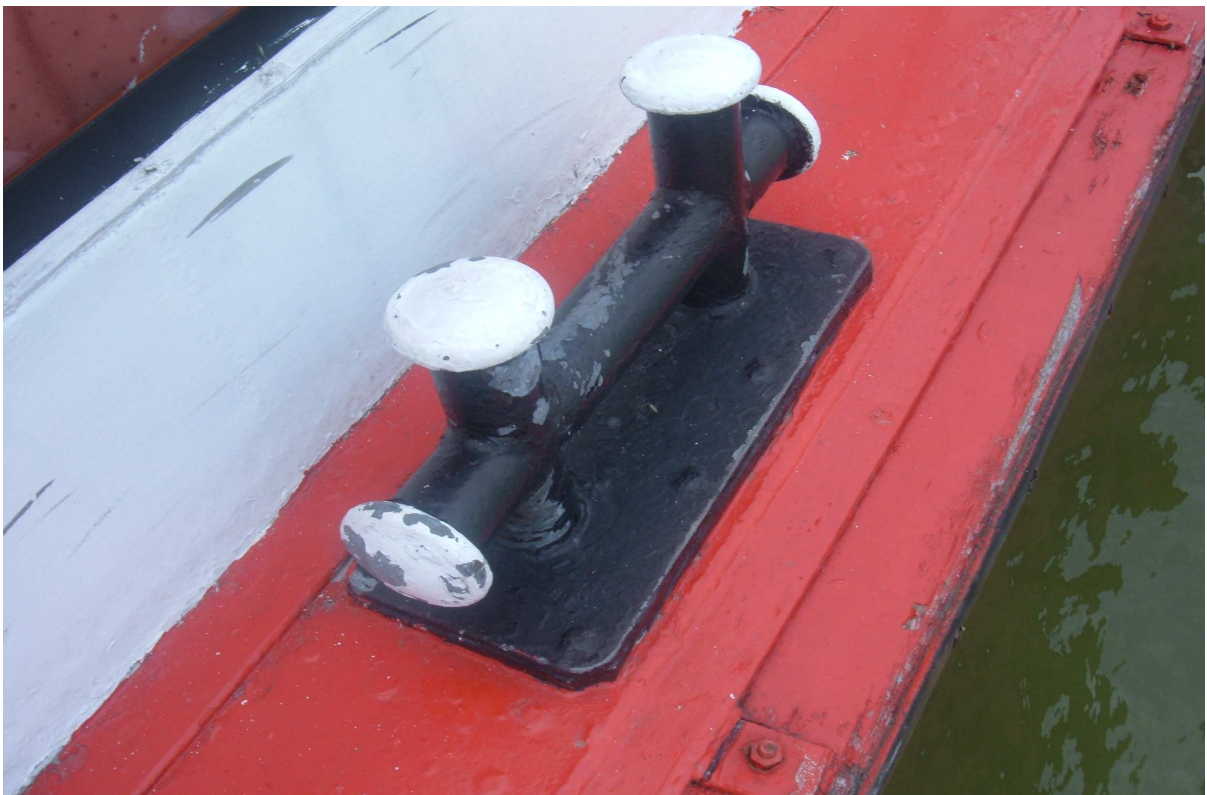
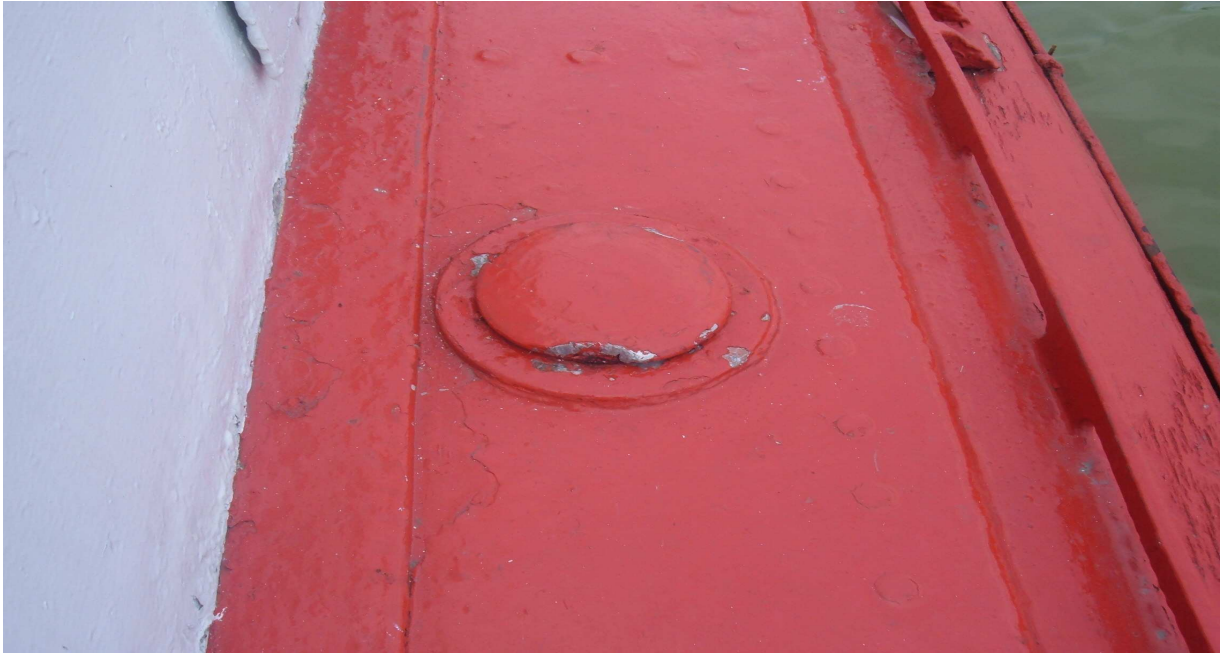
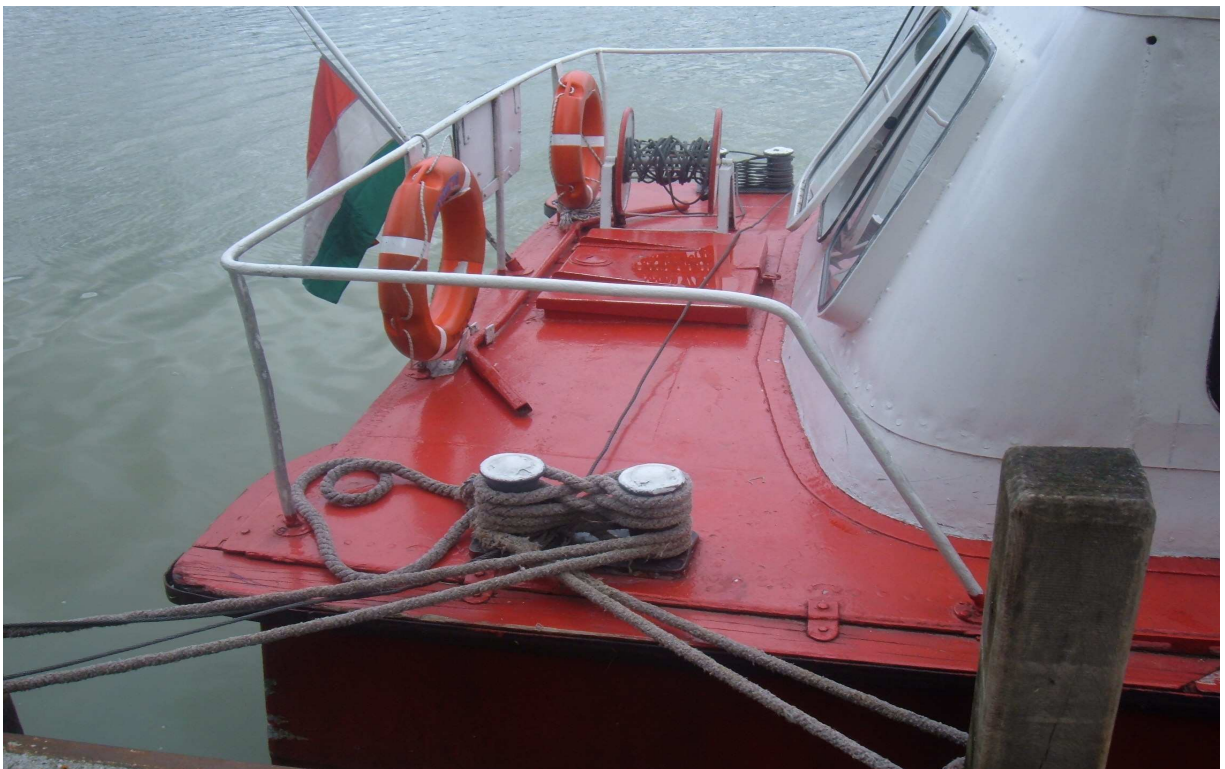
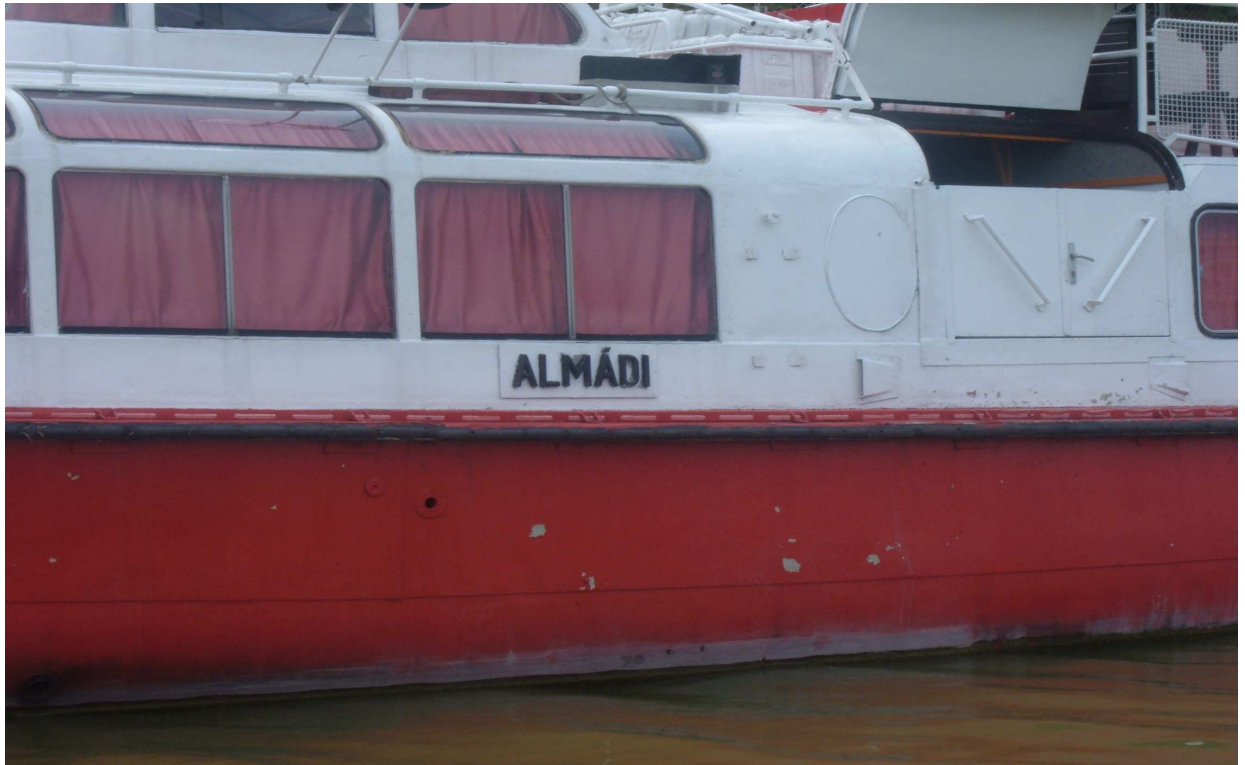
Photos of MS Almádi

The seaman left his post and went to the nearby pub with his friends where they drank alcohol. According to the police record, the seaman's blood alcohol level was 1,75 g/l a thousandth. Coming back to the ship, the seaman probably slipped and tripped over some protruding mountings on the deck of the hull and he fell into the water.

BA 2006-020-6_01. The IC recommends the NTA that it should prohibit the fitting of protruding mountings on the narrow and slippery deck on the sides of the ship. These mountings (except for the fittings for mooring the ship) should be designed in a 'sinkable' form to be able to let them down into the level of the deck.

BA 2006-020-6_02. The IC recommends the NTA that based on previous years' experiences, a so called 'floating rescue pole' should be fitted to the stern on a rope. This method was applied by MAHART in the 1970s and 1980s on their river cruising passenger boats at overnight stops. Naturally, the pole shall be paid down when sailing.
