**ONNETTOMUUSTUTKINTAKESKUS
CENTRALEN FÖR UNDERSÖKNING AV OLYCKOR
ACCIDENT INVESTIGATION BOARD FINLAND**

**A COLLISION WITH PONTOON BRIDGE AND
CONSEQUENCES FOR OPERA FESTIVAL**

29 - 31 March 2009

The KRASNOVIDOVO accident

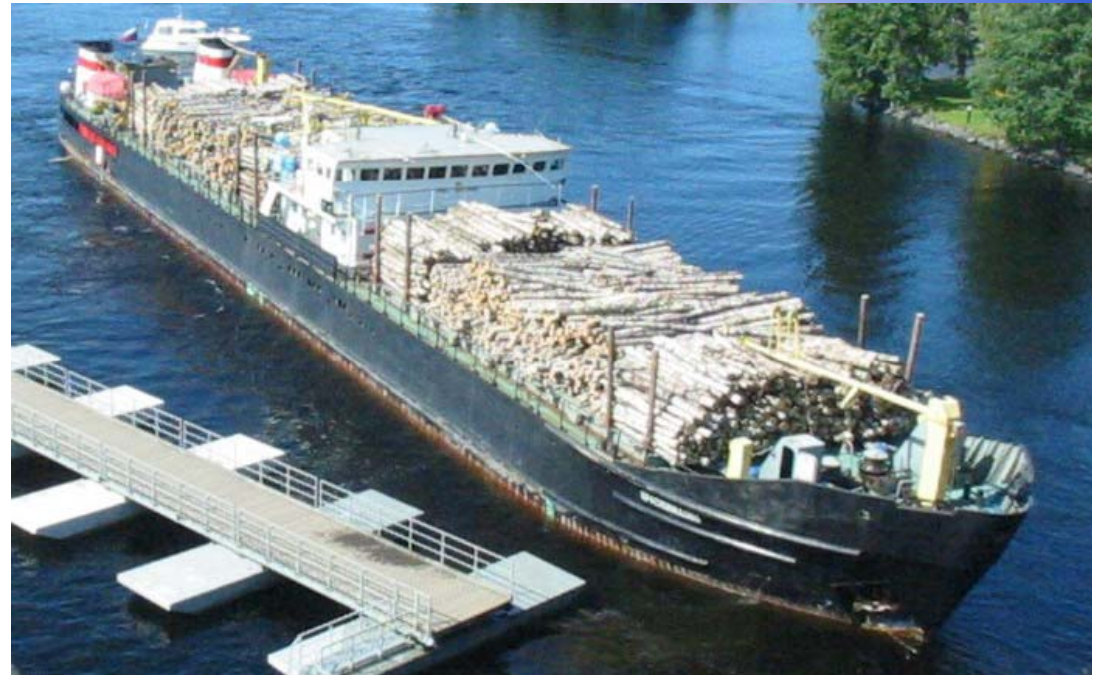
- *Russian flagged river-sea vessel*
- *Built* *1980*
- *Length* *78,10 m*
- *Draft* *3,338 m*
- *GT* *1522*
- *Displacement* *2684 t*
- *Machine effect* *2 x 441 kW*

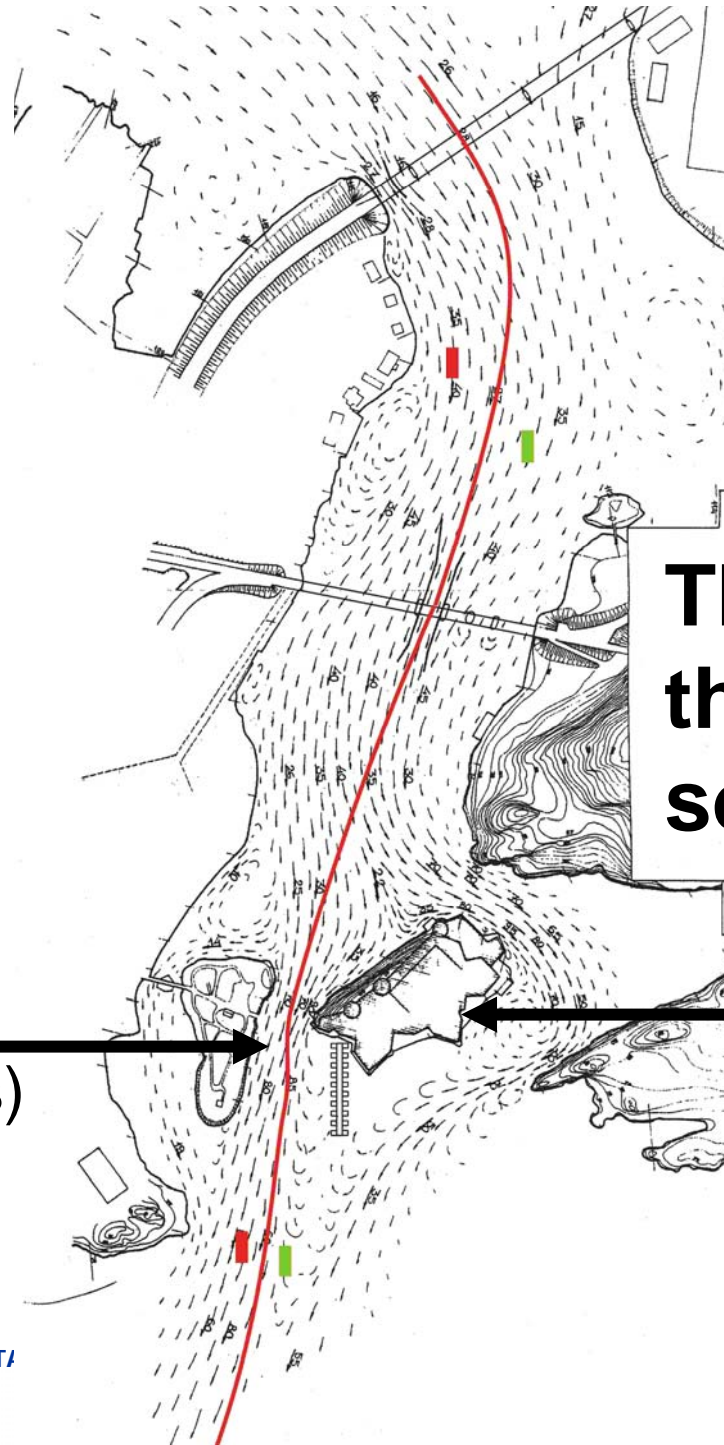
The currents in the Kyrösalmi sound

1 m/s
(2knots)

When the KRASNOVIDOVO approached Kyrönsalmi, the pilot noticed that the current was very strong in the strait. The vessel entered the inhomogeneous current field of Kyrönsalmi at an angle after a turn which had been too long. At the same time the pilot handed the manoeuvring over to the Chief Officer without informing about it in advance.

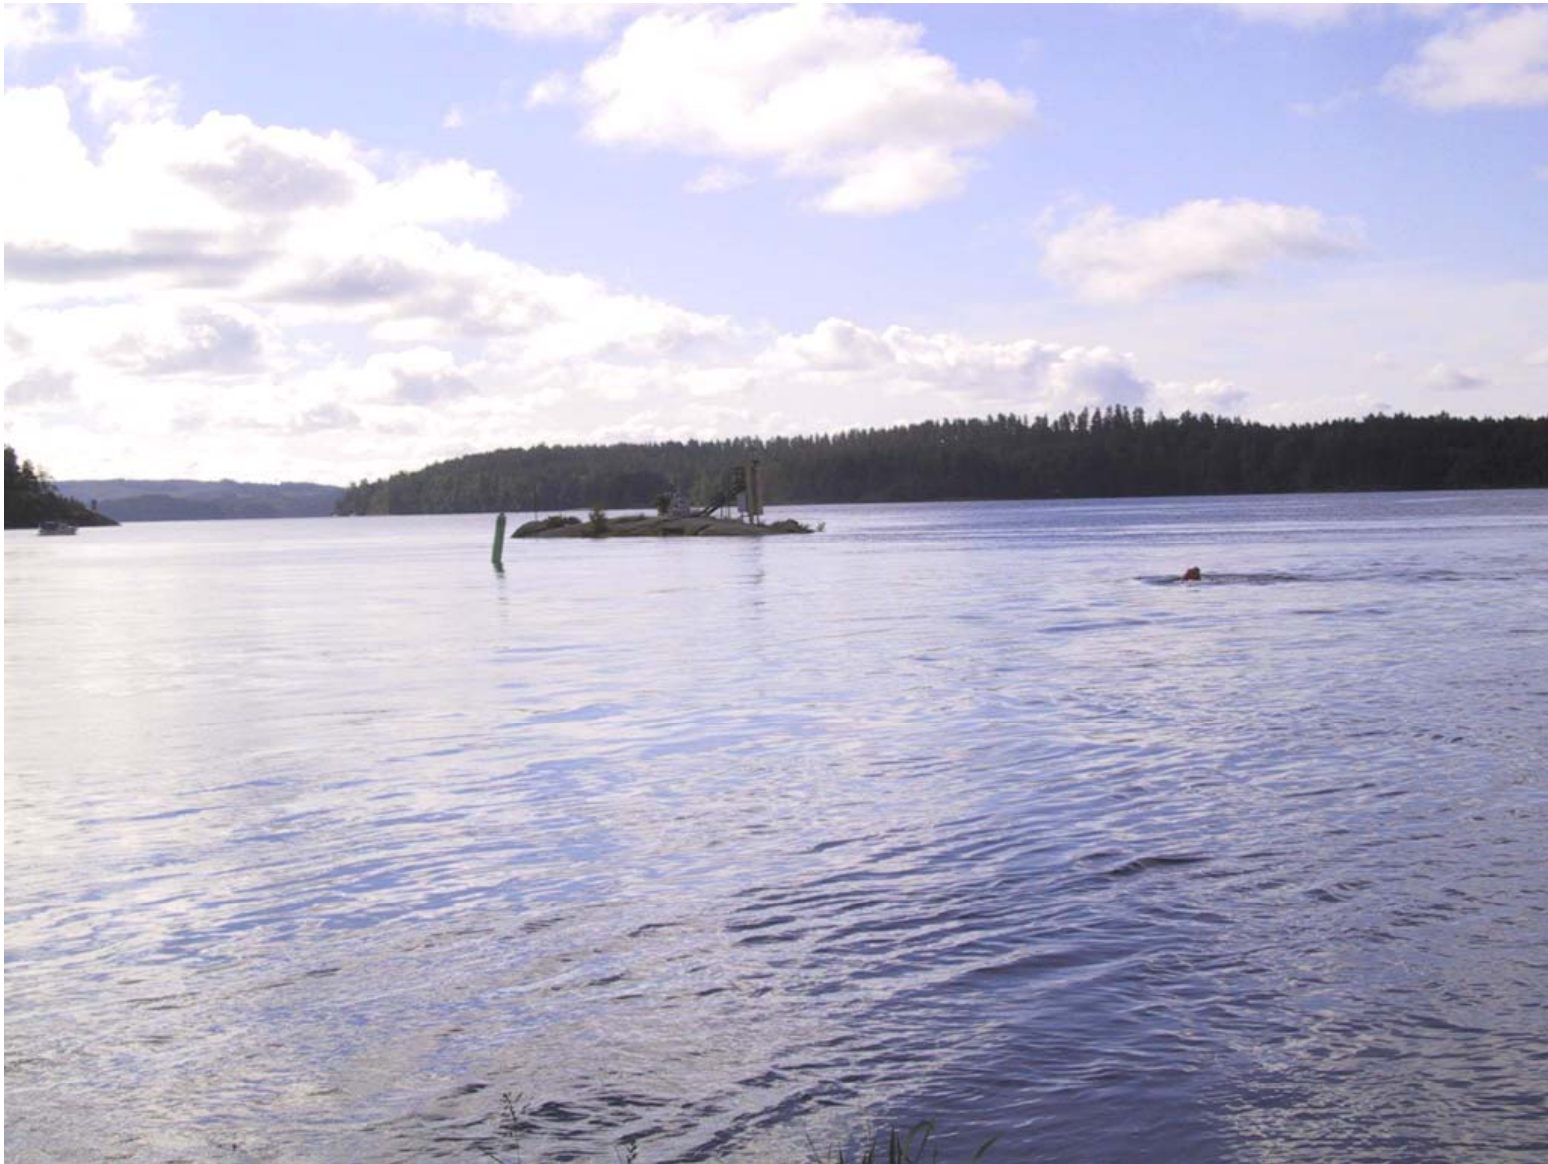
The buoy (right) used as current meter by pilots

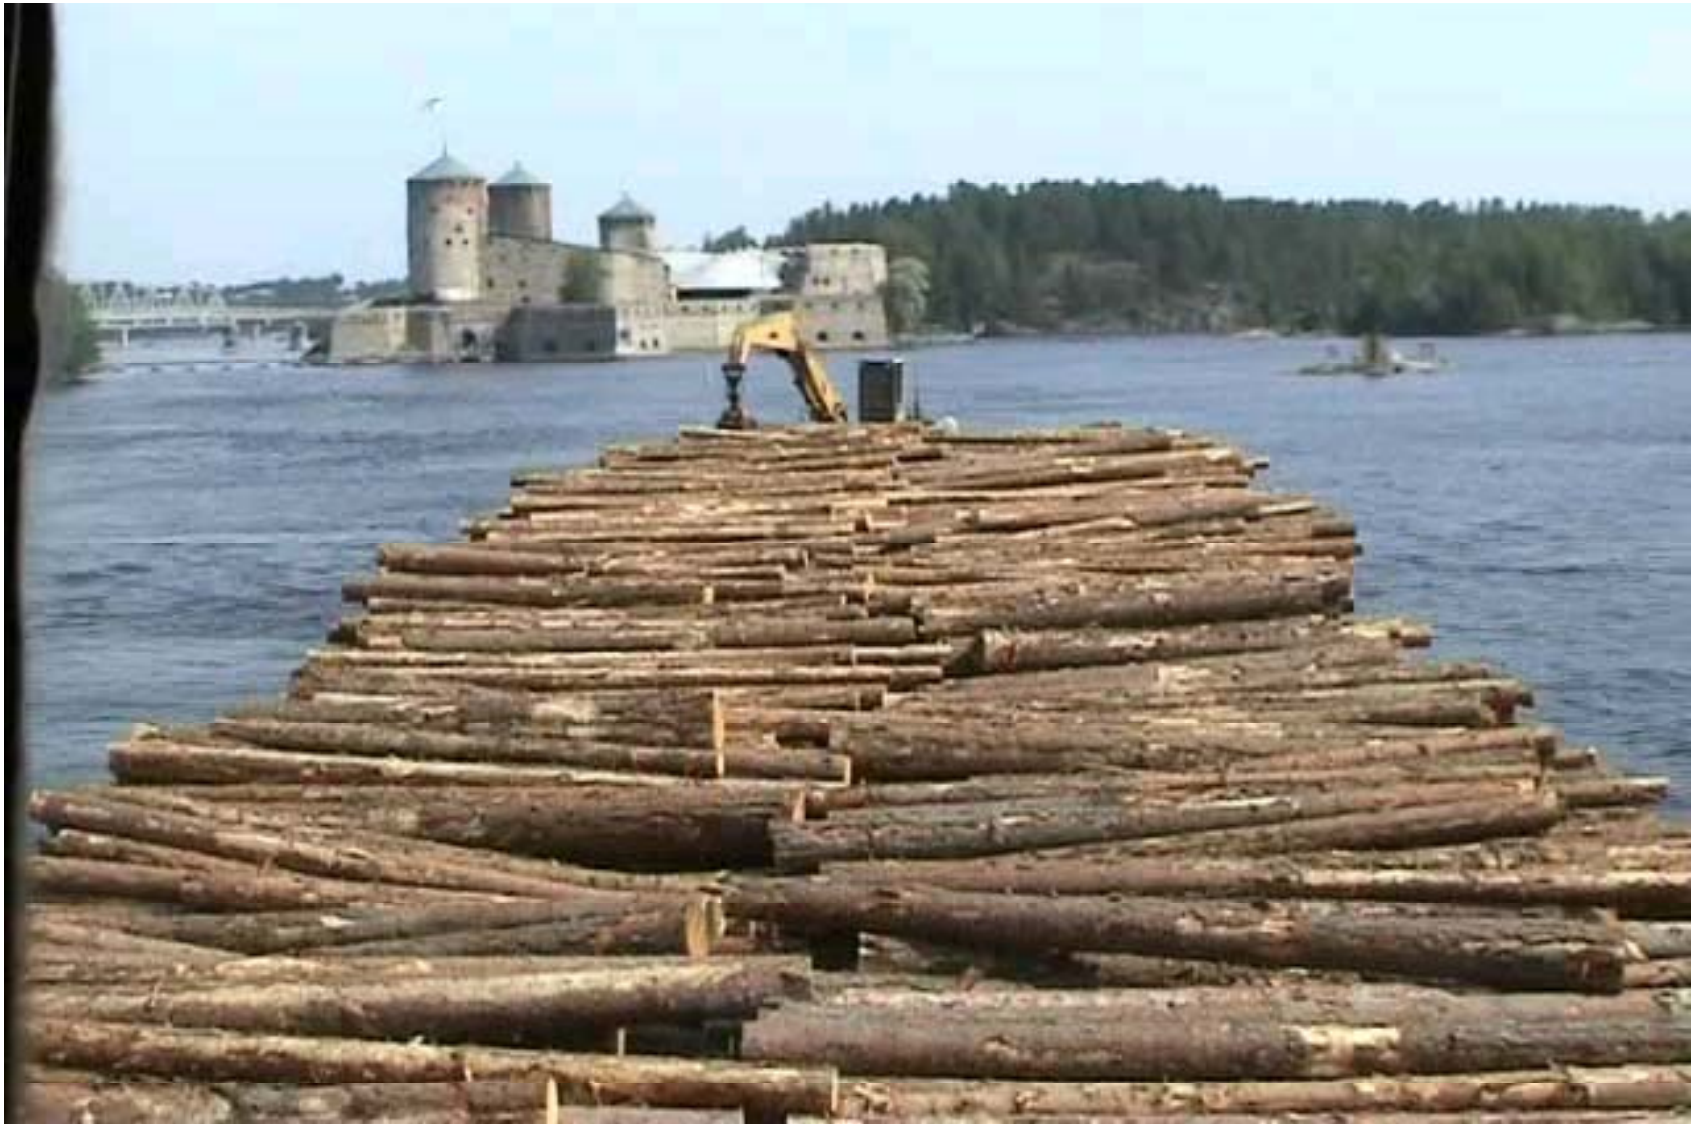
Correct angle of approach to Kyrönsalmi (photo taken on reconstruction run)

The KRASNOVIDOVO entered the Kyrönsalmi fairway at an angle, and the pilot handed over the manoeuvring without any prior notice. These two incidents together were the direct causes of the accident.

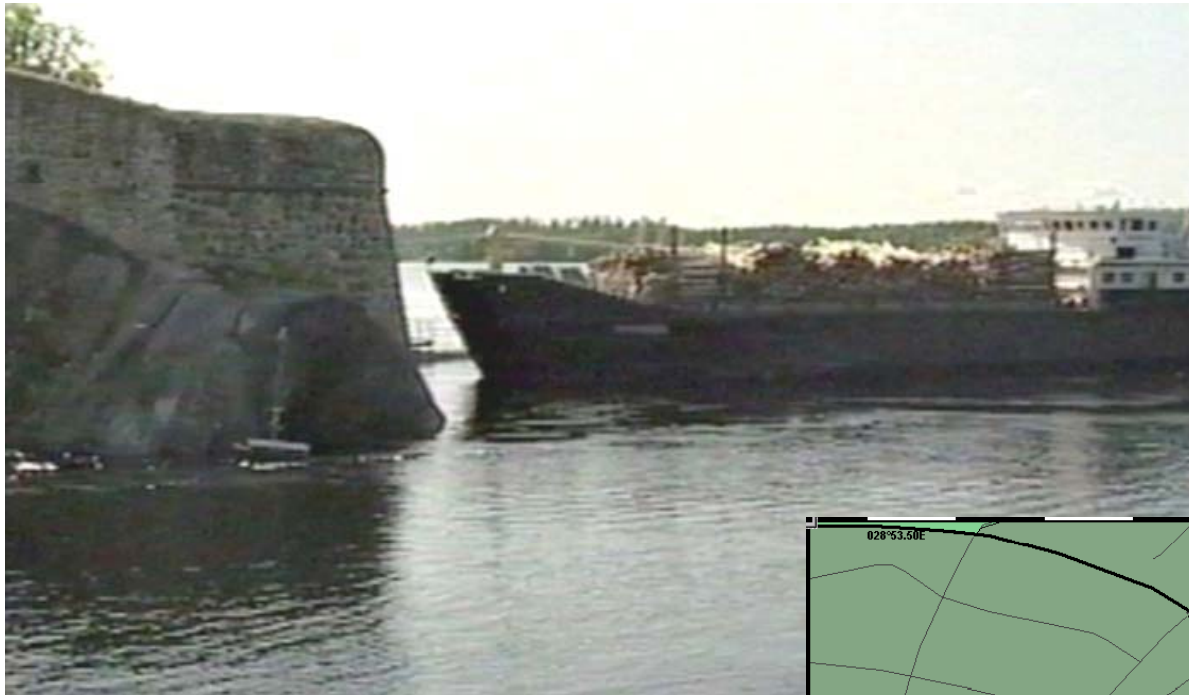
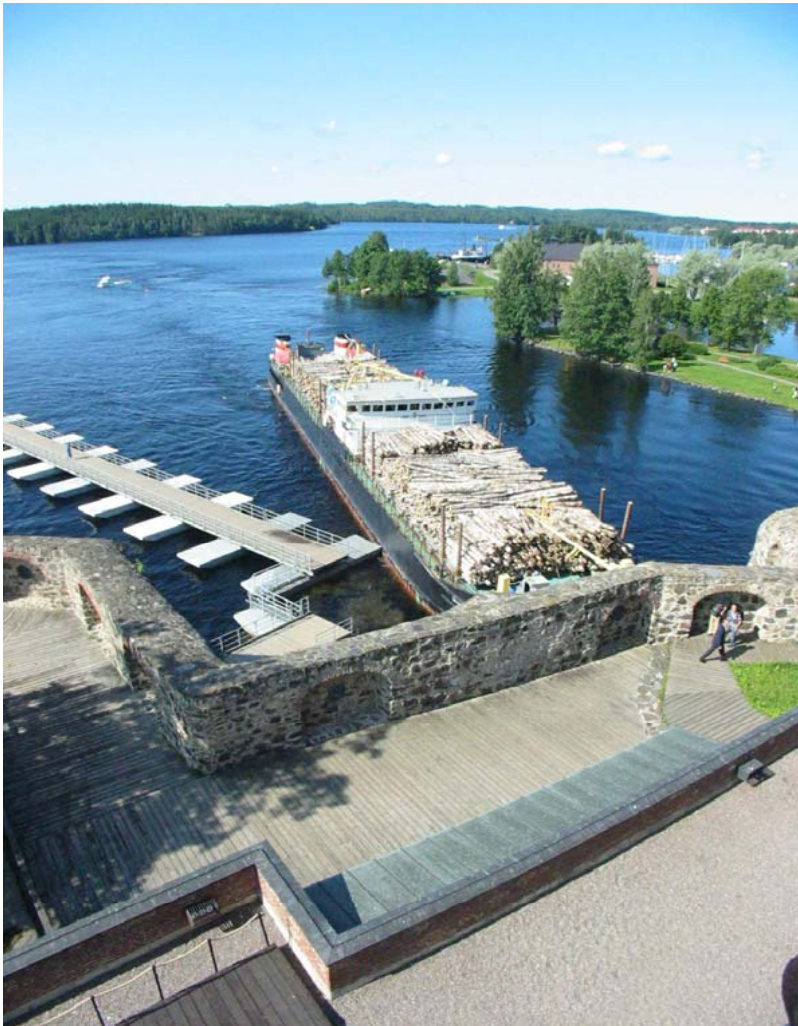
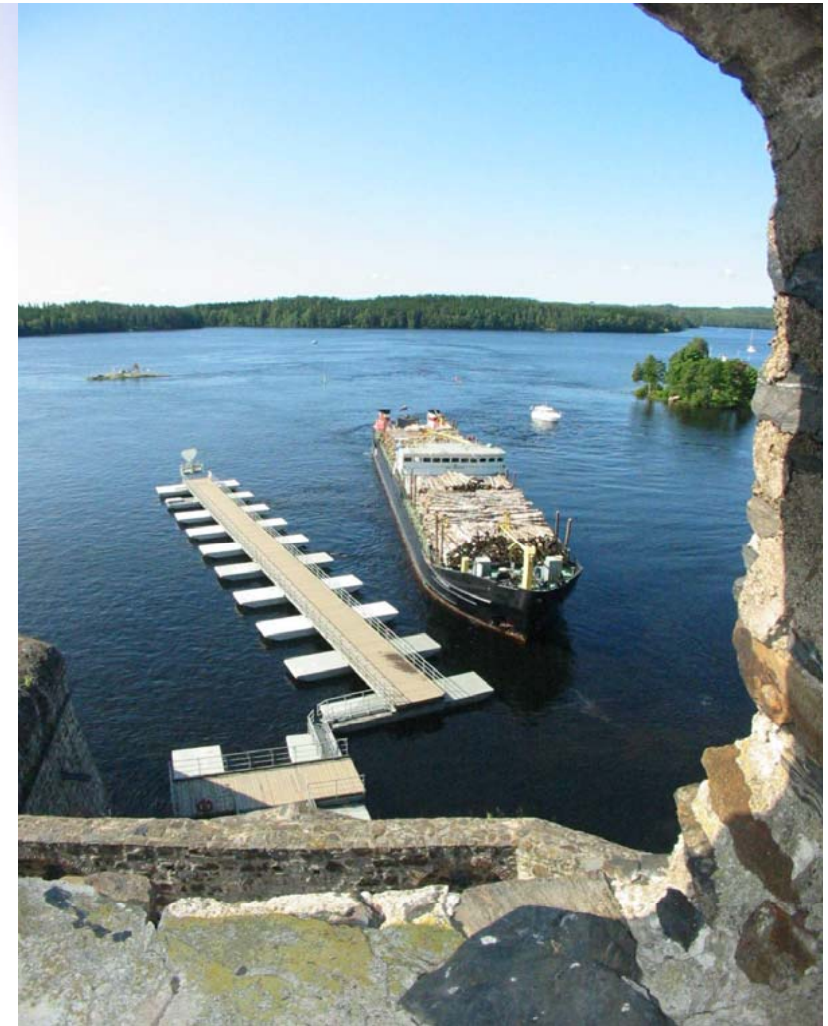
KRASNOVIDOVO
colliding the pontoon
bridge and hitting the
cliffs of the island at 3
knots

The damages on the KRASNOVIDOVO were minor, and a few minutes after the collision the vessel was manoeuvred through Kyrönsalmi.

In the collision the fastening of the fixed part of the pontoon bridge came partly loose, and it was no longer possible to use the bridge as a traffic route.

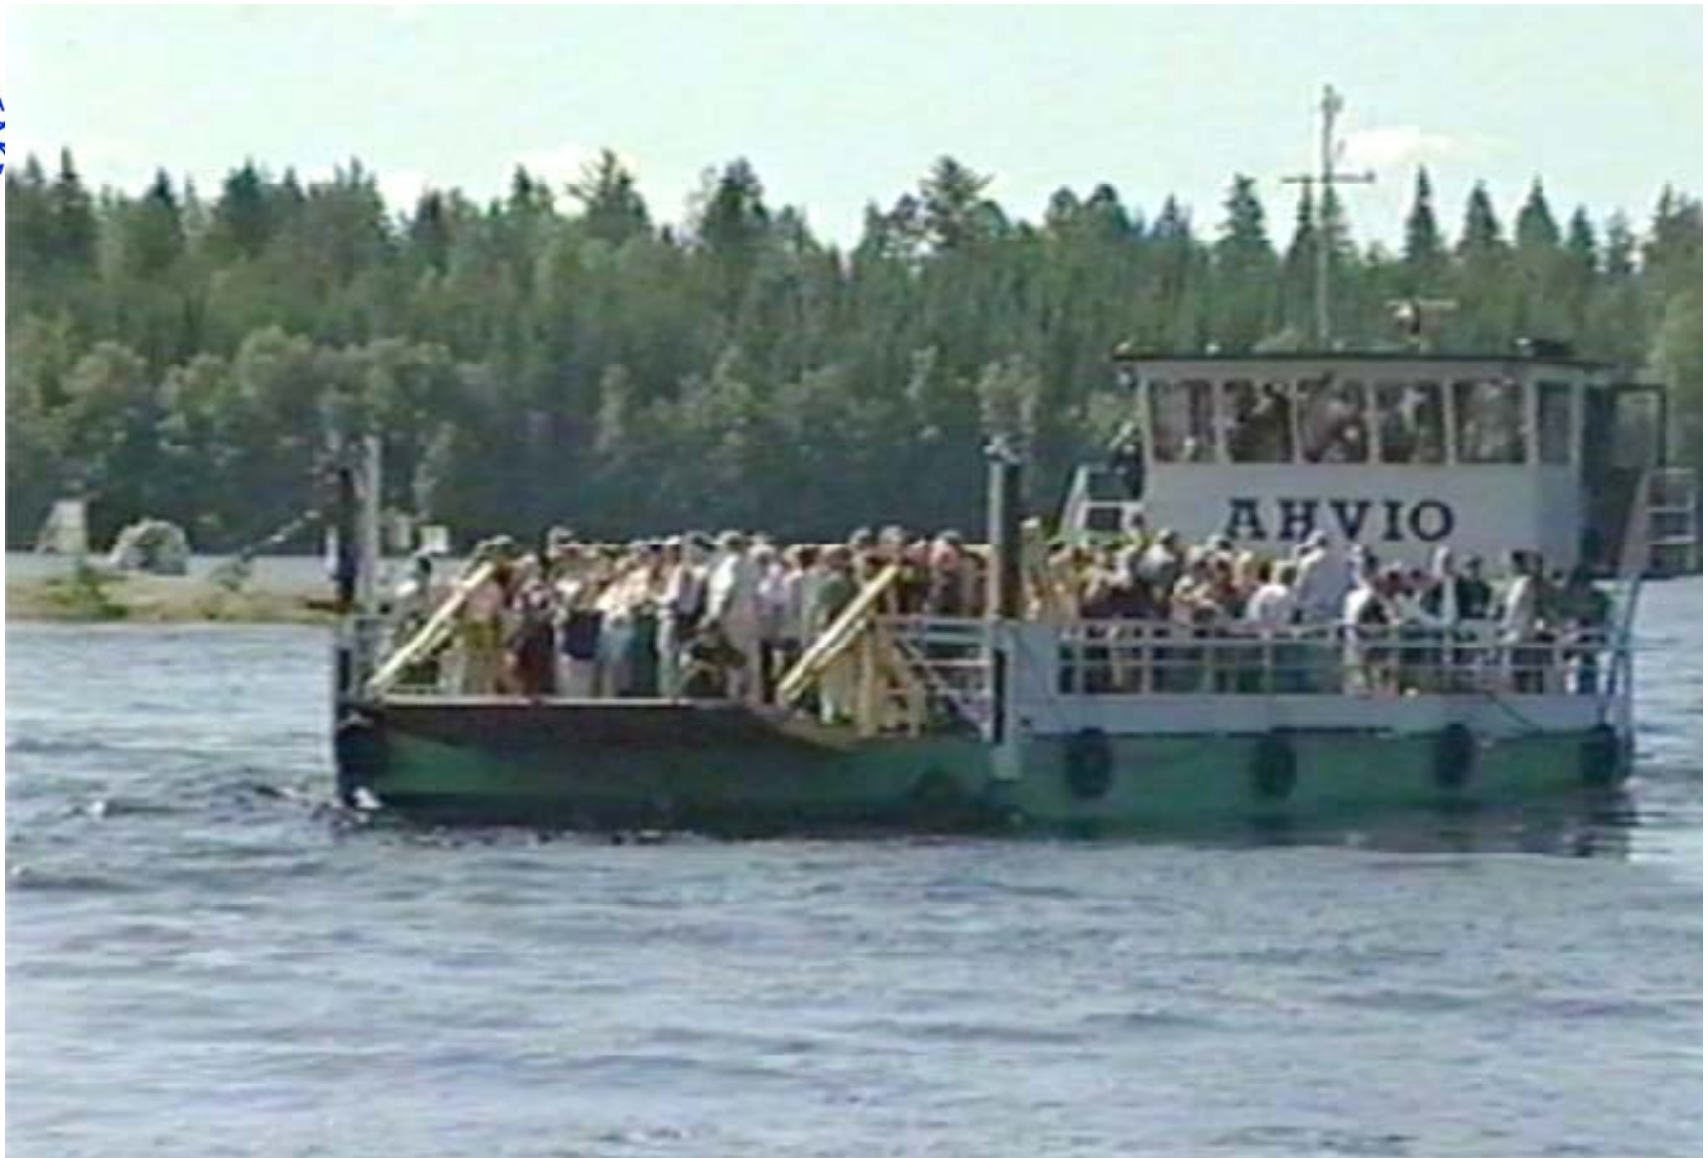
The first round of the Timo Mustakallio song contest was about to begin in the Olavinlinna Castle. A decision was quickly made to convey passengers on a transport ferry, which had not been inspected as a passenger-vessel.

Transportation of the festival public to the castle on a ferry not approved for passengers

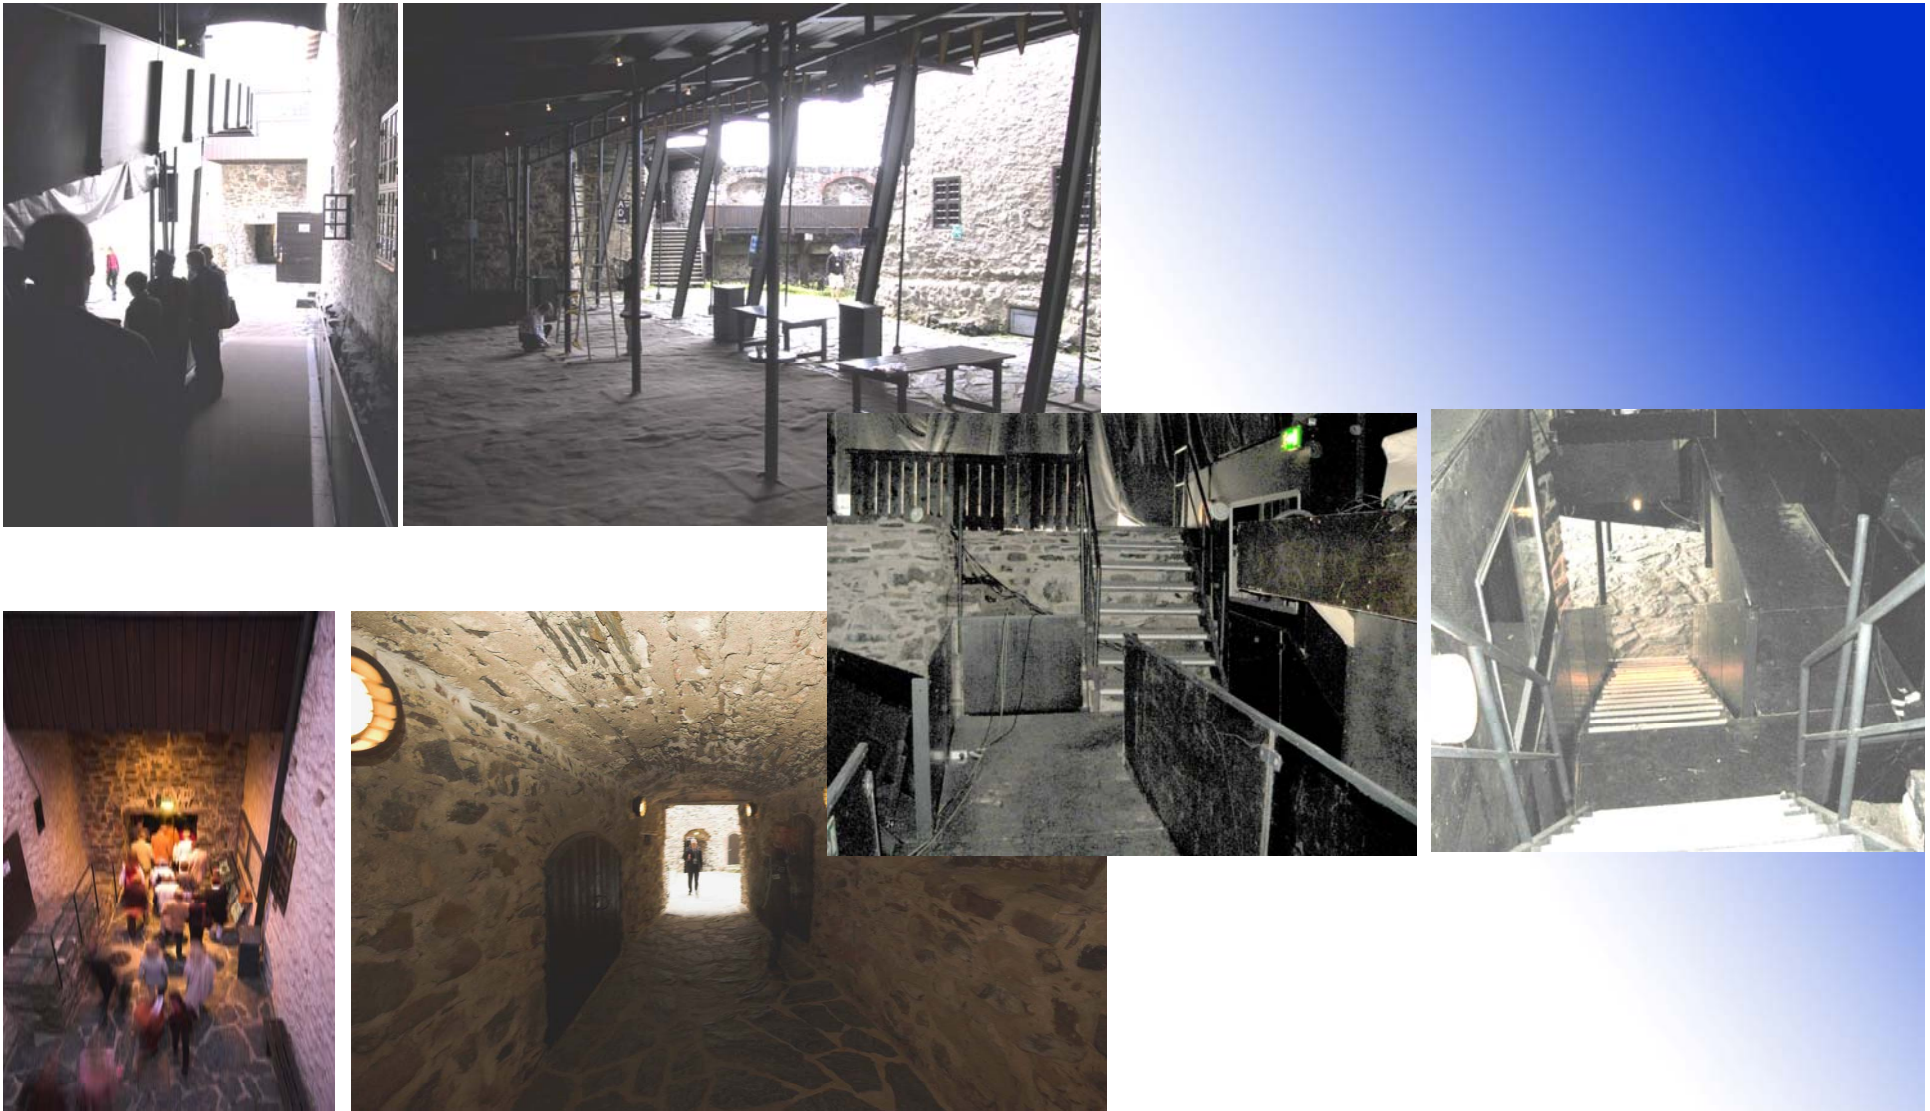
Escape routes from the gallery

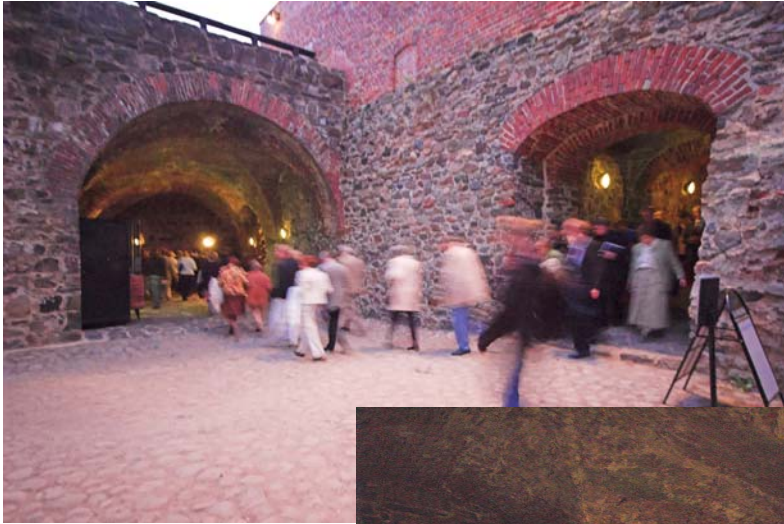
Escape routes from the gallery

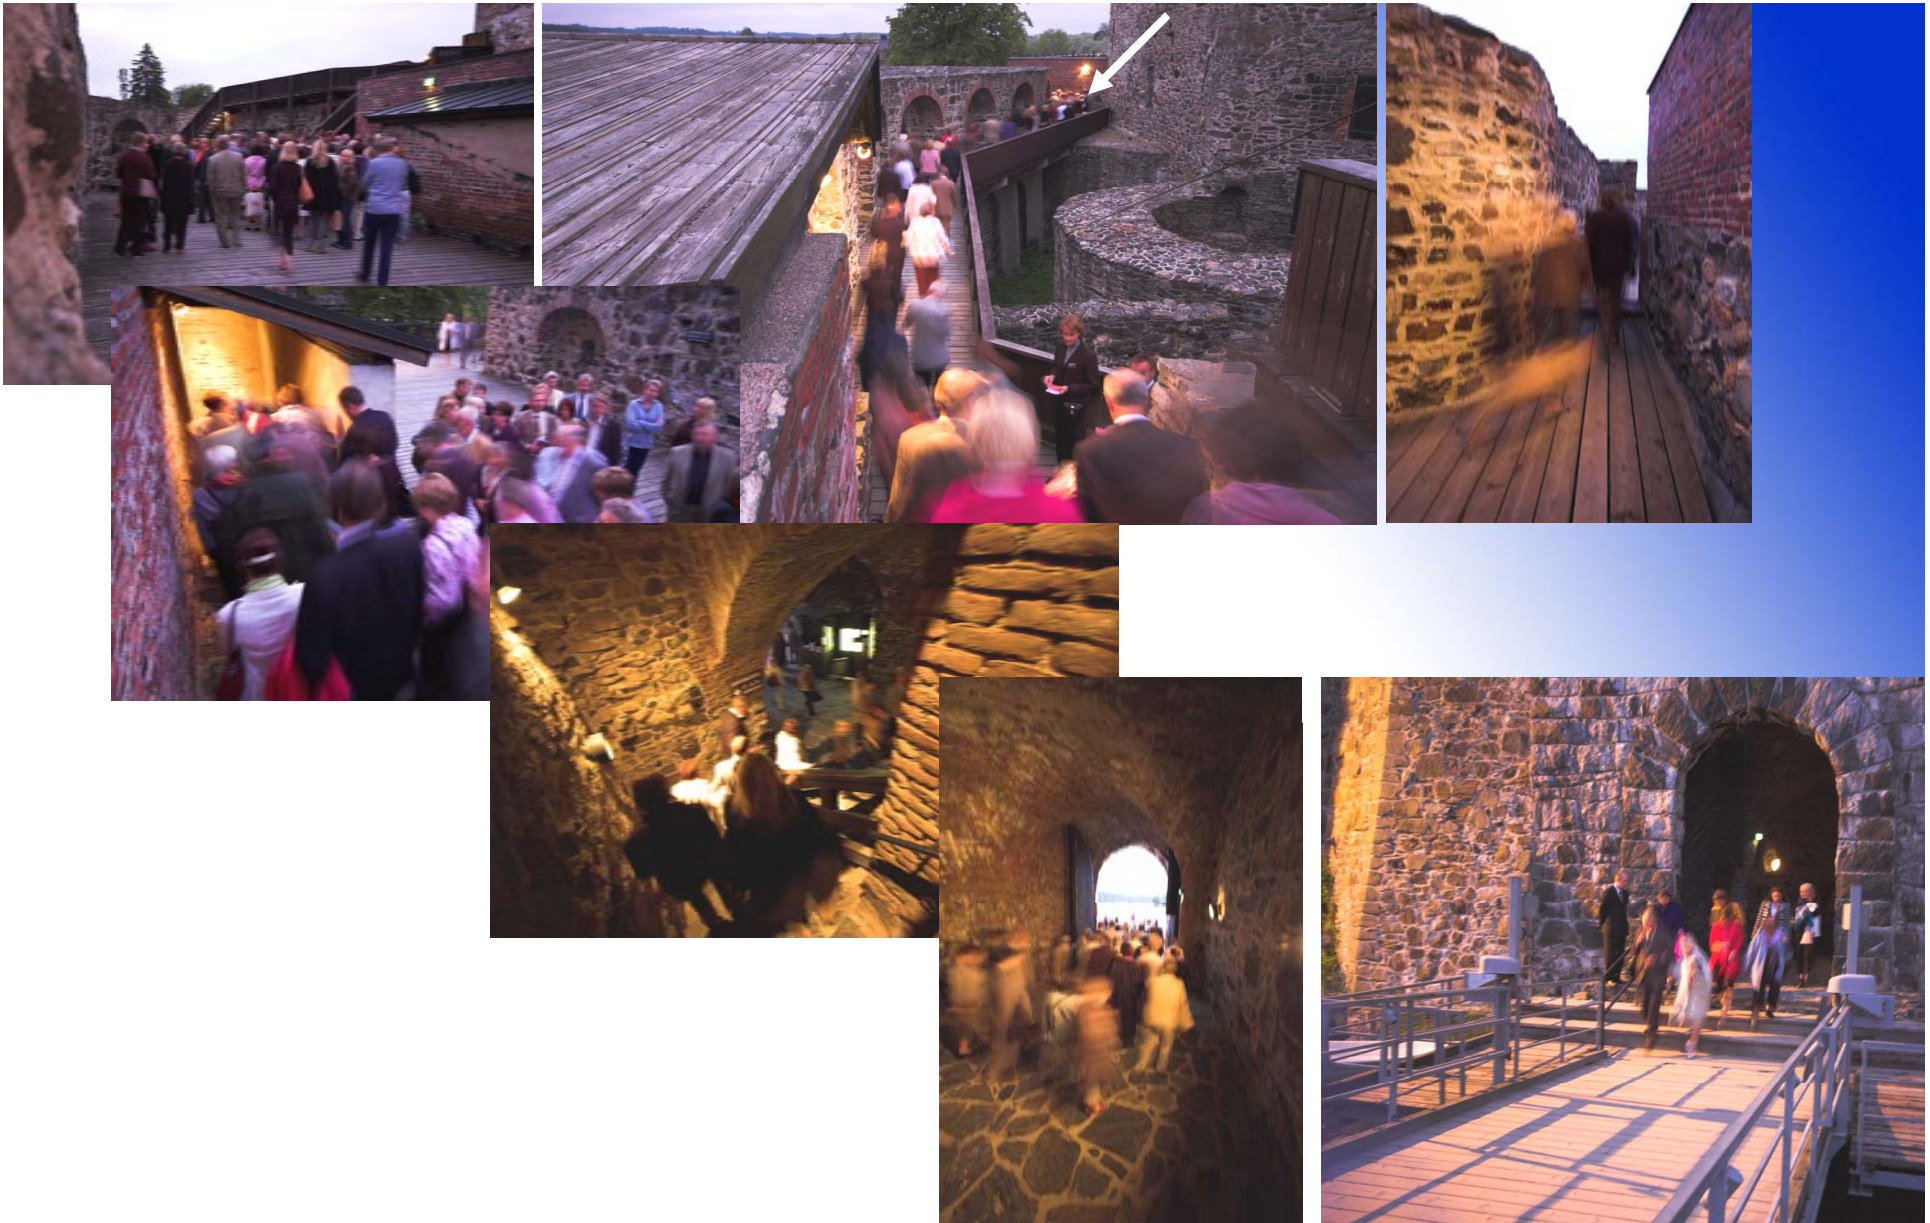
Escape routes from the gallery

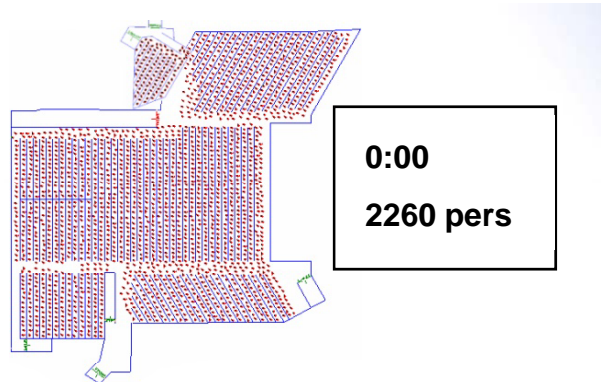
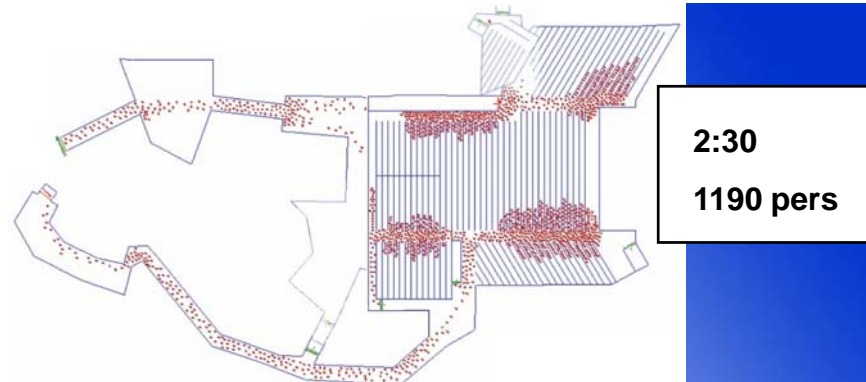
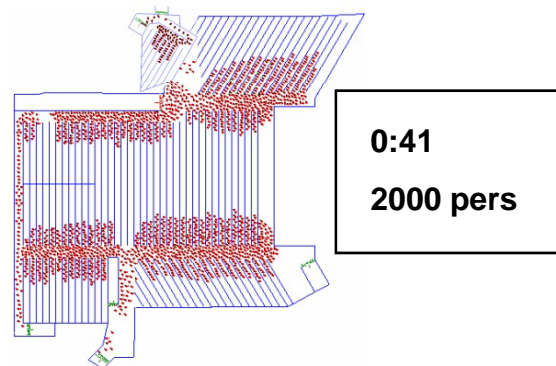
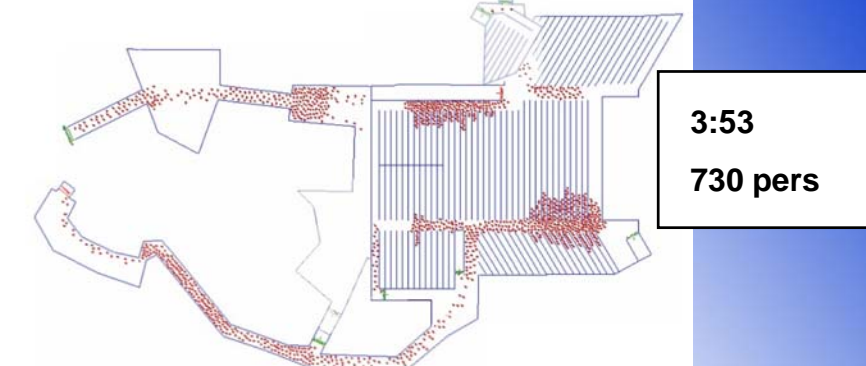
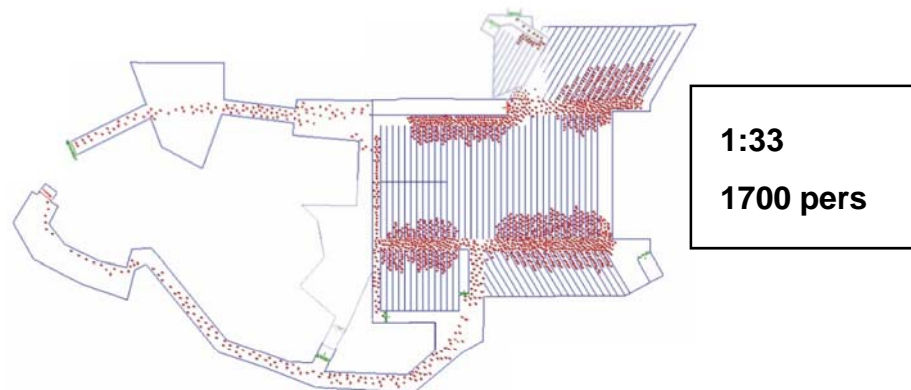
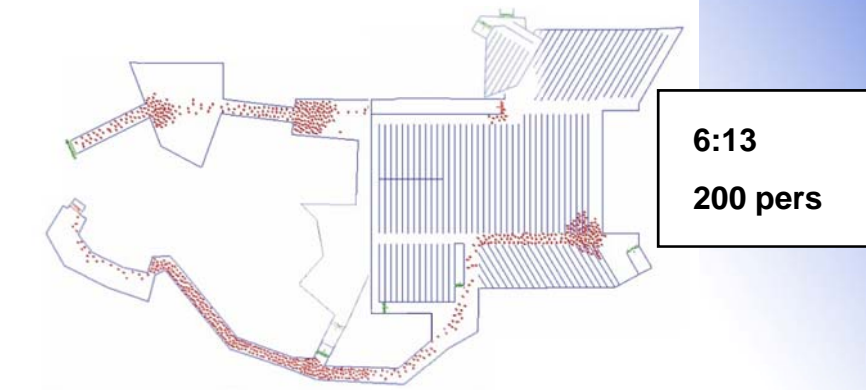
Escape simulations, the gallery fully occupied

The decisions on the maximum number of persons are based on a practice which has continued for a long time, and the situation has not been reassessed when there have been rebuilding of the gallery and stage structures in 2000.
