KÖZLEKEDÉSBIZTONSÁGI
SZERVEZET
TRANSPORTATION SAFETY
BUREAU

FINAL REPORT

2006- 0027-5 RAILWAY ACCIDENT

Between Rákospalota-Újpest and Fót stations 5 July 2006

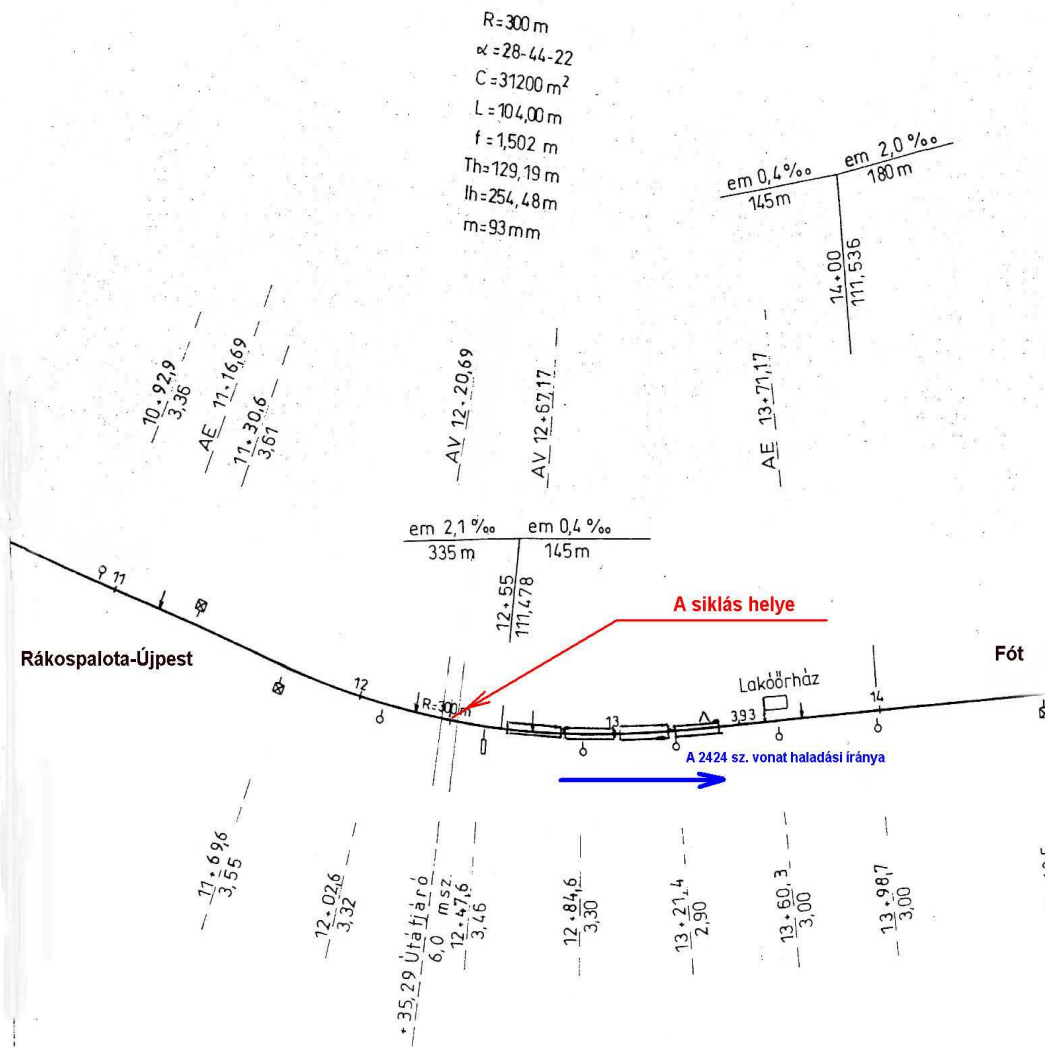
Figure 4: The schematics of the track

The design speed for the track is 60 km per hour, however, there was a (temporary) 20 km per hour speed limit in force between sections 12+00 and 12+50 due to a level crossing construction. The rails of the level crossing section were connected to the main track with clips and C fasteners, and their embedding had not been done yet.

Having arrived at the accident site, the IC noticed that the new track was substantially deformed, pushed outwards, and the inner rail was lifted. The sleepers in the crossing were found moved sideways, and the cant which was clearly visible at the edge of the crossing became practically nonexistent by the middle.

When examining the geo-screws of the connecting sections, the IC established that only those screws were loosened which were needed for the replacement of the track section, while the other screws were not. Therefore the so called 'breathing' of the track was not ensured. The neutral temperature of the track at the time of its construction was +20°C.

According to the interviews, some gaps were left between the connecting rail ends. Nevertheless, this was not sufficient to offer resistance to the significant temperature increase. There was no lateral support which could have resisted the pressure arising from the change of temperature in the rails. The stability of the track was not ensured. The sleeper ends were loose and free and there were not enough ballast chips between the rails. No measures were taken in order to prevent the deformation or shifting of the rails at the connecting points, therefore the rails were shifting from the untouched section towards the opened section. Due to the above reasons, the track shifted sideways and vertically. The extent of the shifting was as high as it lead to the derailment of the train. The final thrust to the shifting of the track panel was the centripetal force arising when the train was running in a bend.
