KÖZLEKEDÉSBIZTONSÁGI  
SZERVEZET  
TRANSPORTATION SAFETY  
BUREAU

**FINAL REPORT**  
**2008-0446-5**  
**SERIOUS RAILWAY ACCIDENT**  
**Monorierdő**  
**6 October 2008**

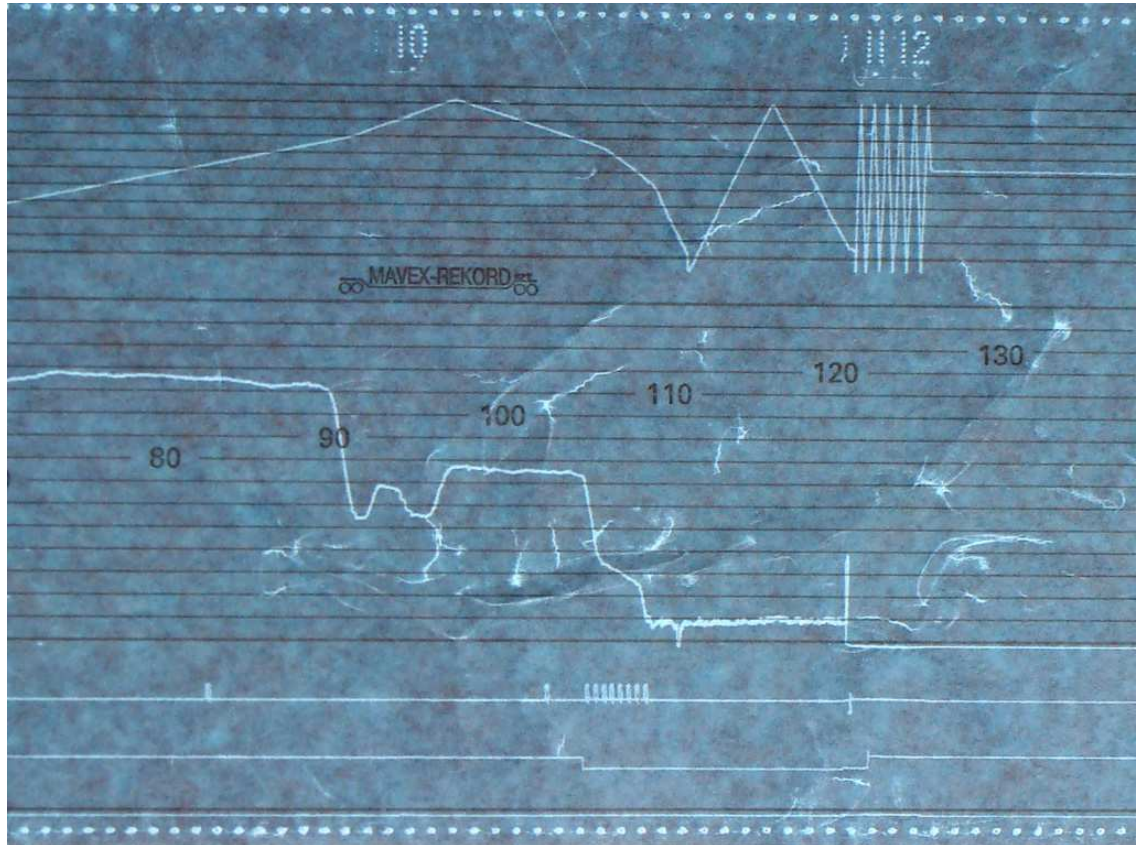
Figure 7: The strip chart recorder of locomotive V43,1030 of train IC 560-1

There was a Teloc RT 9 type data recorder on the locomotive (V43,1030) of train IC 560-1 whose measuring limit was 150 km/h so was the measuring limit of the strip chart recorder inside it (see Figure 7).

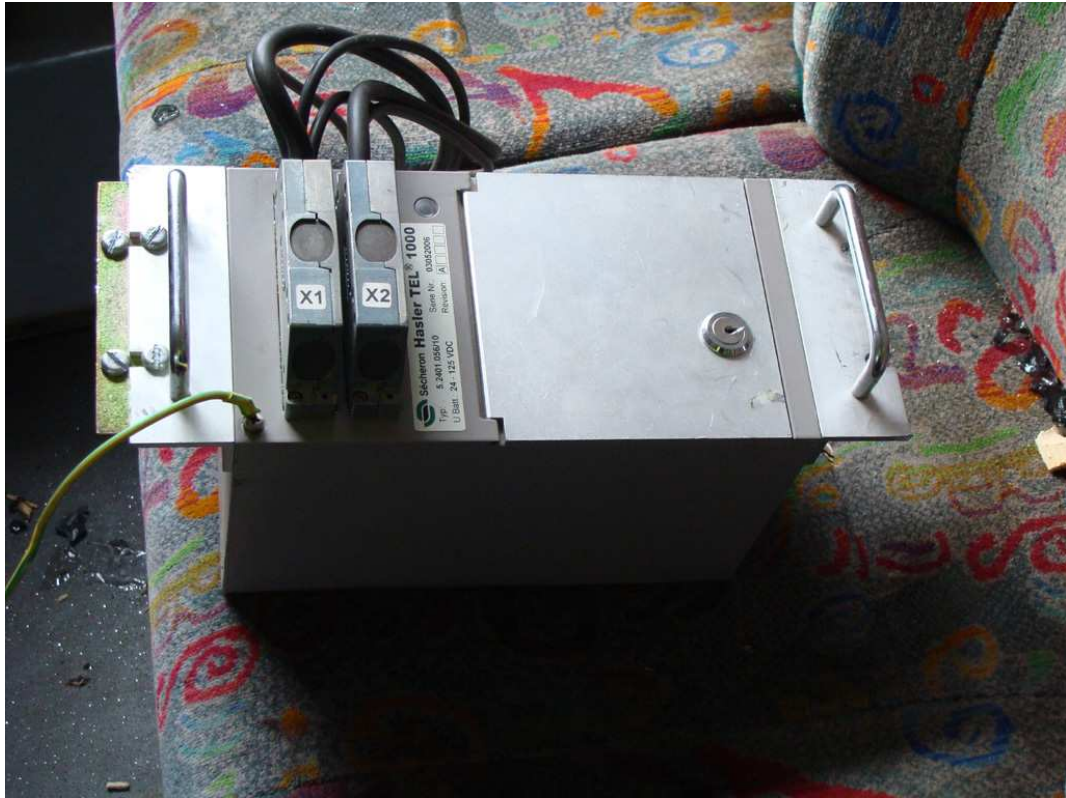
Figure 8: the data recorder of the control car

The experts of MÁV Zrt together with the firefighters found the data recorder of the control car among the wreckages and opened it before the police and the IC (see Figure 8).

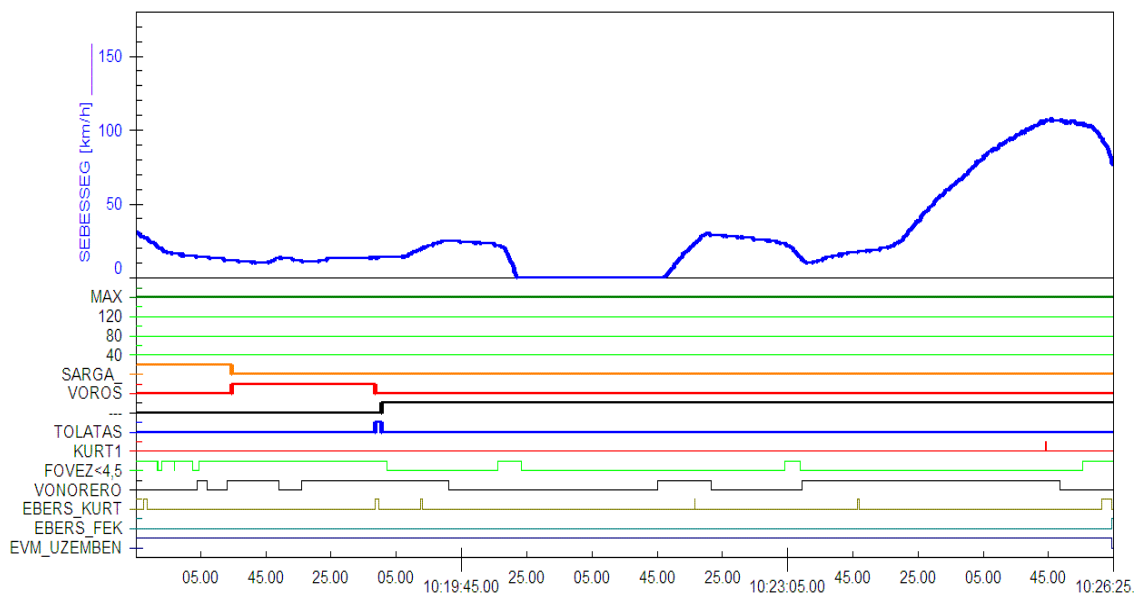
Figure 9: diagram of the BDT 415 control car's data recorder (train 2537)

Excerpts from the relevant points of the recordings, among them the last five registered data (from the STM data storage):

10:26:22	358,53699	85,000	---	
10:26:22	358,53799	85,000	---	
10:26:23	358,56099	84,000	---	
10:26:24	358,58299	80,000	---	
10:26:24	358,60099	78,000	---	last signal, vigilance brake

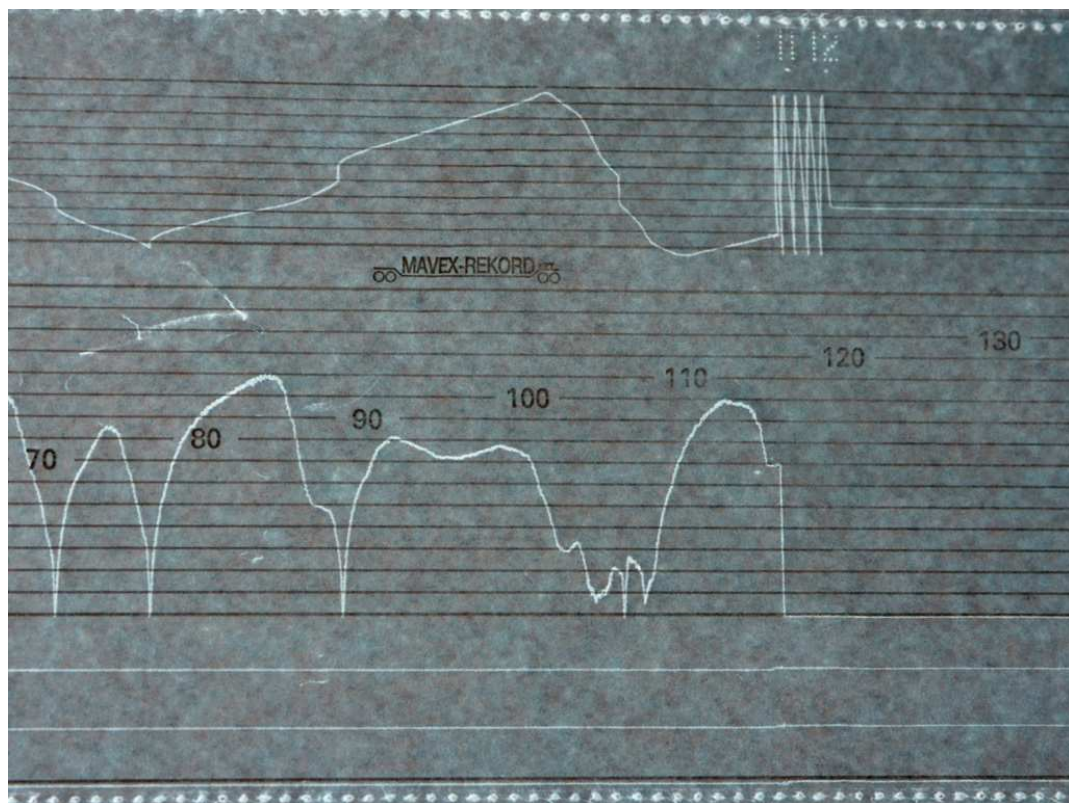
Figure 10: the strip chart recorder of locomotive V43, 2318 (train 2537)

The recordings on the strip chart do not contain the signals of the EÉVB as they can only be detected on the first vehicle. However, the irregular sign due to the collision can be seen on the strip chart recording.

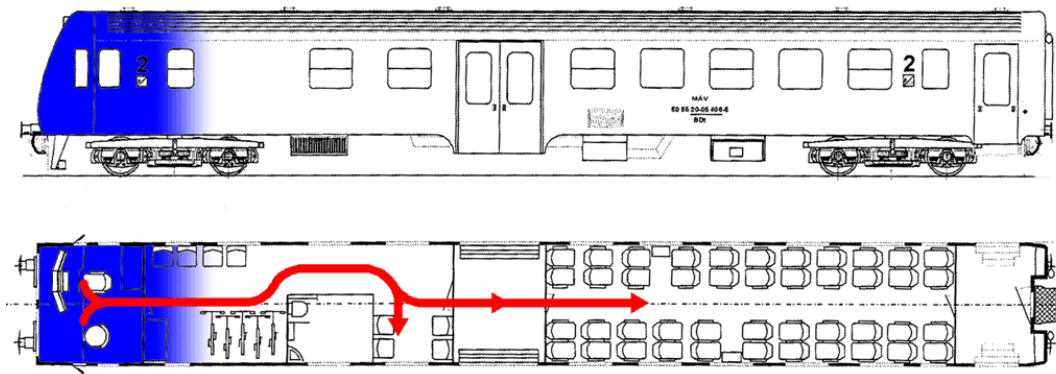
Figure 12: escape from the driver's cab

In this case, the people in the driver's cab ran backwards to the luggage room of the carriage and through it to the passenger compartment (see Figure 12).

Having made all efforts he could in order to reduce the collision speed, the engine-driver went backwards and waited behind the toilet (in the control car), lying with his back against the wall. He did not suffer injuries. The ticket inspector ran from the driver's cab to the passenger compartment, warned the passengers of the collision and then fell over when the collision occurred and suffered minor injuries. The other ticket inspector in the driver's cab (not on duty) got to the hallway where he suffered injuries at the collision.

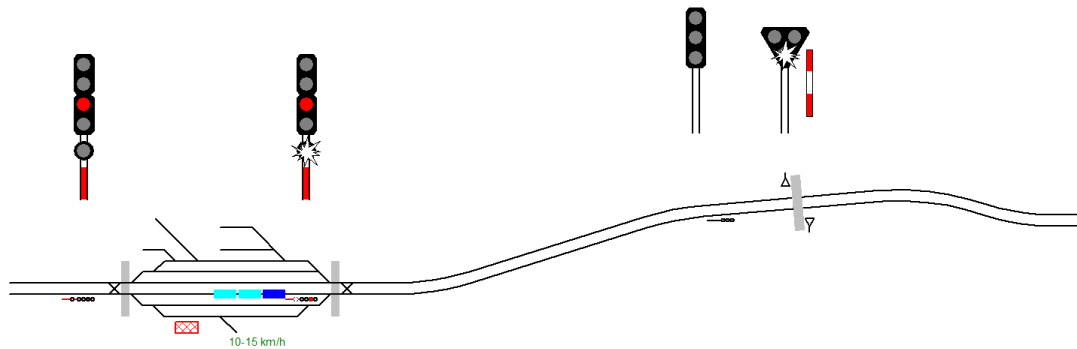
Figure 14: 10:13 hrs

At 10:13 hrs: train IC 560-1 departed from Pilis station onto the left track under subsidiary signal.

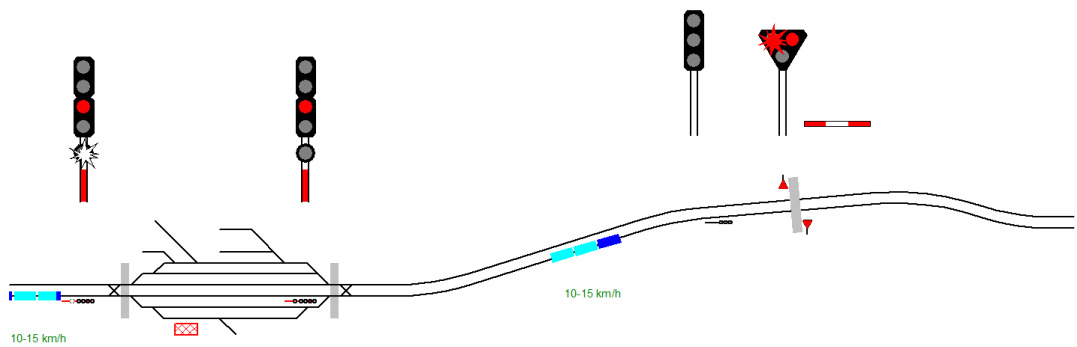
Figure 15: 10:17 hrs

At 10:17 hrs: the passenger train received subsidiary signal on the entry signal and while approaching the station, the train control device of the control car was deactivated. In the meantime, IC train was running slowly on the open track towards Monor, having closed LC AS 450 by this time.

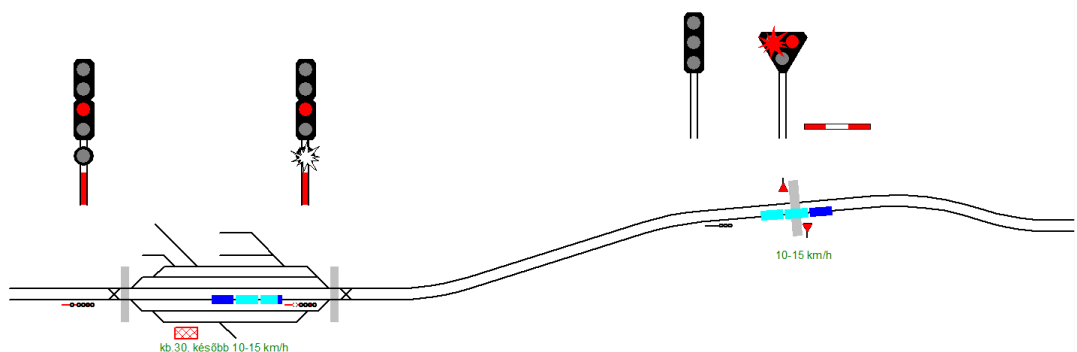
Figure 16: 10:22 hrs

At 10:22 hrs: the passenger train departed from Pilis station onto the left track, also under subsidiary signal while the IC train was passing LC AS 450. However, by this time the LC (its warning lights) became inoperative as the train was running too slowly (the LC was closed for too long time), but it still indicated Stop towards the road due to the so called “red extension” (see 1.8.3.)

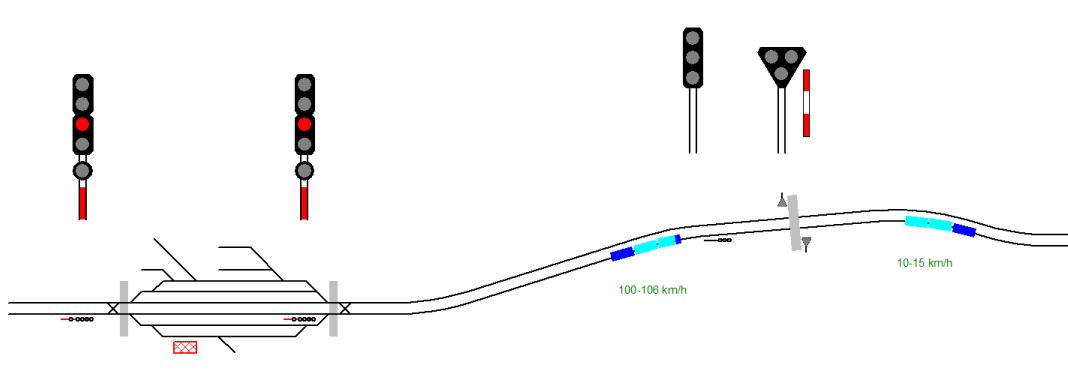
**Figure 17: 10:25 hrs**

At 10:25 hrs: the passenger train passed the dark block signal with high speed and was on its way towards the LC which by this time had become inoperative (was in failure state). It also sounded its horn. Unfortunately, the IC train had just left the straight section of the track before the passenger train arrived there, therefore the engine-driver of the passenger train had no chance to notice the danger.

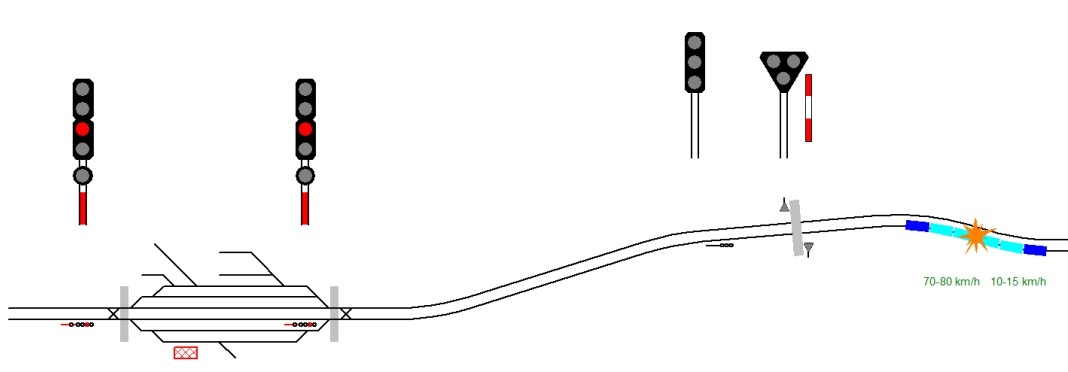
**Figure 18: 10:26 hrs**

At 10:26 hrs: the trains collided with each other.

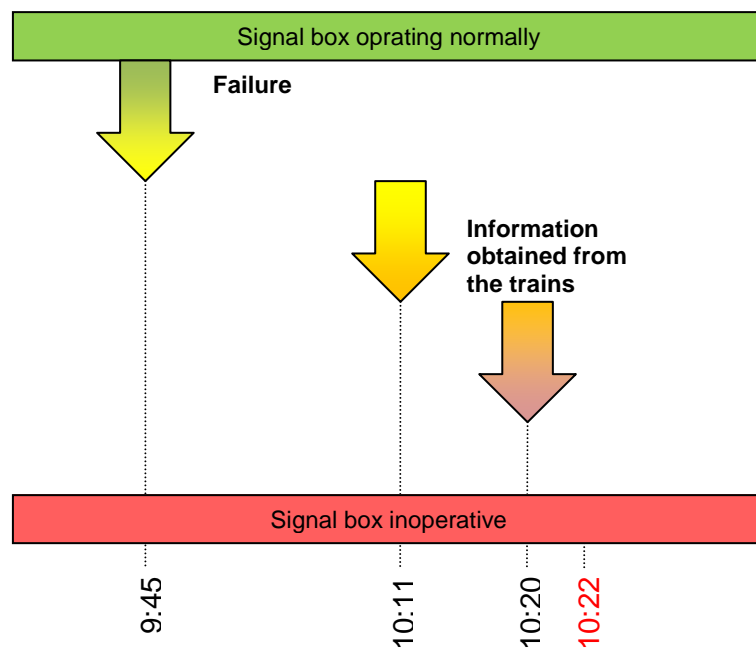
**Figure 21: changing information on the status of the signal box (10:22 – train 2537 departs)**

The staff was uncertain whether the line signal box failed completely or only parts of it became inoperative. In such an uncertain situation, to assume the worst and act accordingly is the safest until one can ascertain the actual facts. The traffic regulations however, do not prescribe the above, and the staff did not act accordingly, therefore they applied the usual technology and procedures.

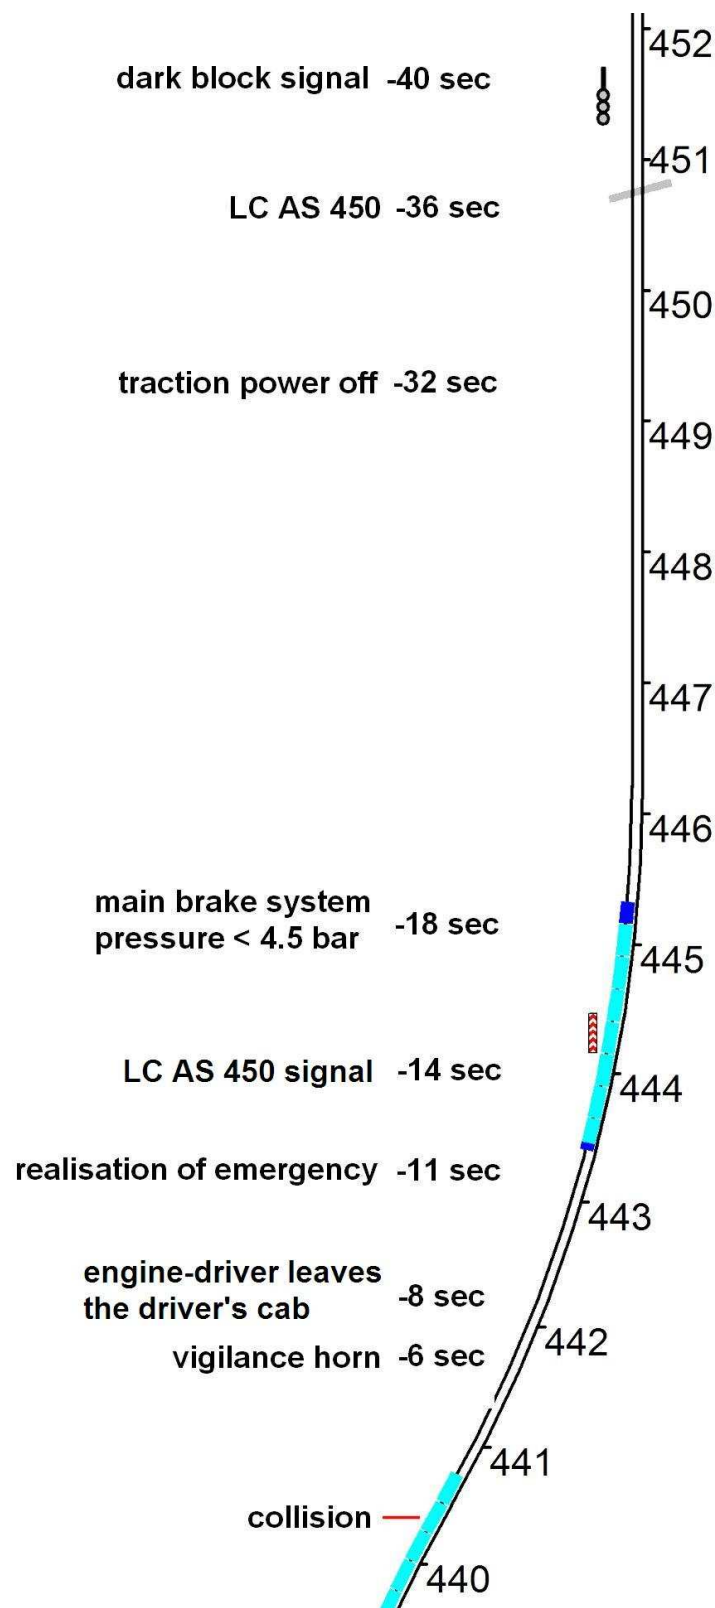
Figure 22: the moments before the collision and the actions/events of train 2537

The below figure shows the moments before the collision. The trains are shown (with light blue colour) in the position when the engine-driver noticed the IC train in front of him.

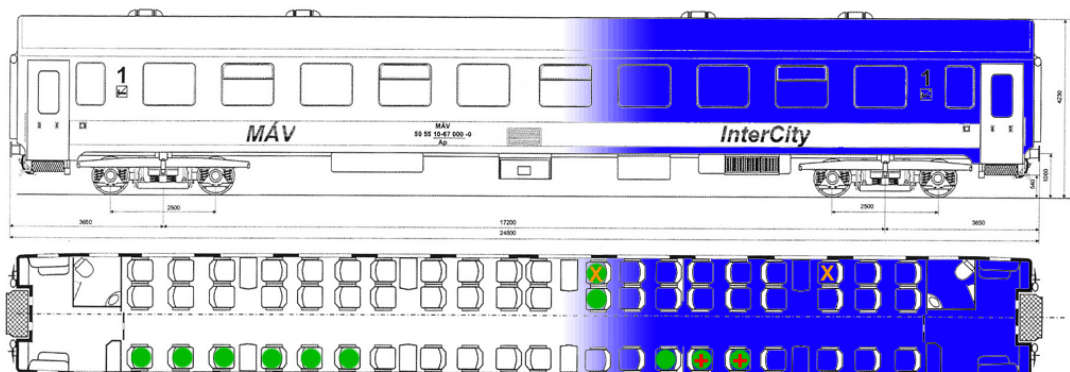
**Figure 26: the position of the passengers in the last carriage of train IC 560-1**

The position of the passengers in the last carriage of train IC 560-1 is shown in Figure 26.

- The green points indicate the seat reservations (sold tickets), however the actual position of the passengers may have been different (they do not always sit where their tickets indicate).
- Orange X indicates where the passengers who answered to the IC's questionnaire were sitting.
- Red + indicates the seats where the two deceased persons most likely sat. As the part of the passenger compartment indicated with blue colour was destroyed, the IC only assumes the seating arrangements based on the injuries to the deceased passengers and their position in the damaged compartment. It was not possible to make such assumptions with regard to the other two victims.

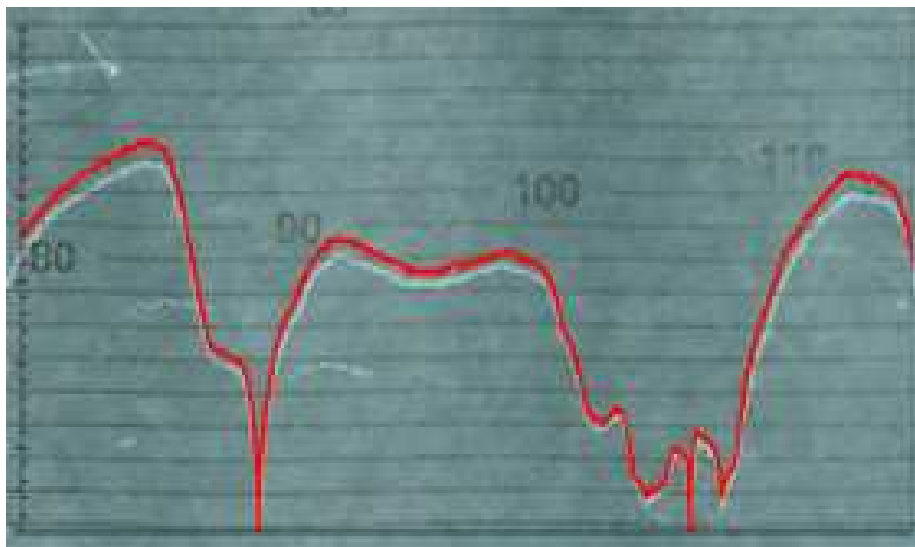
**Figure 27: the recordings of the two data recorders of train 2537 (red line: the digital data recorder)**

The wheels of the locomotive through which the traction is transferred to the track always slip (it is called microslip). This slip can result in a 1% difference between the theoretical speed measured on the driven wheels of the locomotive and the actual travelling speed (which is lower). The effect of microslip makes the recorded speed values for the locomotive even lower. However, this error does not have effect on the results of the analysis and does not diminish the effect of the fact that the train was travelling with high speed at the time of the collision.

The superimposed recordings of the two data recorders are shown in Figure 27. The two stopping locations, the scales of the strip chart data recorder and the digital data recorder and the zero-point error were considered while compiling the diagram.
