MINISTRY FOR  
INNOVATION AND TECHNOLOGY  
TRANSPORTATION SAFETY BUREAU

# FINAL REPORT

Accident

Pipistrel Virus

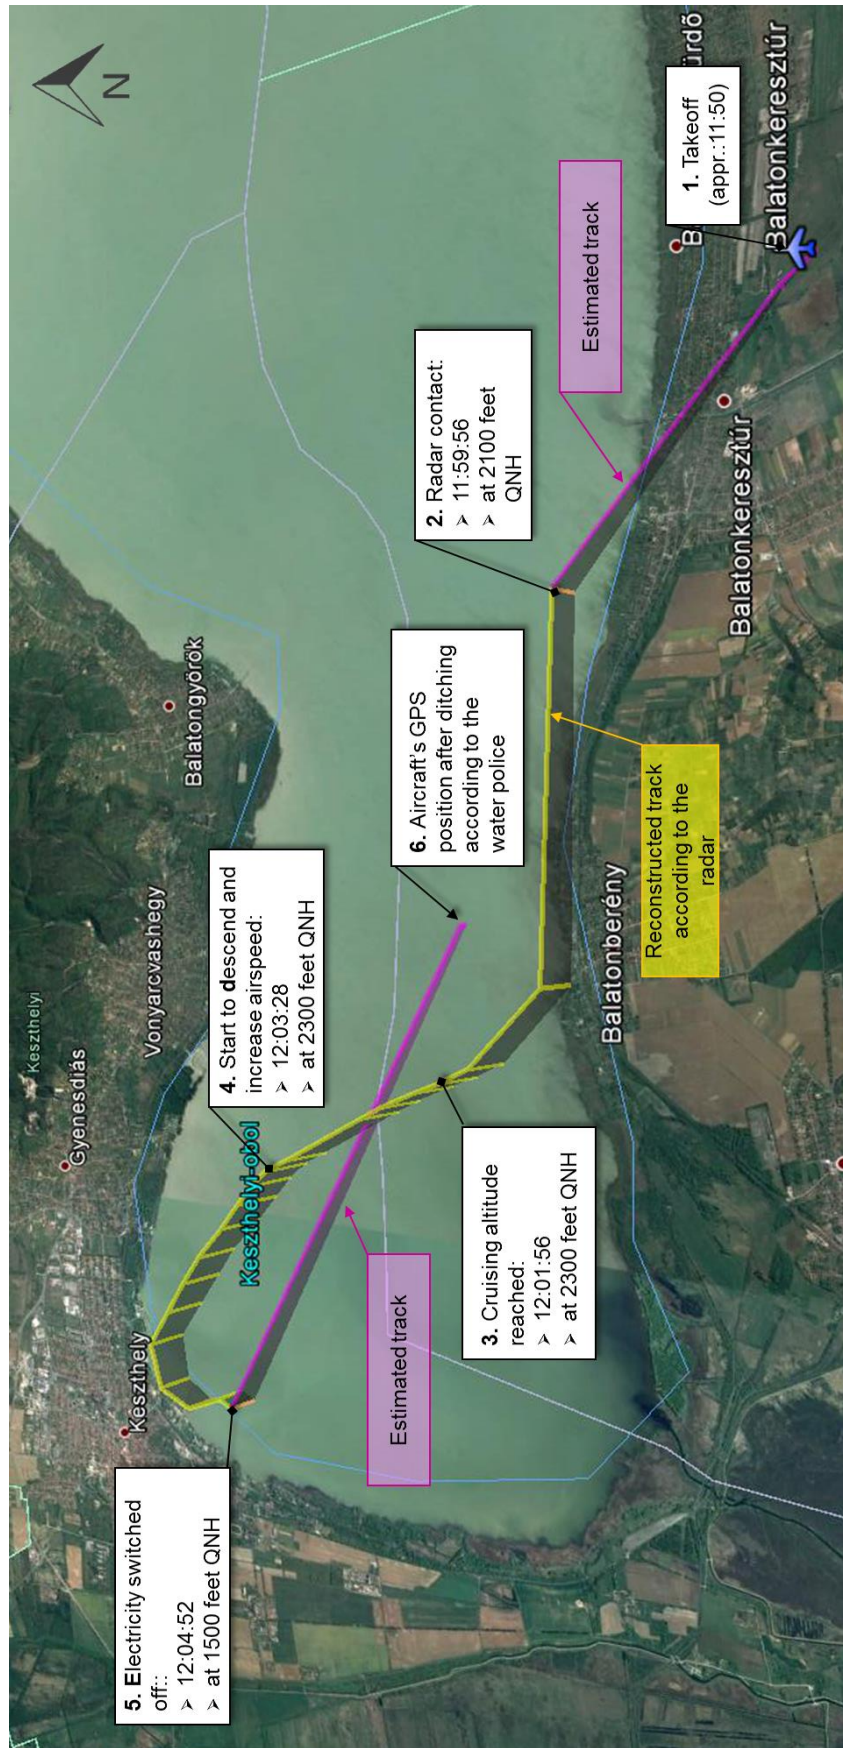
### Annex 1: Route of the aircraft (Source of the map: Google Earth)

After reaching the cruising altitude (Section 3, Annex 1) the pilot set up the cruising parameters, and, according to his report, it was then that he had first detected an increase on the oil temperature on the indicators. He continued the flight along the route planned, and found that, with all other parameters within the normal operating range, the oil temperature reached 120°C. Then he reduced engine power to idle, and began to descend in order to increase aircraft speed, hoping that oil temperature would decrease (Section 4, Annex 1). According to the pilot's report, soon after starting descent he found that the oil temperature still was 120°C, he turned ignition off in order to prevent further damage to the engine. However, the engine did not stop, but continued idle running according to the throttle position. 1 minute and 24 seconds after starting descent, the pilot turned off electricity to the aircraft, as a result of which supply to electric devices was sopped, and the engine also stopped, according to the pilot's report. At that time, the aircraft was ca. 850 metres of the western coast of the lake Balaton and 371 metres (1171 ft) above the water surface (Section 5, Annex 1).
