MINISTRY FOR
INNOVATION AND TECHNOLOGY
TRANSPORTATION SAFETY BUREAU

FINAL REPORT

2016-037-4

Accident
outside Vértistolna
28 February 2016
Cessna FA152
HA-VOK

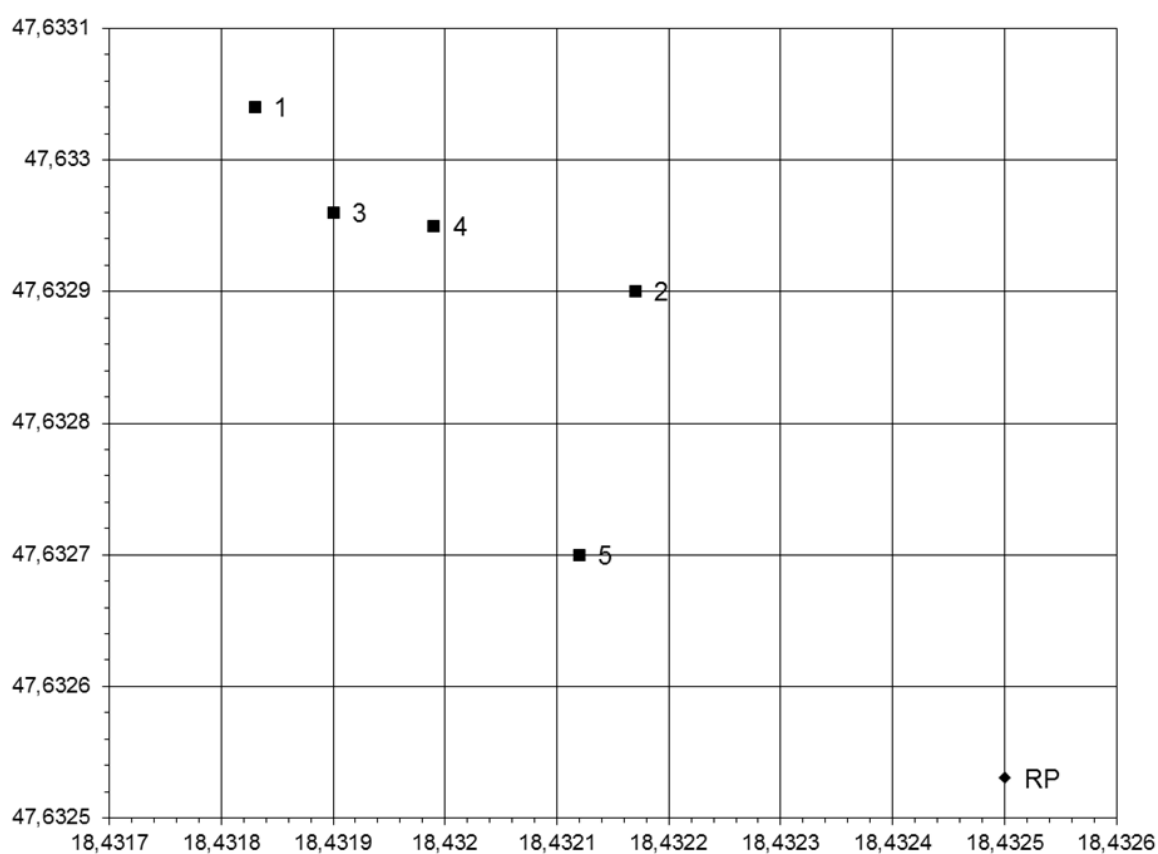
Annex 2:

The damages to the trees and the pattern of scatter of the separated aircraft parts show that the aircraft moved along an almost fully straight line with no deviation of direction from the point of the first collision to the spot where it came to rest, and that its direction was about 311 degrees (Annex 2).

№	Designation	Longitude	Latitude	Distance (m)	Direction (deg.)
<i>RP</i>	First collision with trees	47.63253	18.4325	--	--
1	Wreck of aircraft	47.63304	18.43183	75.74050318	311.0862592
2	Propeller	47.6329	18.43217	48.00208934	322.0894117
3	Tail	47.63296	18.4319	65.63253457	309.3820234
4	LH wingtip	47.63295	18.43199	60.34560772	313.3268547
5	LH aileron	47.6327	18.43212	34.17818737	297.1284009
