MINISTRY FOR
INNOVATION AND TECHNOLOGY
TRANSPORTATION SAFETY BUREAU

FINAL REPORT
2016-071-4P
SERIOUS INCIDENT

LHBP
16/03/2016

ATR 72-200
YR-ATI

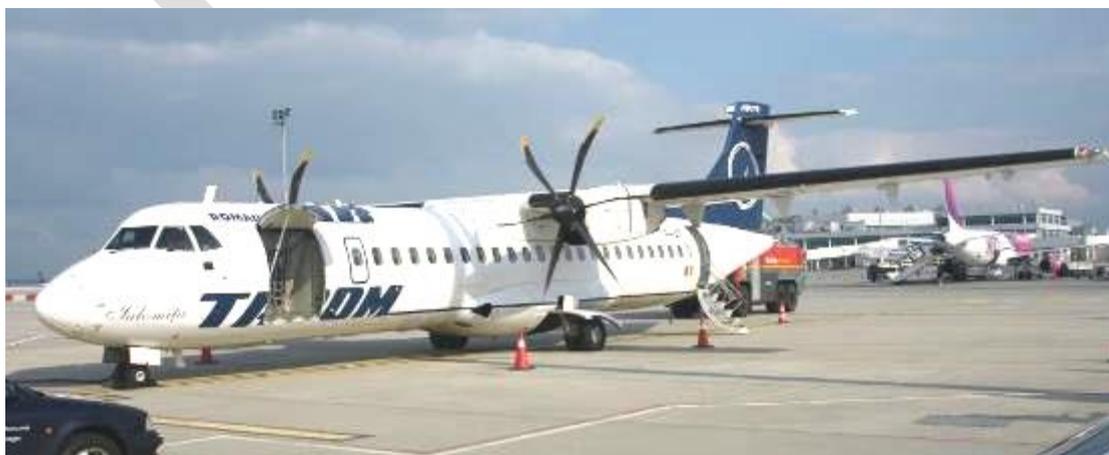
Figure 1: The affected aircraft at Stand № 220 after the passengers disembarked

The №2 (right hand side) engine of the aircraft and its nacelle were significantly damaged in the occurrence.

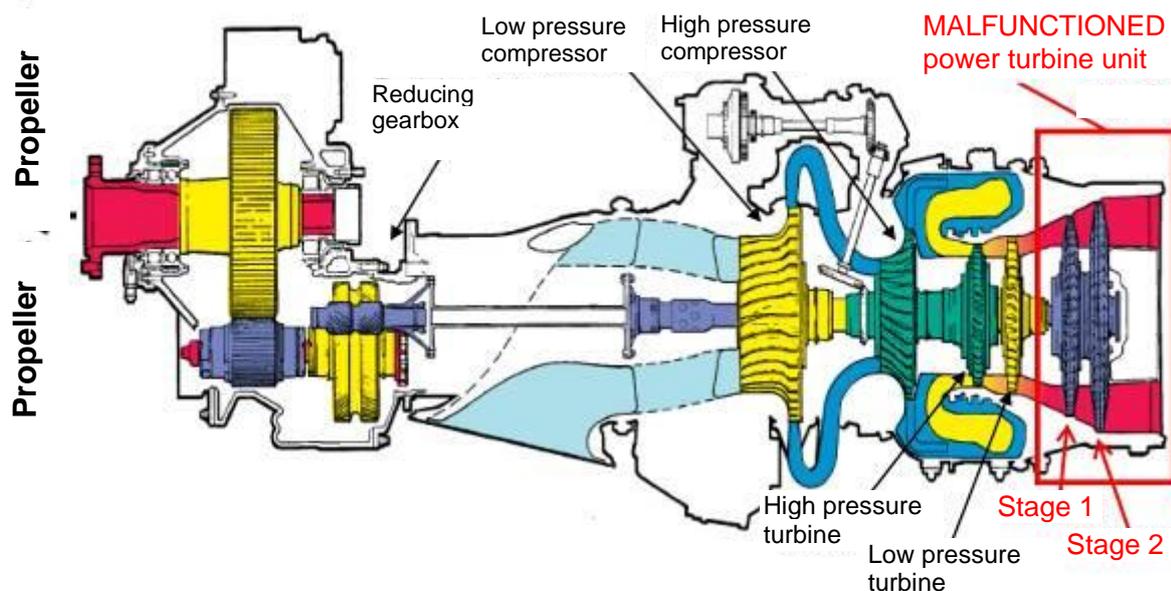
Figure 6: *Principal layout of the Pratt & Whitney PW 127M turboprop engine*

During the flight under investigation, a blade of the rotor assembly of 1st stage Power Turbine fractured in the course of the take-off run. The fractured blade badly damaged the blades of both the stator and the 2nd stage rotor assembly. The outblown debris damaged the tail pipe. The vibration caused by the imbalanced rotor assembly damaged the № 6 & /7 bearing housing and the connected lube oil pipes, and, consequently, also the low- and high-pressure rotor assemblies and shafts. The long-acting high temperature caused further severe damages to the low- and high-pressure turbines and their shafts.

The item number of the turbine blade which initiated the malfunction is 3078563-01, and its serial number is HWMM6651. It was installed in the engine during repair at the plant of Vector Aerospace France on 21 Oct 2014. Then it performed 2 491 hours (2 415 cycles) until the malfunction under investigation.

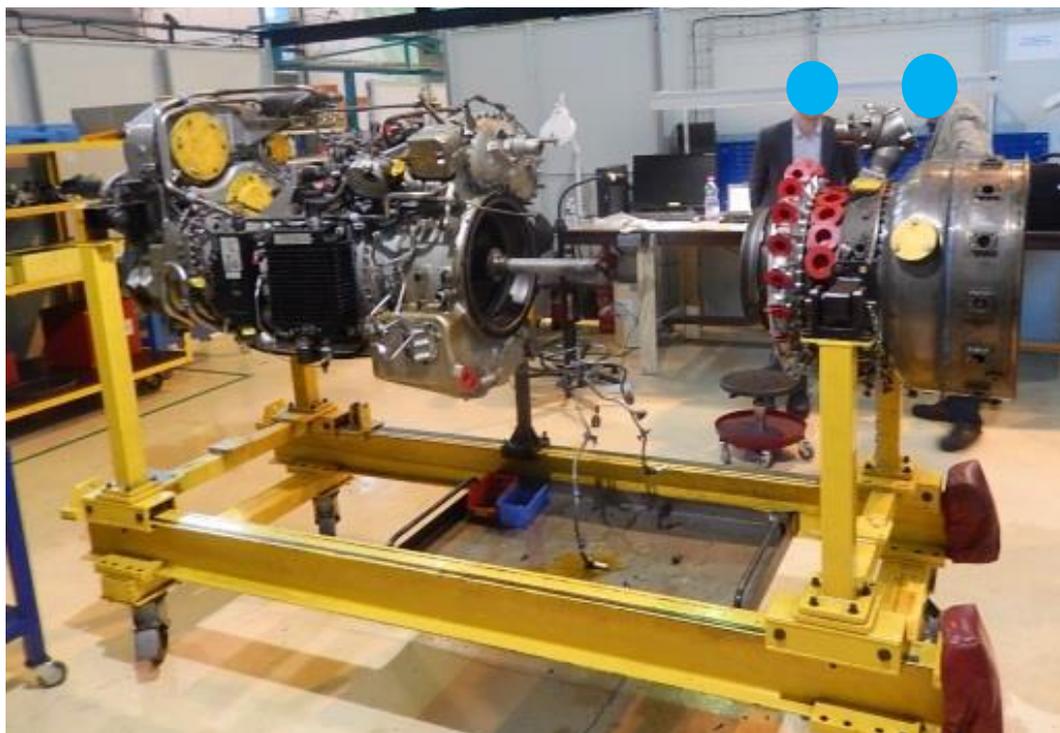
Figure 12: *Disassembly of the engine at the Paris plant of Vector Aerospace France*

The engine dismounted from the aircraft was inspected and disassembled at the Paris plant of Vector Aerospace France (VAF), the contracted maintenance company on 5 and 6 April 2016, in the presence of the representatives of the Hungarian, French and Romanian safety investigation bodies, the operator, the manufacturer, and the affected insurance company.

It was found during the boroscope inspection and disassembly that

- The blades of the discs of both stages of the power turbine were badly damaged
- The low-pressure compressor showed no sign of damage caused by ingested foreign object.
- The outside of the engine showed the signs of effects of high temperatures.
- Significant quantity of metal debris was found in the oil system
- Both discs of the power turbine were badly damaged.

- 19 blades of 2nd stage PT were fractured and the rest of the blades were damaged.
- The tail pipe was damaged by partly molten metal debris flowing out.

- Each blade of the 2nd stage PT stator was damaged.
- Each blade of the 1st stage PT rotor assembly fractured. A blade of the rotor assembly broke off near its root, which may have been the point where the engine started to become inoperable.

- Several blades of the 1st stage PT stator were melted.
- The № 6 & 7 bearing housing disintegrated due to high temperature.
- The shafts of the low-pressure turbines and power turbines melted and fractured.

- Each blade of the rotor assembly of the low-pressure and high-pressure turbines fractured.
- The surface of the stator of the low-pressure turbine melted at the high temperature.

- The blades of the low- and high-pressure compressors were damaged when they reached inside the housing due to the failed turbines, bearings and shafts.

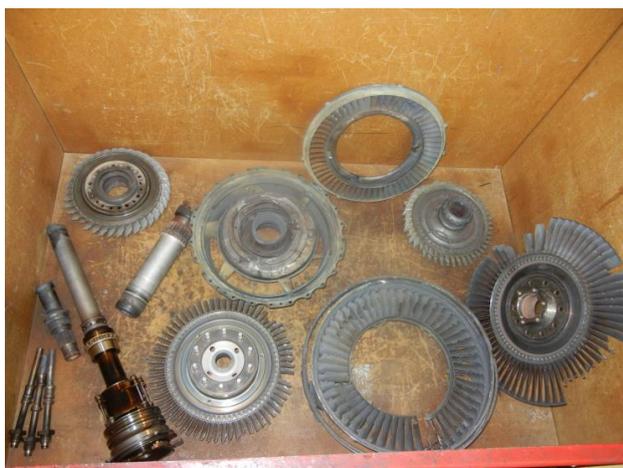
Figure 17: Parts sent to PWC (VAF)

Following the disassembly of the engine in Paris, the following parts were sent to the lab of Pratt & Whitney Canada (PWC) for a more detailed examination:

- stator and rotor assembly of the power turbine
- power turbine shaft
- The common housing of the № 6 & № 7 bearings with the three oil pipes to it
- rotor assemblies of the low- and high-pressure turbines
- shaft of the low-pressure turbine

- The ends of the blades of the rotor assembly of the HP turbine fractured, and there are signs of overheating at the top of the trailing edge.
- A blade of the rotor assembly of the HP turbine broke in halves due to a single impact.
- The rotor assembly of the LP turbine shows signs of mechanical damages and burn.
- The sealing of the № 6 bearing burnt.
- The 1st stage PT stator shows impact damage and molten material debris.
- The 1st stage PT rotor assembly shows damage caused by impact and friction.

- The 2nd stage PT stator shows impact damage.
- Several blades of the 2nd stage PT rotor assembly fractured at different heights due to single impact.
- The bearing housing № 6&7 was overheated, deformed, its fastening screws fractured; the oil pipes to it also broke and show burn marks as well.
- The PT shaft melted and fractured at the № 5 bearing area.
- The shaft of the LP turbine also fractured at the № 5 bearing area as an effect of friction with the fractured shaft of the power turbine.
