MINISTRY FOR Innovation and Technology Transportation Safety Bureau

FINAL REPORT

2016-082-4 accident

Tecnam P2002 JF HA-VOE

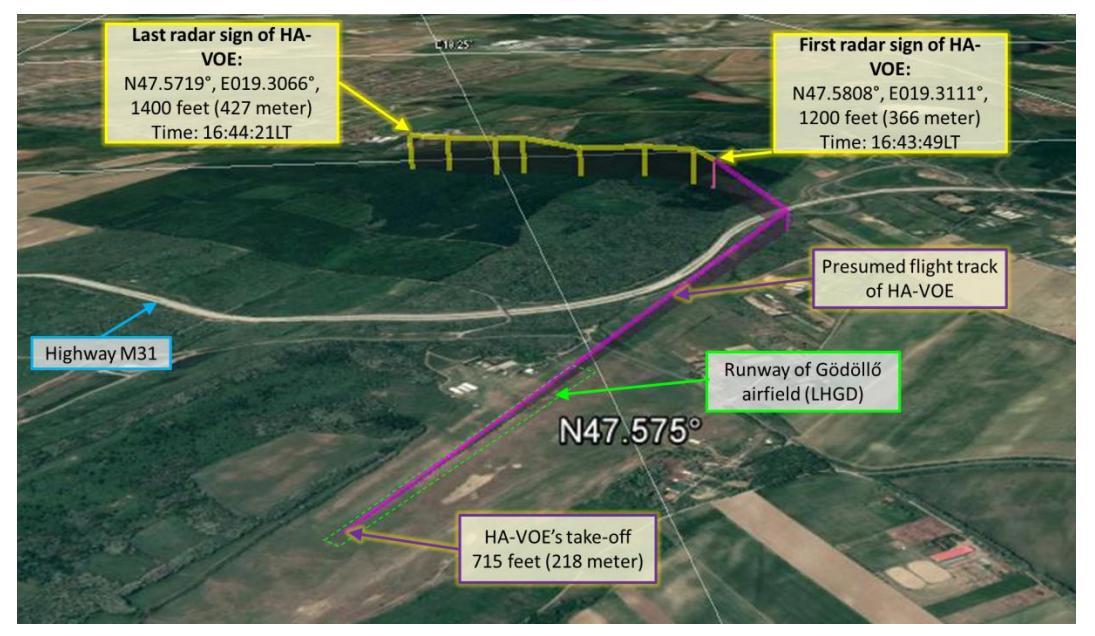
Figure 3: The flight path of the reg. HA-VOE aircraft as recorded by the radar (source of map: Google Earth)

Following the take-off from Runway 31 Gödöllő airfield, the transponder signal of the aircraft appeared on the radar screen of the competent air traffic management service at 16:43:49, and disappeared from the screen 32 seconds later, at 16:44:21. In that moment, the flight altitude was 1400 feet (427 metres) (Figure 3).

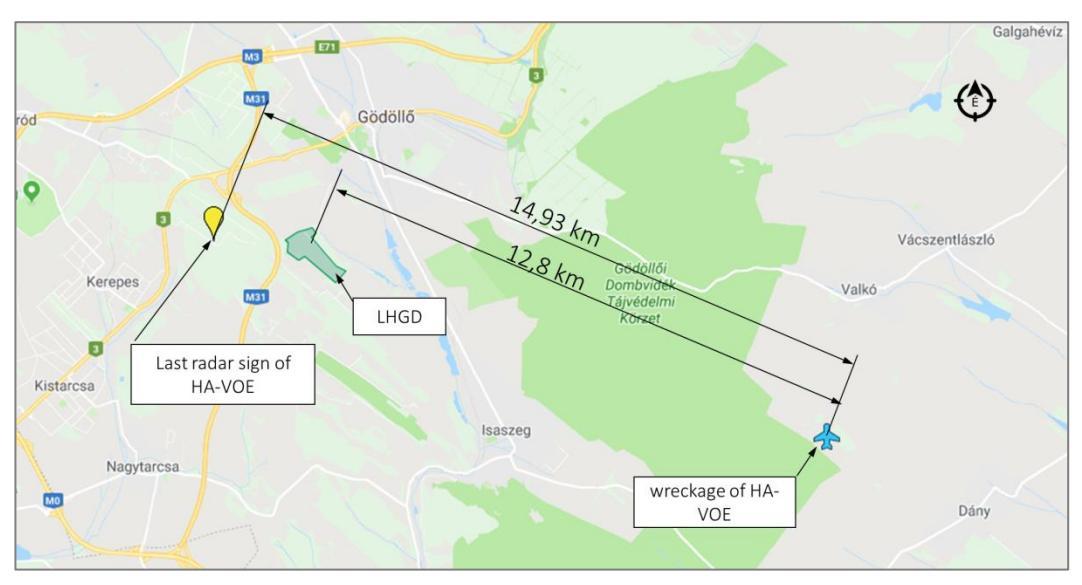
Figure 4: The last radar signal position and the location of the wreck

The search & rescue units identified the wreck of the missing aircraft on 26 March 2016 at about 7 am. The scene of the accident was in a direction of 107° and ca. 15 km of the last radar signal recorded, ca. 13 km of Gödöllő airfield. (Figure 4).

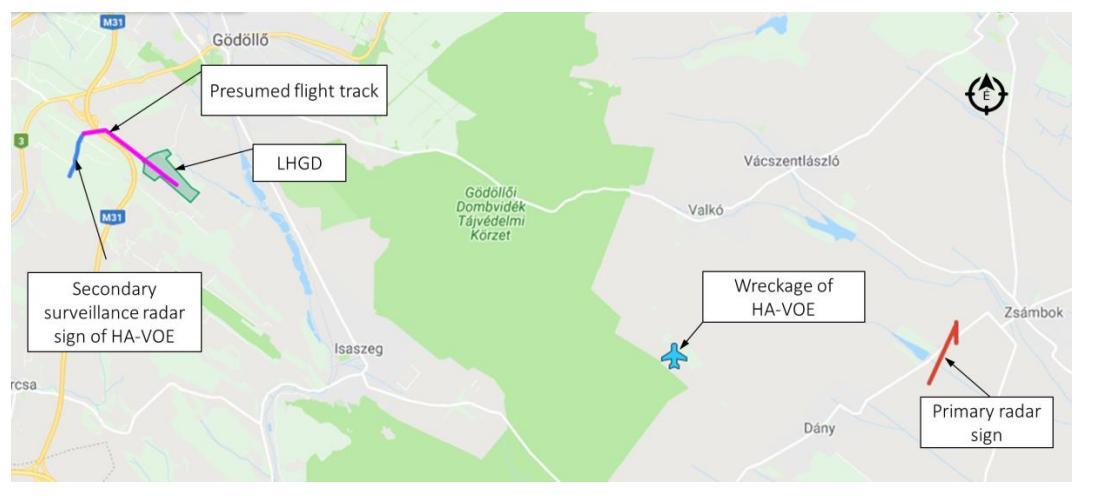
Figure 10: Sections of the flight path recorded on the basis of primary and secondary radar signals (source of map: Google Maps)

The radar data recorded indicates a primary radar signal at 17:07:45 at the location with coordinates N47°31'40" E019°34'39"; it was detected for 12 seconds, and disappeared at the location with coordinates N47°32'27" E019°35'11". The radar processing system of the air traffic management service associated a ground speed of 44 knots to such primary radar signal (Figure 10).

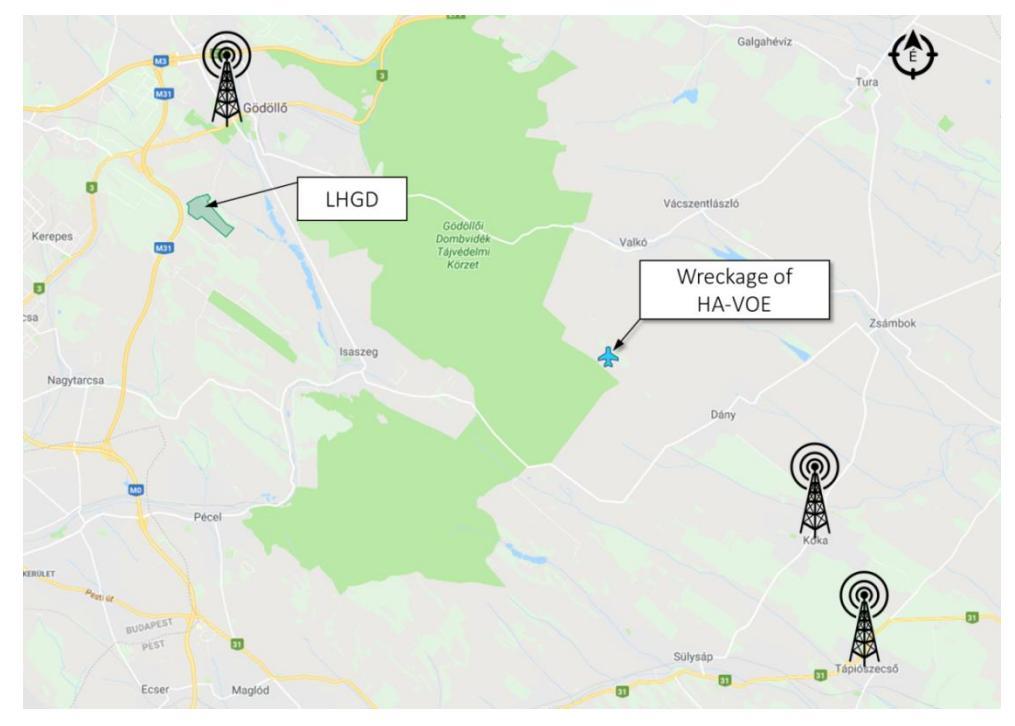
Figure 13: Wreck of the HA-VOE and locations of mobile phone relay stations

At about 10 o'clock pm, ground-based search was completed with a helicopter of the Rapid Response and Special Police Service which searched forest areas using infrared camera. At about 11 pm, the commander of the police helicopter reported they had found no crashed aircraft in the area searched. In the meantime, the police contacted mobile telephone service providers in order to obtain cell data of the mobile phones of the missing persons. The data they received showed that, in addition to the mobile phone relay stations in Gödöllő, the missing persons' phones had been connectable through relay stations in Tápiószecső and Kóka on several occasions (Figure 13). After evaluation of such data, the police expanded the search area to areas southeast of the aerodrome. Rescue activity was temporarily suspended at 00:30 am.

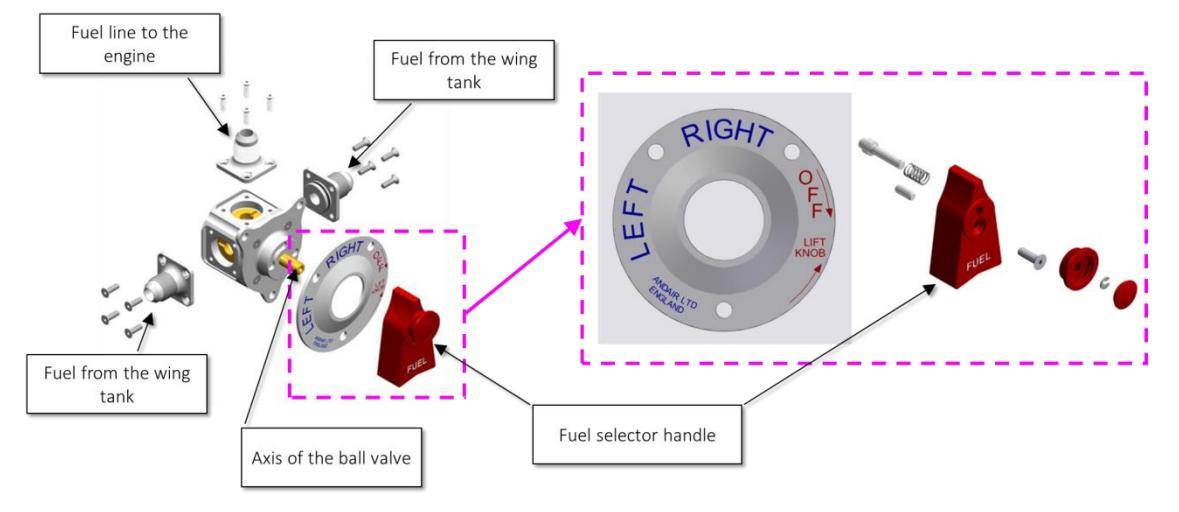
Figure 16: ball valve of the fuel system (source of figure: www.andair.co.uk)

The three-way ball valve of the fuelling system provides three positions: left tank, right tank and OFF. Two of the three connections of the ball valve are connected to the wing tanks, and thee one in the middle is connected to the engine (Figure 16).

The flow direction inside the valve is regulated by a ball (Figure 16 – in yellow colour), which contains two bores arranged perpendicular to each other, in such manner that both bores reach the centre of the ball. When the (red) lever of the valve is set in the LEFT position, fuel can flow freely between the left-hand side connection and the central connection. Setting the lever to the RIGHT position will block the flow between the left-hand side connection and the central connection.

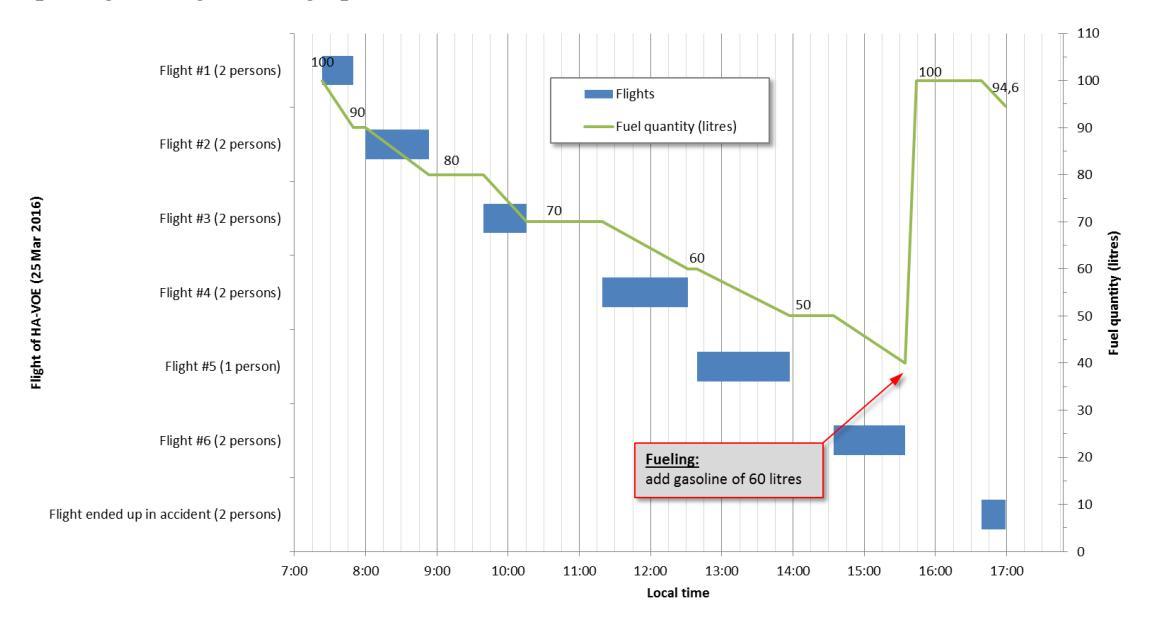
Figure 21: Flights and fuel quantities of the reg. HA-VOE aircraft on the day of the accident, according to entries in the flight logbook

According to information available to the IC, the Organisation used the affected aircraft primarily for training purposes. During the site investigations performed in 2016, the IC was by emplyees of the Organisation that when therewas no more booking for an aircraft for the current day then they fully refilled the fuel tanks of such aircraft. That procedure was confirmed by the fuel refill records used with the organisation and obtained by the IC, as well as the entries in the aircraft logbooks. Using such data, the IC was able to reconstruct the flights directly poreceding the accident; Figure 21 shows the flight times and related fuel quantities of such flights. The chart shows that prior to the first scheduled flight the fuel quantity was 100 litres, and after the last scheduled flight, the fuel tanks of the aircraft were fully refilled again. Later on, the pilot involved in the accident started his flight in an aircraft fully refilled (Figure 21 – the section depicting the flight ending up in accident).

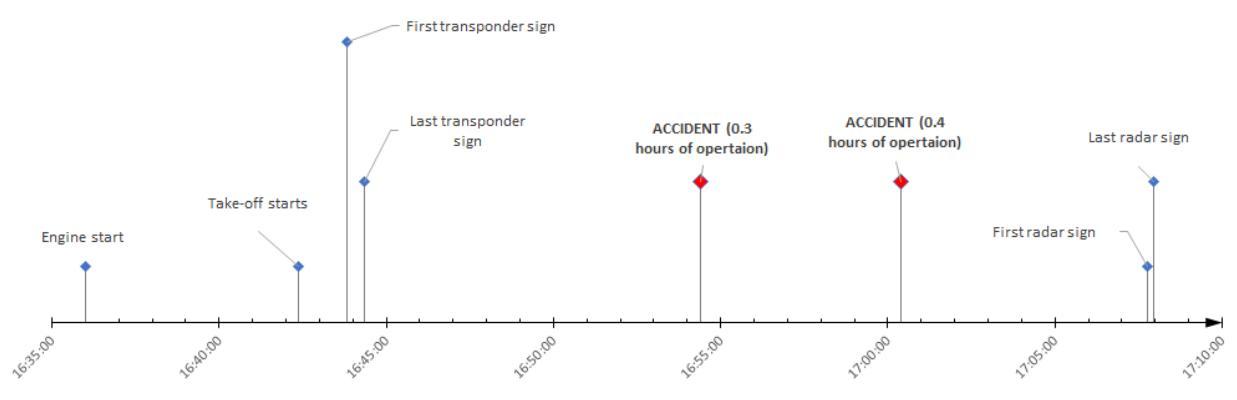
Figure 23: timeline of HA-VOE's flight

According to calculations made by the IC, the accident took place between 16:54:23 and 17:00:23. Figure 23 shows the timeline of the accident.

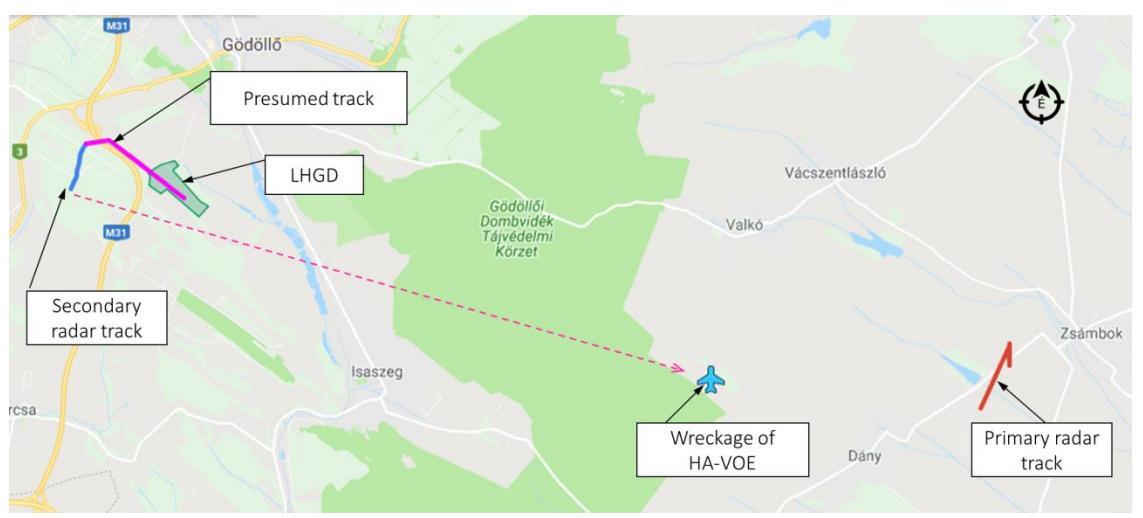
Figure 24: Possible flight path of the reg. HA-VOE aircraft (source of map: Google Maps)

Based on data collected, the IC excludes that the primary radar signal (Figure 24) (described in Chapter 1.1) which was visible for 12 seconds could be the radar signal of the HA-VOE aircraft, because it appeared on the radar screen of the air traffic anagement 7 seconds after the time of the accident of HA-VOE (Figure 23).
