# FINAL REPORT

# 2017-307-4 Accident

Pirtó 245° 2800 m 13 July 2017

> ASW 27-18E D-KRIB

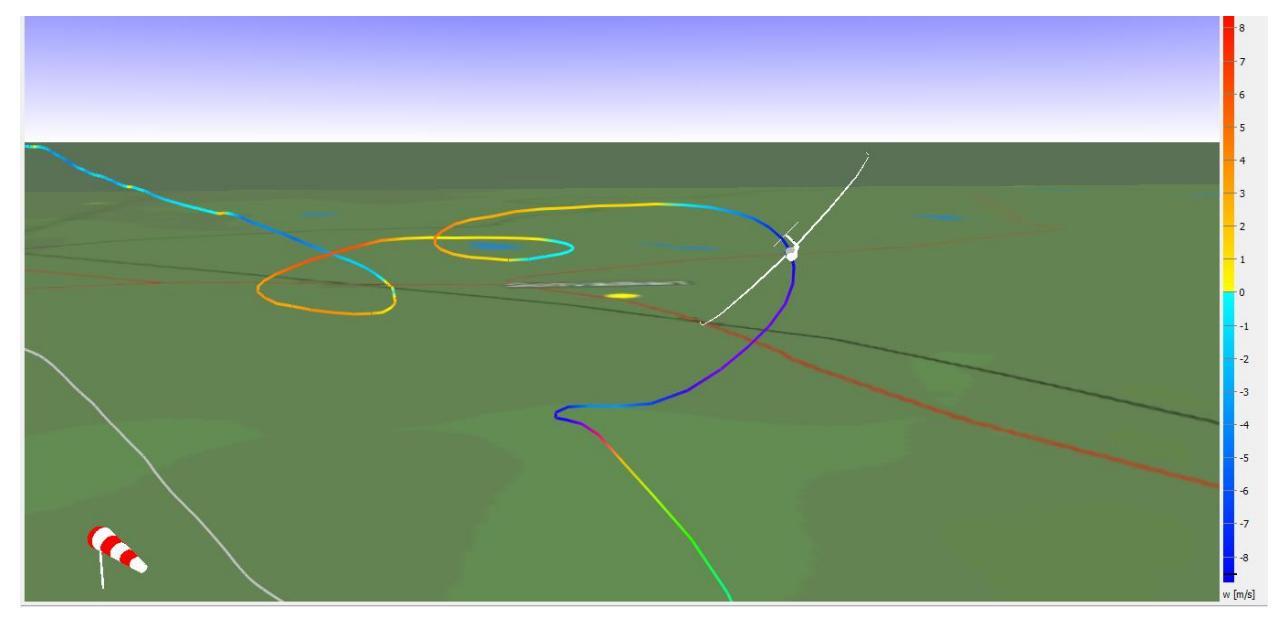
Figure 4: The last minutes of the flight path depicted in space using the See You software

After leaving Kiskunhalas, she did not circle in any rising air current, as presumably she found none. When getting close to Kiskőrös, at 14:41, she might have found that she had no real chance to successfully complete the task, so she gave up her cross-country flight and turned back. Progressing toward Kiskunhalas, the pilot might have detected signs of rising

air currents, because she started circling to the right (Figure 3). During the first two circles, the aircraft climbed to an altitude of 940 metres, with decreasing vertical flight, although part of such climb could have come from the kinetic energy generated by a loss of speed of the flight. Climb completely stopped during the third round, and turned into a more and more intensive descent, the value of which was almost -50 m/s at the altitude of 600 metres, at 14:46:31 o'clock. According to recorded data, rotation of the aircraft stopped in the next 3 seconds, and its descant rate decreased to near -25 m/s. Then, the direction of rotation of the aircraft altered, to the left, and the descent rate increased dramatically again and remained high until the impact.

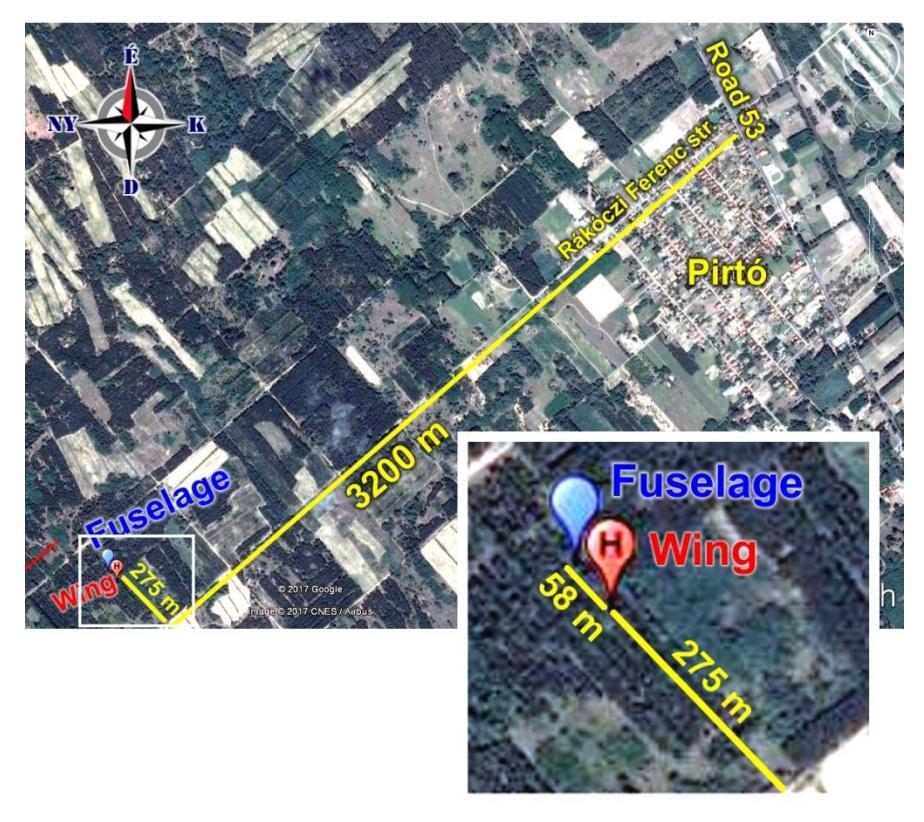
The wrecks of the aircraft with registration sign D-KRIB and the corpse of the pilot were found by the search & rescue unit of Szolnok Helicopter Base, Hungarian Defence Forces, in an area covered with pine and birch trees of 20-25 metres of height, 2.8 km west of Pirtó village, in the morning of the day following the date of the accident. The remains were found in two areas.

Figure 7: Location of the wrecks in a wooded area near Pirtó village

The fuselage of the aircraft and the unseparated right wing were found within a relatively small area but in extremely damaged state. It is a sign of vertical impact that most of the fuselage as well as the stabilizers and the ripped-off engine were found within a circle with a diameter of 3 metres (Figure 8). The nose part of the fuselage (with the body of the pilot) stuck in the sandy forest soil, in a depth of ca. 70 cm. No significant damage to nearby trees was found. Minor pieces of wreckage and other items from the aircraft were scattered around the wreck within a circle with a diameter of ca. 10 metres.

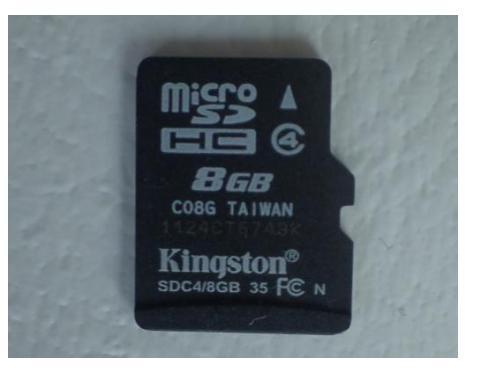
During disassembly and inspection of the component, it turned out that it was part of the Colibri II device installed on-board the aircraft. The micro SD card of 8 GB capacity (Figure 13) removed from the component proved to be fully serviceable, it was possible to recover the file with igc extension from it; the file contained data of the flight which ended up in accident. As the device was connected to the navigation equipment type LX8000 during the flight, it contained data measured by such navigation equipment.

Figure 13: The face of the SD card found

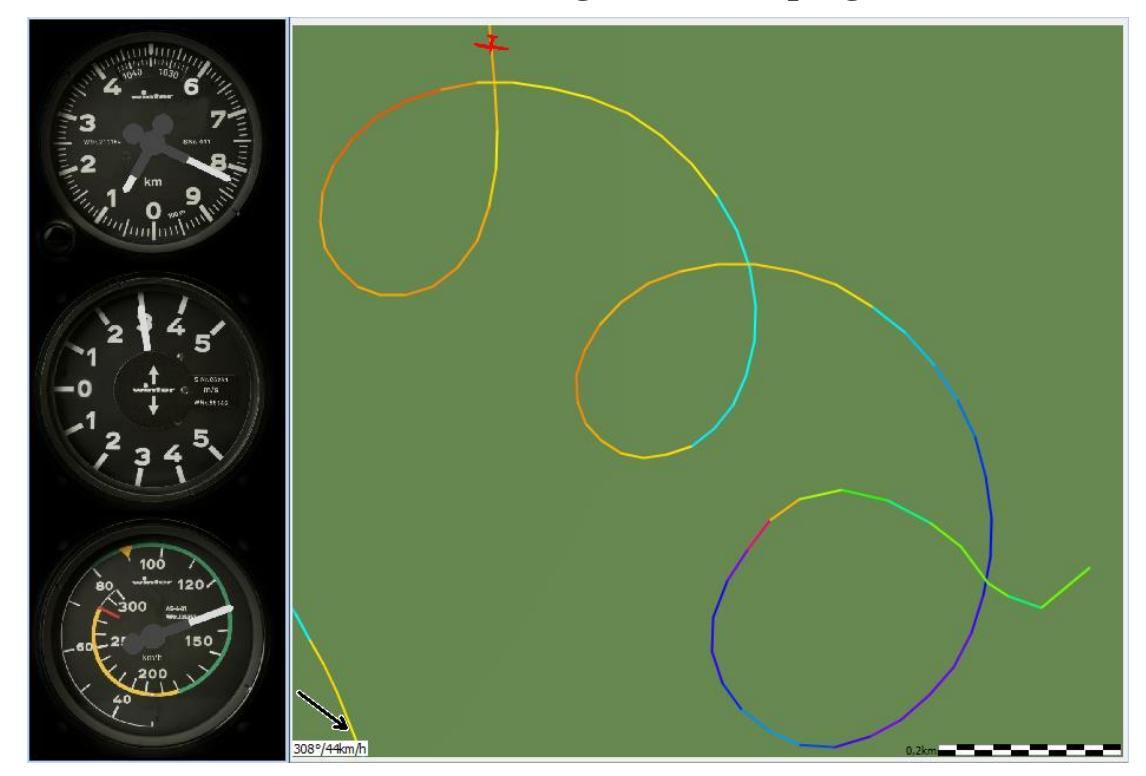
Figure 1/a: (Second -108) Start of circling in the thermal lift.

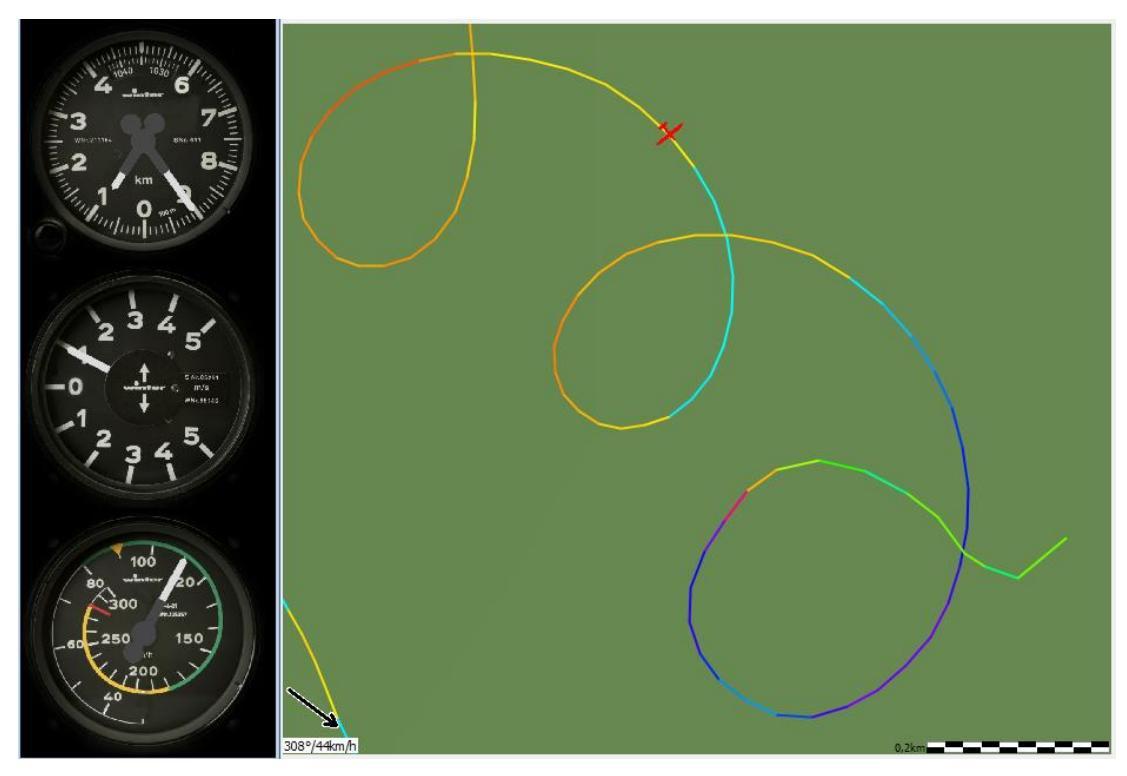
Figure 1/b: (Second -63) Completion of the first circle, after 80 metres of climb.

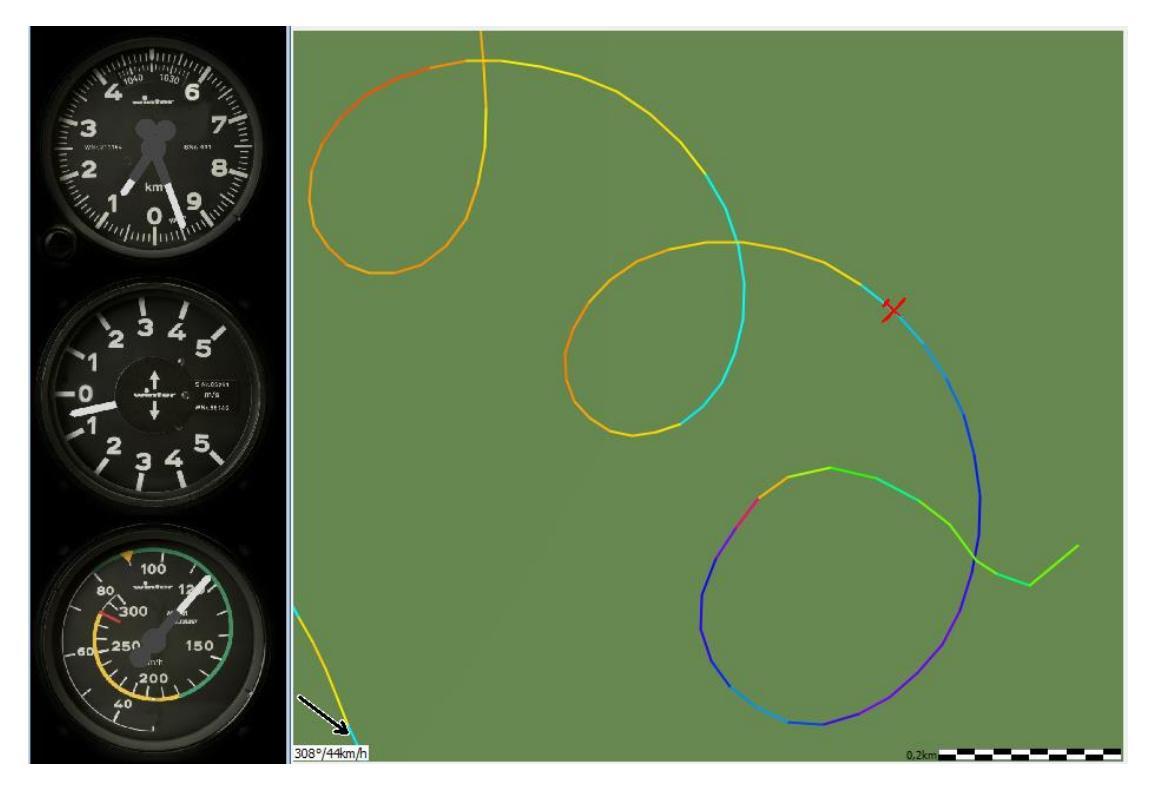
Figure 1/c: (Second -34) Completion of two circles, after an aggregate climb of 120 metres.
