TRANSPORTATION SAFETY BUREAU

FINAL REPORT

Travel Service a.s., Boeing 737-8K5, OK-TVP
Budapest Liszt Ferenc International Airport (LHBP),
23 March 2018

2018-128-4

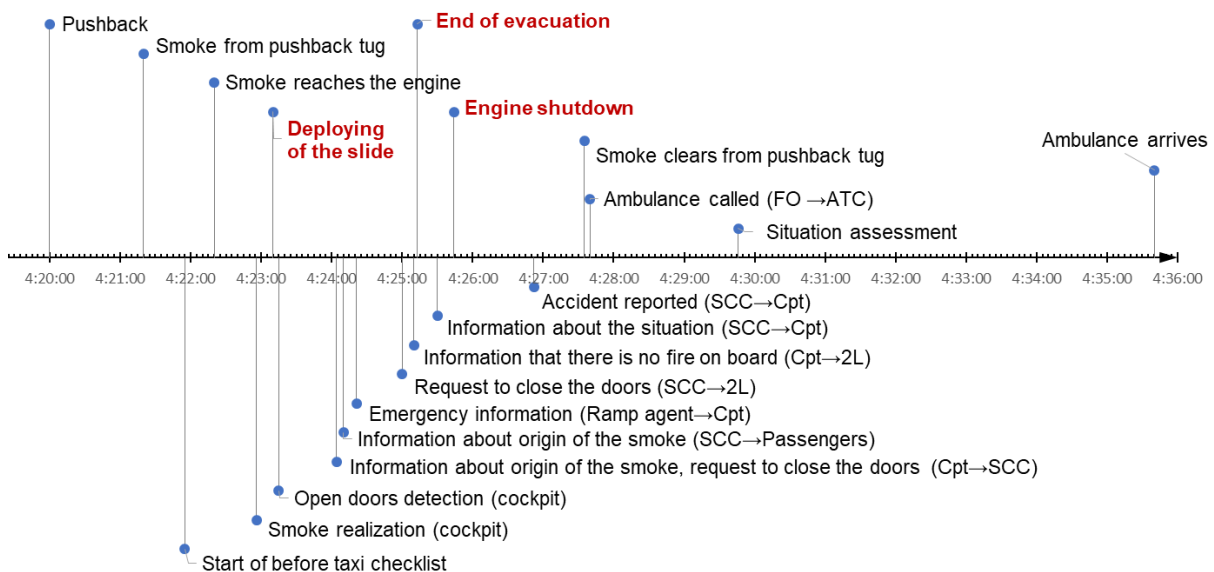
Figure 2: Timeline of the accident

The IC reconstructed the timeline of the accident from witness statements, airport camera footage, data from the aircraft's cockpit voice recorder and radio traffic data recorded by the HC (*Figure 2*). The timeline illustrates the events leading to the accident from the start of the push-back (4:20 am) until the arrival of the ambulance (4:36 am).

On the occurrence timeline illustrated in *Figure 2*, the IC took the initial time as the start of the slide opening (as shown by the airport camera footage) and the time of the opening of the aft service door as realised by the First Officer (as reflected in the on-board voice recording), and reconstructed the sequence of events on this basis.

Figure 2 that was made based on the audio recordings shows that the Captain informed the SCC and then the SCC informed the passengers of the situation and the origin of the smoke before receiving information from the Ramp Agent.

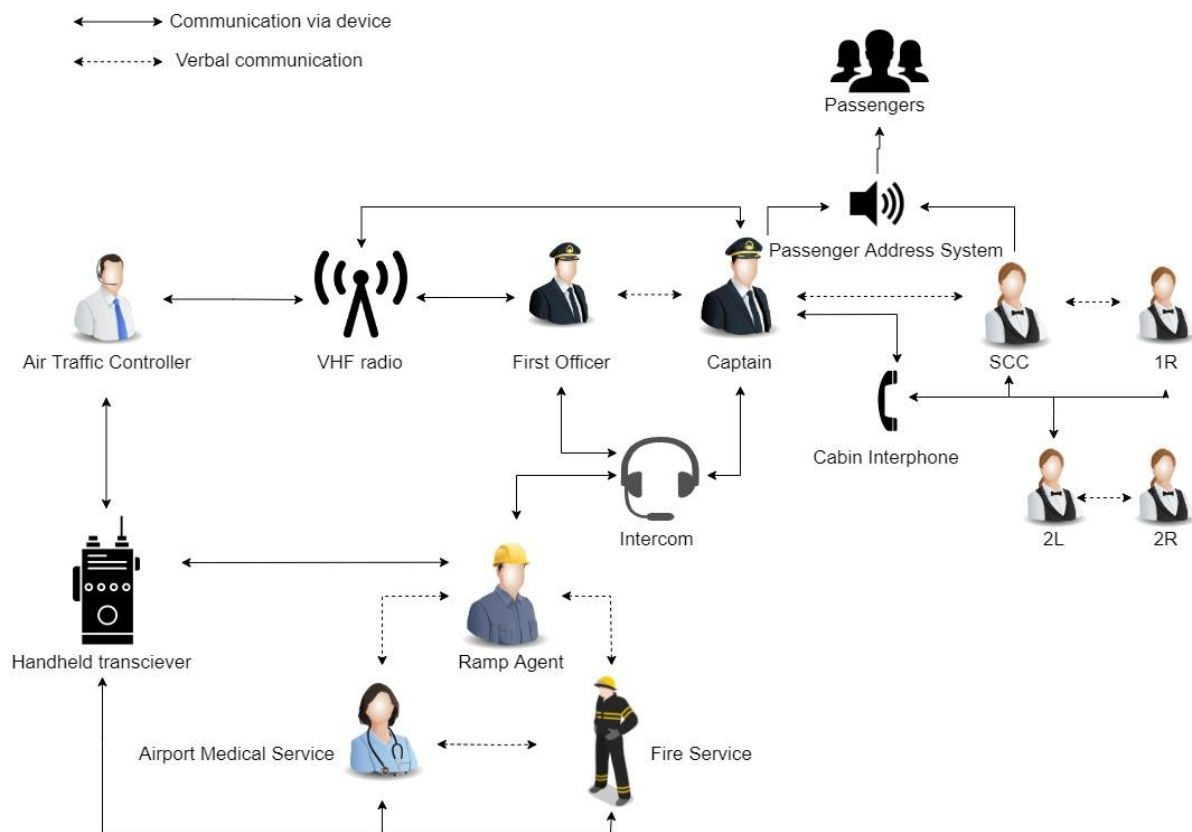
Figure 3: Major channels of communication established during the accident

The IC reconstructed the communication channels during the accident, based on the on-board voice recorder and witness reports, which is demonstrated in *Figure 3*.

During the on-board radio communication, the pilots were in contact with the Tower by radio ('VHF radio'). The Ramp Agent was connected to the cockpit communication system (Flight Interphone) via a headset connected to an external communication point of the aircraft and communicated with the cockpit crew via this system.

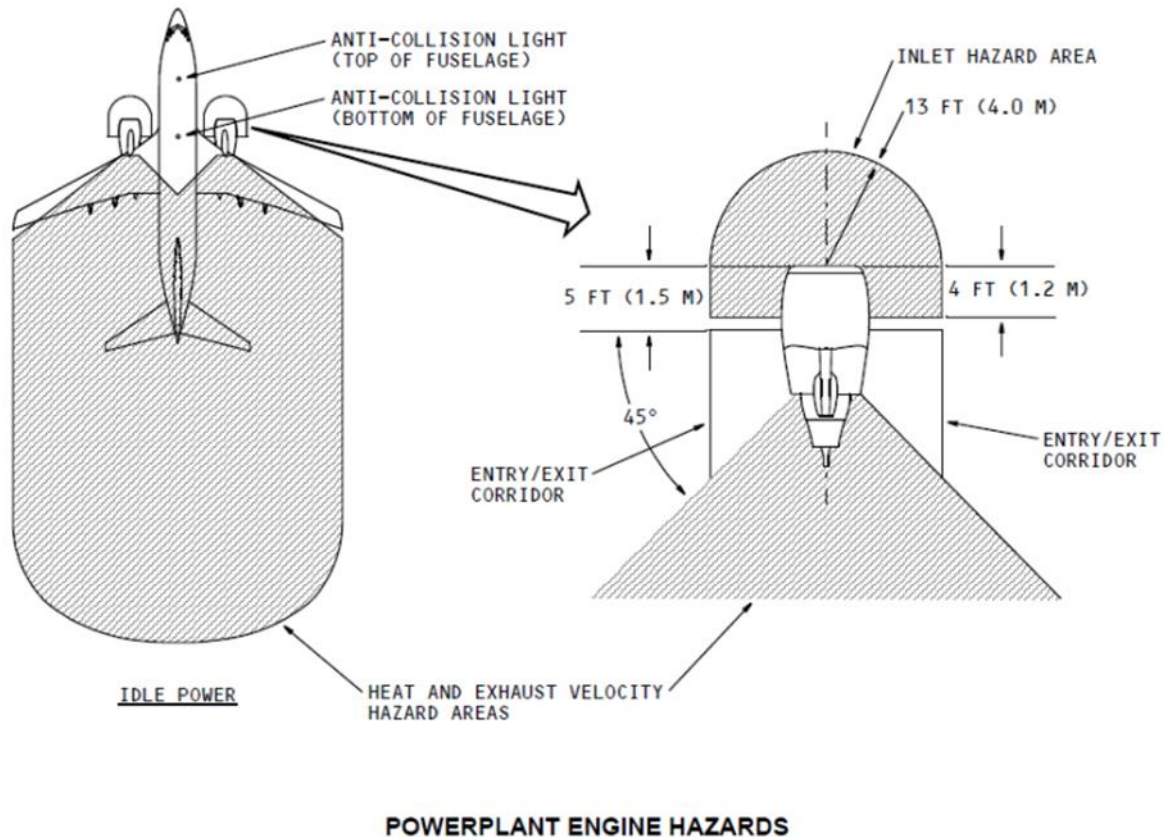
Figure 6: Danger zones of an engine operating on idle
(Source: <http://www.aviationlearning.net/files/B737%20NG%20REFRESHER.pdf>)

Several documents highlight the danger zones of the operating engines. In the area behind the engine, not only the speed and mass of the exhaust air, but also the temperature of the jet blast is dangerous to the health of the people who are standing there.
