MINISTRY FOR Innovation and Technology Transportation Safety Bureau

# FINAL REPORT

2018-548-4

Cirrus Standard OK-7077 SZD-41 Jantar Standard HA-4361

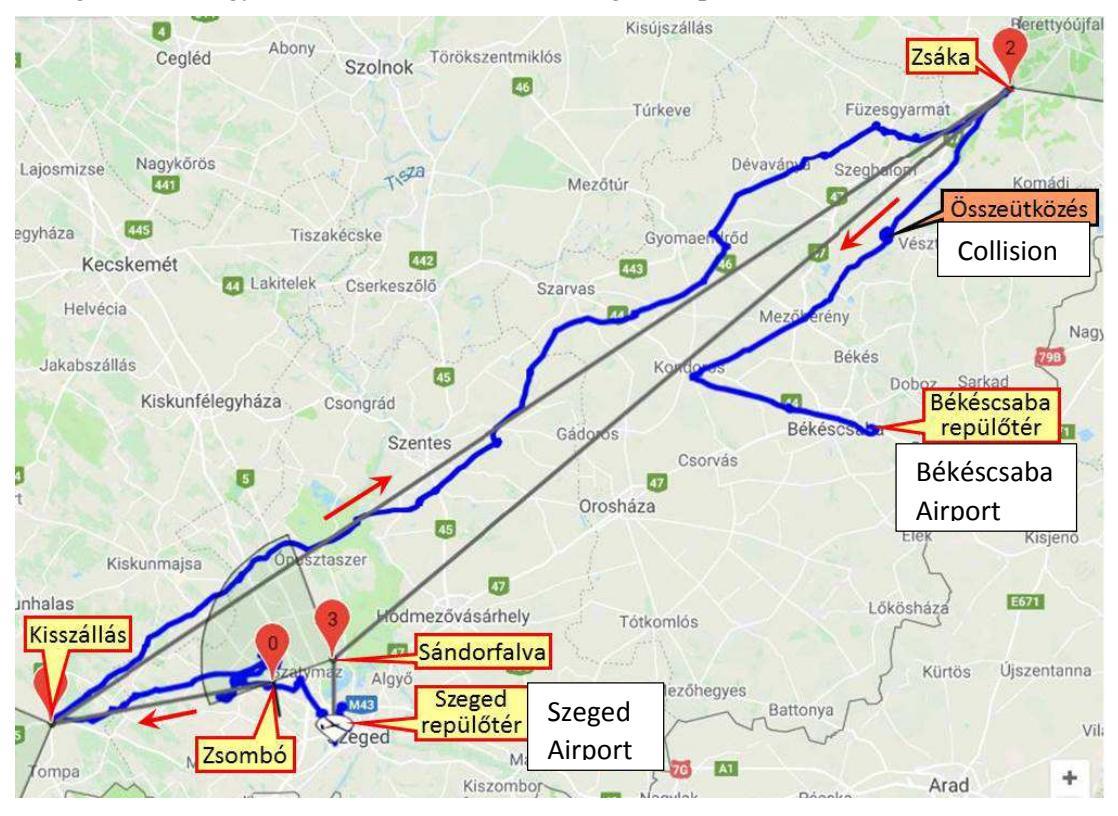
Figure 4: The specified task route (black line) and the flight path of the HA-4361 (blue line) (Source: flight data recorder)

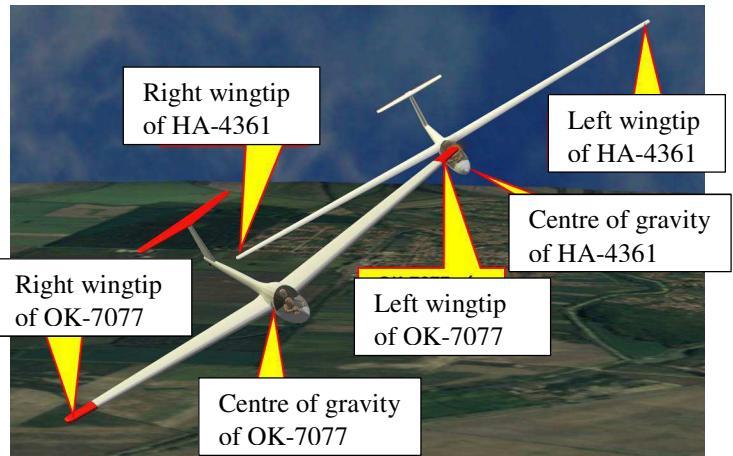
Figure 6: Centre of gravity and height of wingtip at bank

7077, running outside of it (Figure 5). However, the pilot of the OK-7077 reduced the bank of his aircraft, thus increasing the radius of its turn, so its path got closer to that of the HA-4361 aircraft which was outside of his primary visual field and the altitude of which was gradually nearing his own altitude. Due to the banking orientation, the altitudes of the wingtips were 4 to 5 metres different from those of the centres of gravity (Figure 6).

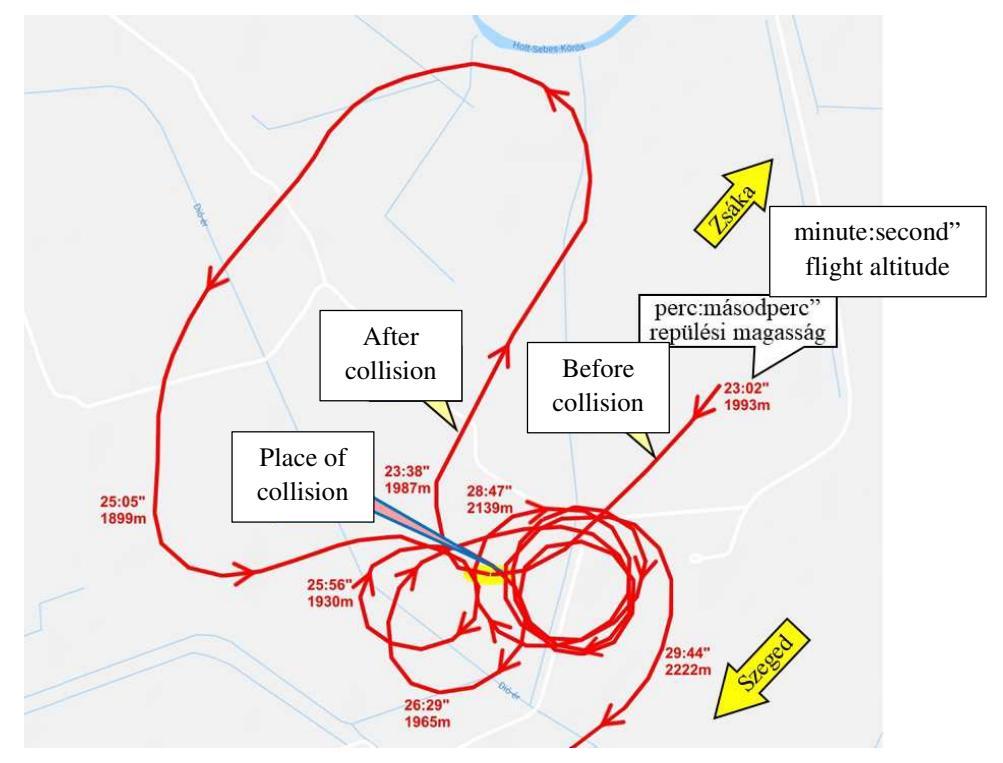
After the collision, the pilot of the HA-4361 aircraft came out of the turn, checked if his aircraft was controllable, then took a wide left turn to return to the scene of the collision in two minutes, and flew six circles in the thermal within four minutes, climbing up to the cloud ceiling which was at 2200 m (Figure 7). From there, he continued gliding in the usual

Figure 7: The path of the aircraft with reg. mark HA-4361 during the six minutes following the collision

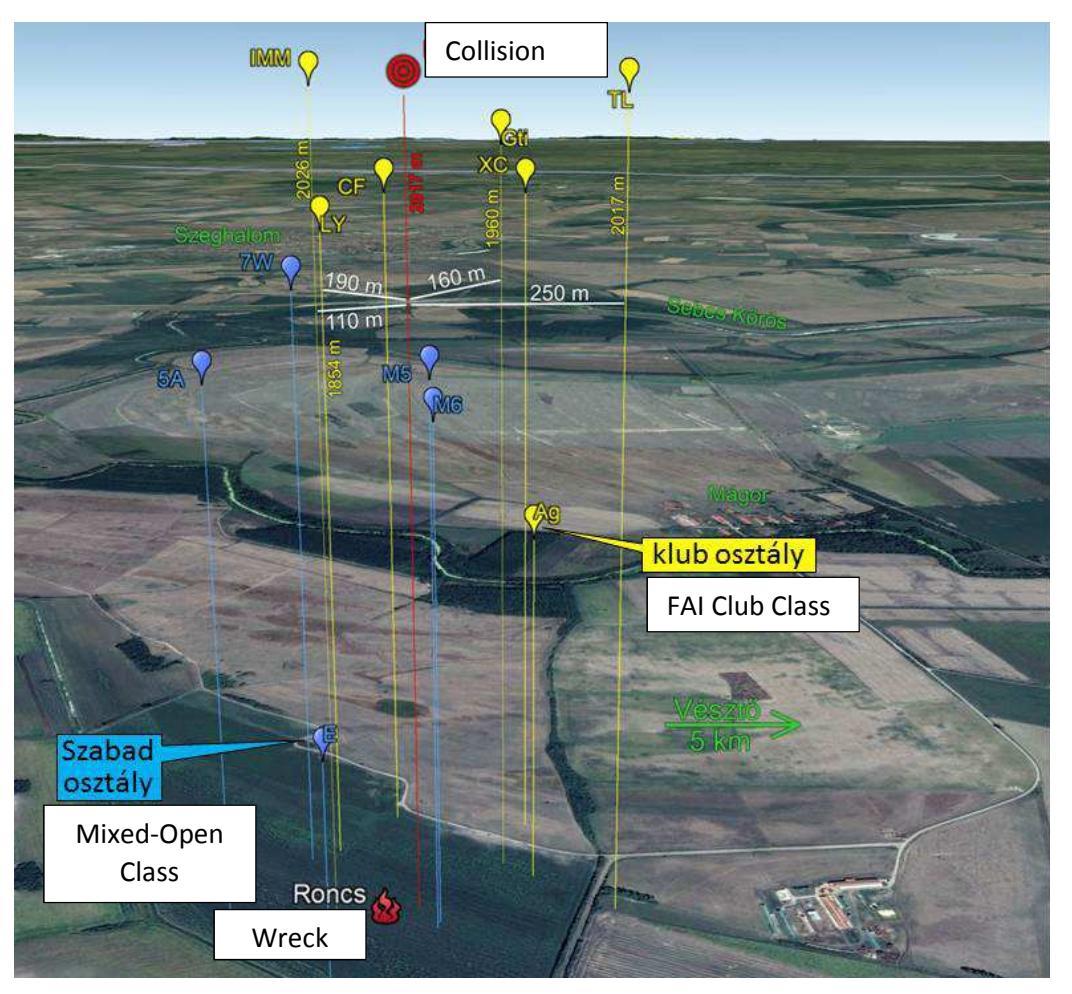
By analysing detailed flight data (IGC files) published on the Internet by the organisers of the competition, the IC found that there were 14 aircraft (9 FAI Club class and 5 Mixed-Open class) soaring in the thermal near Vésztő at the time of the accident, and five of them (including the two involved in the collision) were within a 100-metre altitude range between 1950 m and 2050 m. The distances of other aircraft within that altitude range from the spot of the accident varied from 110 to 250 metres (Figure 8). Simultaneous thermal soaring by aircraft from both sailplane classes could have occurred because some of the FAI Club class sailplanes returning from the direction of Zsáka (towards Sándorfalva turnpoint) met some outbound competitors of the Mixed-Open class (heading to Nádudvar) in the column of rising air beneath the cloud near Vésztő.

Figure 8: Spatial positions of the aircraft flying in the thermal simultaneously at the time of the collision

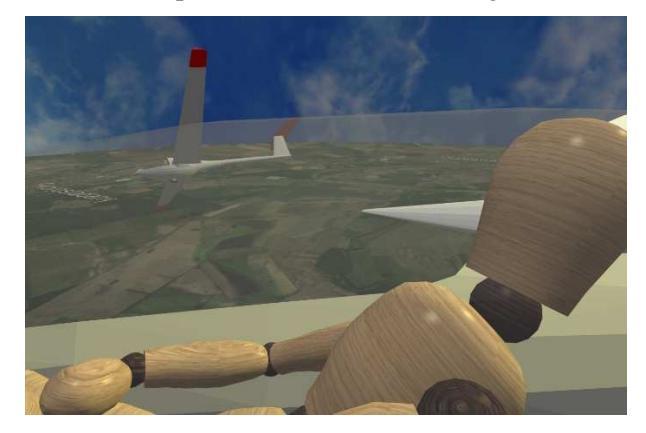
During the minutes preceding the collision, the aircraft with reg. mark OK-7077 was circling to the right (clockwise), with a bank of 35 to 40 degrees. As the other aircraft (HA-4361) was situated on the left in the 10 seconds preceding the collision, the pilot of the OK-7077 had limited view of it only, and he had to focus his attention primarily on the area where his aircraft was heading, i.e. to the right (Figure 24). The aircraft with reg. mark HA-4361 first approached the spot of the collision in a straight line, and finally with a bank of ca. 35°, so he had undisturbed sight of the sailplane with reg. mark OK-7077, and his attention should also have been directed there. (Figure 23). The IC is not aware of any circumstance which could have excluded or limited visibility of the sailplane with reg. mark OK-7077 for the pilot of the aircraft with reg. mark HA-4361.

Figure 23: View from the HA-4361 aircraft

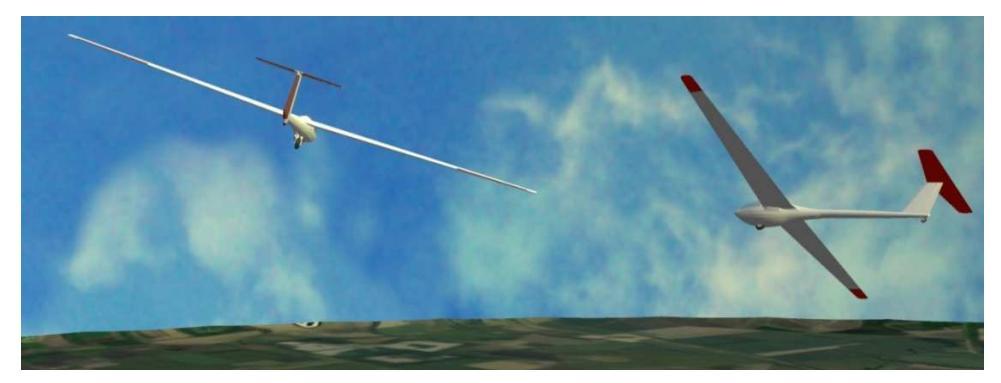
On the basis of data from the IGC files describing the movement of the aircraft and the damages suffered by the aircraft, the IC reconstructed and visualised in 3D (using the Poser software) the course of the collision as follows (Figures 25 to 30):

Figure 25: The sailplanes approaching each other a few seconds before the collision.
