TRANSPORTATION SAFETY BUREAU

# FINAL REPORT

Wizz Air Hungary Ltd., Airbus A320-232, HA-LYD  
Debrecen International Airport (LHDC), 04 January 2020

2020-0008-4

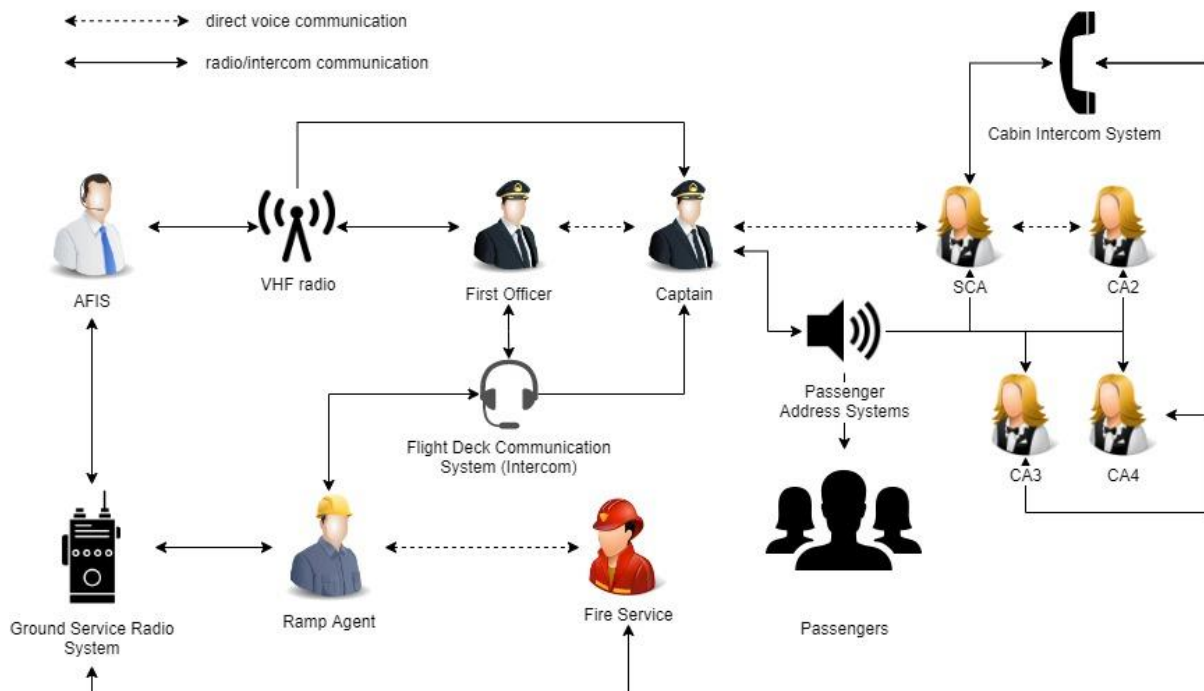
Figure 3. Way of communication during the occurrence

The flight deck had been in radio contact with AFIS on Debrecen Info’s designated frequency (“VHF radio” in Figure 3). The Ramp Agent’s wireless headphone was hot wired to the cockpit’s intercom through the service port, connecting him to the pilots. With the Fire Watch, AFIS and other ground based units he maintained contact via his handheld radio transceiver.

The Captain kept cabin attendants and passengers informed using the PA (“Passenger Address System” in Figure 3).

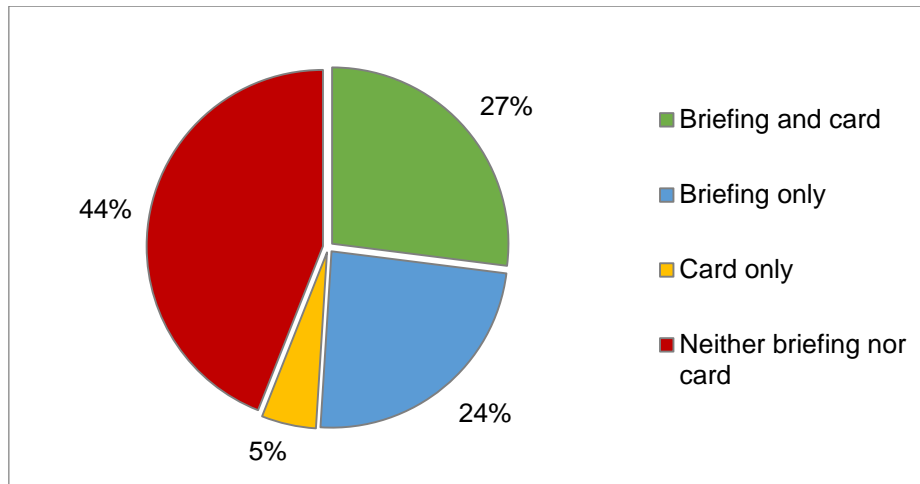
Figure 8.

According to a study<sup>17</sup> conducted by NTSB in 2000, 13 percent of polled passengers would completely disregard on-board safety demonstrations on a regular basis, while 48 percent would listen to at least 75 percent of the demonstration. The study has also revealed that most people seated in the emergency exit rows do not read the safety briefing card and almost half of all passengers (44 percent) would purposely ignore both the safety demonstration and the safety briefing card as well (Figure 8).
