MINISTRY OF
TECHNOLOGY AND INDUSTRY
TRANSPORTATION SAFETY BUREAU

FINAL REPORT

TOMI AX-8, HA-864

Vál, Aligvári dűlő, 5 September 2020

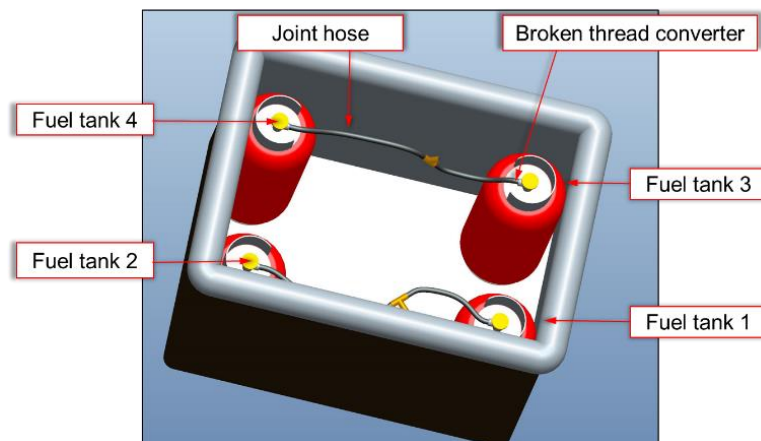
Figure 2: Arrangement of the fuel tanks in the basket

The hot-air balloon was equipped with a double gas burner. The fuel tanks were placed in the four corners of the basket, the tanks were connected two-by-two along the long side of the basket with fuel hose/manifold assembly (*Figure 2*) that were connected to the burner. The site surveys found that the hoses used were unnecessarily long and the fuel hose/manifold assembly connecting the fuel tanks was of unknown origin. None of the used thread adapters had specific markings or identification number or were part of the certified configuration. Their layout did not meet the professional standards or EU norms. One part of the fractured thread adapter connected to Fuel tank 3 (*Figure 2*) was found inside the flare nut of the joint hose, and the other in the connector of the fuel tank. Due to the location of the fractured part in the fuel system and the fracture surface, the IC ordered further analysis of the material (1.16). There was also another broken T-connector in the fuel system, which was analysed by experts during a material test ordered by the police.

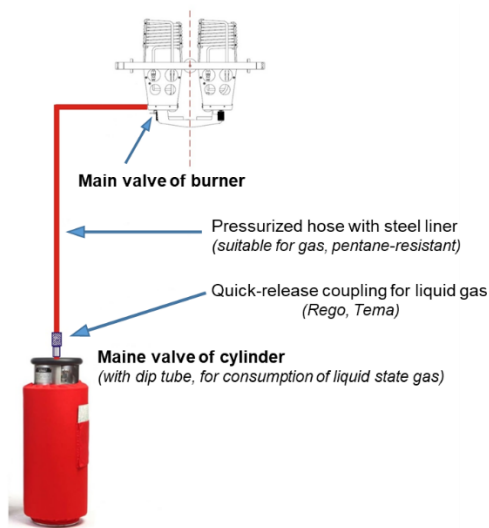
Figure 12: Direct feed

A possible method of fuel supply of hot-air balloons of this size is to use a direct feed system, i.e. without joint hoses. This system is equipped with one quick-release coupling for each tank, i.e. with only one possible source of malfunction (Figure 12).

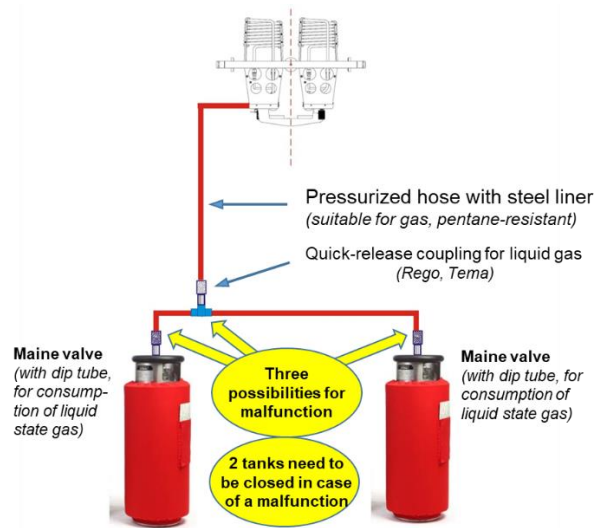
Figure 13: Use of a joint hose

Another option is to use a fuel hose/manifold assembly where more than one tanks are connected to the system through a fuel hose T-joint. In that case, replacement of a tank consists of simply shutting the empty tank and opening the full tank. However, that system contains three or more quick-release couplings, which entails three or more sources of malfunction (Figure 13).

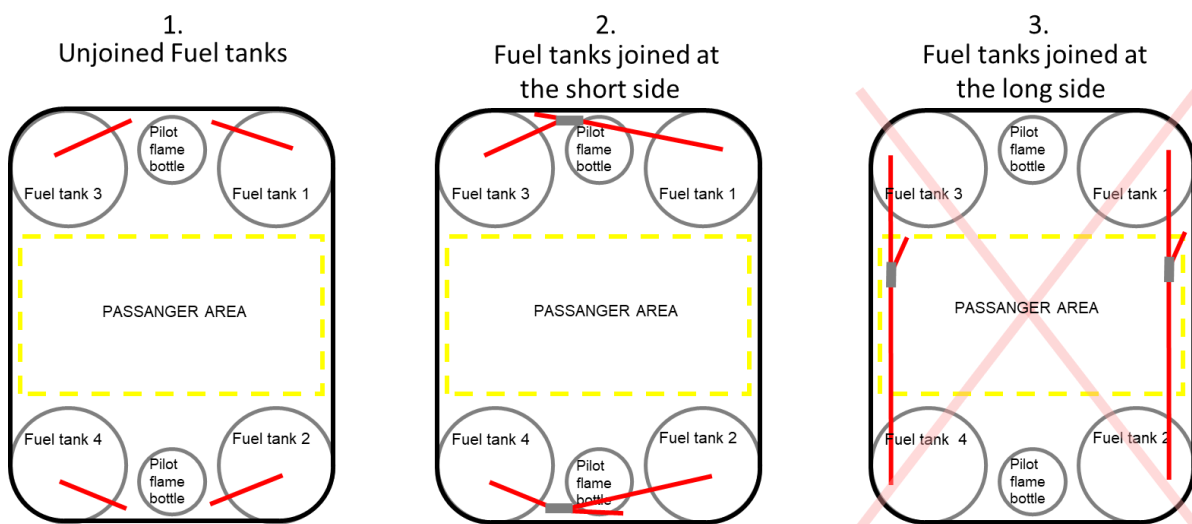
Figure 14: Fuel tank connection layouts

According to the manufacturer’s specifications, the lengths of the pressurised fuel hoses routed in the soft protective cover of the rods holding the burners are sized to reach the tanks by the shorter side, they should never reach other tanks situated by the longer side. The tank connections should face the shorter wall, i.e. they must be protected from inadvertent contact with either the crew or passengers. The hoses should be routed below the top frame of the basket, possibly in such manner that they should not project into the passenger space, thus minimising the risk of anyone bumping into a hose (*Figure 16*).

As a general rule, if a pilot uses a T-piece, the pilot may connect it at the short side, and never at the long side. This is also ensured by the short size of the fuel hose/manifold assembly (*Figure 14 2., Figure 15*Figure 14: Fuel tank connection layouts). If any fuel manifolds are used (although their use is optional) they must be inspected and tested against the same standards as fuel hoses.

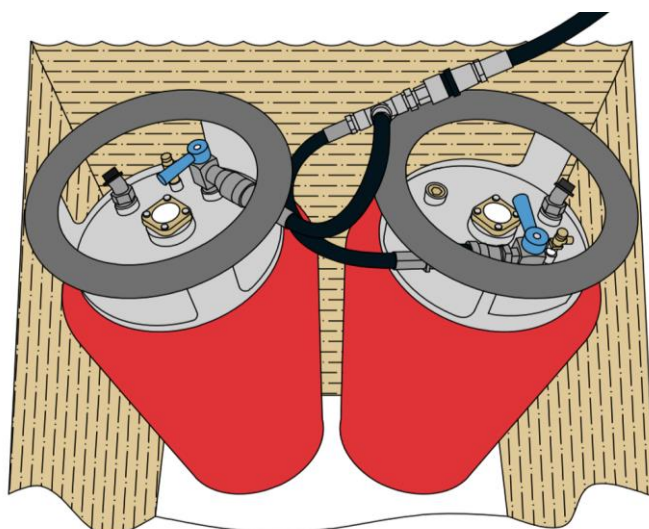
Figure 15: Application of a fuel hose/manifold assembly (Source: Schroeder Flight Manual)

By mistake, the pilot attempted to stop the gas flow by shutting off the valve (which was in off position anyway) of the tank № 3 connected to the jointed line, while the gas was actually flowing out of the tank № 4 through the T-joint (1.1, Figure 4, Figure 15). In the case of a less complicated system with no joint hoses, the supply to the flame could have been stopped by shutting the appropriate gas bottle.
