MINISTRY FOR
INNOVATION AND TECHNOLOGY
TRANSPORTATION SAFETY BUREAU

FINAL REPORT

2021-0195-4

Discus bT

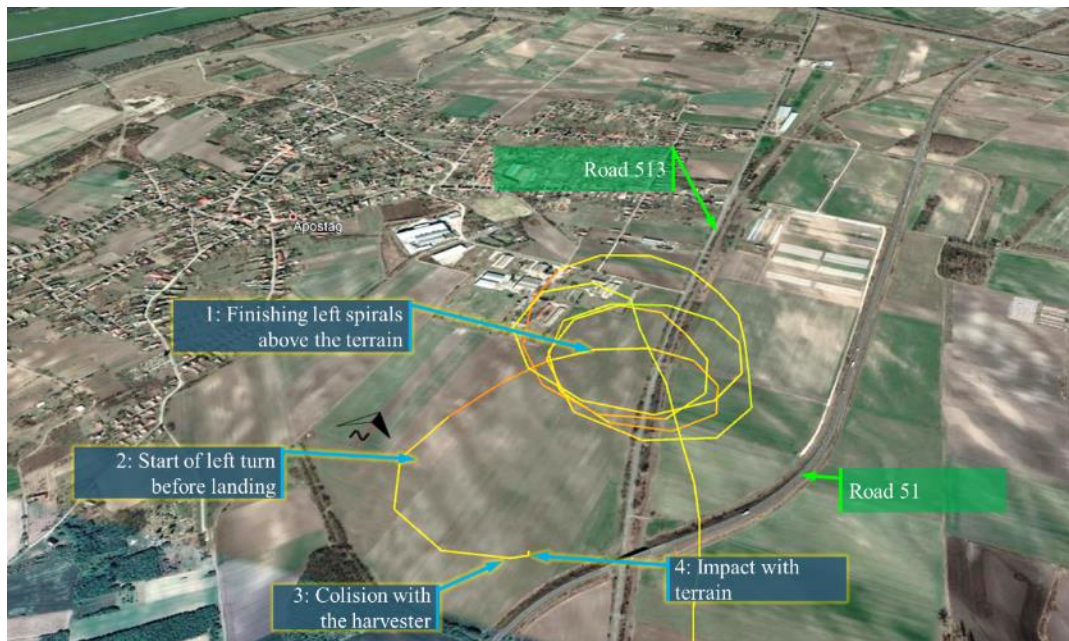
Figure 3: Flight of D-KIBT prior to the accident

At 17:00 at 139 meters over Dunaegyháza east the Pilot started his limping engine again, only to encounter a similar loss of power following 4 to 5 seconds of normal operation. Leaving the struggling engine on, the Pilot continued heading north while hardly maintaining altitude (90-130 meters) on engine power. At 17:04:58 he reached the south-eastern limits of Apostag at 117 meters AGL, where he started spiralling left in an attempt to gain altitude. He kept on trying for nearly 3 minutes while he was continuously losing altitude and only abandoned spiralling at 28 meters AGL (*Figure 3, 1*). The Pilot then rolled out, heading for the southern edge of his intended landing stretch in crossing tailwind, while he shut down the engine and initiated the stowing sequence. At 17:08:18, reaching the end of his intended landing strip at 8 meters over the ground, the Pilot engaged in a left turn to line up for landing (*Figure 3, 2*). During the turn, at 17:08:, the aircraft hit a combine harvester at work in the field, with the landing gear snagging at the harvester's grain hold doors (*Figure 3, 3*). The aircraft then impacted the ground nose first and came to a halt across the harvester (*Figure 3, 4*).

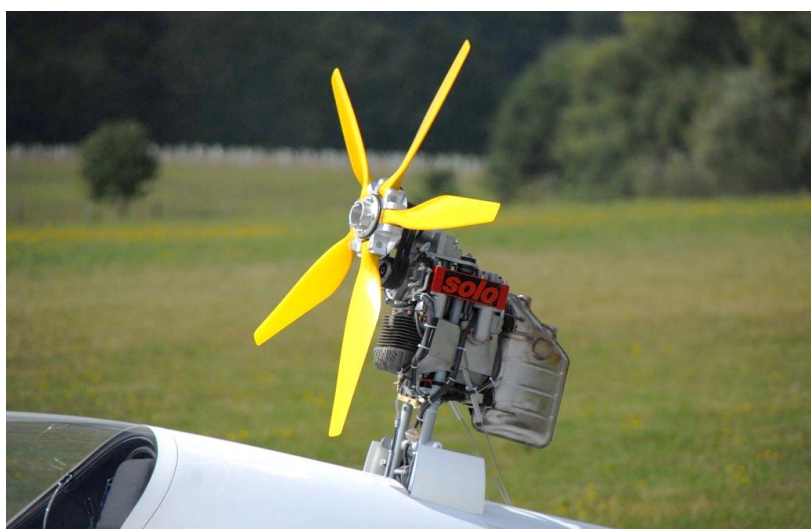
Figure 6: Solo 2350 engine (source: <https://www.schempp-hirth.com>)

Category	two-stroke, two-cylinder gasoline engine
Engine manufacturer	SOLO-Kleinmotoren GmbH
Type	SOLO 2350 (<i>Figure 6</i>)
Serial number	382
Hours / cycles flown	
Total	148 hours
Since overhaul	N/A
Since last inspection	7 minutes

On removal of the engine it became apparent that the locking nut on the front decompression valve was missing and the decompression valve on the rear cylinder had run loose. The valve stem threads were intact on both valves, the rear valve could be tightened. No damage was found on the valve sealing surfaces. The spark plug in the rear cylinder was partially fouled, indicative of insufficient fuel burn. Spark testing this plug still yielded a passing result.

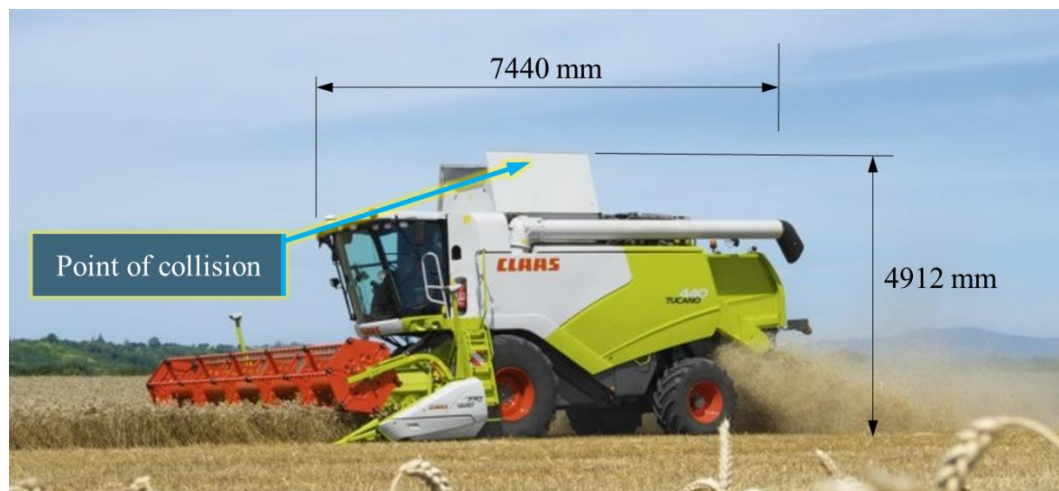
Figure 13: Claas Tucano 440 harvester (source: <https://app.claas.com>)

The combine harvester's grain hold doors and their hinges were damaged on impact with the glider.

The agricultural equipment involved in the accident was a Claas Tucano 440 combine harvester, its dimensions with open grain hold doors are shown in *Figure 13*.

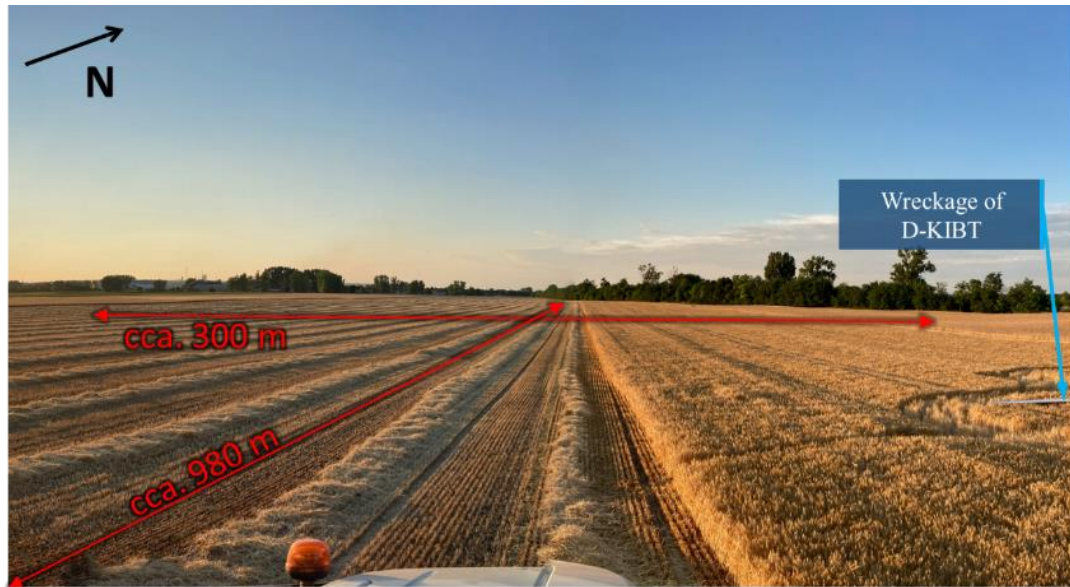
Figure 14: The dimensions of the landing site available

Although engine issues also contributed to the accident, the IC found human factor as the root cause of the accident. Sustainer engine failure or loss of power must not directly and unavoidably result in a hull loss and severe personal injury; especially in terms of a high performance glider aircraft.

As apparent from this accident, in a non-standard situation even an experienced pilot can get confused and mess up his prioritisation and situational awareness.
