FINAL REPORT

MOONEY M20M, N999U

28 September 2021

2021-0436-4

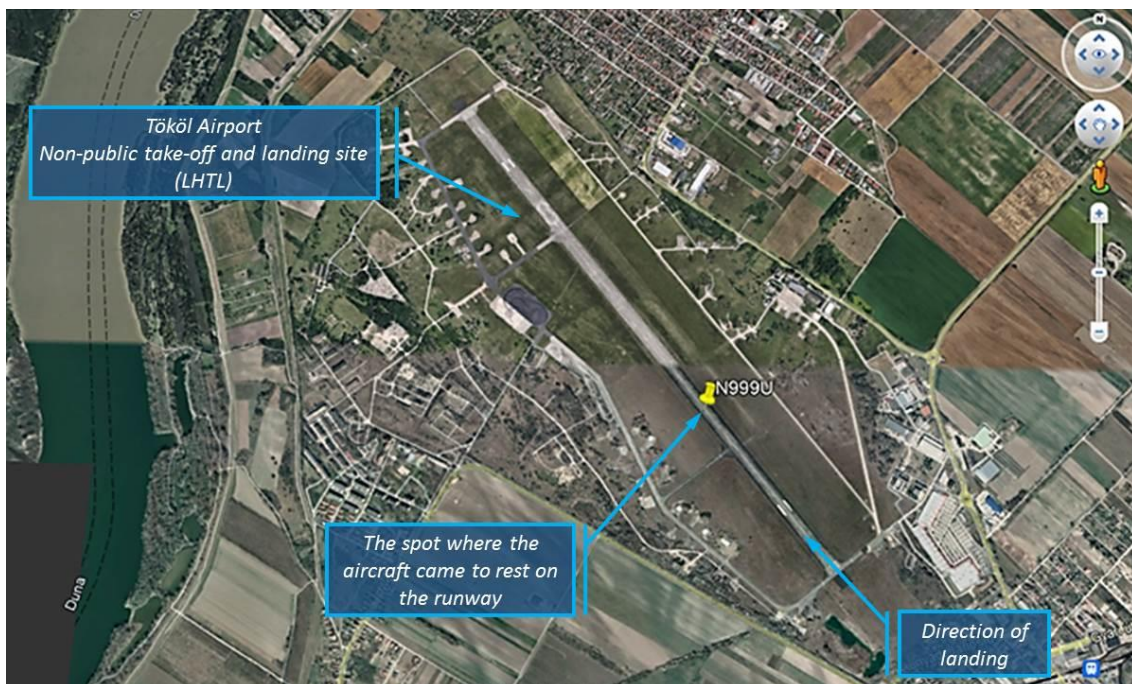
Figure 3: Tököl Airport non-public take-off and landing site, as well as the direction and spot of halting of the aircraft concerned at the airport (Source: google.com/map)
