MV NATISSA

An unlucky
River sea trader

A CHAPTER OF ACCIDENTS

E- MAIF 30-31 march 2009 – BUDAPEST

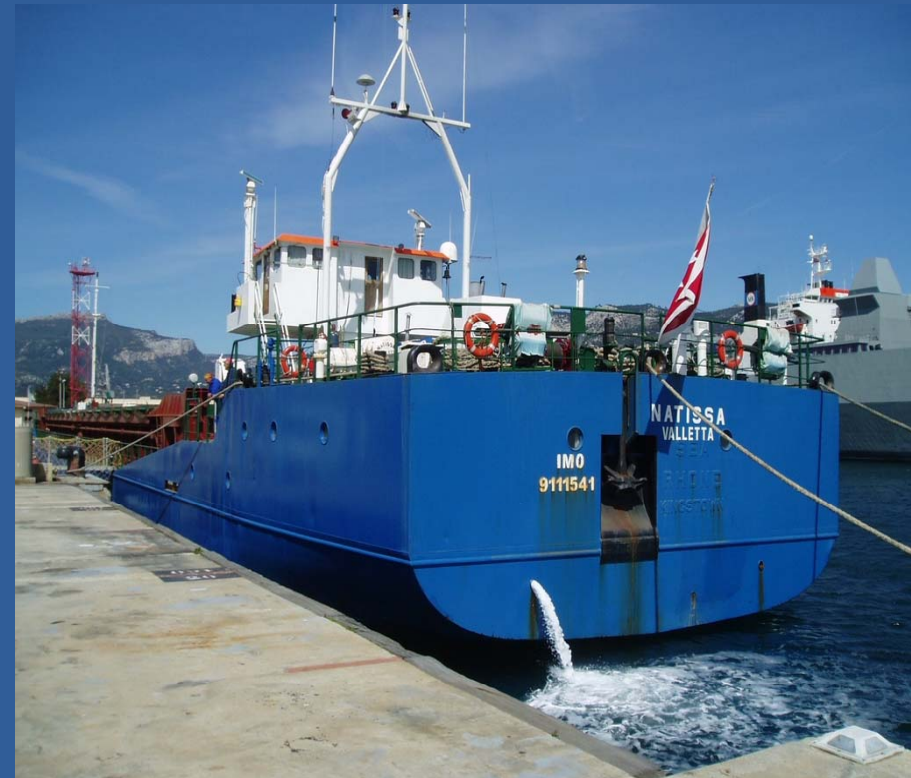
- Built in Hull (UK) in 1995
- Length: 81,6 m
- Width : 11,30 m
- Depth : 24,6 mm
- Draught : 5,3 m
- Freeboard : 1617 mm
- Tonnage : 1554 UMS
- Capacity: 1917 MT
- Speed : 10 knots
- Telescopic wheelhouse

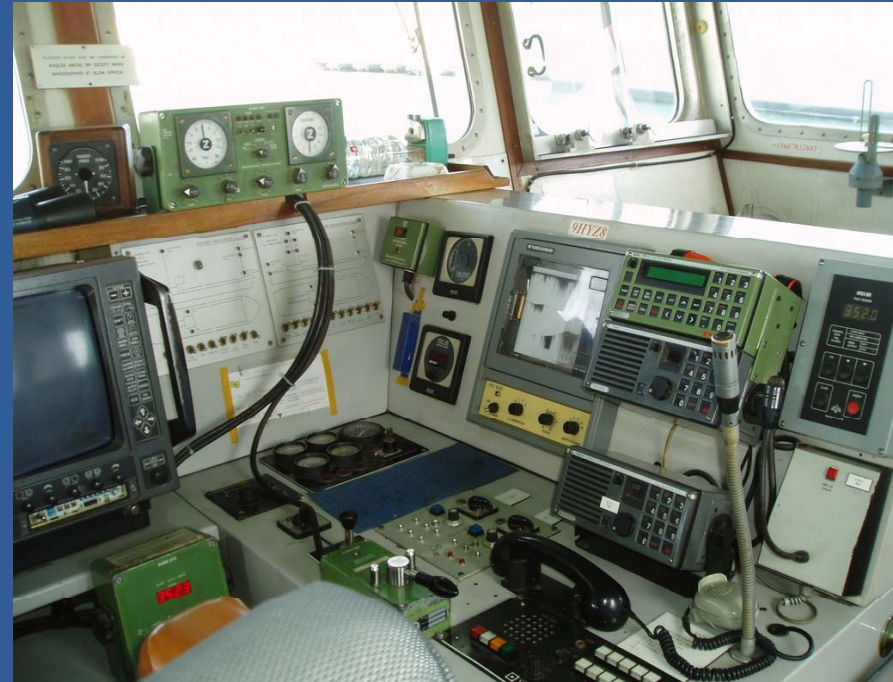
The bridge on starboard side
