Collision of Eurocity train No. 108 with an obstacle (fallen bridge structure) in Studenka station

The Rail Safety Inspection Office

Accident basic data

Date and time: 8th August 2008, 10:30:27

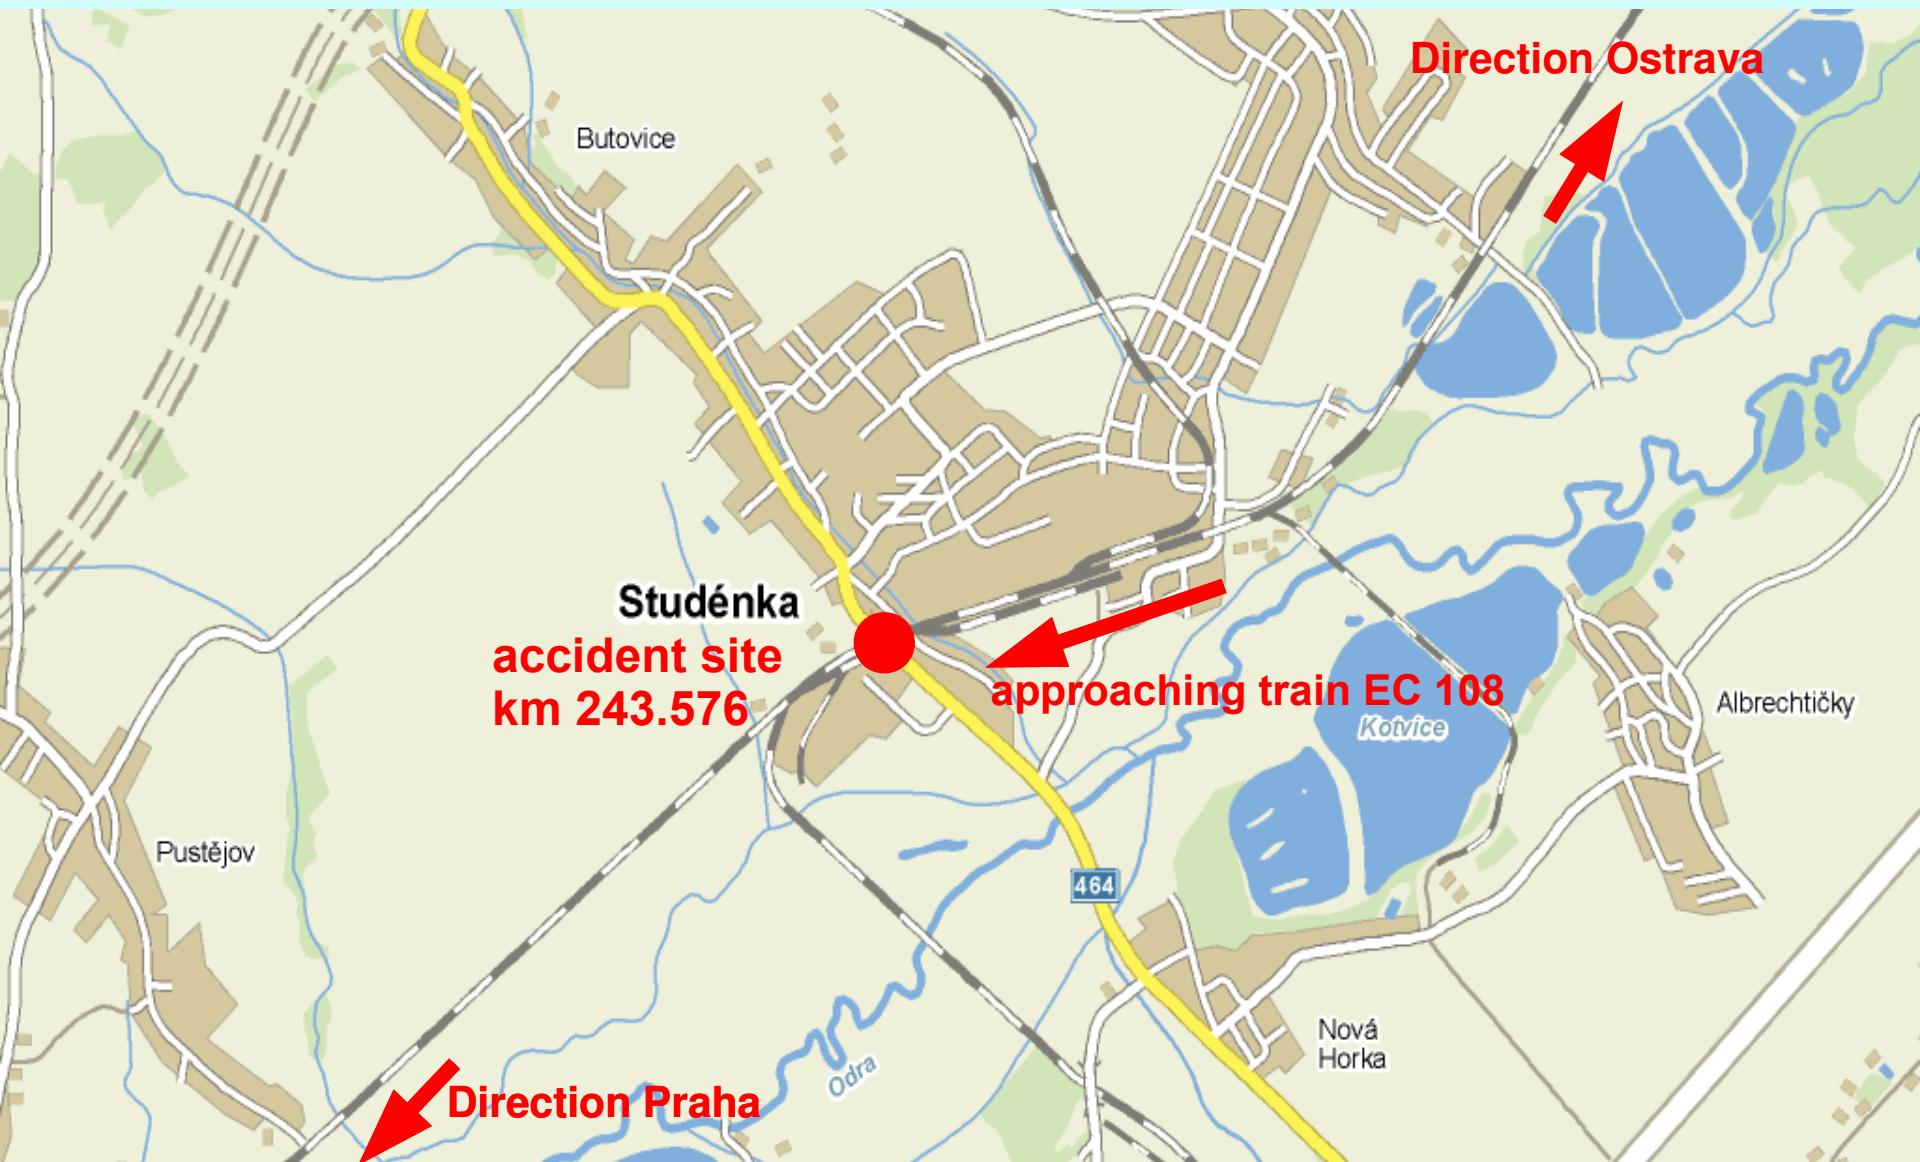
Accident site

A road bridge above the station collapsed just in front of approaching Eurocity train No. 108. The train collided with the ruins of the bridge and derailed. 4 derailed carriages consequently collided with a stationary goods train, causing derailment of 3 wagons of the goods train.

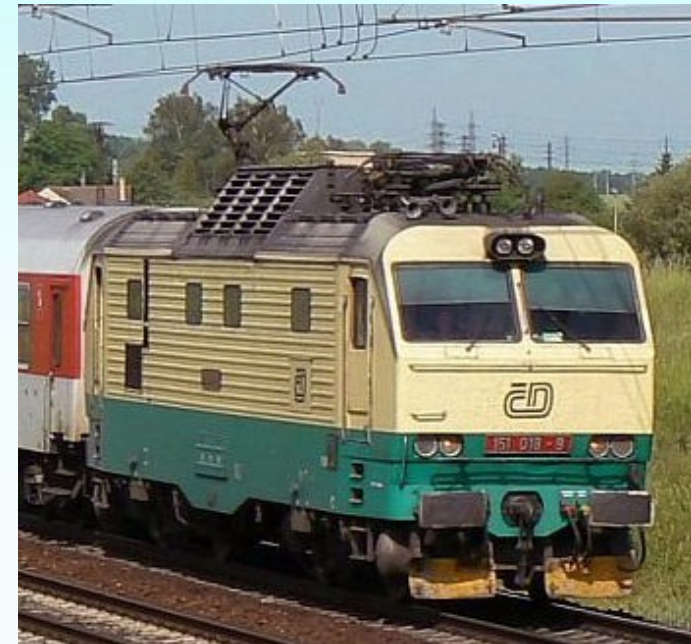
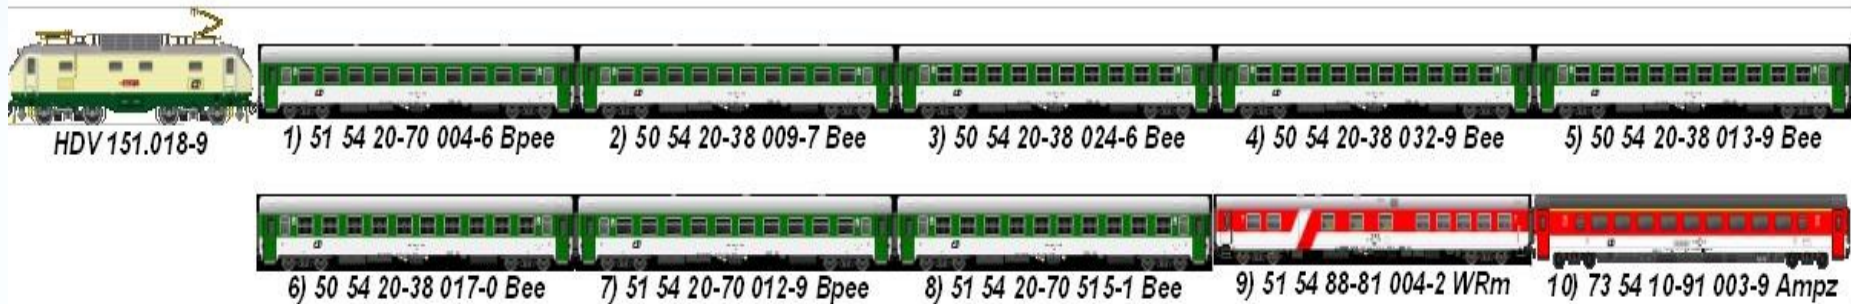
EC 108 „Comenius“

- ★ locomotive 151.018-9
- ★ 10 passenger carriages with the passengers
(classes: Bpee, Bee, WRm, Ampz)
- ★ length 266 m
- ★ mass 539 t
- ★ cca 400 passengers
- ★ from Kraków (Poland) to
Praha hl. n. (Czech Republic)

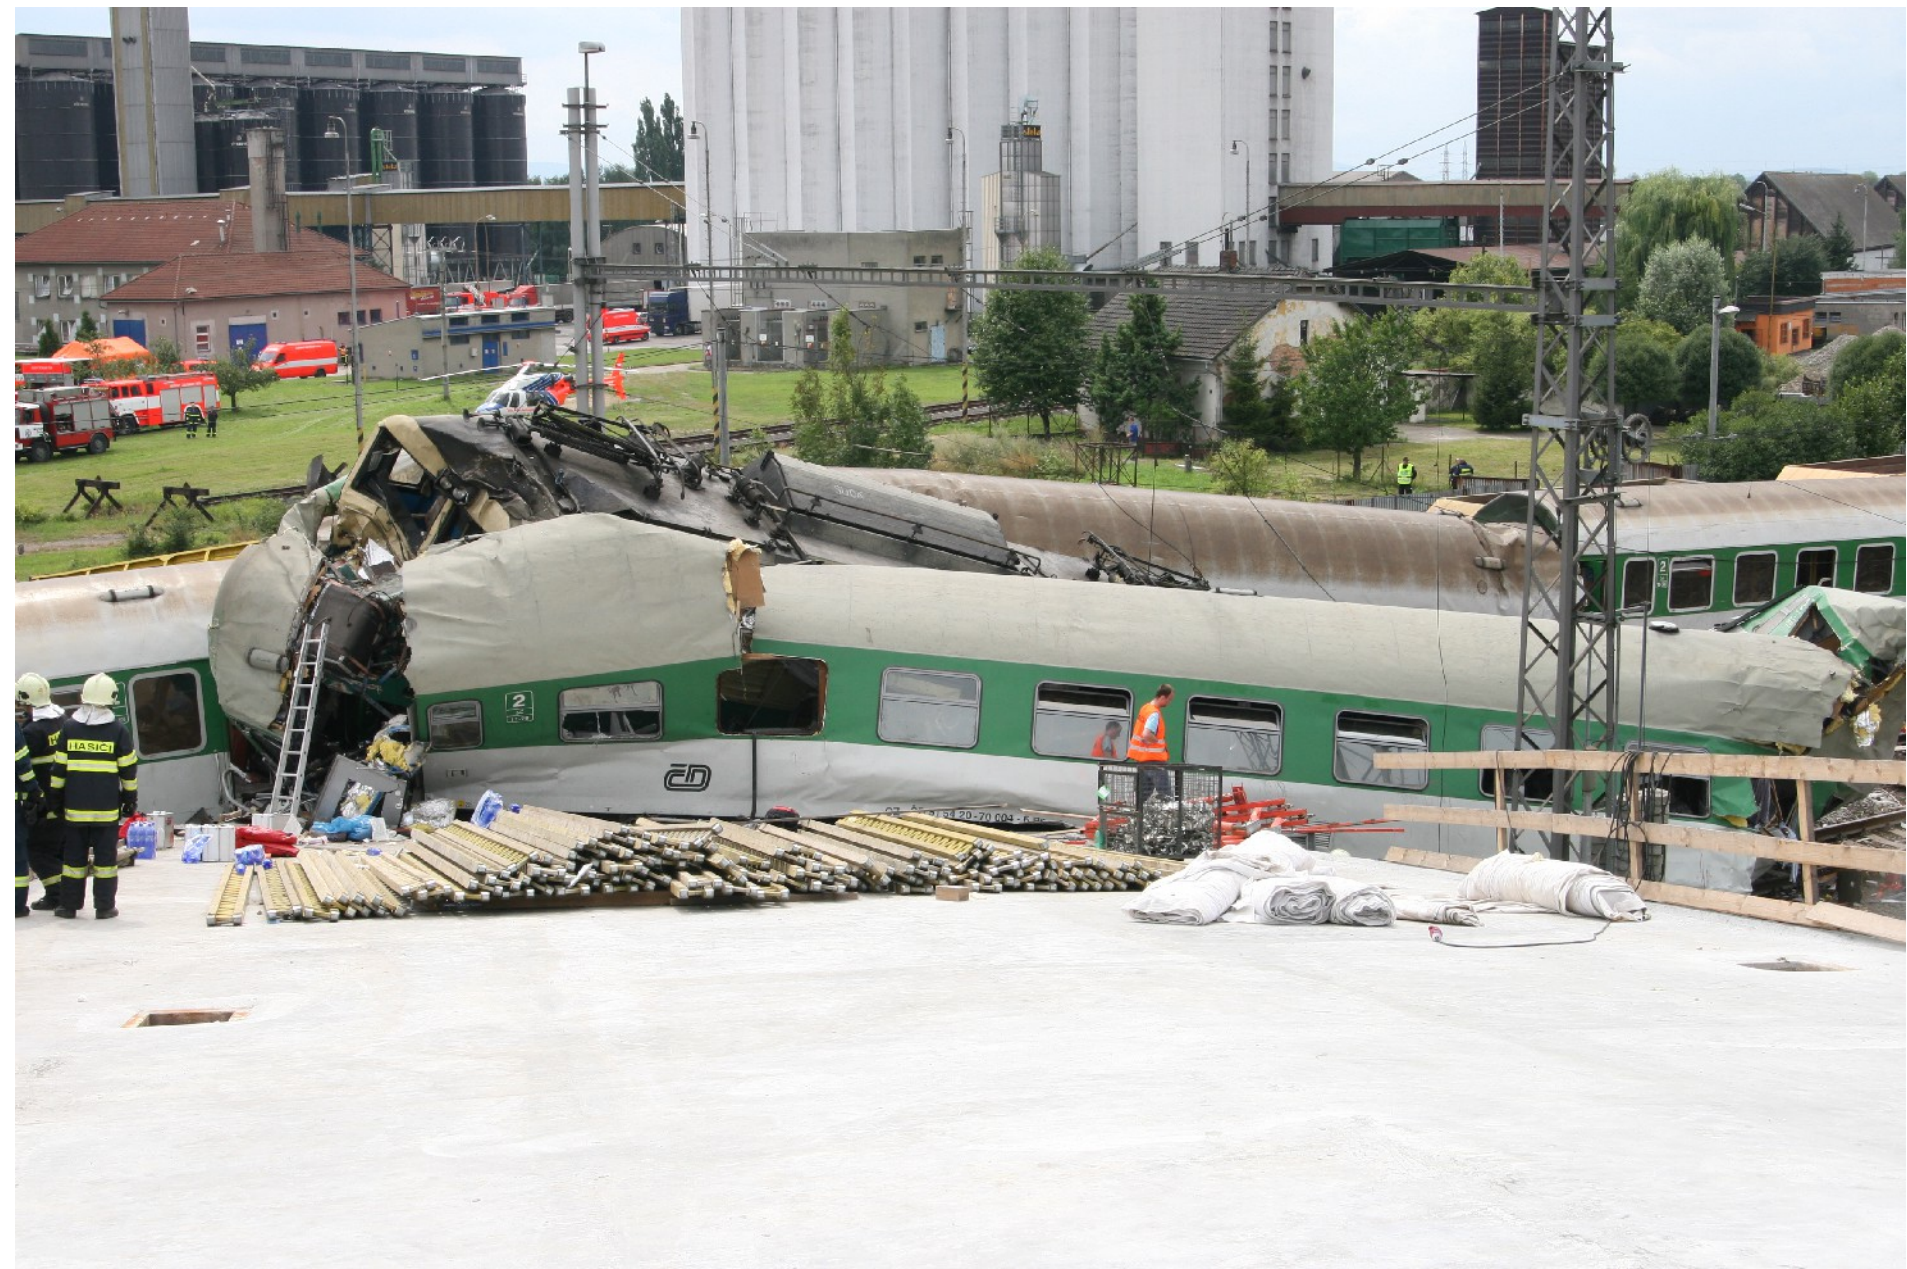
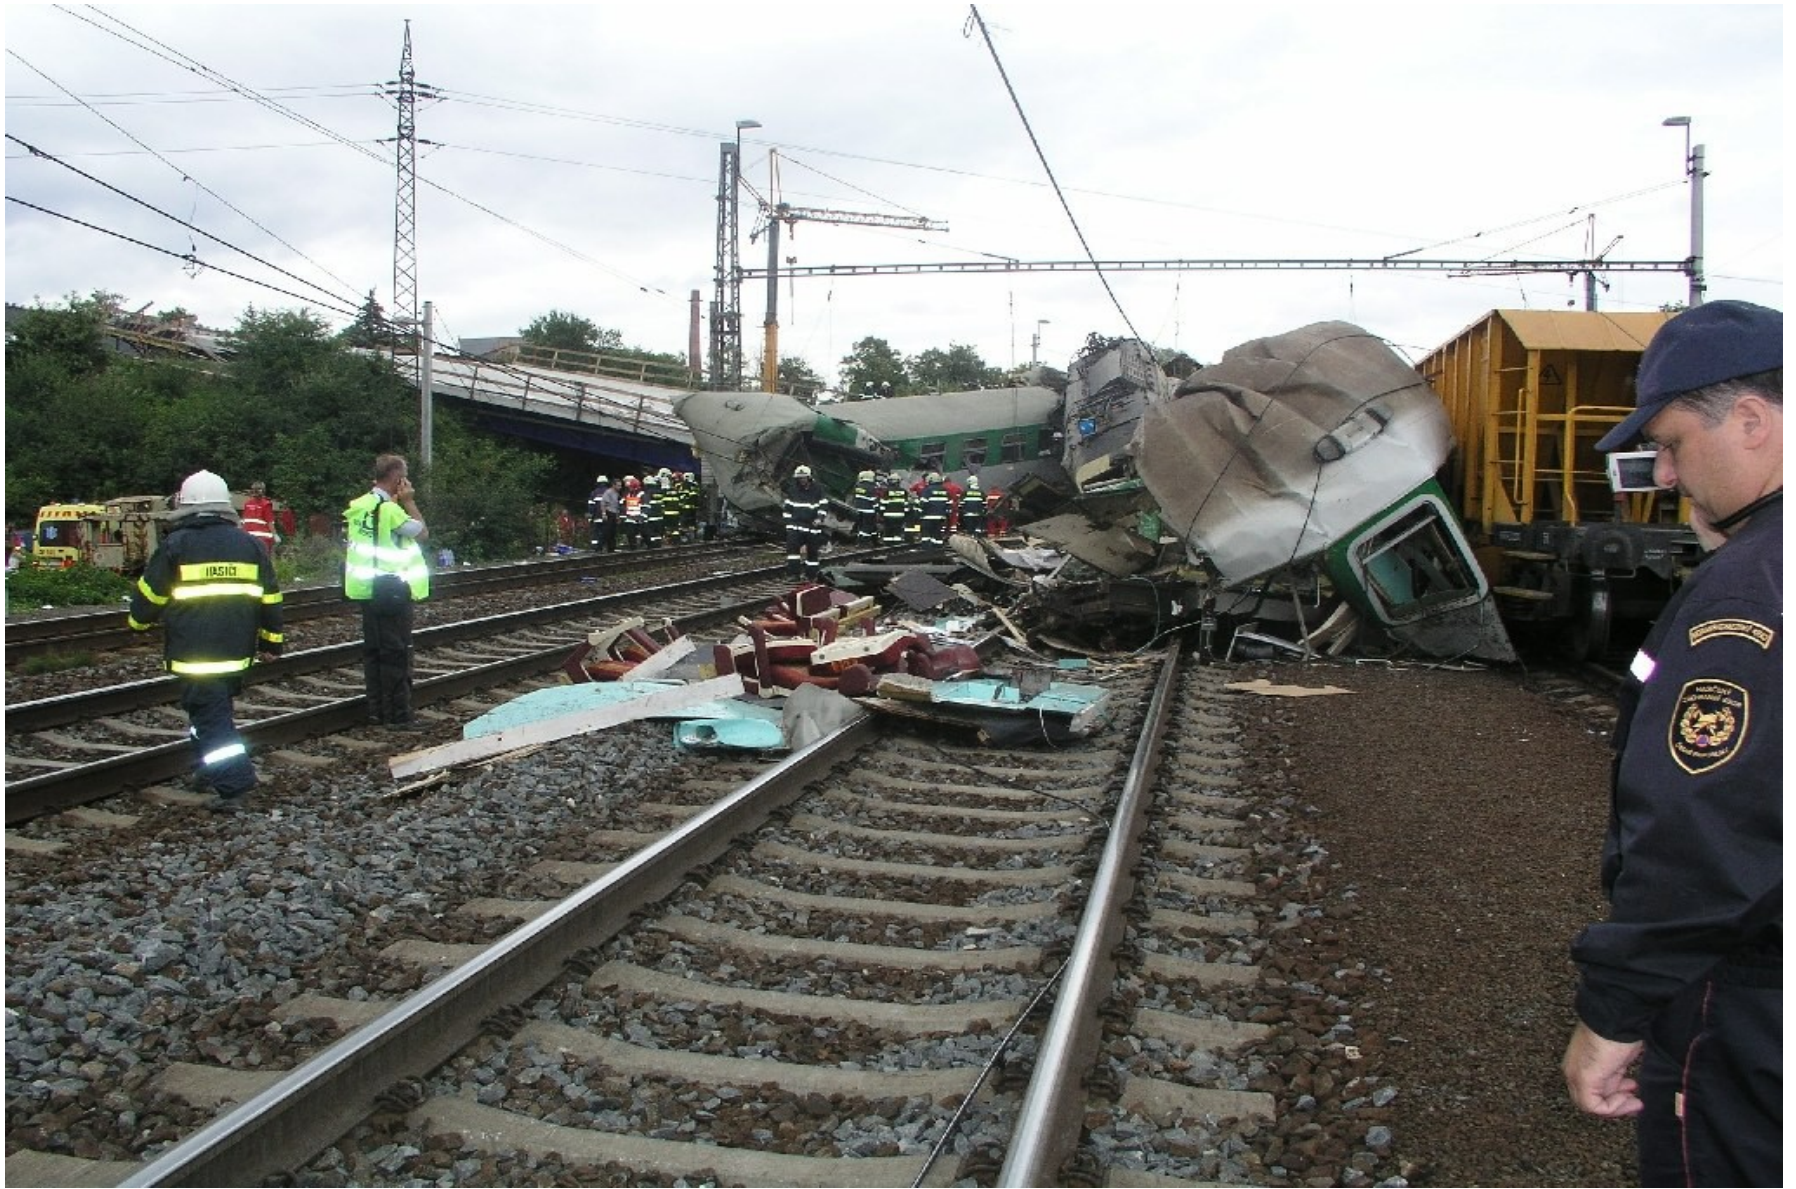
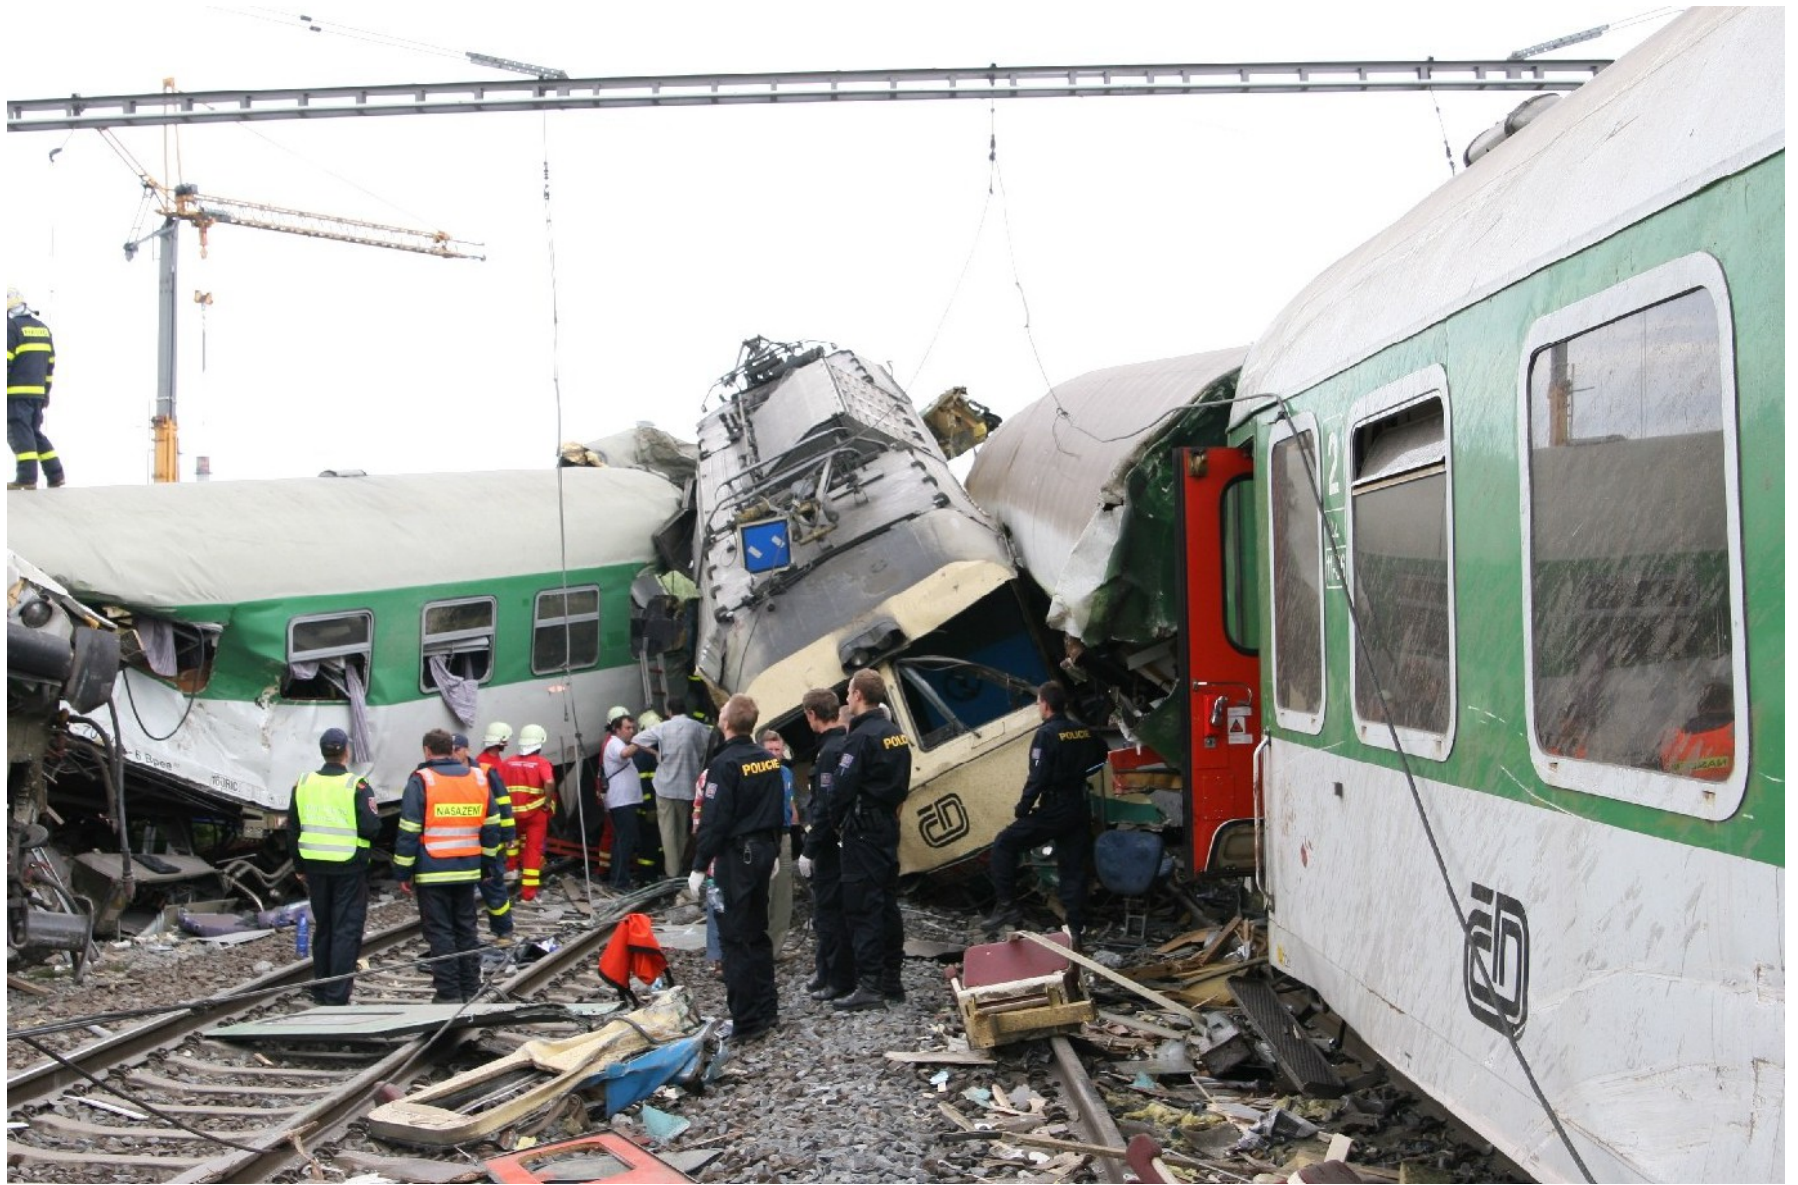
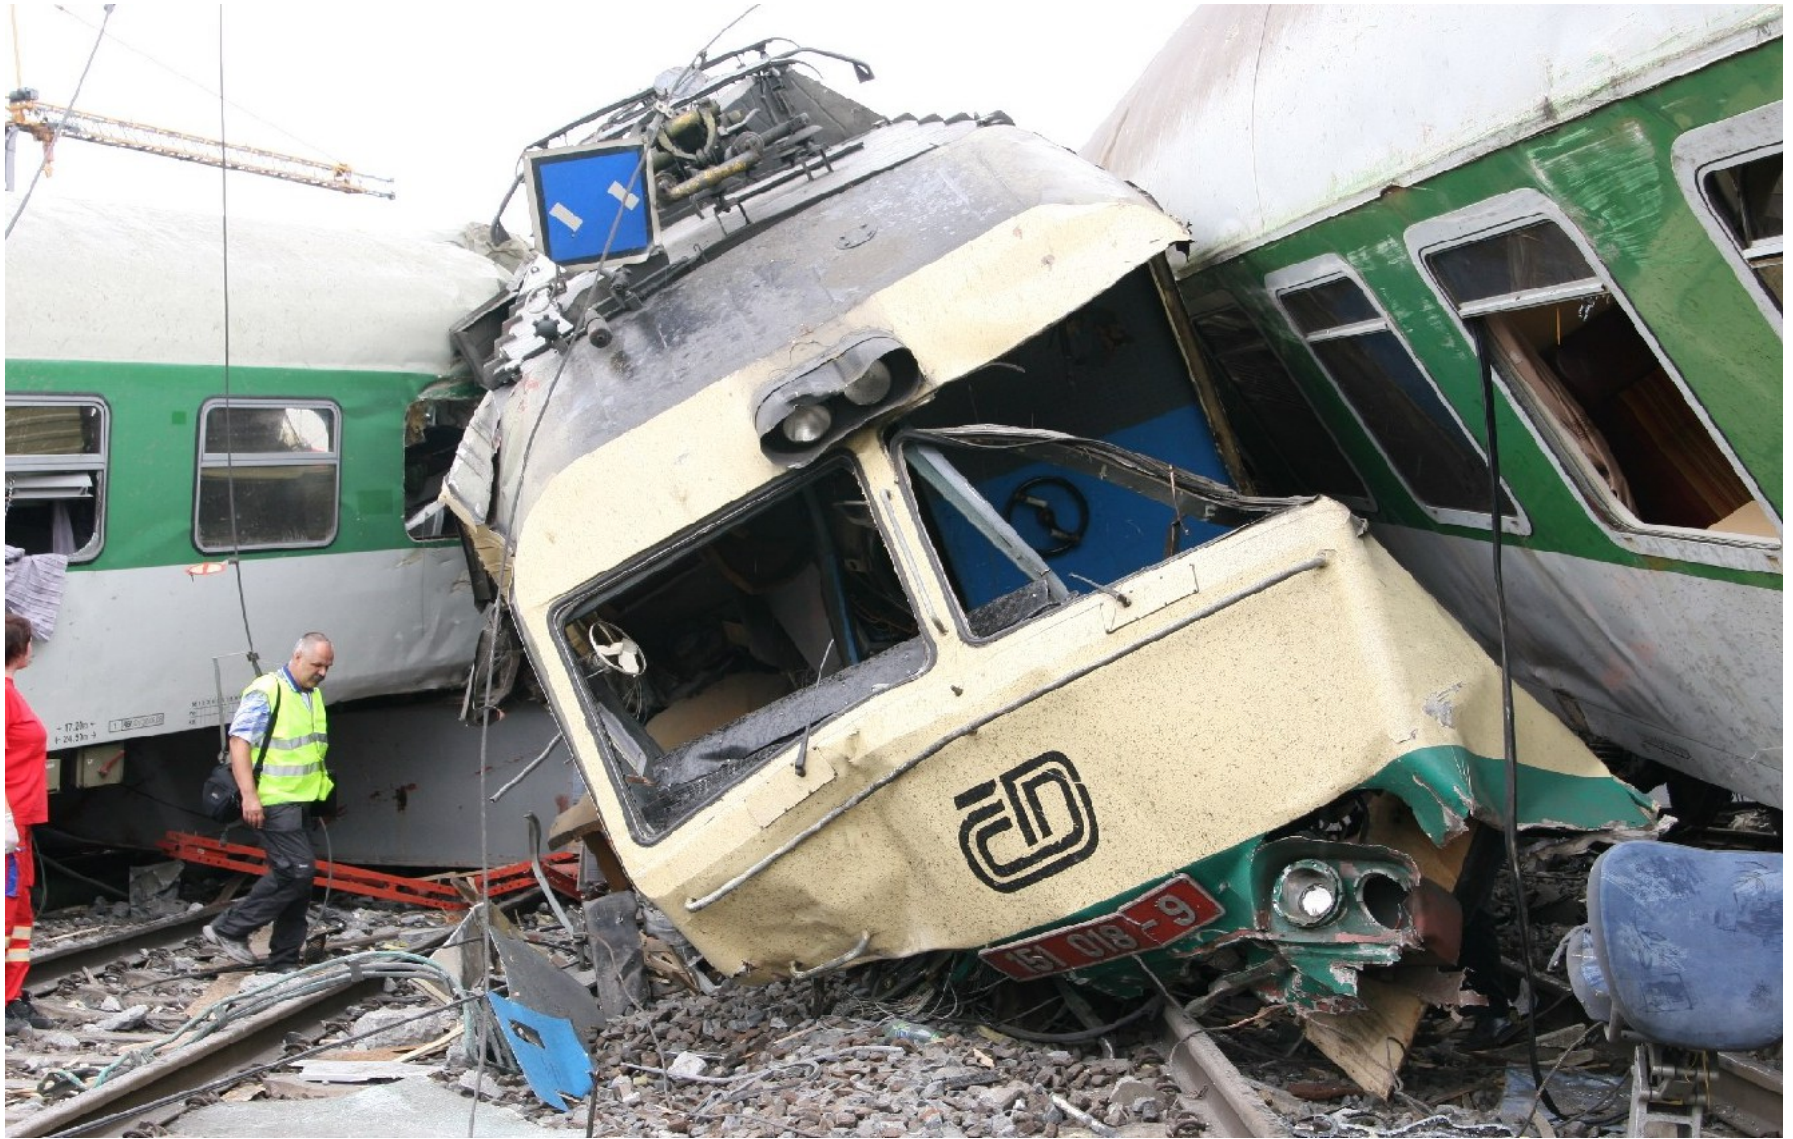
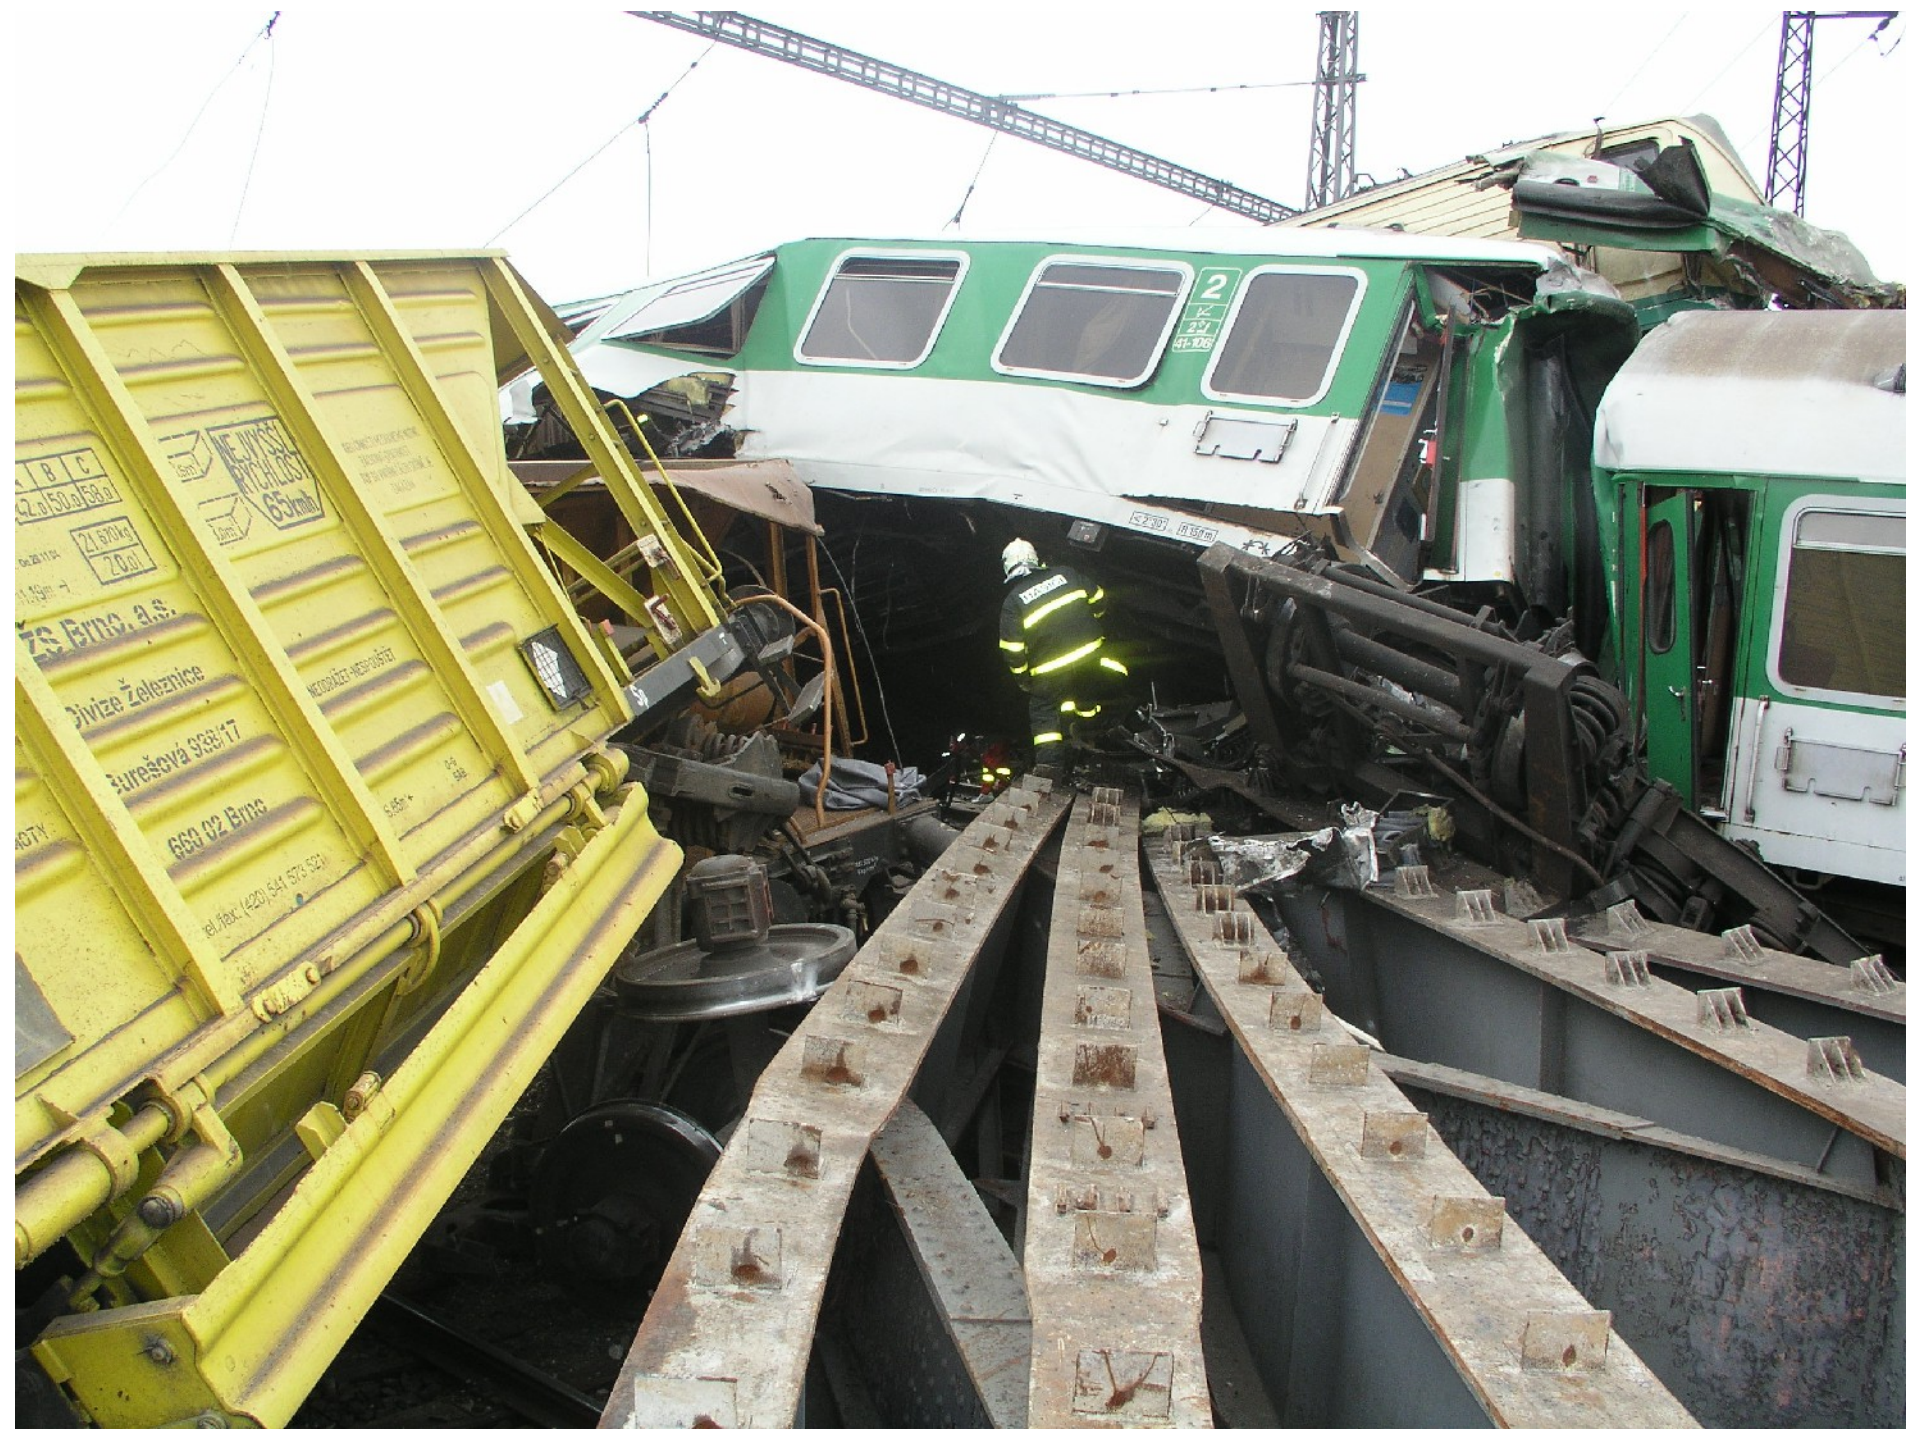
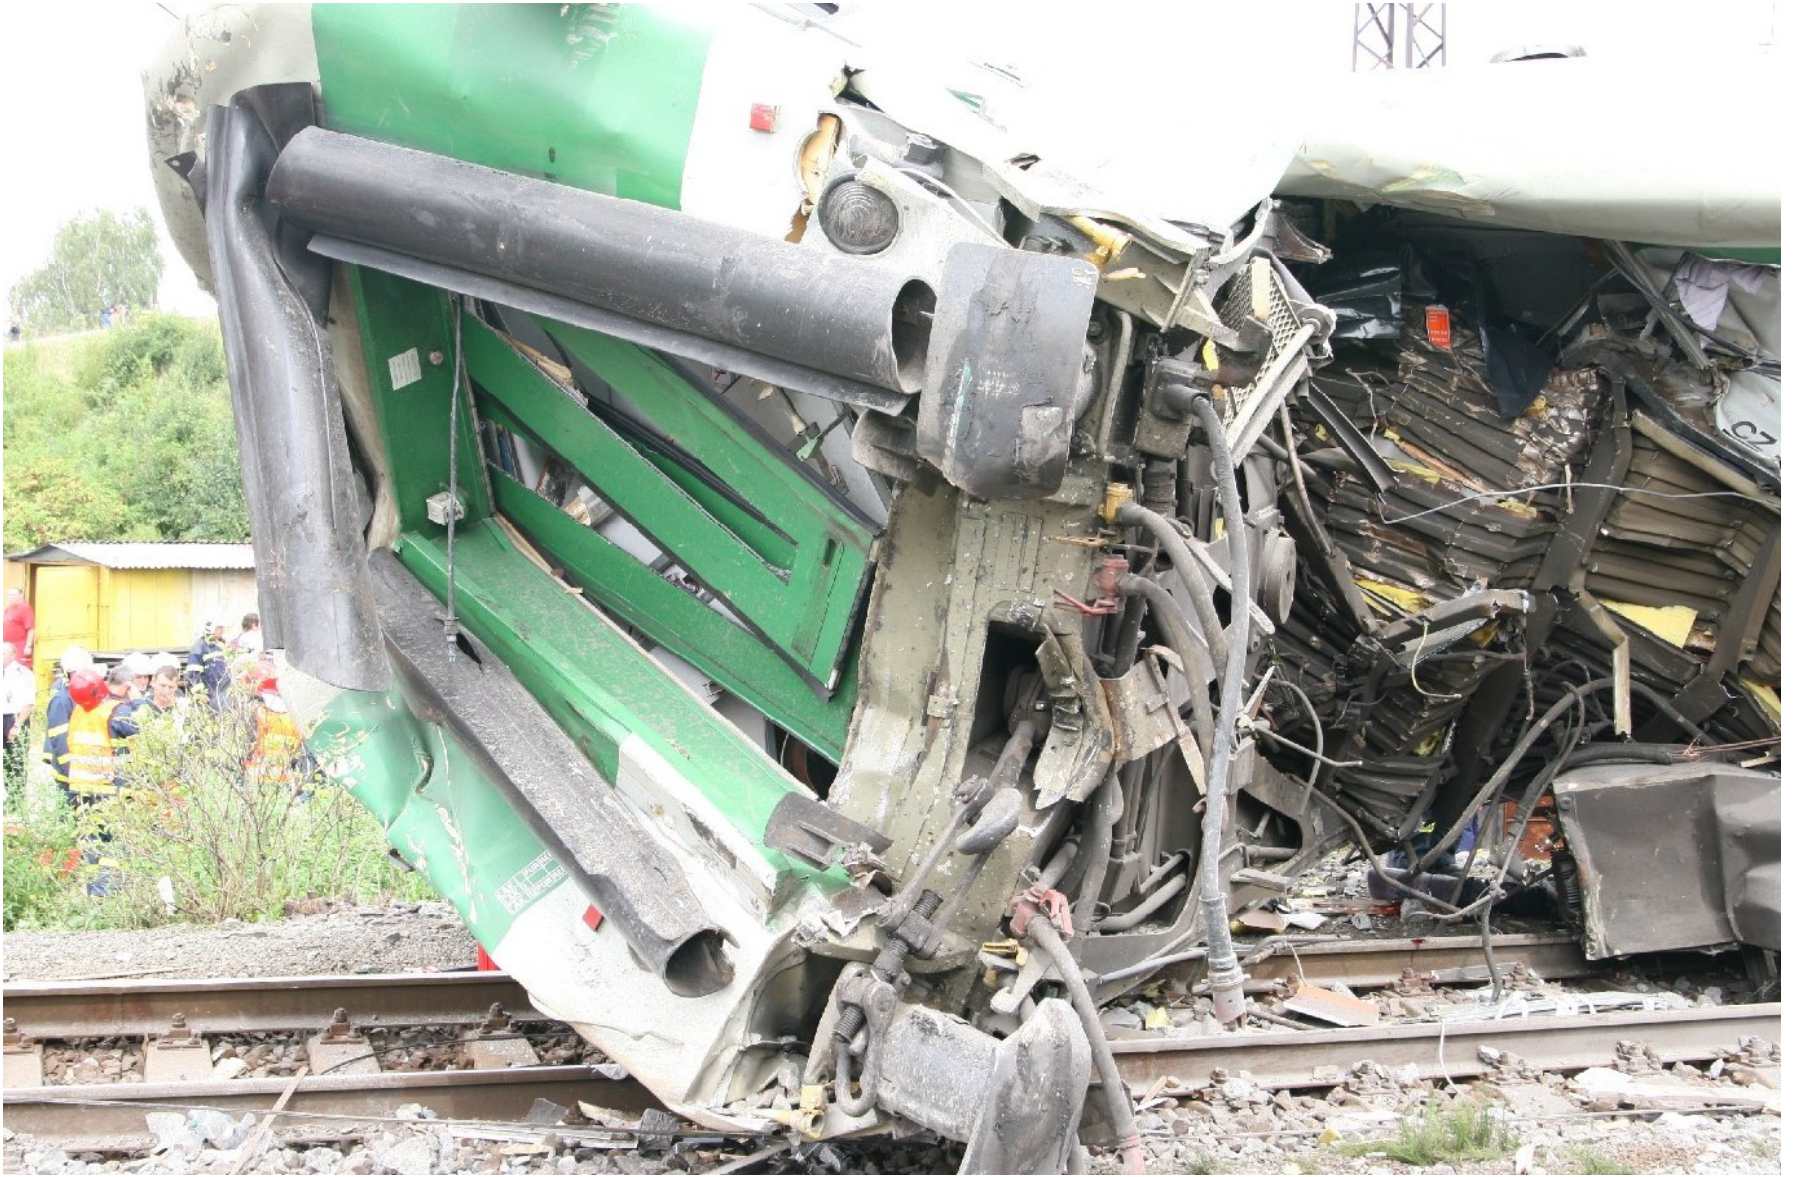
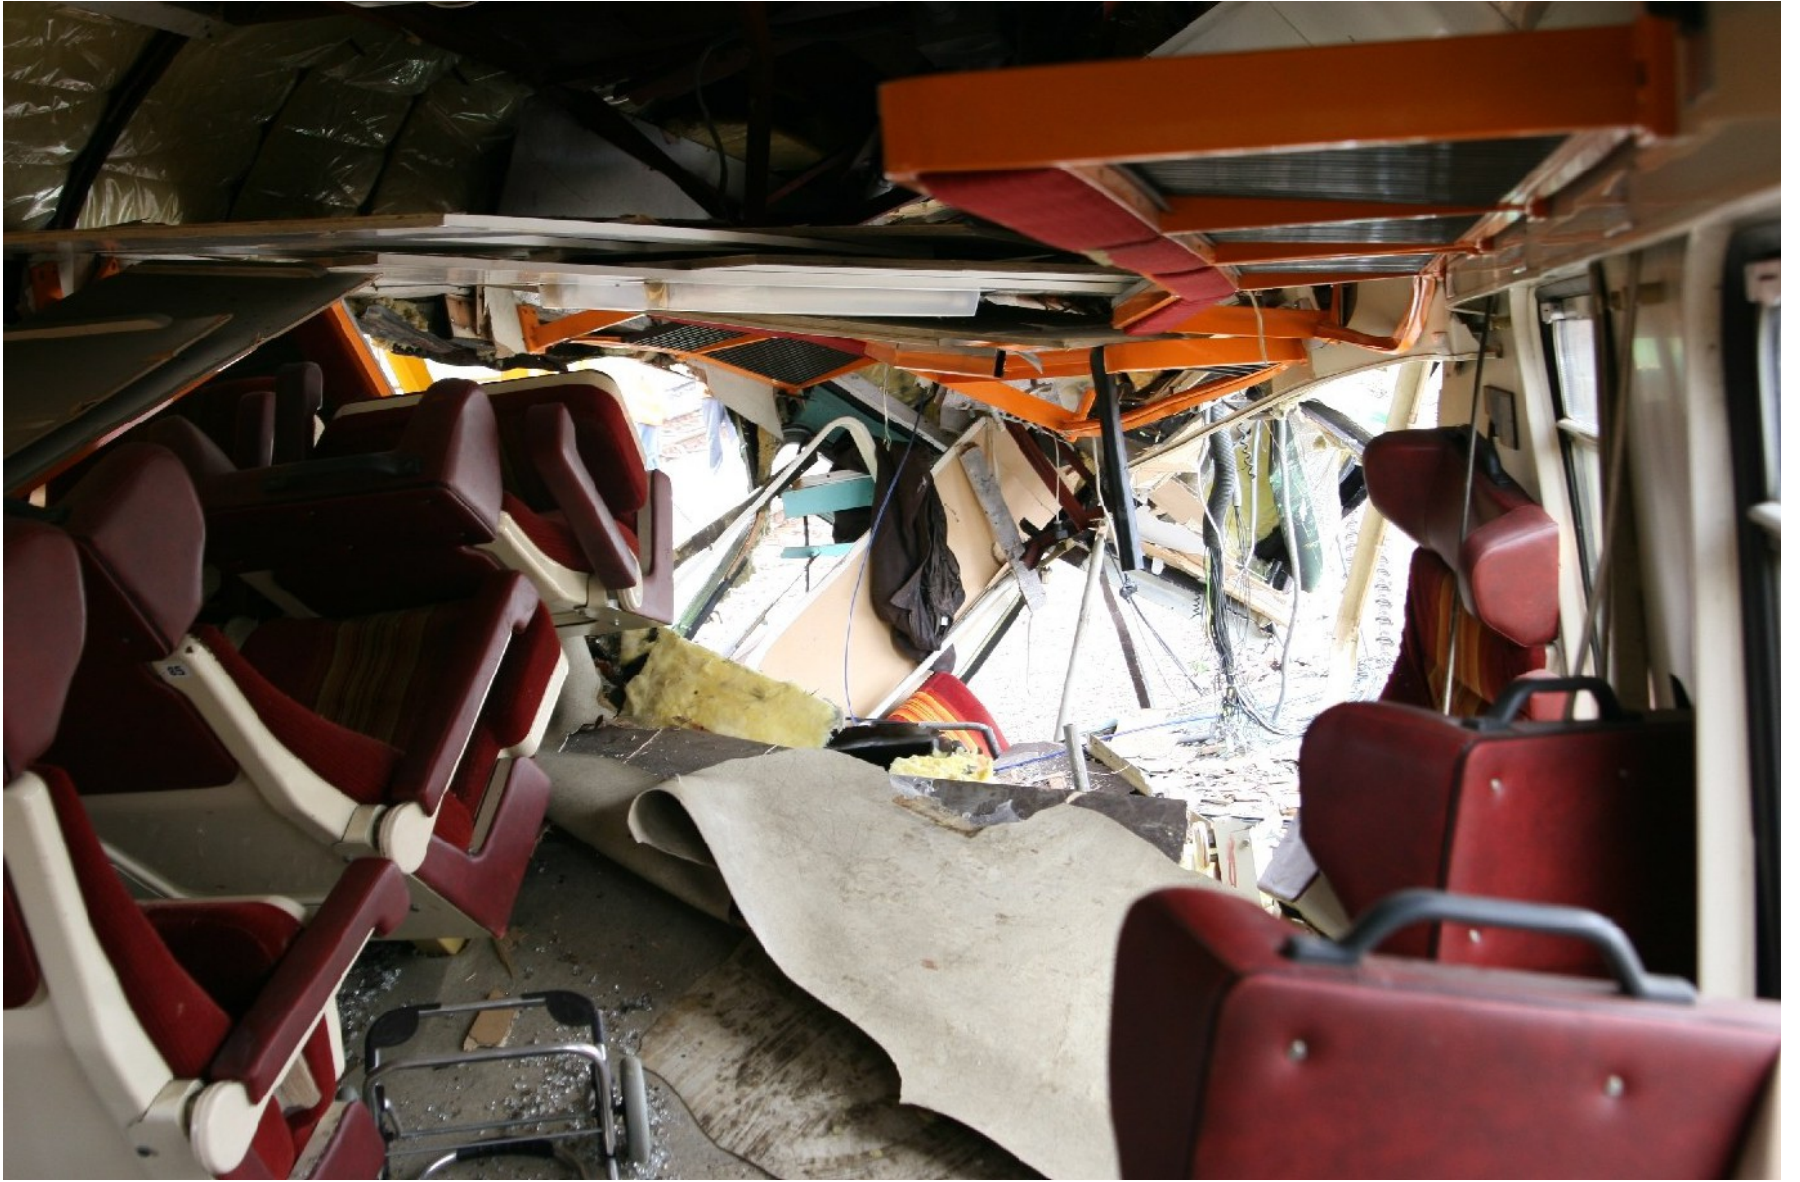
Fatality:	7 + 1 passengers (1 died after 30 days)
Injuries:	84 passengers 4 staff (engine driver + 3 train crew)
Damage:	CZK 62 458 840,11 (2 500 000 EUR)
Totally destroyed:	locomotive (class 151) 3 carriages (classes Bpee and Bee) 3 wagons (class Faccp)
Damaged:	1 carriage (class Bee) 2 wagons (class Faccp) 288 m of track (tracks No. 101-105) 982 m catenary (tracks No. 101-105) steel concrete bridge construction
