FINAL REPORT

2012-159-4P SERIOUS INCIDENT

Budapest FIR – Bugac area 11 June 2012

Bombardier CRJ900 / Airbus A320 D-ACKC / OE-LEU

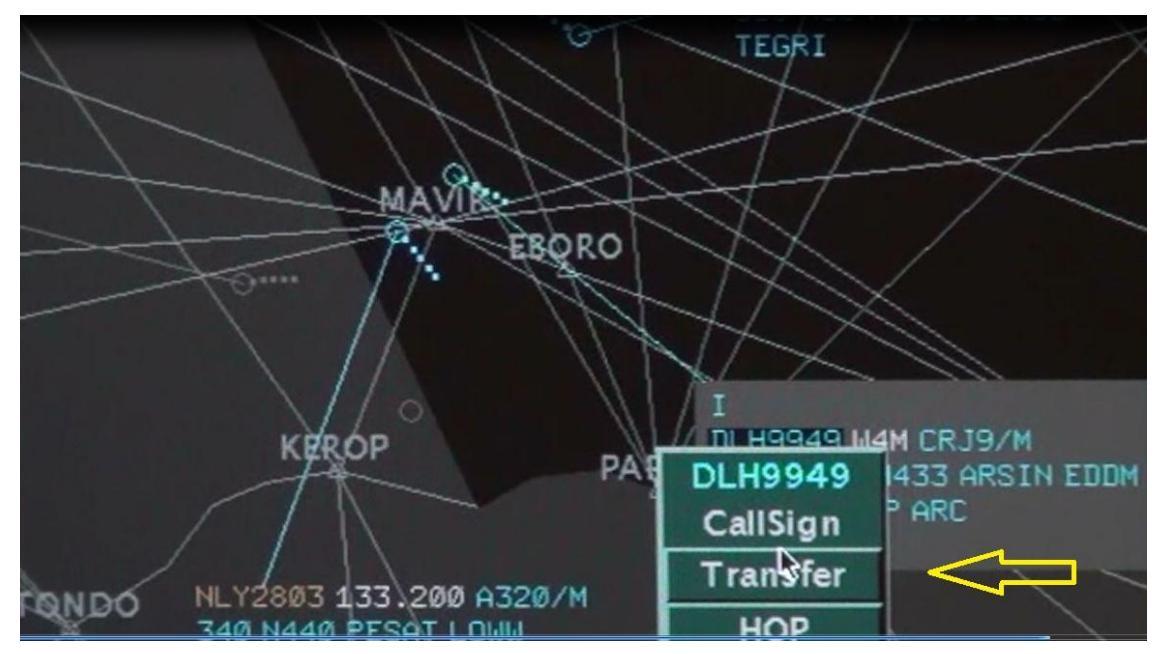
EL EC screen: EL EC initiates handover of DLH9949 to WL with TRANSFER

DLH9949 asked for confirmation of the new frequency but she did not acknowledged the new approved altitude. At this point the aircraft was in climb, and her altitude of FL324 corresponded with her creared altitude.

At the time of the frequency switch (E-39 sec) the Pilot Flying of DLH9949 set FL360 on the Autopilot Control Panel. \checkmark

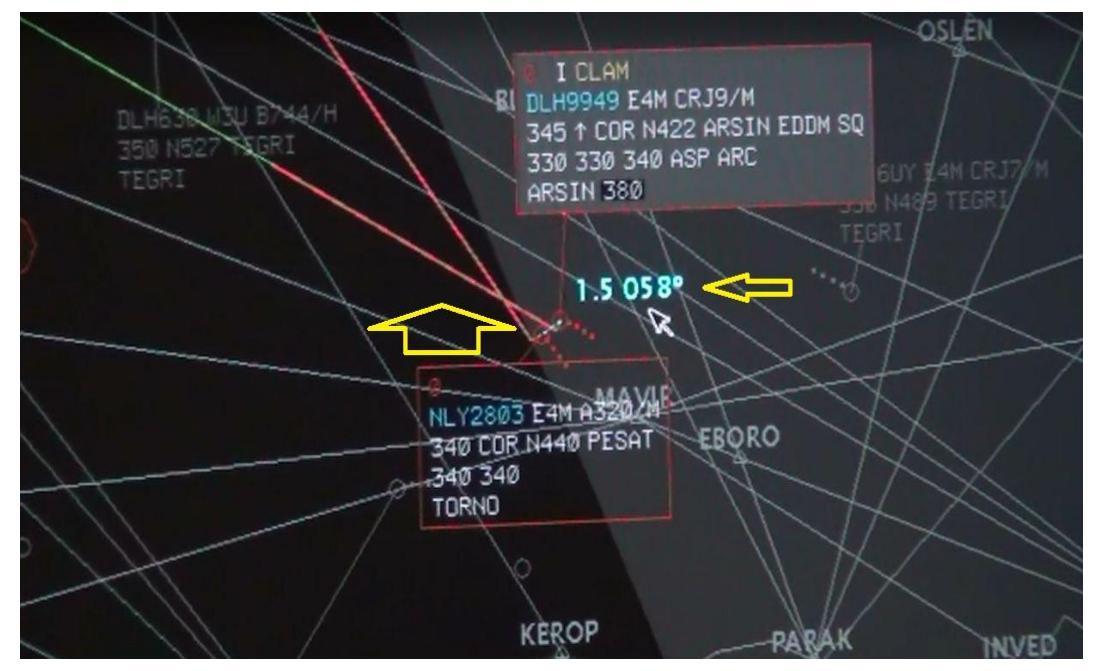
NLY2803 asked WL EC at 13:56:10 (E+10 sec) if he knew about another traffic at 1 o' clock from her. The controller replied that he just noticed it. He also measured the distance between the two aircraft on the radar screen using the QDM function.

WL EC screen: WL EC measures the actual and calculated distance between DLH9949 and NLY2803 using QDM function

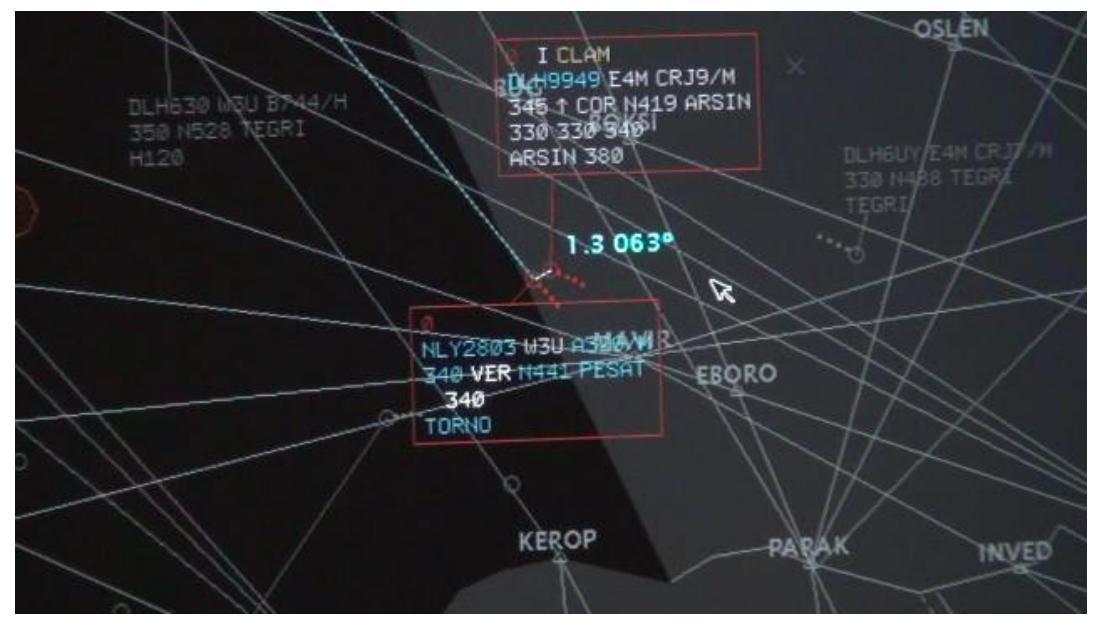
At the same time the captain of DLH9949 járat saw another aircraft (most possibly NLY2803) approximately 600-700 feet below, on a crossing route.

WL EC screen: Position of DLH9949 and NLY2803 at the moment DLH9949 could be raised on radio again

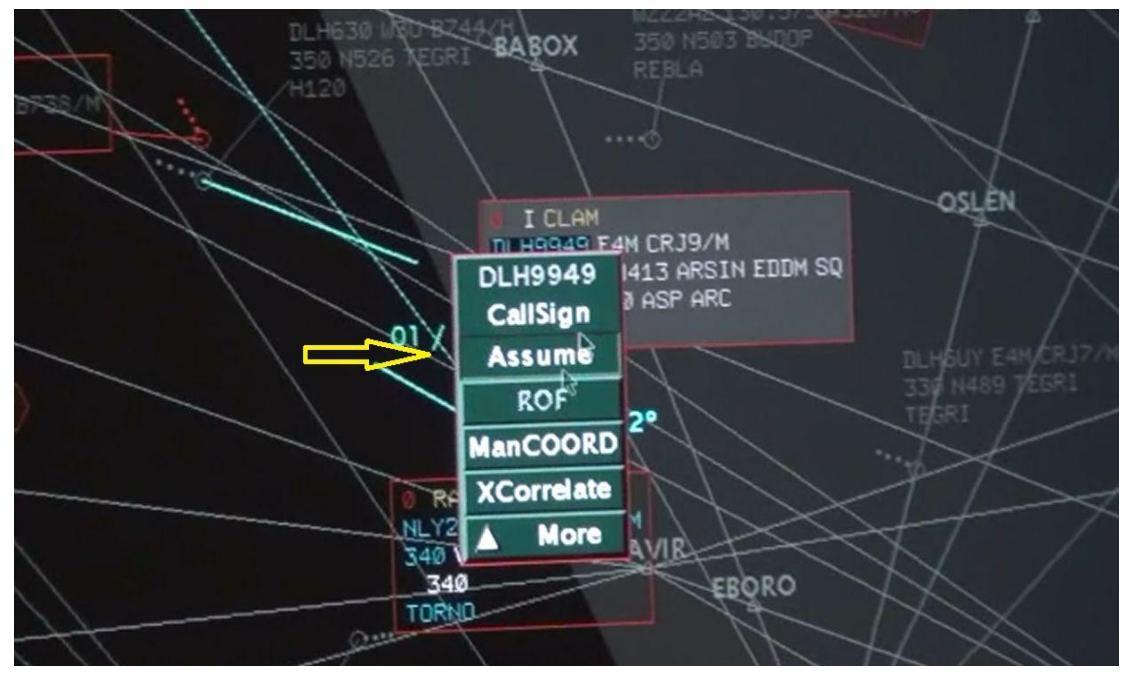
WL EC electronically took over DLH9949 at 13:56:40 (E+52 sec). At this moment DLH9949 was in climb, at FL349.

WL EC screen: WL EC takes over DLH9949

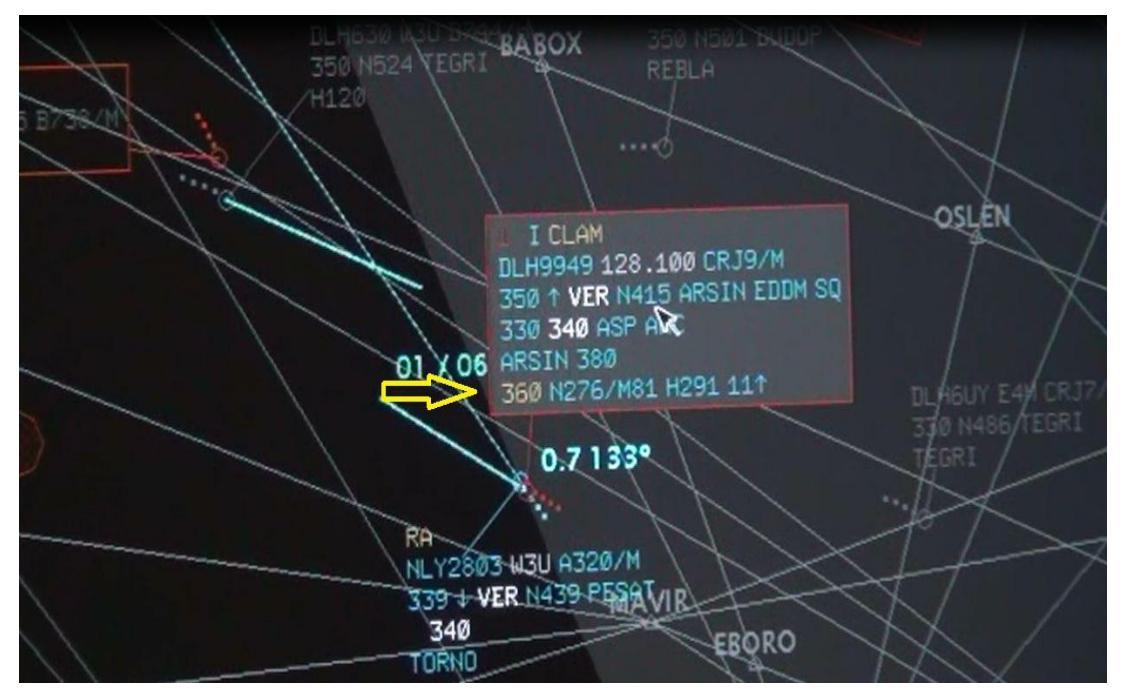
The S-mode set altitude difference warning for DLH9949 reappeared on WL EC radar screen at 13:56:43 (E+55 sec) then it disappeared after 2-3 sec.

WL EC screen: DLH9949 S mode set altitude difference warning

BA2012-159-4P-2: It was found that the S mode set altitude difference warning was not clearly noticeable for the operator resulting in a long reaction time.

The approval and implementation of the recommendation would ensure that ATC operators are notified faster and with higher reliability on the fact that a flight crew set an altitude different from the value cleared by ATC.

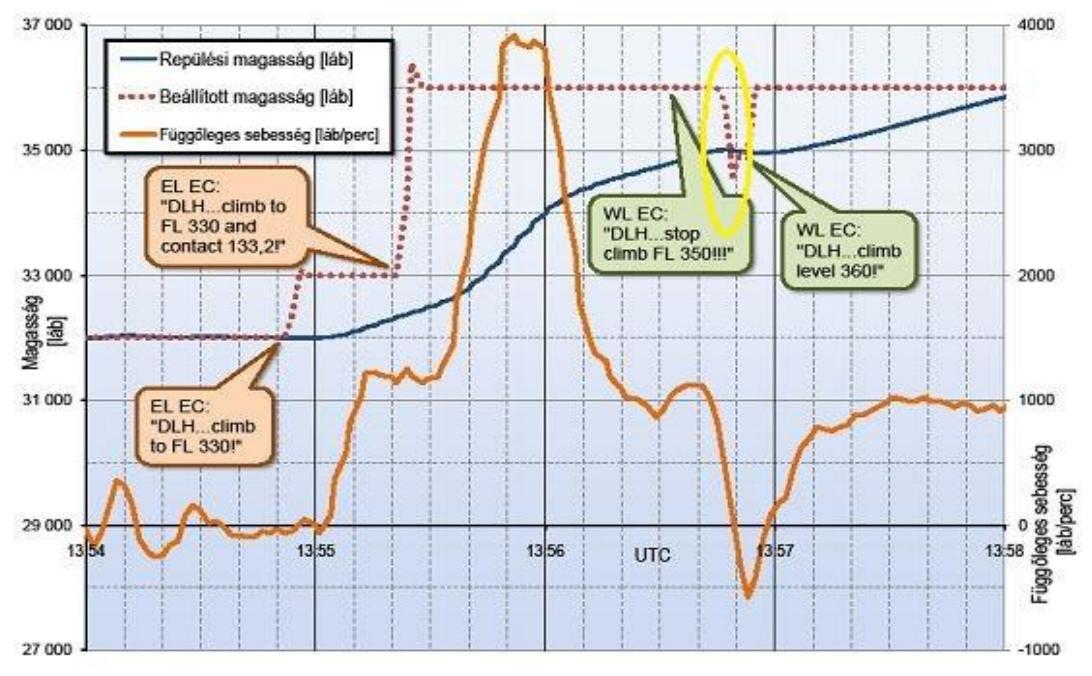
DLH9949 FDR data: Setting FL350

LH9949 set FL350 at 13:56:45 on the autopilot (when reaching this altitude) and the aircraft leveled off.

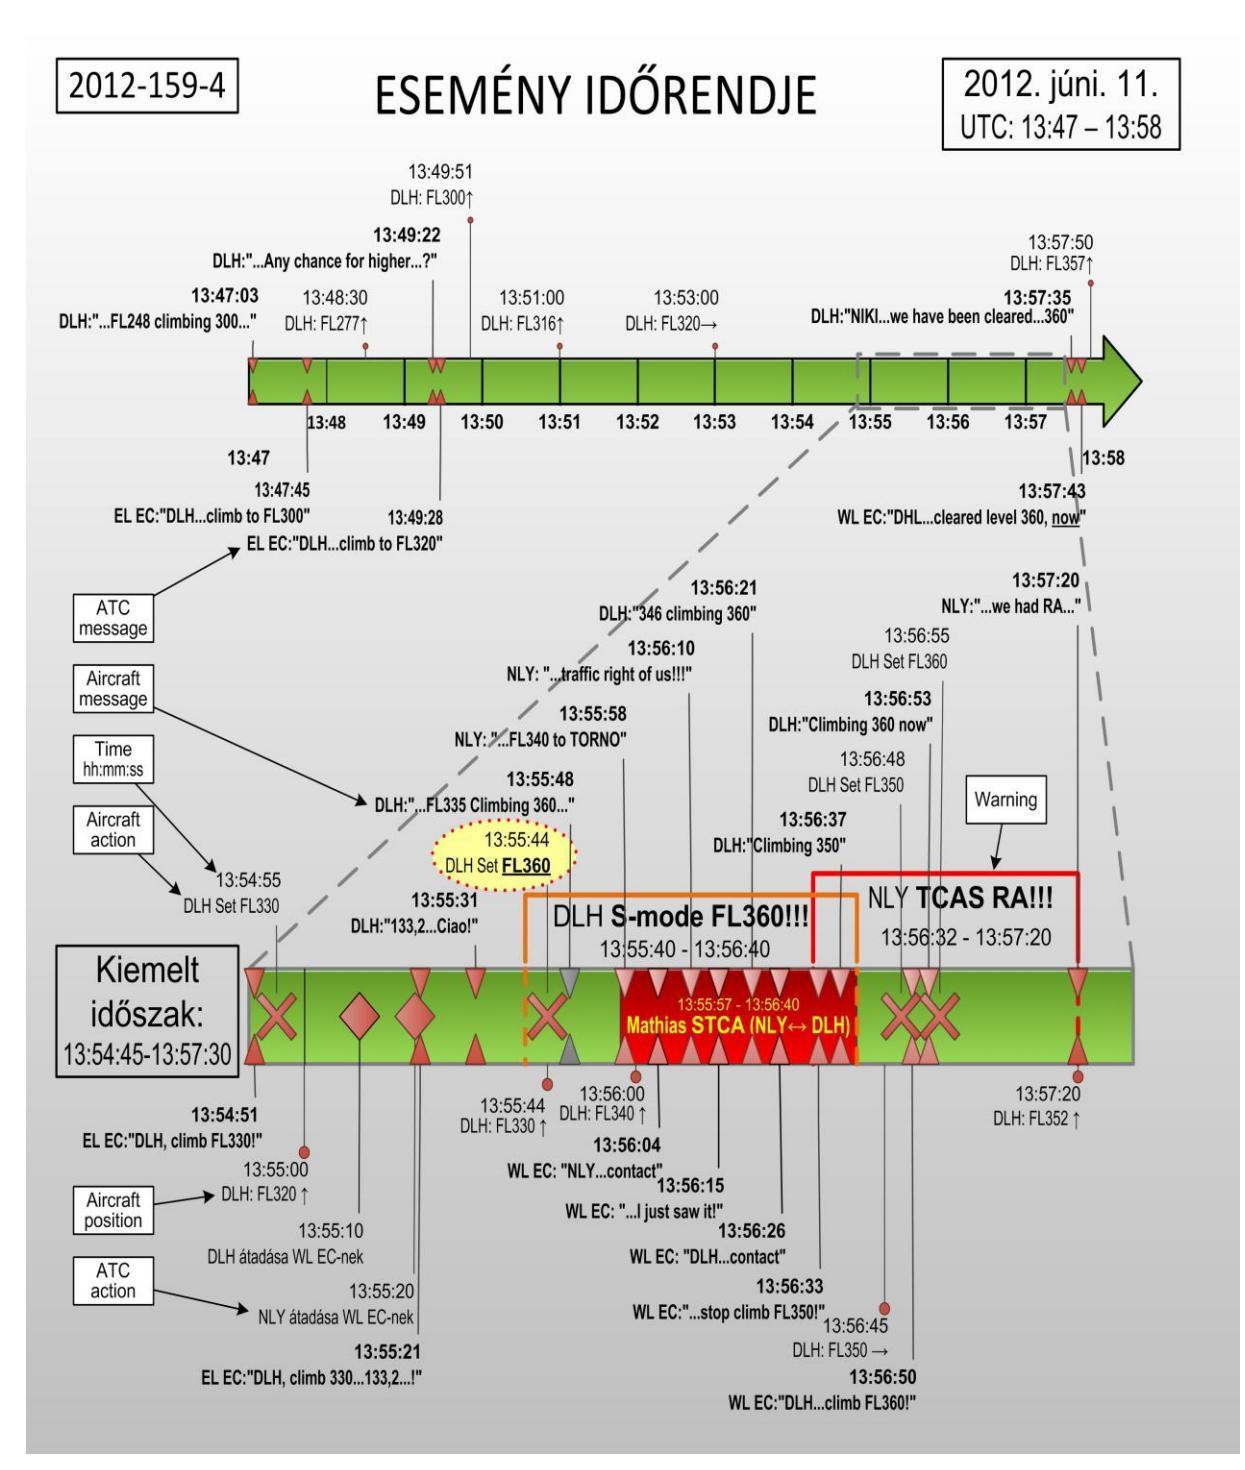
Horizontal separation at the time DLH 9949 crossed FL340: 1.9 NM.

The course of events (13:54:45 - 13:57:30 magnified)
