TRANSPORTATION SAFETY
BUREAU OF HUNGARY

FINAL REPORT

**2014-093-4P
Serious Incident**

**Airbus A320-232
G-EUUE**

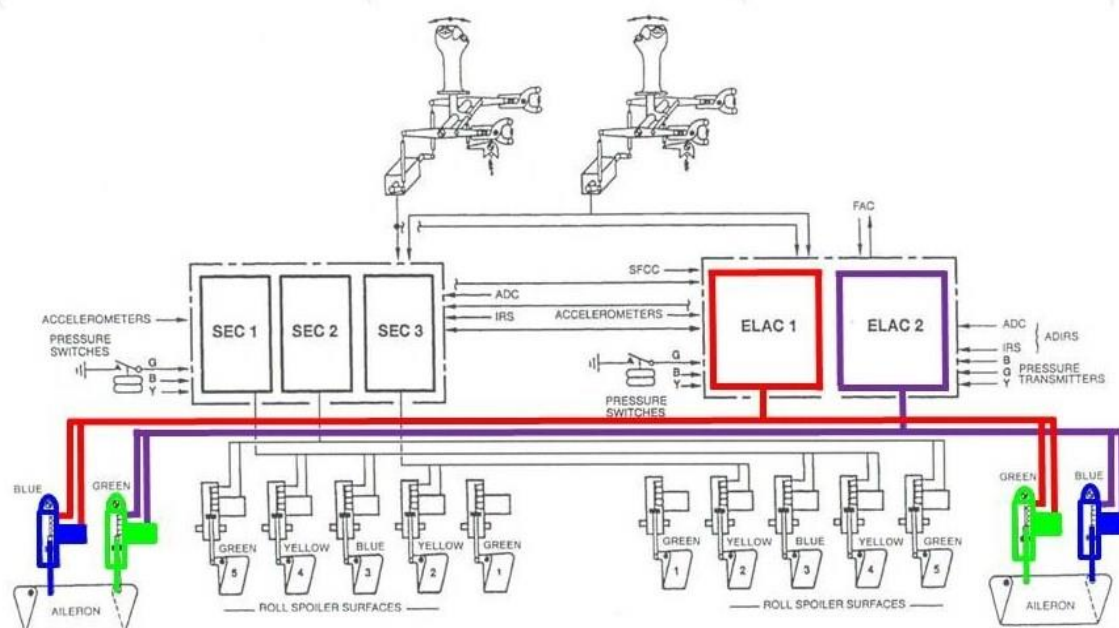
When the ELAC2 computer is active the left aileron is operated by the green servocontrol, and the right aileron is operated by the blue servocontrol.

In the case of any single part failure, the control of the ailerons is automatically transferred to the other servocontrol.

Figure 4: Schematic diagram of the operation of the roll control channel of the A320 aircraft
(source: Maintenance Training Manual of the A320 family)

On 21 March 2014, previous to this event, the right aileron blue servocontrol was deactivated in accordance with Section 27-14-04A of the MEL.
