FINAL REPORT

2006-0033-5 RAILWAY ACCIDENT

**Between Csajág and Balatonkenese stations
at level crossing no. AS380**

15 July 2006

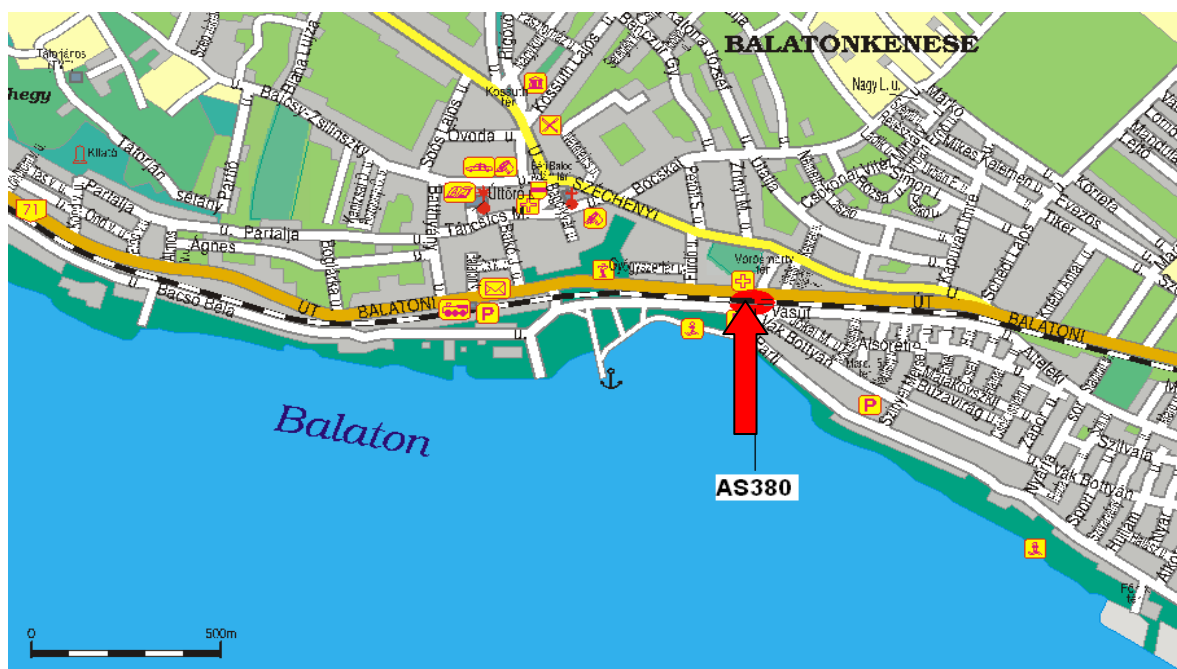
Figure 2: Location of level crossing no. AS380 secured with warning lights

Level crossing no. AS380 between Csajág and Balatonkenese stations (See Figures 1 and 2).

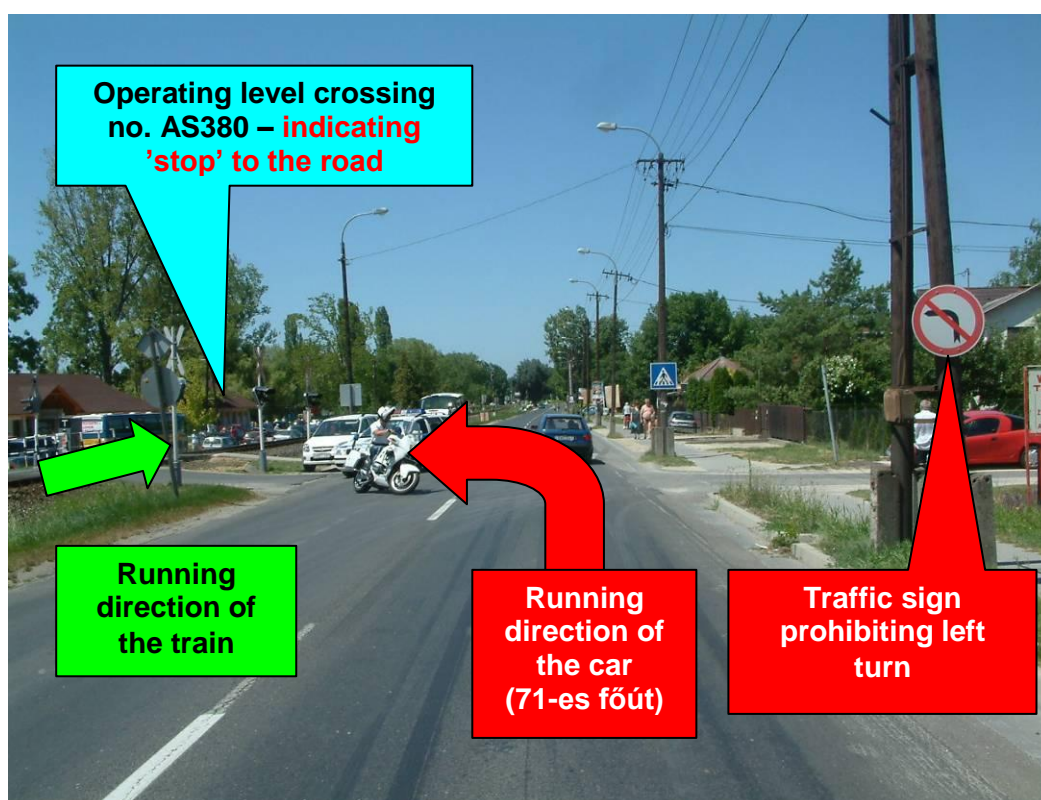
Figure 3: Traffic situation prior to the accident

Locomotive (registration number M41-2311) of passenger train no. 1972 running from Budapest-Déli station (Budapest Southern Railway Station) to Balatonfüred collided with a Ford Fiesta type car at 10 hours 09 minutes on 15th July 2006 between Csajág and Balatonkenese stations in railway section no. 380+29, at level crossing no. AS380 secured with warning lights giving stop signal towards the road. Following the collision, the train pushed the car in front of itself on a 209.9 metre distance. After the train had stopped, the spilling fuel in the engine compartment of the car ignited. The engine driver and the arriving police extinguished the fire with a fire extinguisher. As a consequence of the collision, the pregnant woman sitting on the front right seat died of her injuries. The driver of the car suffered serious, perilous skull injuries and was taken to Veszprém County Hospital by an ambulance helicopter.

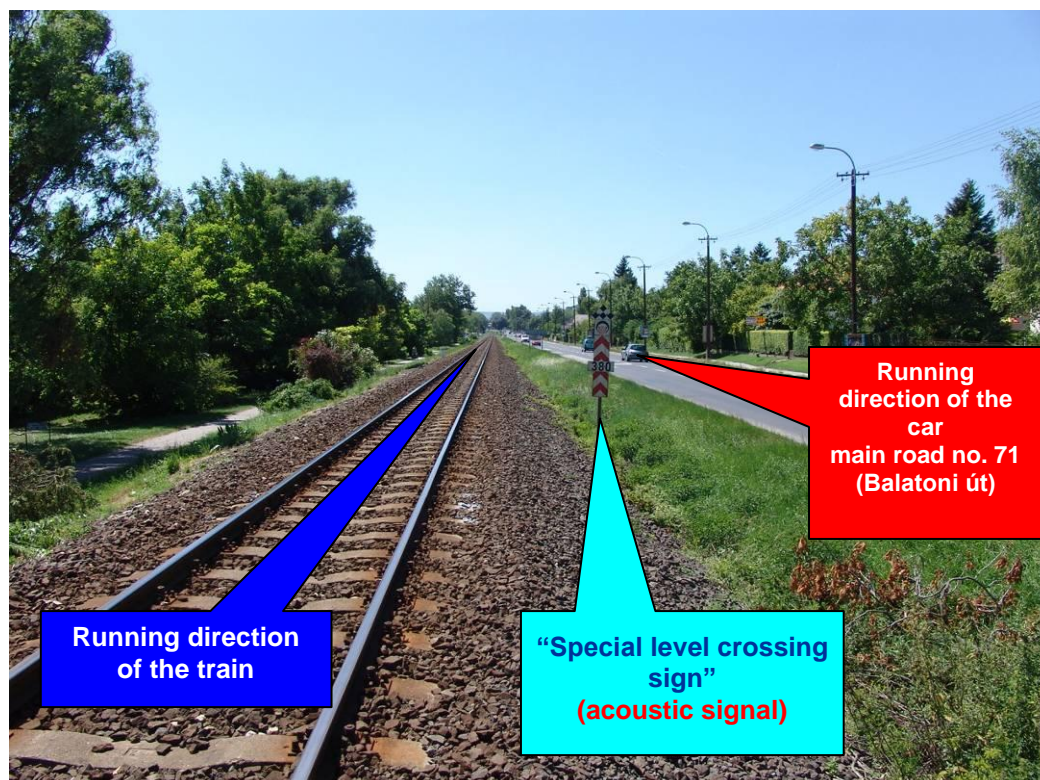
Figure 7: The “special level crossing sign” on the right side of the rail track

There is a “special level crossing sign” in the start point direction (Csajág), at section no. 376+28 on the right side of the rail track before the level crossing (see Figure 7).

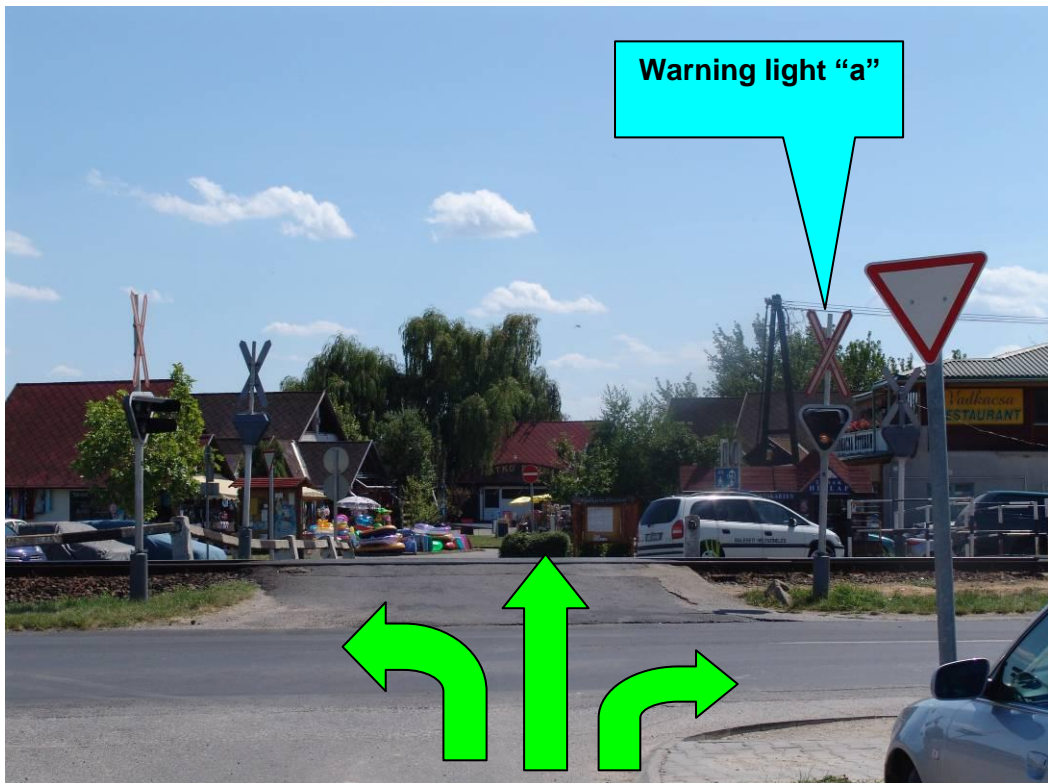
Figure 9: LC no. AS380, turning possibilities from the direction of Vörösmatry tér

Warning light “a” is perpendicular to the LC, set in the direction of Vörösmarty tér (which is on the other side of main road no. 71 (Balatoni út) (See Figure 9).

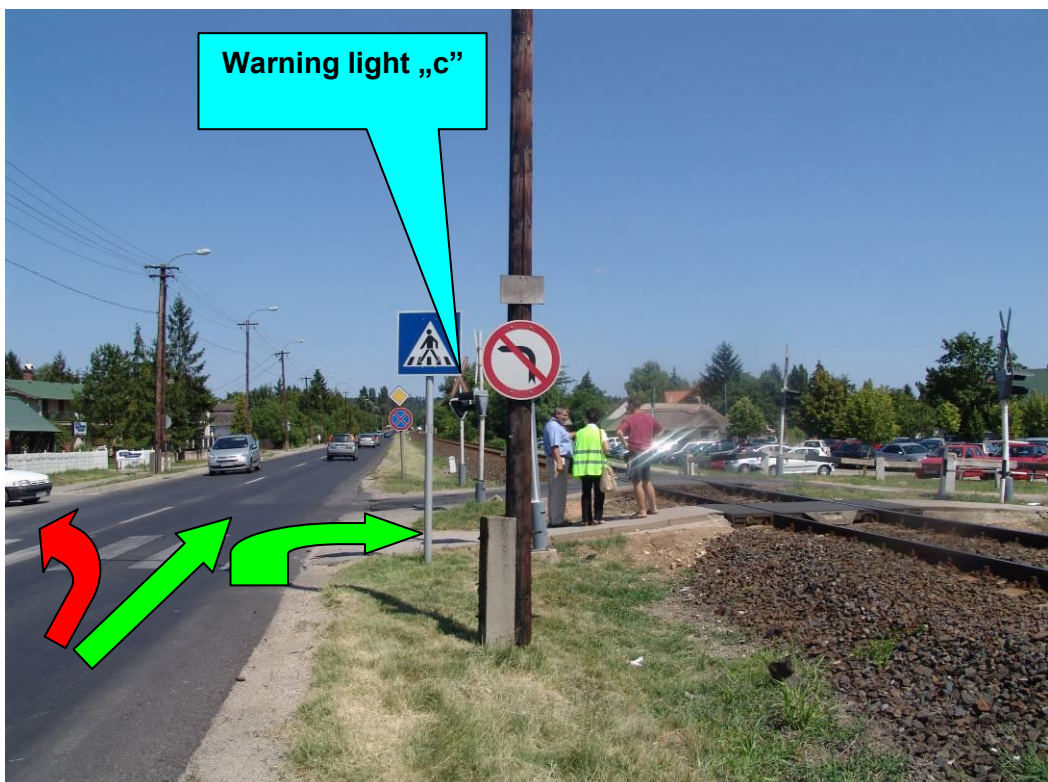
Figure 10: LC no. AS380, turning possibilities from main road no. 71 (Balatoni út) from the direction of Balatonkenese downtown

Warning light "c" is set towards vehicles arriving at the LC from main road no. 71 (Balatoni út) from the direction of Balatonkenese downtown (See Figure 10).

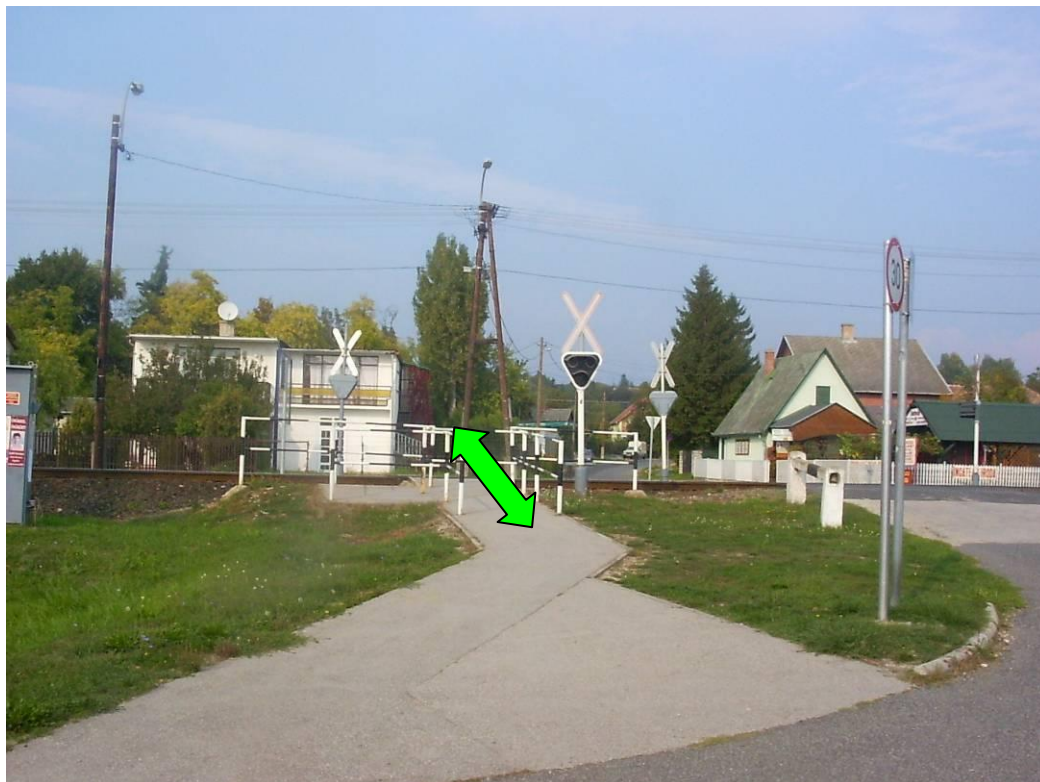
Figure 13: Pedestrian crossing equipped with warning lights

- According to VBO Szombathely, the railway track was not damaged. However, the shifted STRAIL plate of the pedestrian crossing had to be set back. (See Figure 5).
- The service of the signal box specialists cost 14 086 HUF.
- Although the engine oil and the fuel spilt from the car to the railway embankment, it did not cause significant damage, therefore it was not necessary to indemnify damages.

Next to LC no. AS380 (in the direction of Balatonkenese station), there is a pedestrian crossing secured with warning lights and so called ‘labyrinth barriers’, and the crossing is paved with STRAIL plates (See Figure 13).

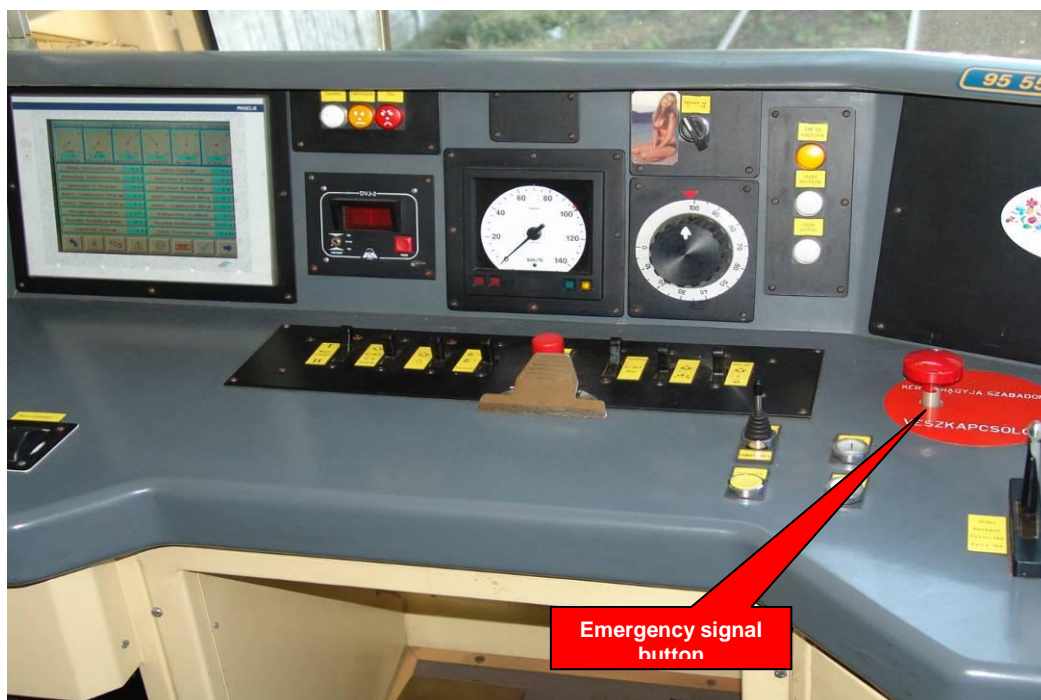
Figure 15: The driver's cab of the locomotive (registration no. M41-2311)

The LC and its warning lights were in compliance with the regulations of the authorities and were distinctly visible from the road.
- The placing of the road traffic signs were in compliance with the regulations.
Prior to the accident, the technical condition of locomotive M41-2311 was satisfactory and in compliance with the transport safety regulations.
The engine driver was qualified and authorized to drive the locomotive. He acted satisfactorily and performed the prescribed tasks in the course of the accident.
The engine driver did not exceed the 80 km/h speed limit for the line and the train.
The engine driver said that he had immediately pressed the emergency signal button which started the emergency braking (Figure 15).

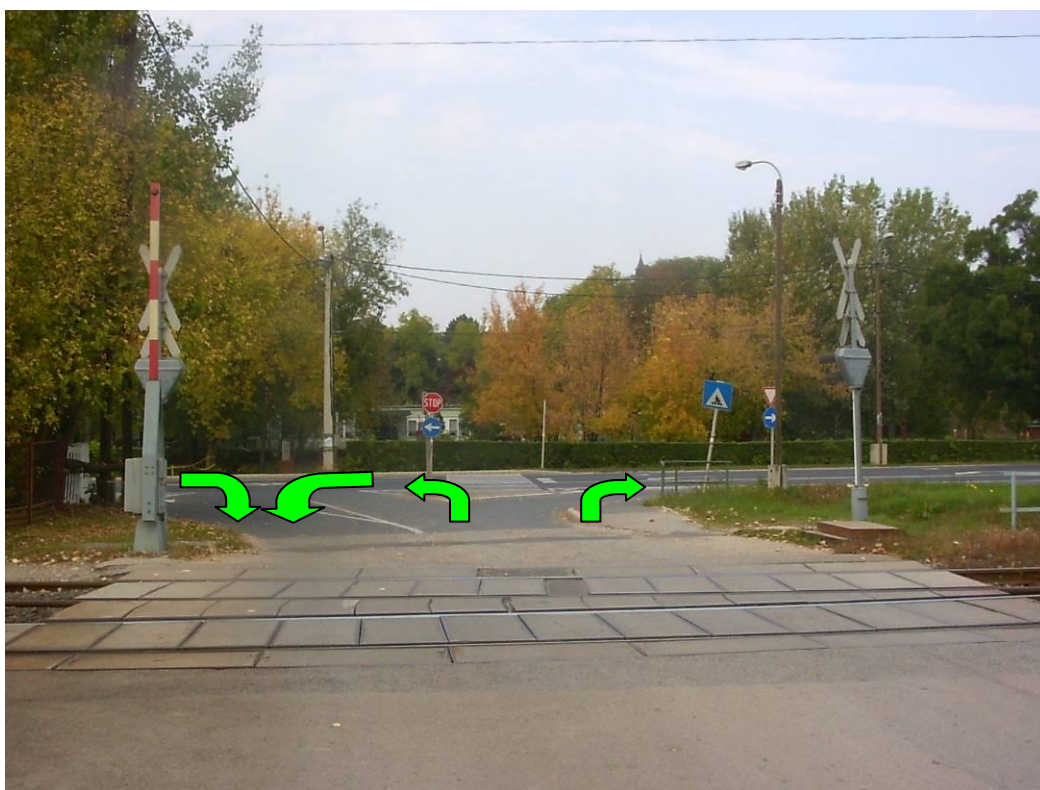
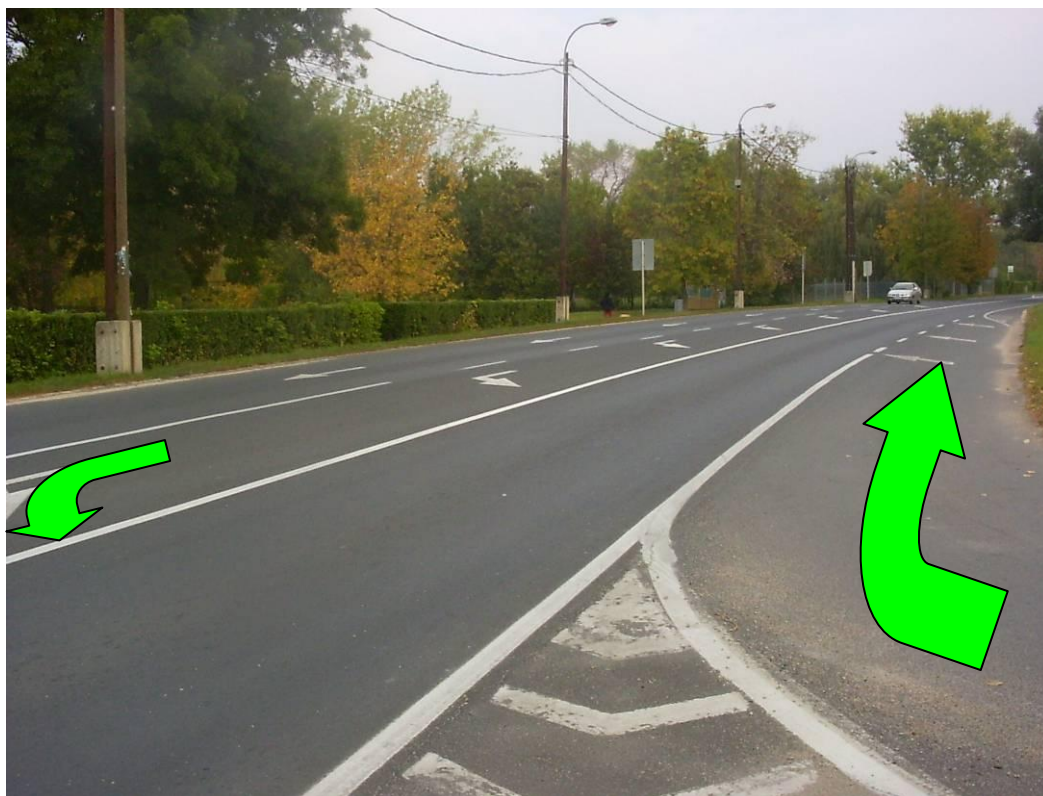
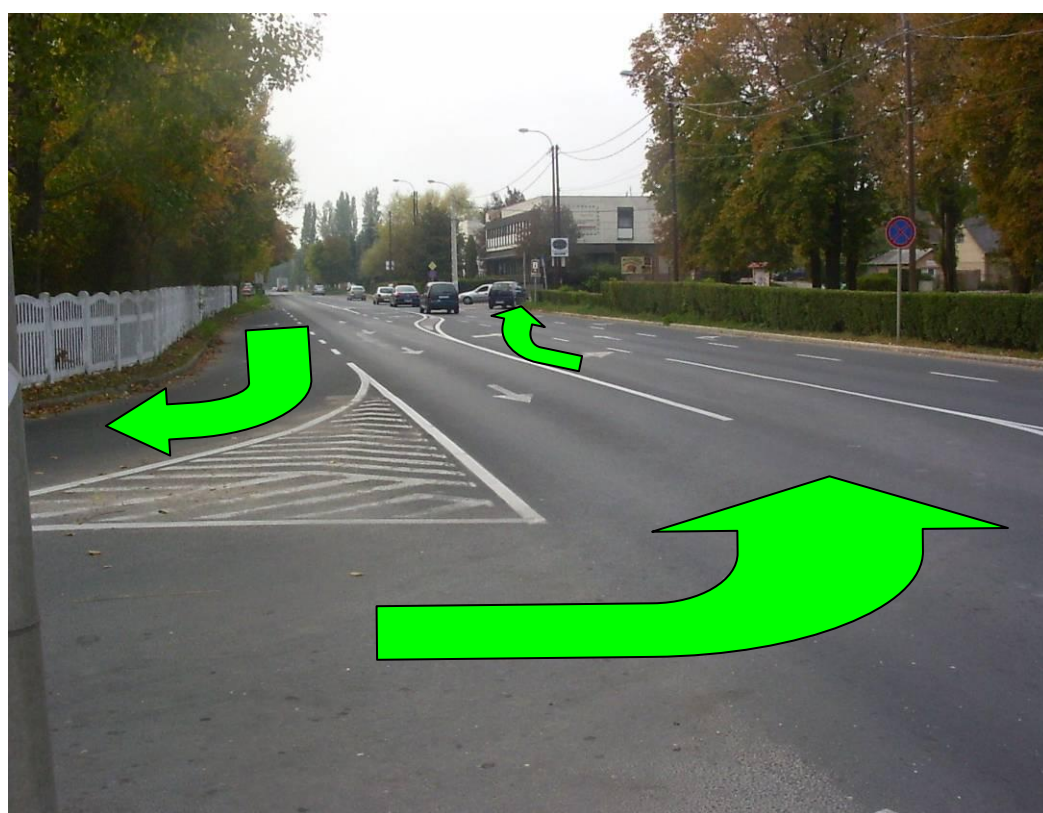
No. SR2 LC (secured with warning lights and half barrier) of Balatonkenese station located approximately 500 metres from LC no. AS380 in the direction of Balatonkenese is a considerably safer LC as there are turning lanes and acceleration lanes leading to the LC (See Figures 20, 21 and 22).

Figure 20: LC no. SR2 of Balatonkenese station connecting to main road no. 71

Figure 21: Turning lanes at LC SR2 on main road no. 71 in the direction of Balatonakarattya

Figure 22: Turning lanes at LC SR2 on main road no. 71 in the direction of Balatonfűzfő

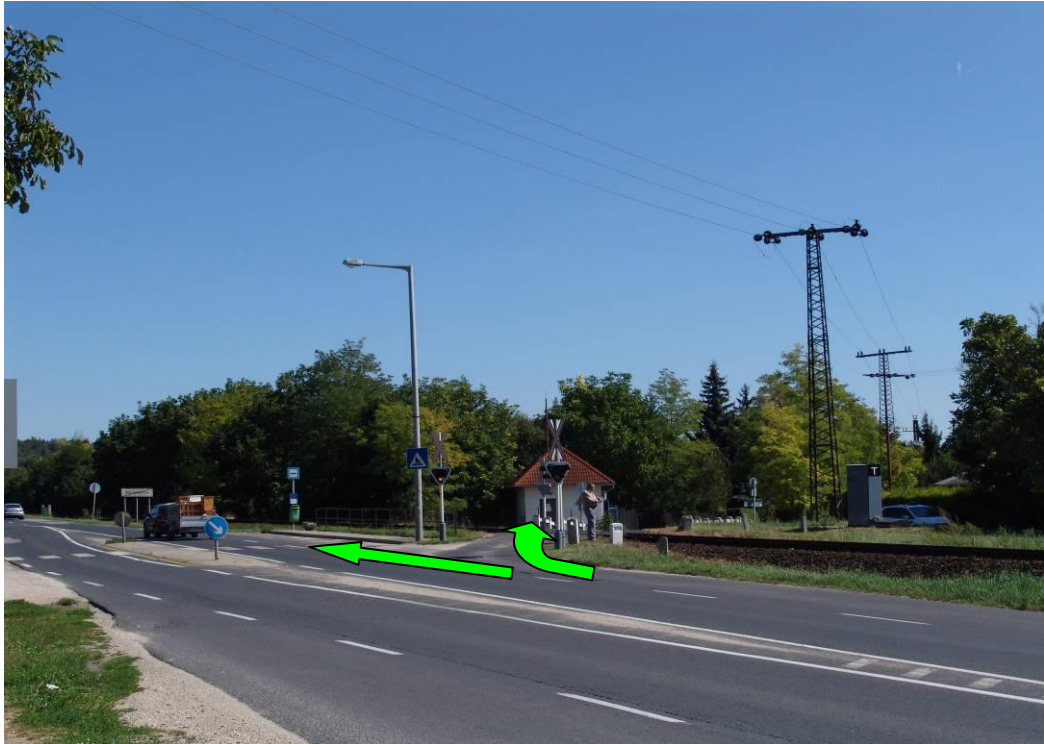
There is another LC (no. AS373) in the inner-town area of Balatonkenese approximately 700 metres from LC no. AS380 in the direction of Balatonakarattya with a connecting turning lane, which is also a safer LC (See Figure 23).

Figure 23: LC no. AS373 secured with warning lights in the direction of Balatonakarattya
