**FINAL REPORT**

**2006- 0048-5**

**RAILWAY ACCIDENT**

**Komárom station**

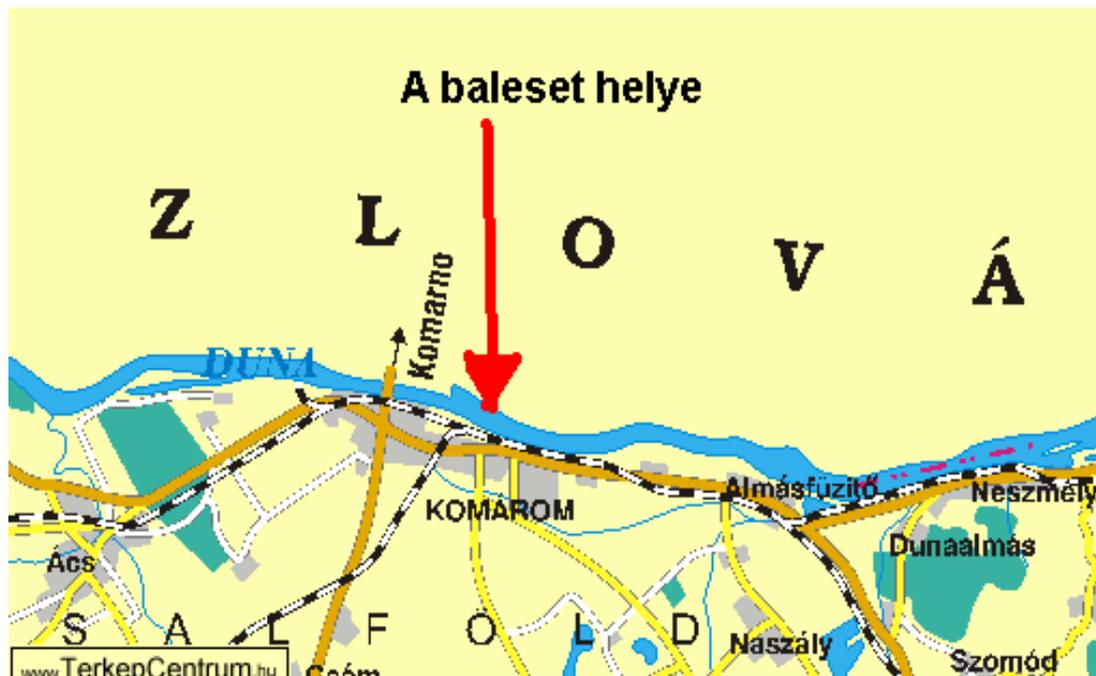
Figure 2: Location of the accident

The investigation established that the accident was caused by a scotch block left under the first pair of wheels of the first freight car.
