FINAL REPORT

2010-069-5

Railway accident

**Budapest- Nyugati station
9 February 2010**

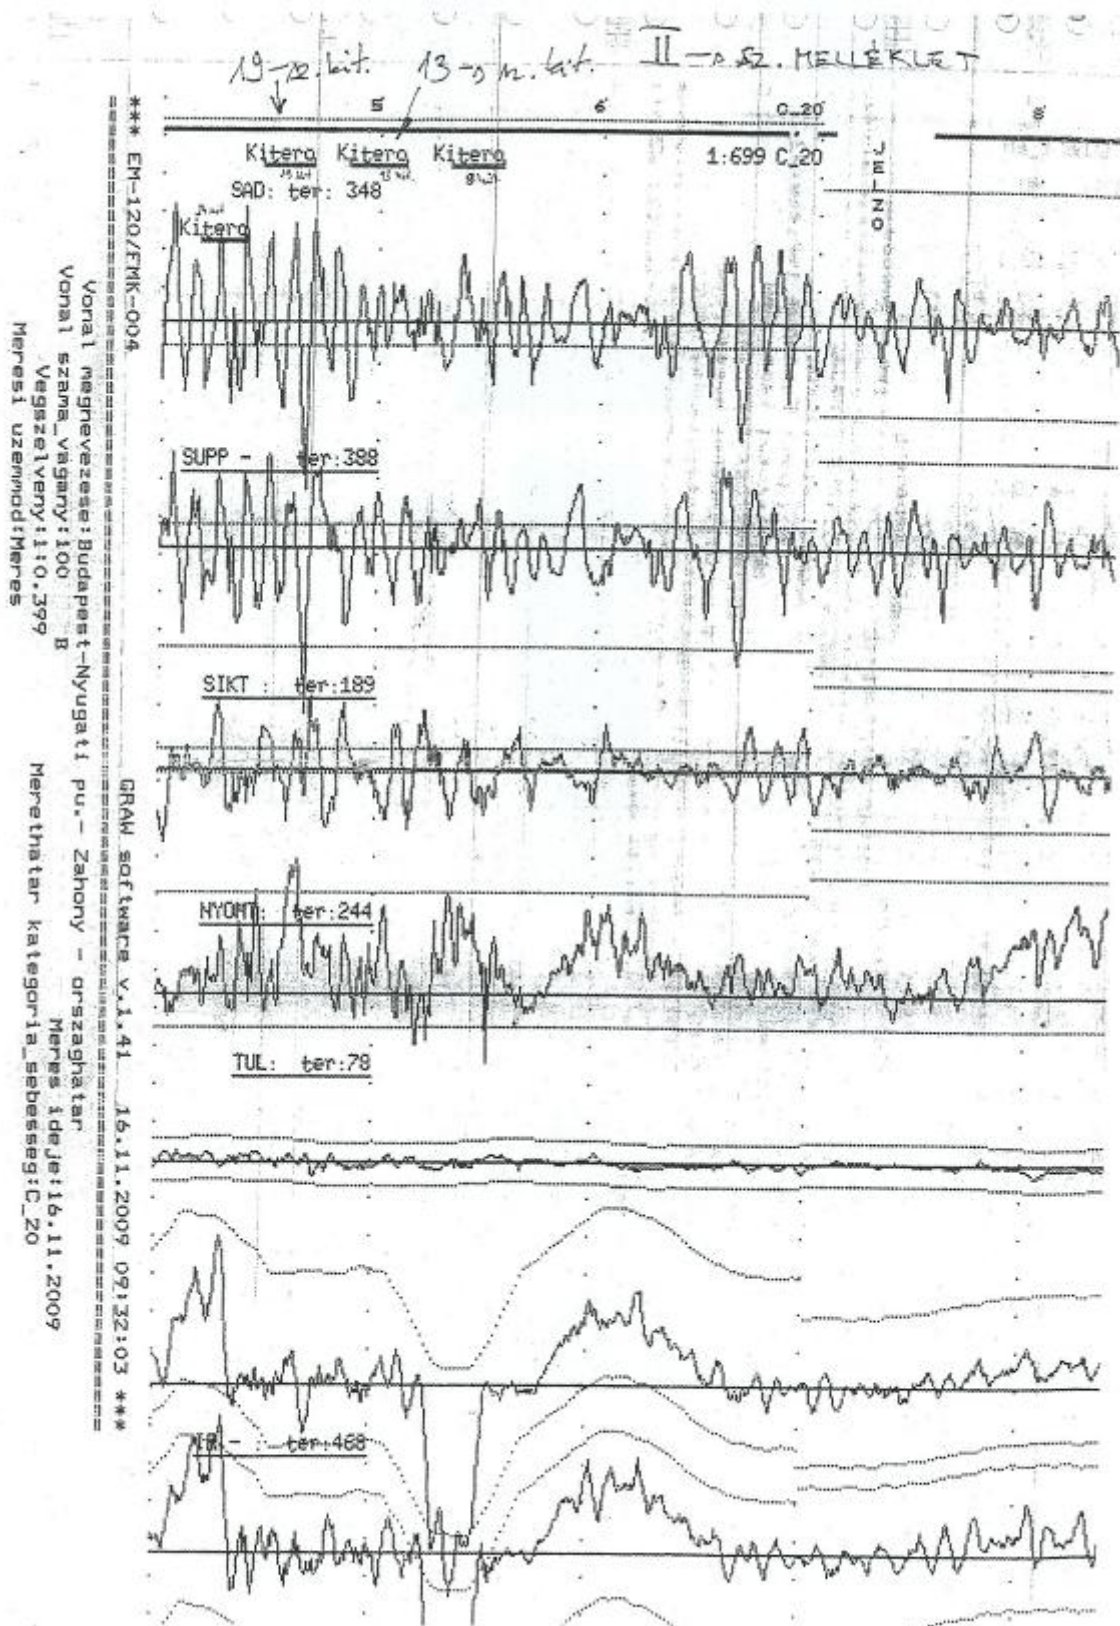
Appendix 2: Graph done by the test train

- No fault requiring repair was found based on the graph (November 2009) of testing train no. EM 120.
- No fault requiring repair was found during the manual examination of the curve between points no. 13 and 19 in 2009.
- No fault requiring repair was found during the manual track gauge examination and inspection of super-elevation between points no.13 and 19 in August 2009.
- Sleeper replacement and gauge rectification was recorded on the worksheet dated April 2008.
