MINISTRY FOR  
INNOVATION AND TECHNOLOGY  
TRANSPORTATION SAFETY BUREAU

## **FINAL REPORT**

**2018-0679-5**

**Railway incident / Runaway of a vehicle**

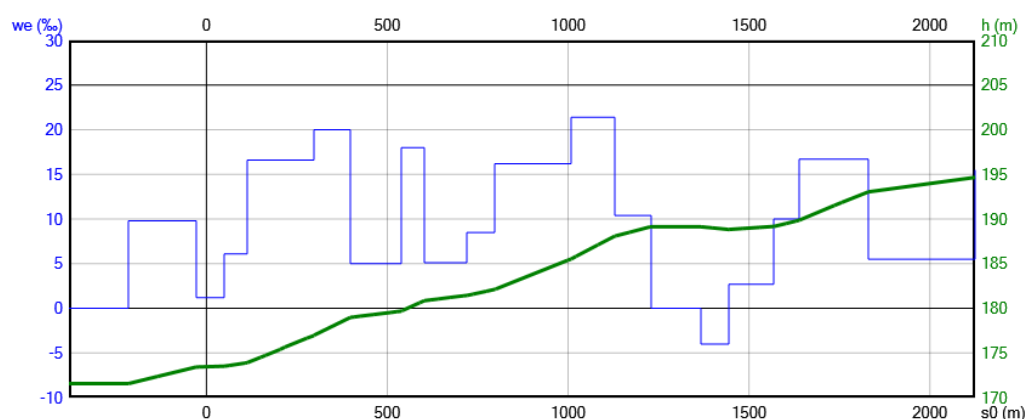
**Figure 7: gradients between the stations Dorottya u. Miskolc and Majláth; blue: degree of ascension; green: longitudinal section**

The railway track between the stations Majláth and Dorottya street descends almost all along the line: the altitude difference between the two stations is 23 m. The speed limit for the track section is 20 km/h.

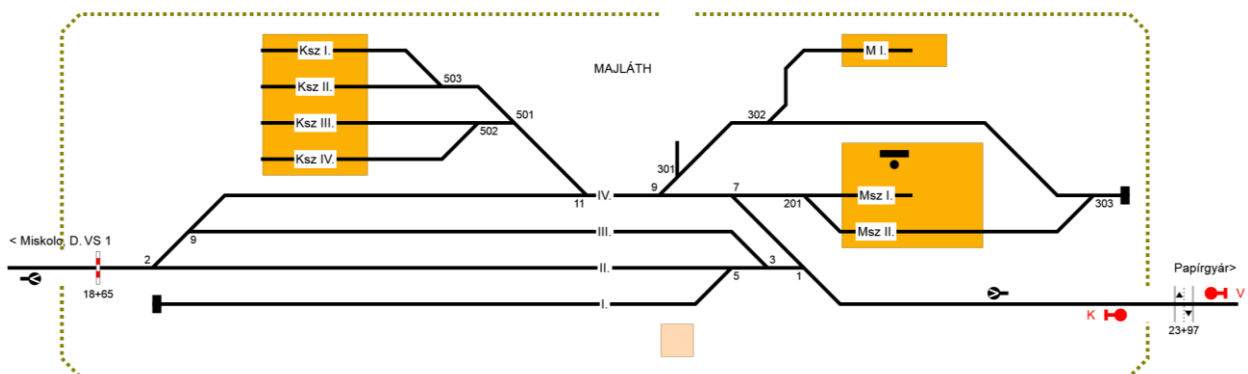
**Figure 9: The track system of Majláth station**

The tracks of the station can be seen in Figure 9. The main track is Track II; the common shunting limit signal of the tracks I and II at the down-side end is located in the section № 20+85.

The runaway wagons had been stopped on the main track running through Majláth Station, although there are some tracks (e.g. tracks Nos. Ksz I to IV which are dedicated to the storage of rolling stock and which end in a buffer stop in the direction of possible runaway) (Figure 9). But there, due to limited capacity of the tracks, it would be more difficult to store the wagons: partly outside the shunting limit signal, which would hinder other possible necessary shunting movements.

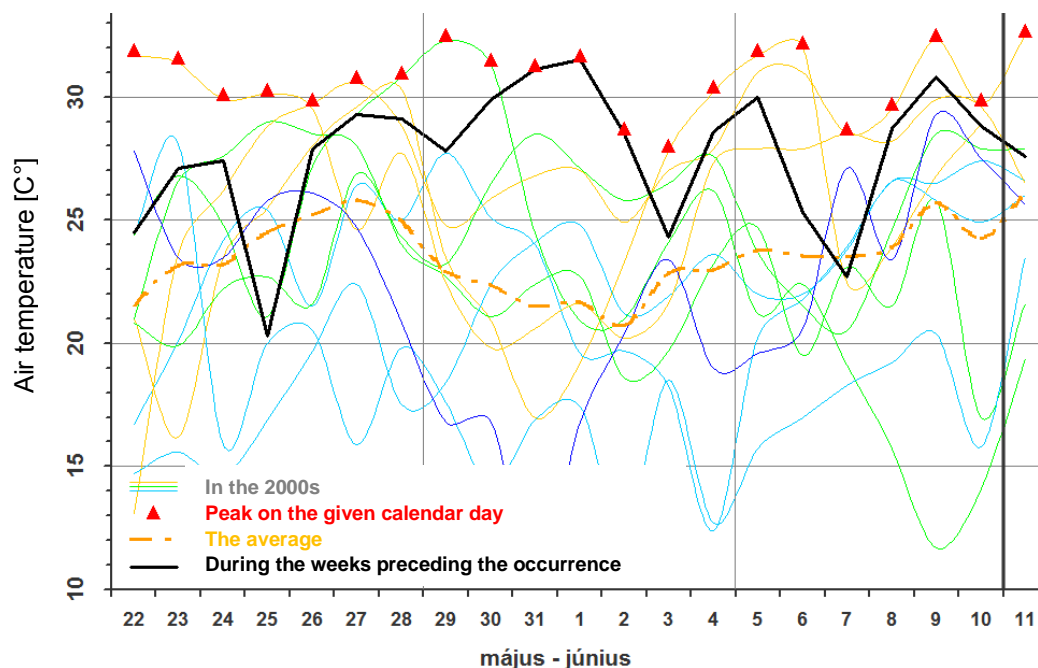
**Figure 13: Daytime highest temperatures in Miskolc**

Such a sequence of high peaks had lasted for two and a half weeks by the time of the occurrence, with new records in three subsequent days, i.e. the temperatures had been extremely high in Miskolc for several weeks preceding the occurrence (Figure 13).

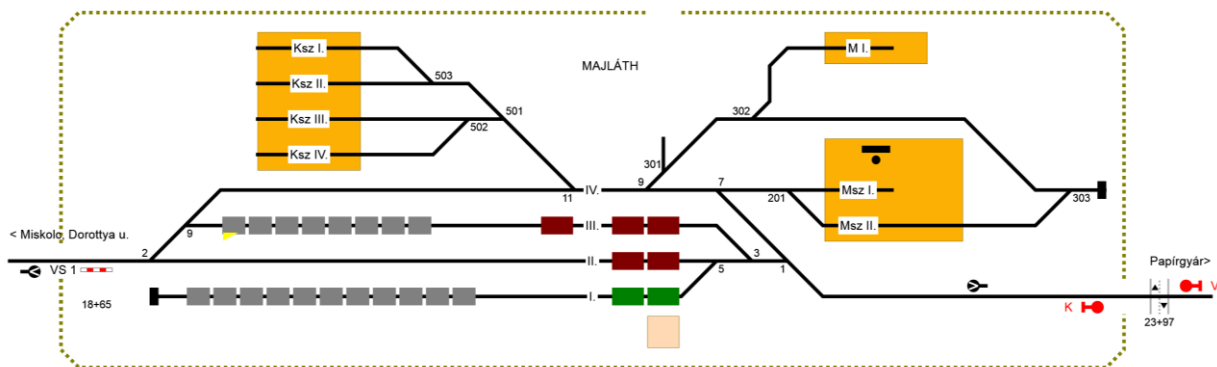
**Figure 16: Majláth Station with the stationary wagons**  
(The figure excludes the vehicles stopped on the track of the wagon shed and locomotive shed, the number of grey wagons is not reflected exactly.)

The reserve locomotive driver locked the gates of the Depot, but the red-white track barrier was left open (1.12).

The traffic manager checked the closing of the gate by having a glimpse at the live camera image, but he did not regard the open position of the red-white track barrier a mishap, although it is also shown by the same camera (1.12). Now the wagons were situated at the Station as shown in Figure 16.
