# **ANNUAL REPORT 2010**

## **Transportation Safety Bureau**

### **Hungary**

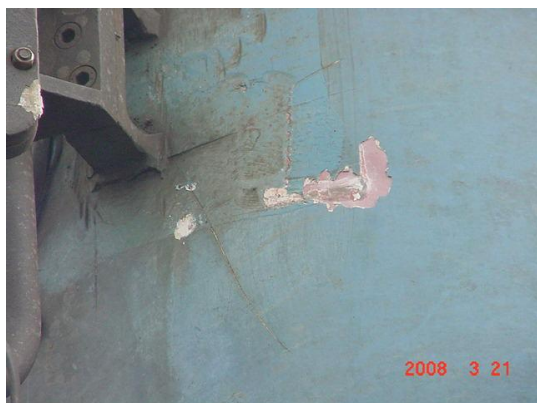
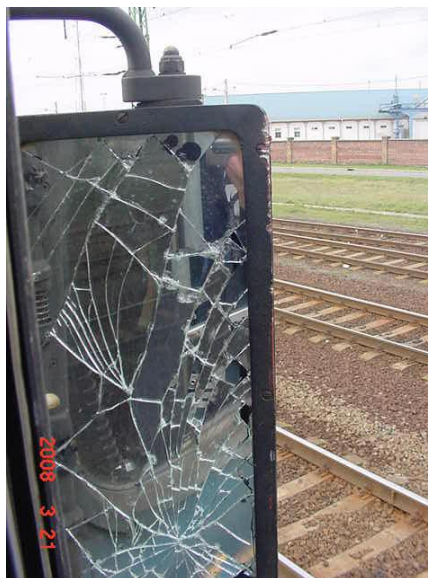
On 21 March 2008 at 9:17 hrs, having departed from track IV and passed exit signal indicating 'Stop', train no. 65540-1 collided with train no. 65411 passing track III at Szerencs station. The two vehicles collided with a little force, therefore only the first right rear-view mirror of the locomotive (reg. no. V43-1060) of train 65540-1 broke.

The engine driver of train no. 65540-1 did not pay sufficient attention to the exit signal indicating Stop, it collided with passing train no. 65411.

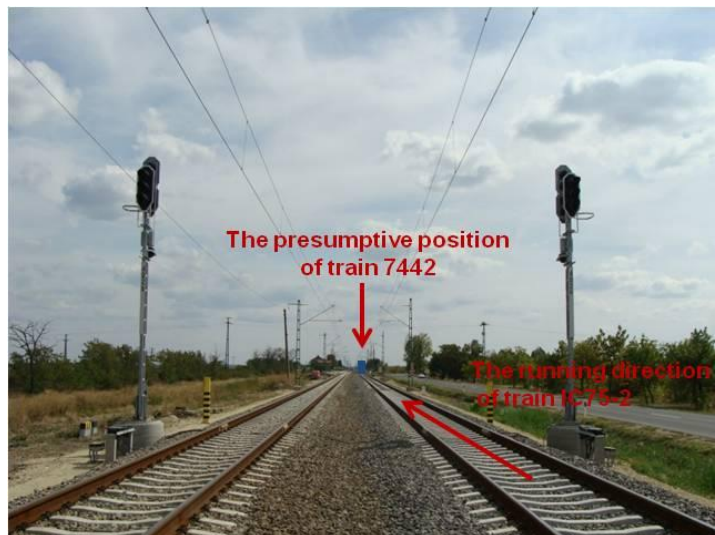
The block system between the two stations developed a fault due to the previous day's storm. As a consequence, block signal no. AT376 became inoperative (red light was on the signal) and it was impossible to send clear signal onto entry signal 'B' of Nagylapos crossover. At the same time, traffic control was also impossible between Nagylapos and Gyoma.

- The staff did not comply with the regulations of the written order given at Mezőtúr station when travelling with train no. IC75-2.
- The Unified Vigilance Warning and Train Control Device (EÉVB) was not switched off at the right place.
- The 'look-out service' i.e. a second person on board the locomotive ordered at Mezőtúr station could not prevent the accident.
- Having passed the entry signal, they followed behind the train standing in the occupied block section.
- This was the first occasion the engine driver of train no. IC 75-2 had driven a train after the section had been reconstructed and he had not been informed about the changes.

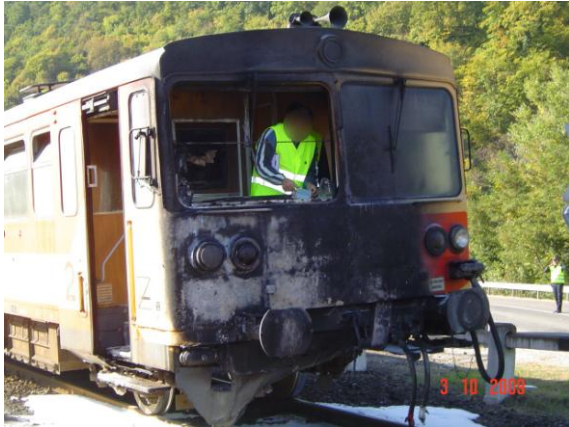
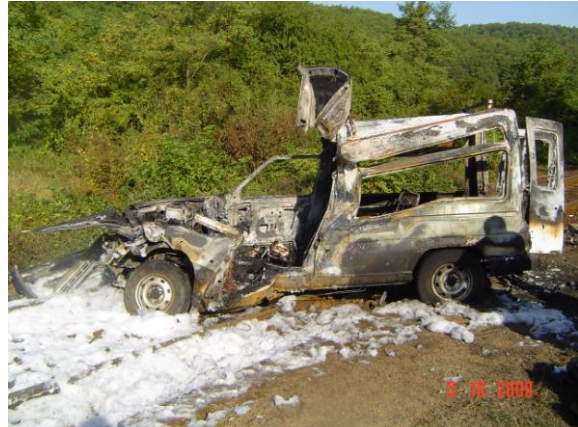
On 3 October 2009, passenger train no. 35412 (Bzmot335) collided with a Renault type van at LC no. AS 391 protected with warning lights between Edelény and Szendrő stations.

As a consequence of the occurrence, the driver of the van died at the site, the van burnt down and the motor coach (driver's cab) of the train also caught fire.

- The warning lights were operating normally at the time of the accident.
- The warning lights and the signposts on the road were well visible and the reduced visibility triangle (clearance) was ensured.
- The railway vehicle travelled with the permitted speed.

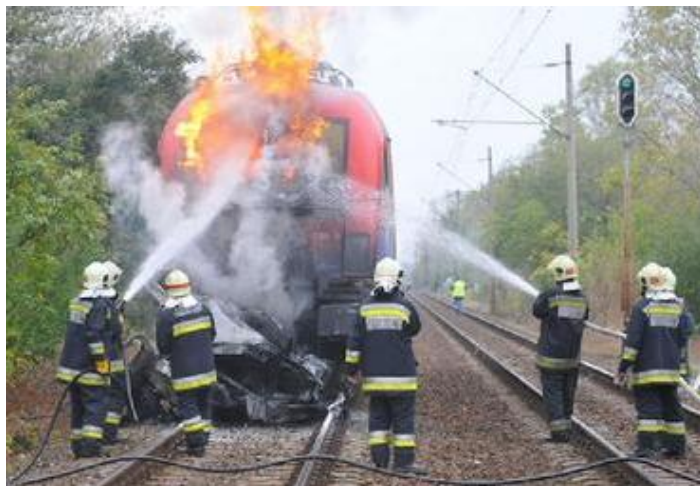
On 17 October 2009 at 12:10 hrs, passenger train no. 6588 collided with a car at LC AS2179 - protected with warning lights and half barriers - between Ebes and Debrecen stations. The car was torn in two and part of it was crushed underneath the locomotive. After stopping, the part of the car under the locomotive caught fire which spread onto the driver's cab of the locomotive. The driver of the car died at the site of the accident.

- The half barrier of the LC was in vertical (open) position at the time of the accident.
- Train no. 6588 had closed LC no. AS2132 between Ebes and Debrecen stations, however, it remained closed for a longer time than usual (it did not open automatically) and therefore after the timing it went into failure mode (the warning lights turned dark and the half barriers opened).

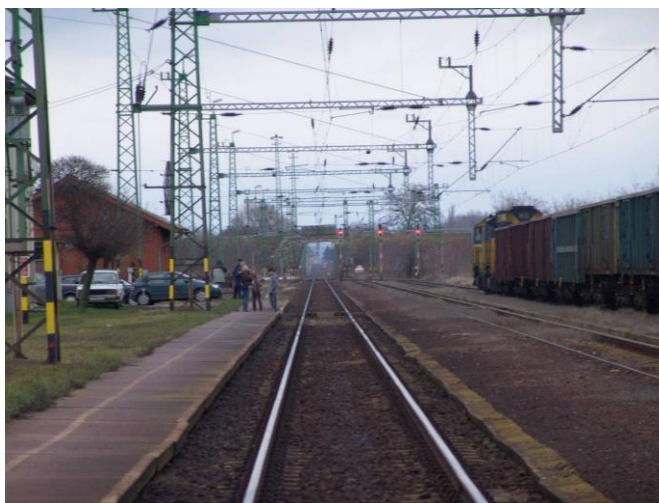
While the train was waiting for departure, its crew left it - without stopping the locomotive and locking the wagons - and went to the traffic office. As a consequence, the train broke loose (as the station is on a slight incline), split points no. 1 open and rolled towards Tüskevár station.

The crew was unable to stop the train either at the area of Devecser station or on the open track. It was eventually stopped by the movements inspector of Tüskevár station - who had been notified about the incident - with two double scotch blocks. Beforehand he arranged for train no. 905 (which was to arrive at Tüskevár) to be stopped at the neighbouring station.

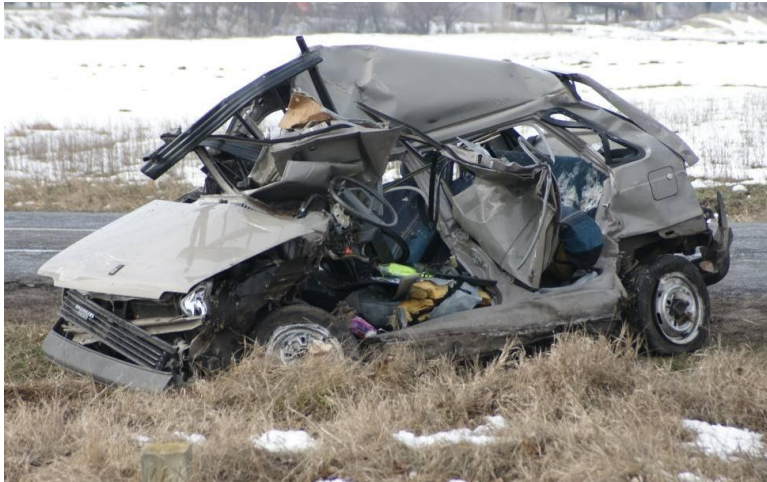
As a consequence of the accident, two passengers of the car lost their lives. The motor coach sustained minor damage but remained operable. The car was written off.

The IC established in the course of the investigation that the warning lights were indicating flashing red light signal towards the road at the time of the accident. The construction and design of the IC complies with the relevant regulations in force. The train did not exceed the speed limit.

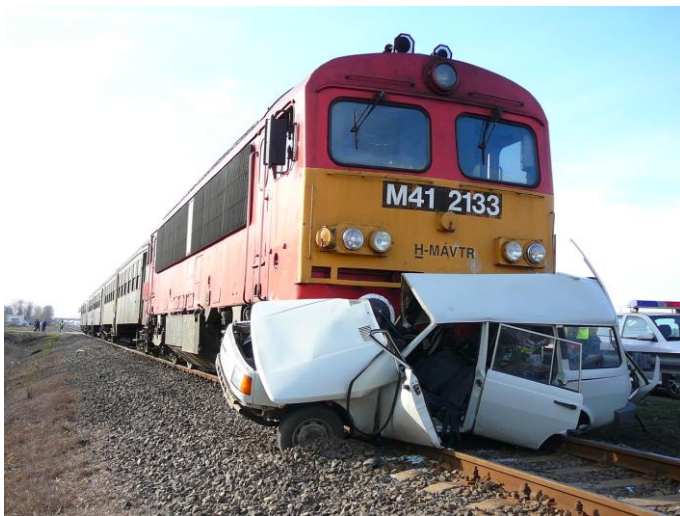
The passenger of the car died at the site and the driver was taken to hospital with serious injuries. As a consequence of the collision, the locomotive (M41-2133) sustained minor, and the car sustained substantial damage.

The warning lights of LC AS41 operated normally at the time of the accident; they indicated 'Stop' towards the road. The car drove onto the LC disregarding the Stop signal, where it collided with the passenger train. Train no. 6615 did not exceed the speed limit.

The IC conducted a site survey immediately after the accident and examined the site on a number of occasions afterwards as well. In the course of the investigation, the IC examined the construction and design of LC assuming that it might have had an indirect effect on the occurrence of the accident. The IC considered the accidents previously occurred at this LC as well as the effects of the measures taken by the relevant authorities. It also emphasised the deficiencies of the construction and design of the junctions at the LC causing recurring accidents.
