TRANSPORTATION SAFETY
BUREAU

ANNUAL REPORT 2011
Transportation Safety Bureau
Hungary

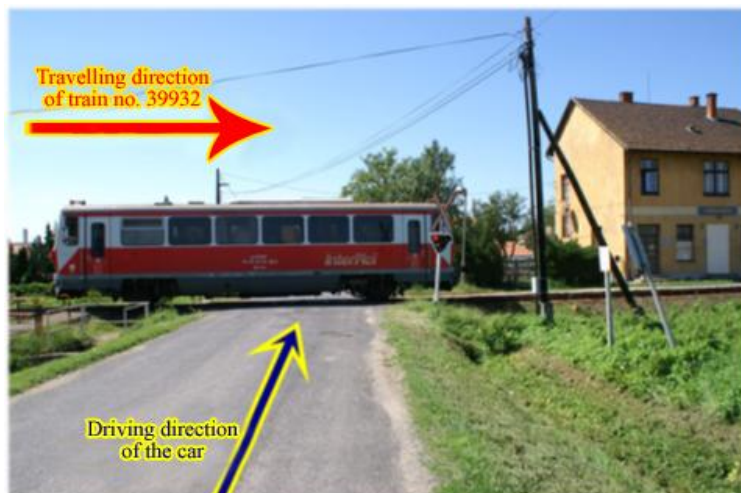
2010-303-5

On 16th July 2010 at 10:19 hrs, between Szombathely and Kőszeg stations, power car no. Bz-354 of train no. 39932 collided with a car at Lukácsháza halt on the level crossing protected with warning lights no. AS52 2010 operating properly.

As a consequence of the accident the driver of the car suffered serious injuries that resolve in more than 8 days. No passengers of the train were injured. Power car no. Bz-354 was slightly damaged, but remained operative, the car was seriously damaged. The train delayed 87 minutes as a consequence of the accident.

In the course of the investigation the IC established that the light signal was operating properly at the time of the accident, it was flashing red lights towards the direction of the road. The structure of the level crossing complied with the laws in force, the passenger train was travelling according to the timetable and at a speed not exceeding the speed limit.

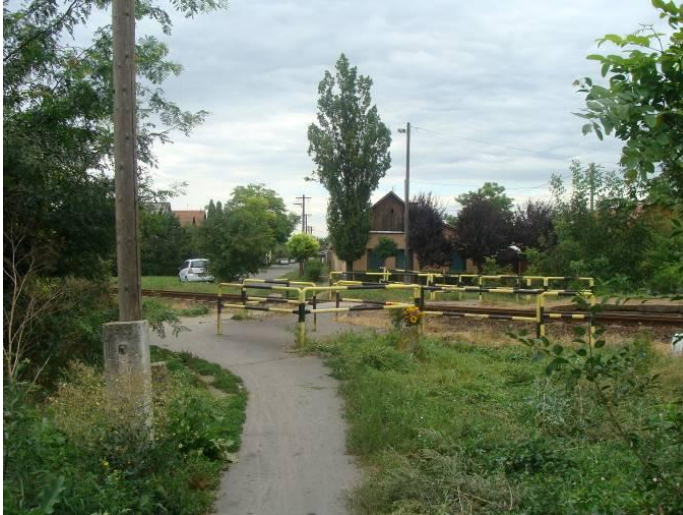
2010-369-5

On 17th August 2010 at 13:07 hrs, power car Bzmot 168 of train no. 7254 struck a children's bicycle on the rail pedestrian crossing in railway section no. 24+90 at Bereghát halt between Szentés and Szegvár stations. As a consequence of the collision the bicycle was pushed out by the power car to the right (in relation to the travelling direction). The bicycle hit the child causing so serious injuries that the child died at the site. The IC examined the site of the accident, the construction of the rail pedestrian crossing, the visibility conditions and the actions to be taken by the staff of

the train in case of an incident or an accident. The IC considered the occurrence of the accident as being caused by human factors relating to the bicyclist boy, but had further findings concerning the notification procedure to be followed in case of the occurrence of an accident. The IC issued a safety recommendation in order to assure that the ambulance would be notified in the shortest time of the occurrence of an accident.

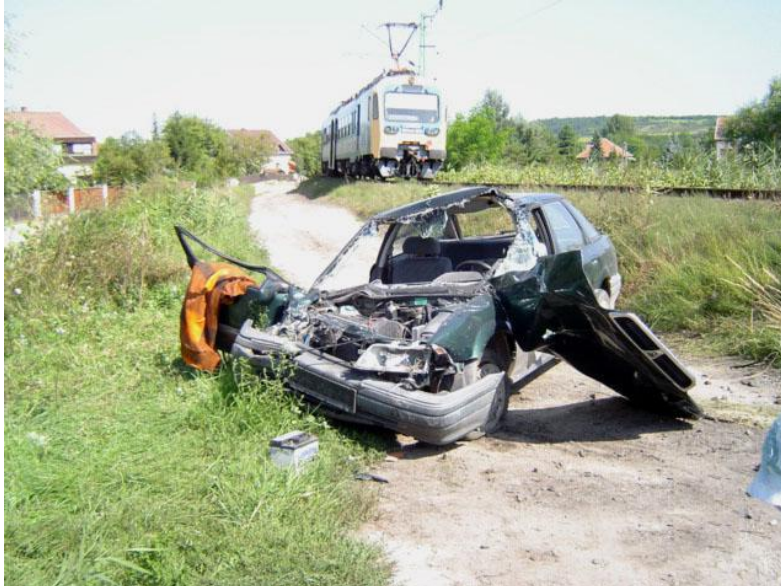
2010-382-5

On 21st August 2010 at 10:04 hrs, train no. 2422 (power car no. BDV 020) leaving Órbottyán station with signals operating properly collided with a car entering in front of the train on the unprotected level crossing in railway section no. 235+95. The train pushed the car aside the track.

As a consequence of the accident the driver of the car suffered serious injuries and was transported to the hospital by a rescue helicopter.

The car was totalled and a damage of approx. 1.2 million HUF was caused to the power car. No passengers of the train or members of the train personnel were injured.

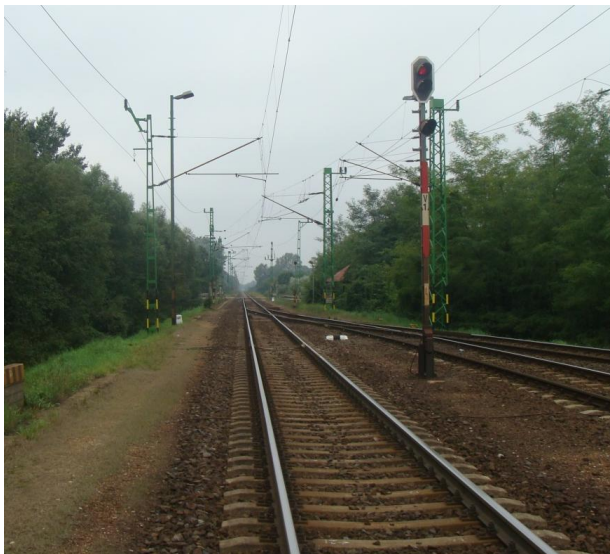
2010-410-5

On 4th September 2010 at 10:54 hrs, train no. 9912, scheduled to stop at Ikrény station, ran unauthorized through the station, passed exit signal V1 at danger, split points no. 1 and stopped as a result of the operation of the train protection system.

No one was injured in the occurrence.

The IC established during the investigation that the occurrence was caused by human factors.

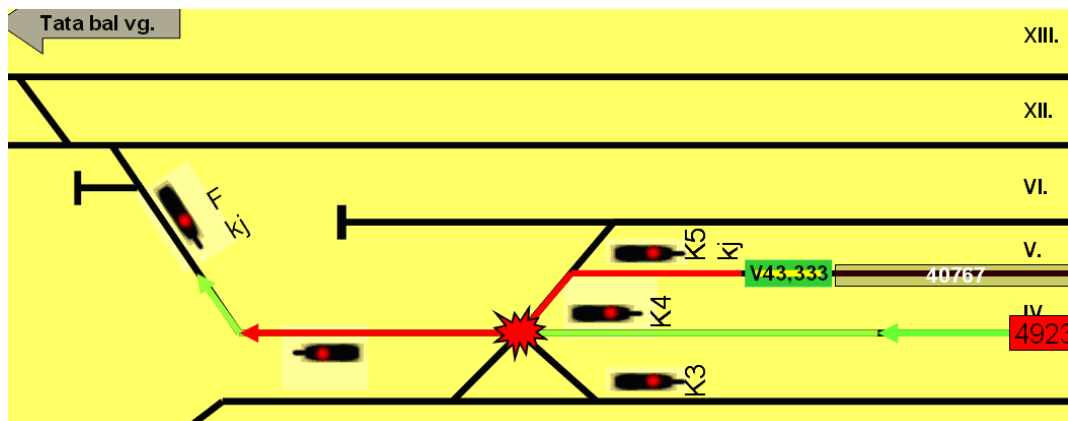
On 1st October 2010 at 19:16 hrs, freight train no. 40767 passed unauthorized from track V at Almásfüzitő station the exit signal at danger and split points no. 12a. After a notification received on train radio on the unauthorized movement the train stopped. No one was injured. During a later test a technical failure was established, namely that the signal on the track used by the train displayed even in the case of a “Stop” indication on the exit signal a different, misleading indication. Causes of the technical failure determined during the test had been detected by the safety installation inspection services, repair was completed and the inadequate operation was eliminated.

The IC considers that the occurrence was caused by the appearance due to technical failure of a misleading indication and also by human factors manifested in the fact that the engine driver had not been monitoring the indications of the exit signal and had not interpreted properly the contradictory indications received. Since the technical failure was eliminated during the investigation the IC does not consider issuance of safety recommendations necessary.

The IC considers that the occurrence was caused by the combined effect of human factors and technical failure:

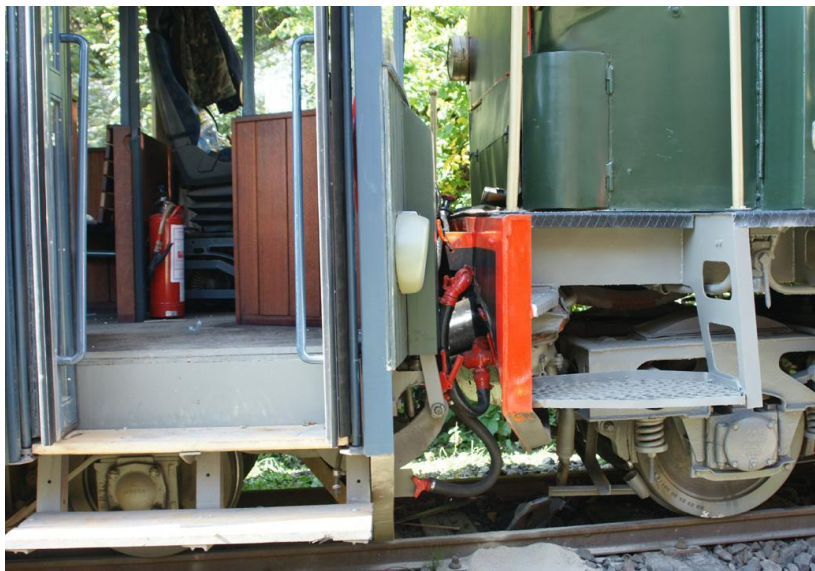
On 10th October 2010, two passenger trains moved approaching each other and collided near Hártókút station on the narrow-gauge railway line of Királyrét Forest Rail. Two passengers of the trains suffered serious, one suffered minor injuries.

The trains were scheduled to cross at Hártókút station, but the train travelling in the pair direction – arriving earlier to the station – had not waited for the other and leaving the station collided with it on the curve with poor visibility near the station.

The IC established that traffic control procedures were not applied, train crossings were completely based on the knowledge of schedule of the train crew. There had already been a similar occurrence in 2009 on the same railway line – with no collision that time – related to which TSB also established traffic control

deficiencies.

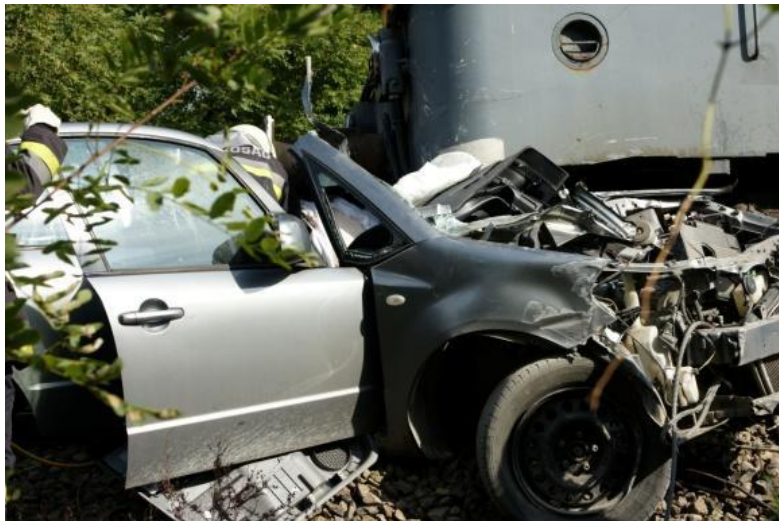
2010-474-5

On 13th October 2010 at 12:27 hrs, between Kiskunfélegyháza and Petőfiszállás stations locomotive no. V43-1010 of intercity train no. IC705 collided with a car on the level crossing AS628 protected with properly operating warning lights indicating red lights toward the road.

The driver of the car died at the site. Locomotive no. V43-1010 sustained minor damages, the car was totalled. No one of the passengers of the train was injured.

The railway track was blocked until 14:52. As a consequence of the accident 7 trains delayed 695 minutes in total.

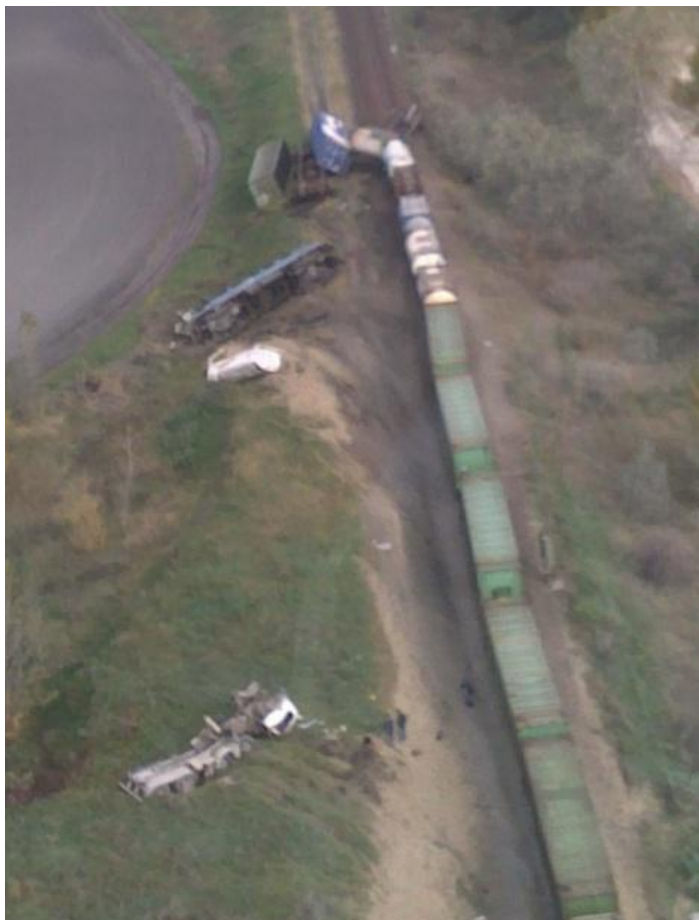
2010-490-5

On 20th October 2010, freight train no. 40760-1 collided with a lorry loaded with sand between Kiskunlacháza and Délegyháza stations on the level crossing AS322 protected with properly operating warning lights. The locomotive and the first 2

wagons of the train derailed, the locomotive fell over to the embankment, the track and the overhead contact line was damaged in a 250 m length, the lorry was totalled. The engine driver died at the site, the driver of the truck was seriously injured. The traffic on the damaged track was started on 21st October 2010 at 12:33 hrs, at the reduced speed of 10 km/h.

The IC established during the investigation that the warning lights were flashing red lights toward the road at the time of the accident, the train was not exceeding the speed limit. The IC considers that the accident was caused by human factors related to the driver of the lorry. The IC issued immediate safety recommendations concerning the structure of the level crossing.

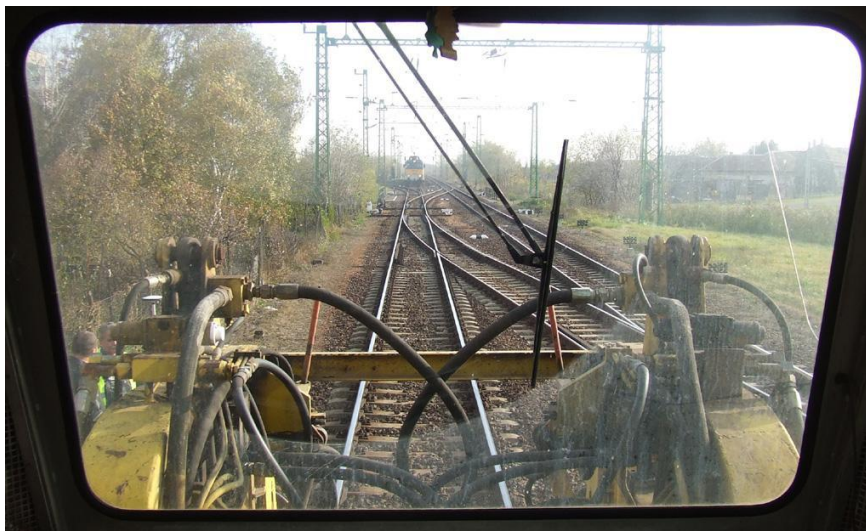
2010-504-5

On 4th November 2010, a ballast compactor running from Jászakisér to Godisa passed exit signal at danger on track II at Újszász station, split points no. 11 and approached from opposite direction to passenger train no. 3315. The two trains stopped at a 100-200 m distance from each other.

The IC established during the investigation that the occurrence was caused by lack of attention and incorrect application and interpretation of hand signals. Beyond that some of the statements of the involved

crew revealed deficiencies of their knowledge on traffic operation nevertheless, the present regulatory system does not provide the possibility of officially obligating the employees concerned to take extra exams. The problem will be solved by the foreseen legislation, therefore, the IC did not issue any safety recommendations.

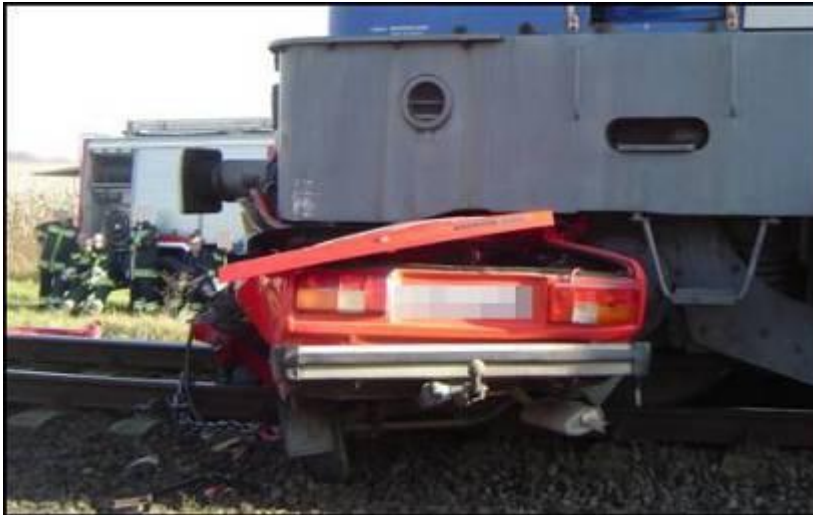
2010-520-5

On 15th November 2010 at 11:01 hrs, train no. 6200 collided with a car between Sóstóhegy and Kemece stations on the level crossing no. AS105 protected with properly operating warning lights and half-barriers. The driver of the car died at the site and the locomotive was rendered inoperative. The IC established during the on-site inspection following the accident that the structure and indication of the level crossing, toward the road traffic and railway traffic as well, were complying with the regulations. Train no. 6200 was travelling at the speed specified in the schedule and the engine driver took every action possible in order to avoid the collision.

The IC considers that the driver of the car was not approaching the level crossing with due foresight and entered it ignoring the “Stop” indication of the warning lights and the closed position of the half-barriers. He could not exit the level crossing before the train arrived and this resulted in the

collision of the vehicles. The IC considers that accidents of this kind and similar ones can be avoided by the compliance with traffic rules on how to approach and go through level crossings, therefore no safety recommendations were issued.

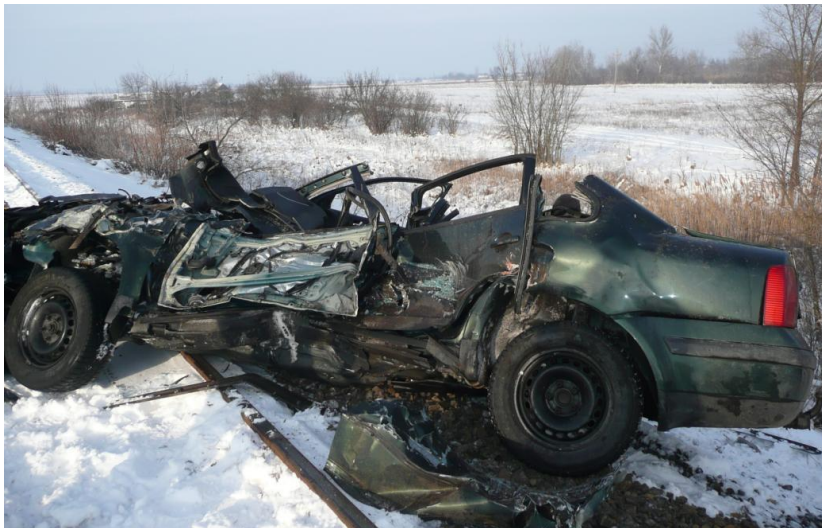
2010-597-5

On 19th December 2010, passenger train no. 7245 collided with a car on the level crossing AS319 protected with warning lights between Hódmezővásárhelyi Népkert and Mártély stations. The driver of the car suffered serious injuries. The motor coach train was damaged, the car was totalled.

The IC examined the structure and operation of the level crossing and established that the warning lights were flashing red lights toward the road at the time of the accident. The train was not exceeding the speed limit.

The driver of the car entered the level crossing ignoring the “Stop” sign displayed by the properly operating warning lights, therefore human factors can be considered as the cause of the accident.

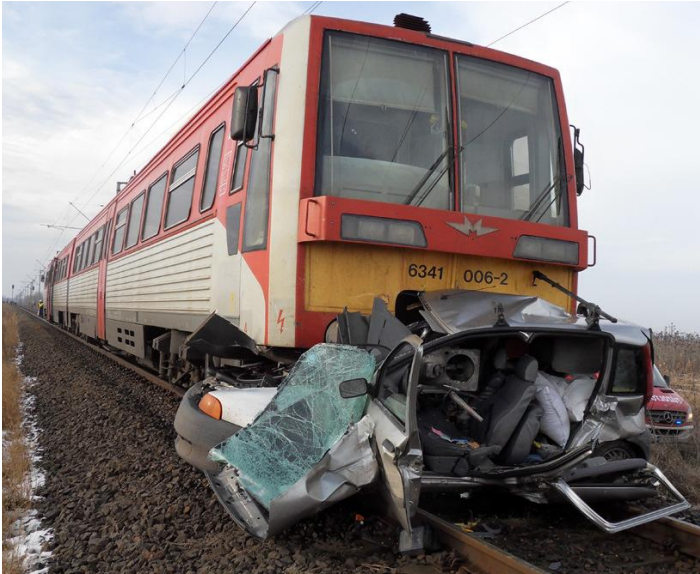
- warning lights were operating properly at the time of the accident,
- road traffic signals were partly missing, but the indications of the warning lights were clearly visible,
- the railway vehicle was travelling at a speed not exceeding the speed limit.

The IC considers that the accident was caused by human factors related to the driver of the car.

The IC considers that the accident was caused by human factors related to the driver of the car. The train was travelling at the permitted speed, the warning lights were operating properly.

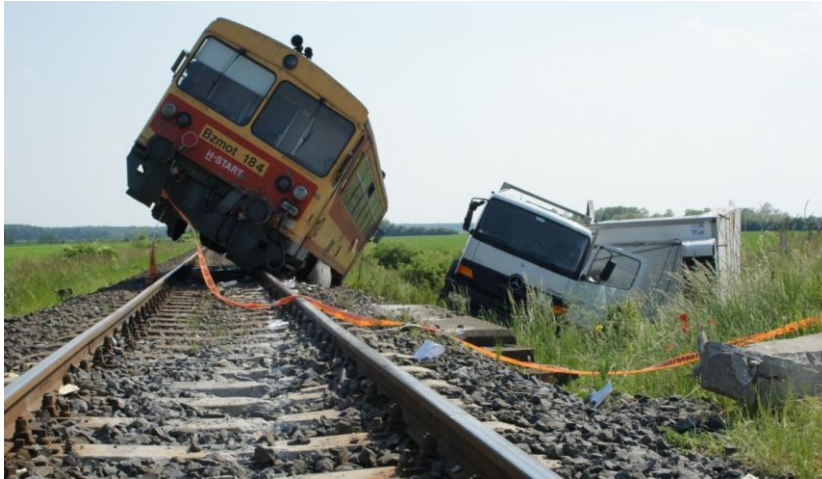
2011-218-5

On 20th May 2011 at 12:38 hrs, passenger train no. 39822 collided with a lorry on railway line Hegyeshalom-Szombathely, between Ölbö-Alsószeleste and Porpác stations on the level crossing AS24 protected with warning lights located in railway section no. 24+85. The driver of the lorry and his passenger suffered minor injuries, the power car derailed as a consequence of the accident.

The driver of the lorry and his passenger suffered minor injuries and were transported to the hospital. The train was formed of one motor coach of type Bzmot, on which one of the crew suffered minor, another suffered serious, 6 of the passengers suffered minor, one

passenger suffered serious injuries. The railway vehicle derailed with both axles and was seriously damaged, the road vehicle was also seriously damaged, its load scattered and the warning lights equipment "a" fell out.

The IC inspected on the site the structure and operation of the level crossing and because of deficiencies of sight triangles considered issuance of immediate safety recommendations necessary. The IC established during the investigation that the warning lights were indicating flashing red lights toward the road, visibility of which not being obstructed by vegetation or other obstacles. The train was travelling at a speed reaching or even exceeding the speed limit. Sight triangle at the level crossing was not properly assured due to the dense vegetation, but this did not obstruct the visibility of the warning lights.

The IC considers that the accident was caused by human factors related to the driver of the lorry.

TSB recommends the Inspectorate of Transport of the Government Office for Vas County to obligate the undertaking operating the infrastructure (MÁV Co.) to ensure the sight triangle obstructed by the dense vegetation (trees, bushes) in the LC protected by light signal no. AS24 between Ölbő-Alsószeleste and Porpác stations in railway section no. 24+97.

Issuance of the safety recommendation is justified by the fact that from the direction of the road vehicle involved in the accident sight triangles toward the direction of the approaching train no. 39822 were not assured, even though the indication of the light signal was visible from the road no. 8485. This adversely affects the visibility of road and railway vehicles approaching the LC and decreases safety by this.

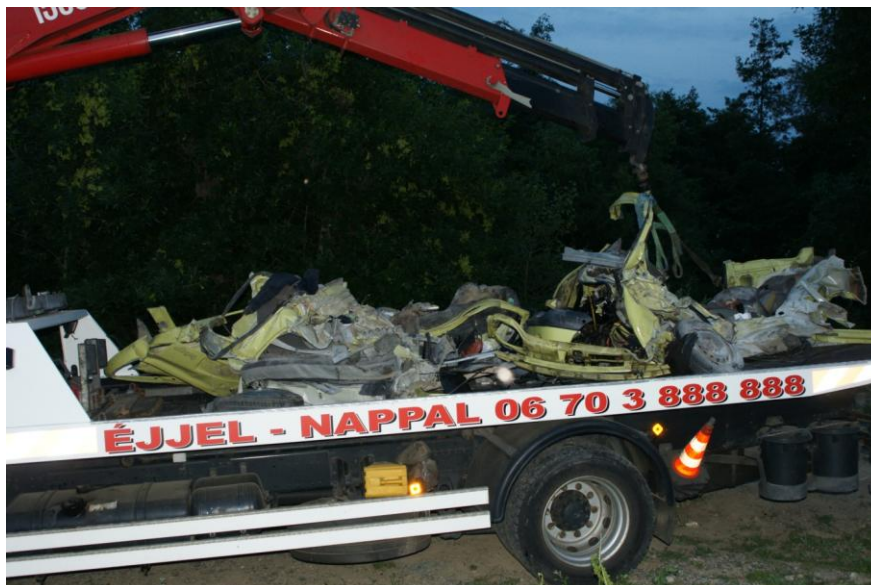
The driver of the car died at the site of the accident. Locomotive no. V43-327 was damaged and rendered inoperative. The car was totalled.

The IC established during the investigation that the warning lights were flashing red lights toward the road at the time of the accident, the train was not exceeding the speed limit.

The driver of the car entered the level crossing ignoring the flashing red lights of the properly operating warning lights, therefore human factors can be considered as the cause of the accident.
