**TRANSPORTATION SAFETY
BUREAU**

ANNUAL REPORT 2012
Transportation Safety Bureau
Hungary

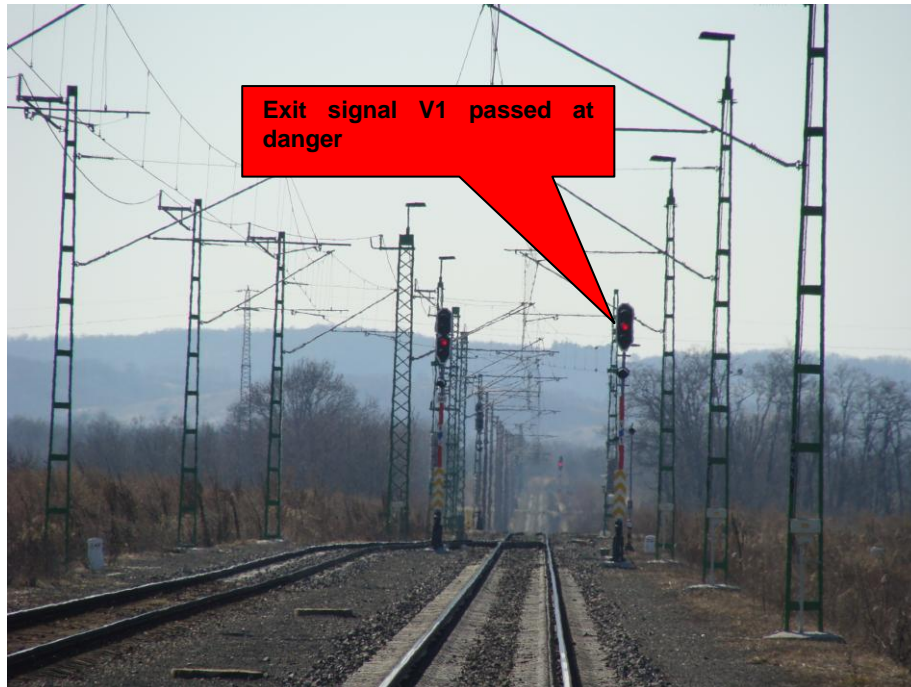
2011-106-5

On 6th March 2011 at 13:13 hrs, freight train no. 42001-2/48081-2 passed without permission exit signal V1 at danger on Ötvös turnout, left the station in the straight direction, split points no. 1 and entered the closed level crossing protected with warning lights SR1.

At the same time, passenger train no. 9534 was approaching the direction of station Zalabér-Batyk. The engine driver of the train noticed the train approaching from the opposite direction, applied emergency braking and gave visual warning signals using the lights of the locomotive. The driver of the train approaching from the opposite direction noticed the signals and stopped the train. No one was injured.

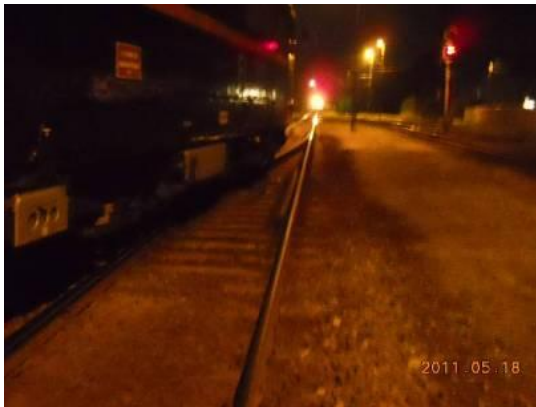
The IC considers that the occurrence was caused by human factors. The engine driver departed with the train relying on the sound signals of the digital cab signal.

The engine driver did not observe the digital cab signal or the colour indication on the exit signal K5.

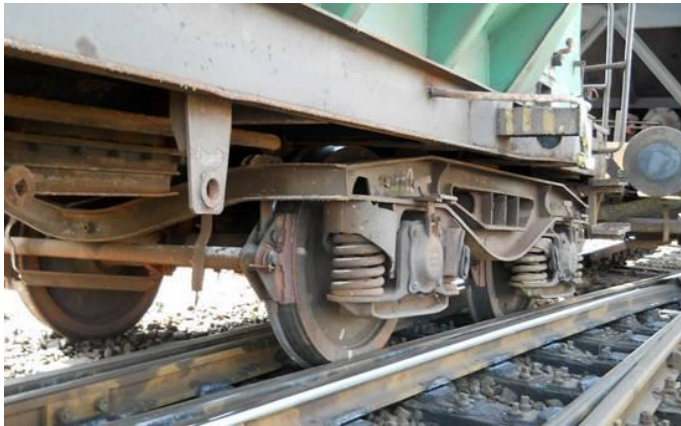
2010-563-5, 2010-576-5, 2011-425-5

On 29th August 2011 at 09:38 hrs, first two wagons set directly after the locomotive of freight train no. 45481-2 leaving Debrecen station regularly, according to the signal indications, running on track VI, derailed on the crossing middle blade of turnout 73/b. No one was injured.

In the course of the investigation of the occurrence the IC considered previous occurrences as well, and concluded that the present occurrence and its causes were similar to the mentioned previous cases.

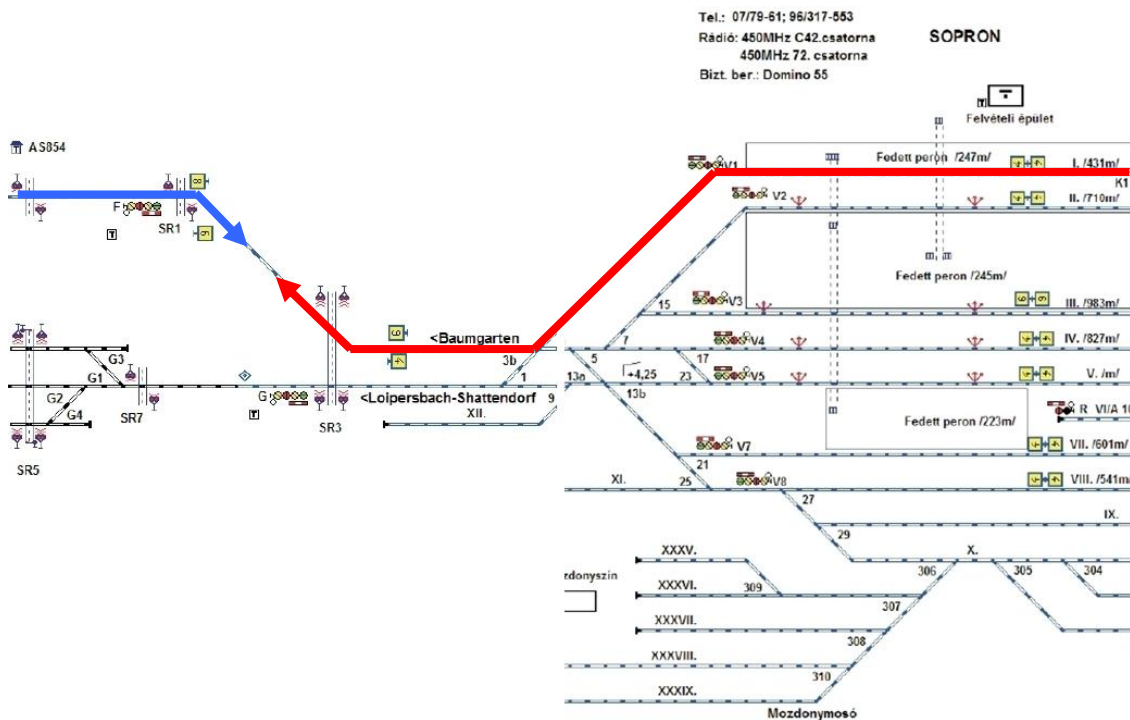
On 18th September 2011 at 22:54 hrs, train no. 47116 entering Sopron station on track V1 passed the individual exit signal at danger, running further split points no. 3/a, passed through LC protected with warning lights SR3 and entering a curve to the right noticed the light of a locomotive approaching from the opposite direction. The engine driver immediately applied emergency braking, stopped the train and notified the station inspector. The train stopped in railway section no. 848+70.

At this time, train of locomotives no. 85875 was running from Ebenfurth (Austria) station to Sopron station, the station inspector set its route to track V and set 'Clear' indication on the entry signal. The entry signal changed to 'Stop!' indication after the points no. 3/a had been split. The engine driver, when noticing this 'Stop!' indication, applied emergency braking and stopped the train at approx. 180 m distance from the train approaching from the opposite direction. No one was injured.

1. Passing of exit signal V1 at danger at Sopron station was caused by human factors, the reason of the occurrence being the fact that the train did not stop at the 'Stop!' indication of the signal.

2. Sopron station was equipped with EVM train control system, from the border INDUSI train control system was operating. Train no. 47116 was scheduled to run in Austria after leaving Sopron-Rendező station. For this reason the engine driver had set INDUSI operating mode at Sopron-Rendező station, which had the effect that no train control was operating at the time of the occurrence, since the continuous signal transmitted by the equipment of the railway line could not be interpreted by the locomotive.

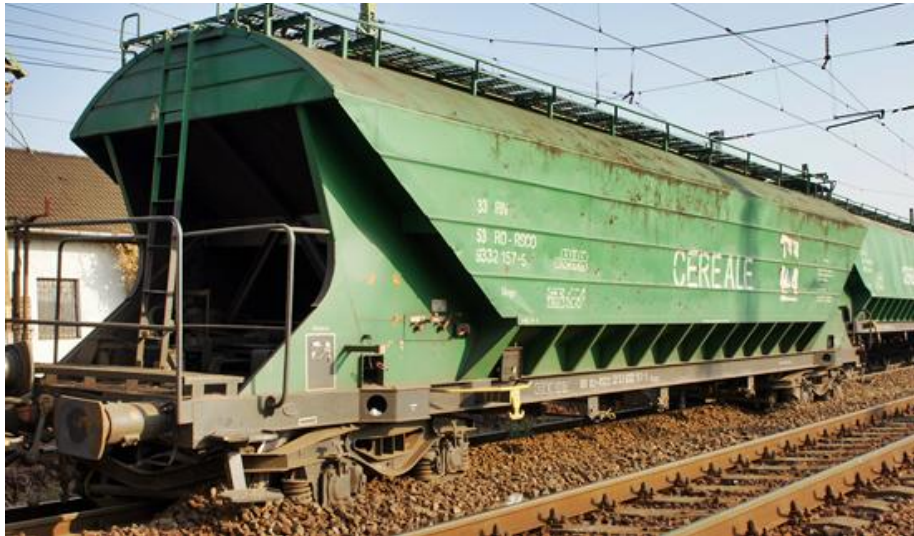
2011-474-5

On 22nd September 2011 at 5:00 hrs, the 18th wagon of train no. 45214-1 departing Szolnok station on track V derailed with four axles on the turnout no. 22. The derailed wagon damaged the points no. 22 and 14, as well as the railway track.

The IC considers that the occurrence of the accident was caused by more factors acting simultaneously, factors that acting alone would not have necessarily lead to an accident.

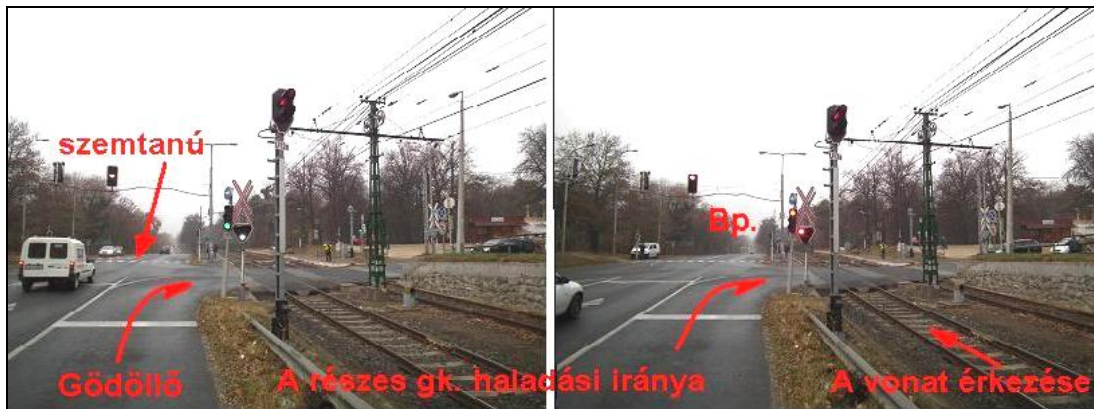
2011-588-5

On 20th November 2011 at 10:30 hrs, a passenger train on the H8 Gödöllő HÉV (suburban railways) line of BKV Zrt. collided with a car at the level crossing protected with warning lights no. AS306 at Erzsébet park stop.

One of the three persons in the car suffered serious injuries, the other two persons suffered minor injuries in the accident. The car was totalled.

The IC established that the driver of the car entered the LC and drove on the railway ignoring the 'Stop!' indication of the properly operating warning lights.

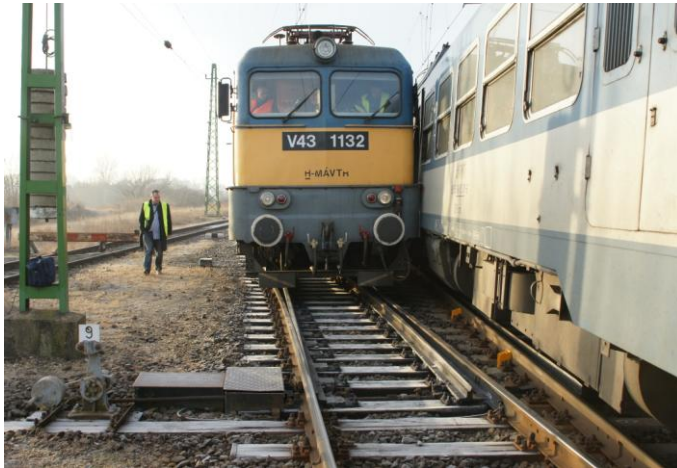
2011-610-5

On 7th December 2011 at 06:47 hrs, train no. 2378, when entering Göd station on track III under normal signalling, did not stop in the station, passed individual exit signal V3 at danger at a speed of approx. 7 km/h. Train no. 45502 departed with permission from track IV and collided into the side of train no. 2378. No one was injured. The locomotive of the freight train and the first wagon of the train set derailed.

The passing of signal V3 at danger and the collision of the trains was caused by human factors, the accident occurring because:

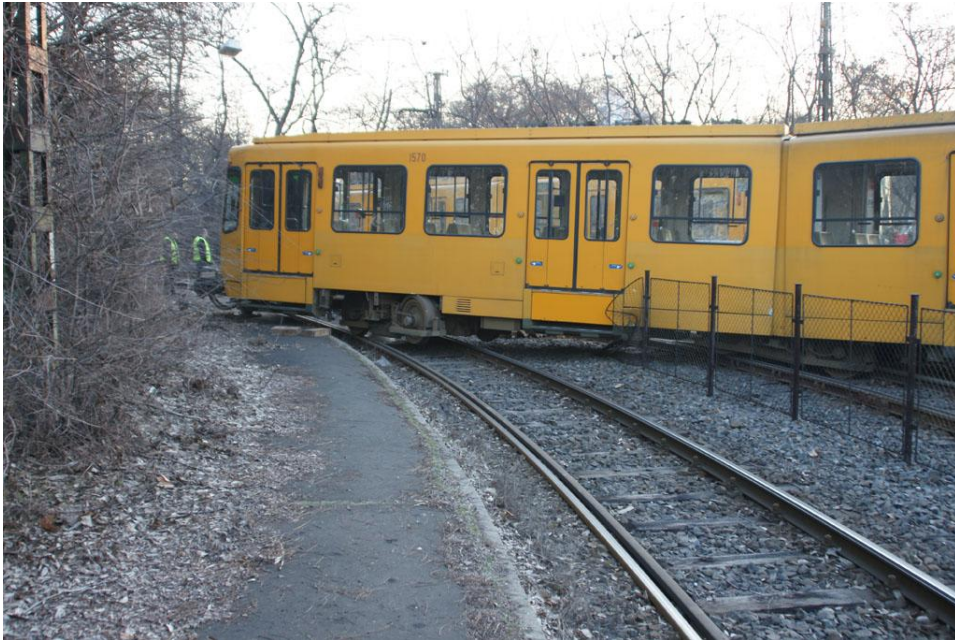
2012-067-5

On 1st February 2012, two trams were running after each other when the driver of the second tram did not notice the switching device at the first points on the branch towards Határ út at the Nagykőrösi junction and modified the points while passing it. The first tram derailed, still being in motion on the points. No one was injured, the traffic was obstructed.

The device supposed to prevent switching under the train was out of order.
