**TRANSPORTATION SAFETY
BUREAU**

ANNUAL REPORT 2013
Transportation Safety Bureau
Hungary

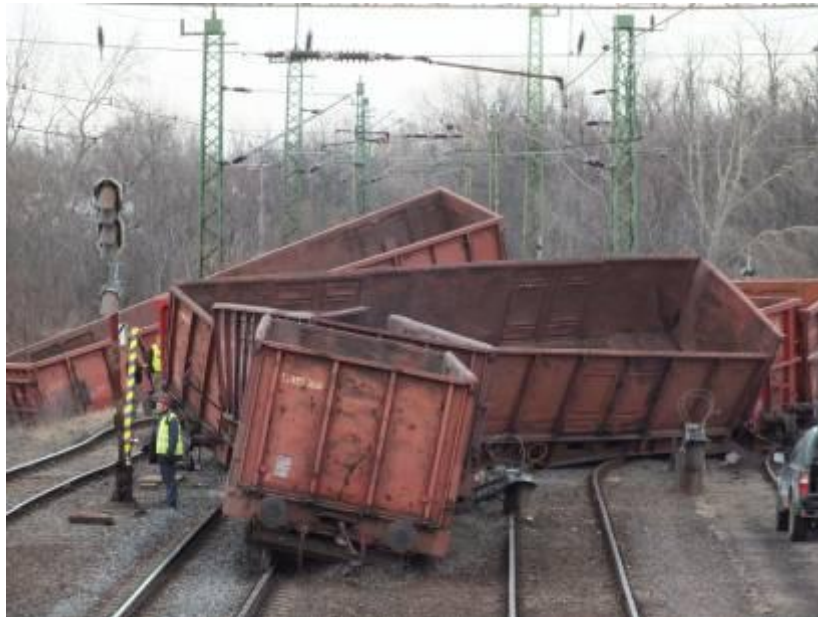
The derailed wagon was obstructed by the crossing part of the turnout at the points No. 2, and the 11 wagons running behind the derailed wagon jammed. The train was dismembered, and stopped by the brakes automatically.

There was no personal injury.
