**TRANSPORTATION SAFETY  
BUREAU**

**ANNUAL REPORT 2015**  
**Transportation Safety Bureau**  
**Hungary**

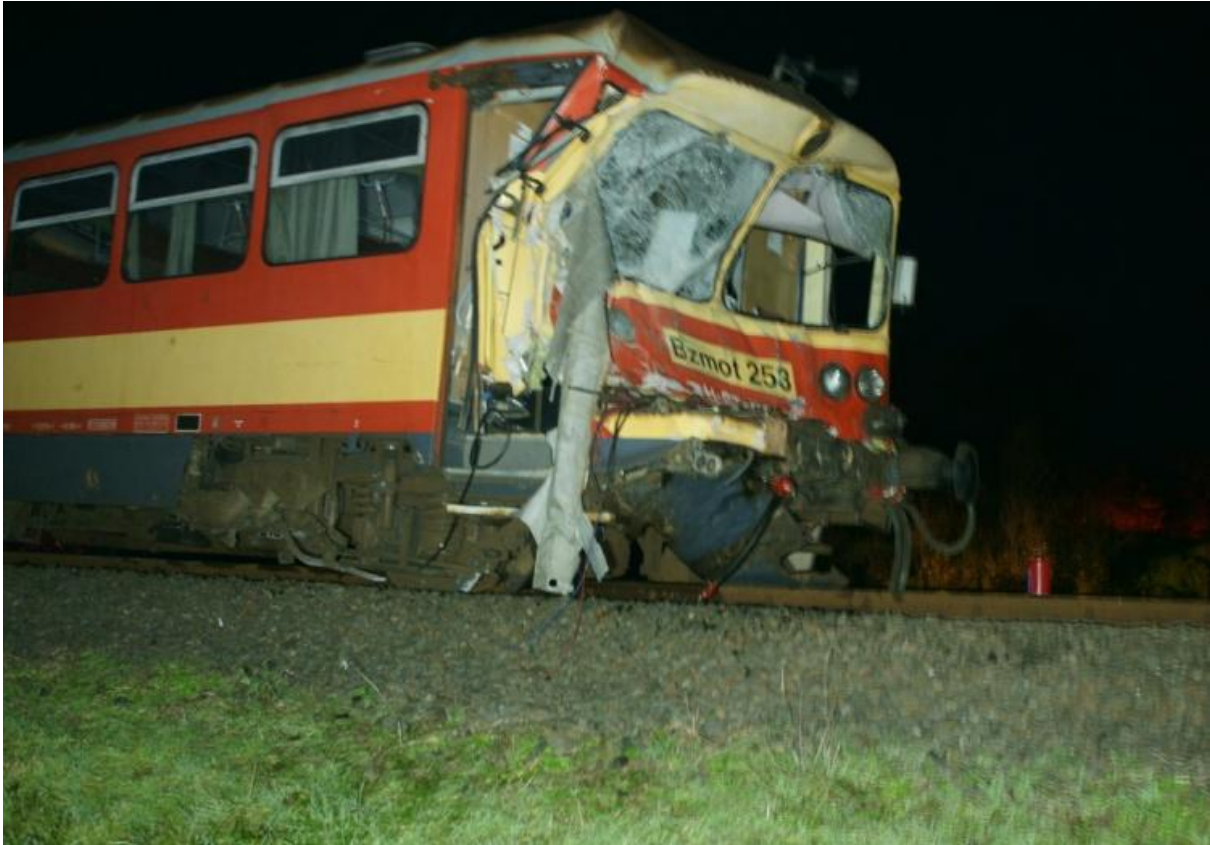
The IC attributed the occurrence to human factors on the part of the truck driver.

The driver of the truck accessed the level crossing without stopping, despite the fact that, due to the current light conditions, he could not see anything displayed (flashing red lights) by the warning light apparatus.

The IC does not find it necessary to issue a safety recommendation in connection with the occurrence.
