Ministry of  
Construction and Transport

**ANNUAL REPORT 2022**  
**Transportation Safety Bureau**  
**Hungary**

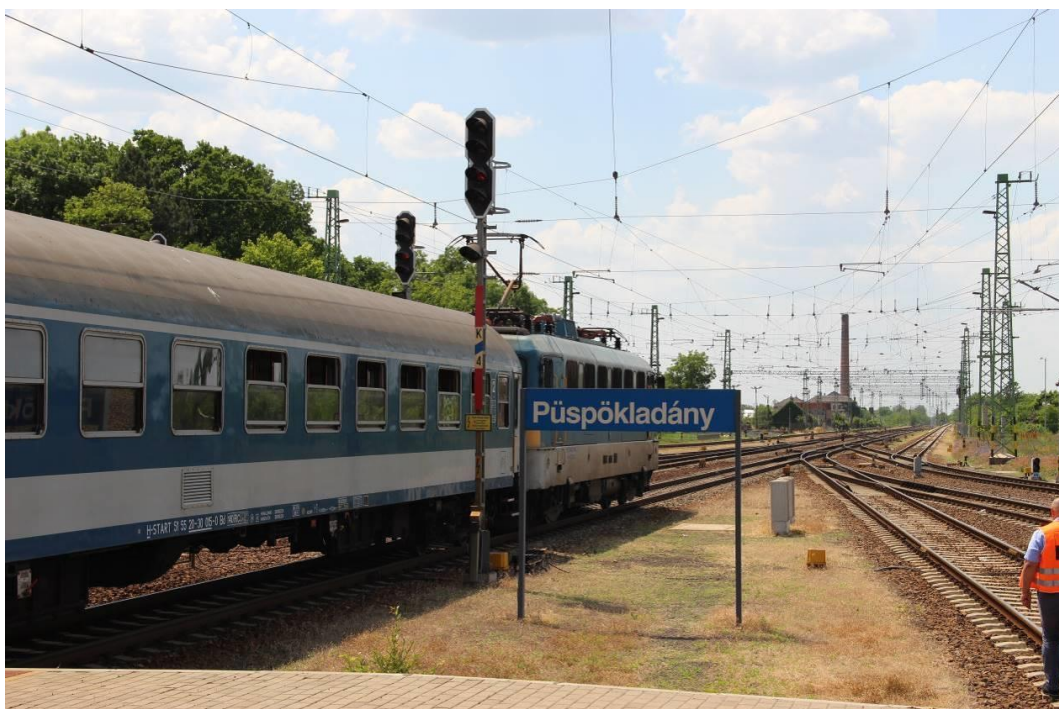
**SUMMARY OF OCCURRENCE № HU-10066**

<i>Grade:</i>	<i>Railway incident</i>
<i>Date and time:</i>	<i>15 June 2021 (22:18)</i>
<i>Location:</i>	<i>Sározd (station)</i>
<i>Occurrence type:</i>	<i>Signal passed at danger</i>
<i>Movement type:</i>	<i>Regional passenger train</i>
<i>Description:</i>	<i>Train no. 4018 departed after a scheduled stop from Sározd station and passed the „V2” exit signal at danger without permission. The train stopped in a distance of 228 meters from train of locomotives no. 28279, which was waiting near the entry signal. No injuries occurred.</i>
<i>Consequences:</i>	<i>0 fatality / 0 serious injury No damage (0 EUR)</i>
<i>Parties:</i>	<i>MÁV Zrt. (IM) MÁV-START Zrt. (RU)</i>
<u><i>Direct cause(s):</i></u>	<ul style="list-style-type: none"> <li><i>the locomotive driver did not stop the train before the exit signal at danger because his level of situational awareness was reduced and he was not aware of the signal aspect</i></li> <li><i>the chief ticket inspector gave the "Ready to depart" signal despite the exit signal giving the danger aspect</i></li> </ul>

<u><i>Contributory factor(s):</i></u>	<ul style="list-style-type: none"> <li><i>the locomotive driver's level of situational awareness was reduced by mobile phoning during the entry</i></li> <li><i>the train control equipment used could not force the train to stop before the main signal giving the "Stop!" signal or to pass in front of it at a speed of up to 40 km/h</i></li> <li><i>the chief ticket inspector was called for duty from his day off and was therefore more tired than usual</i></li> </ul>
<u><i>Underlying cause(s):</i></u>	<ul style="list-style-type: none"> <li><i>none</i></li> </ul>
<u><i>Recommendation(s):</i></u>	<i>none</i>

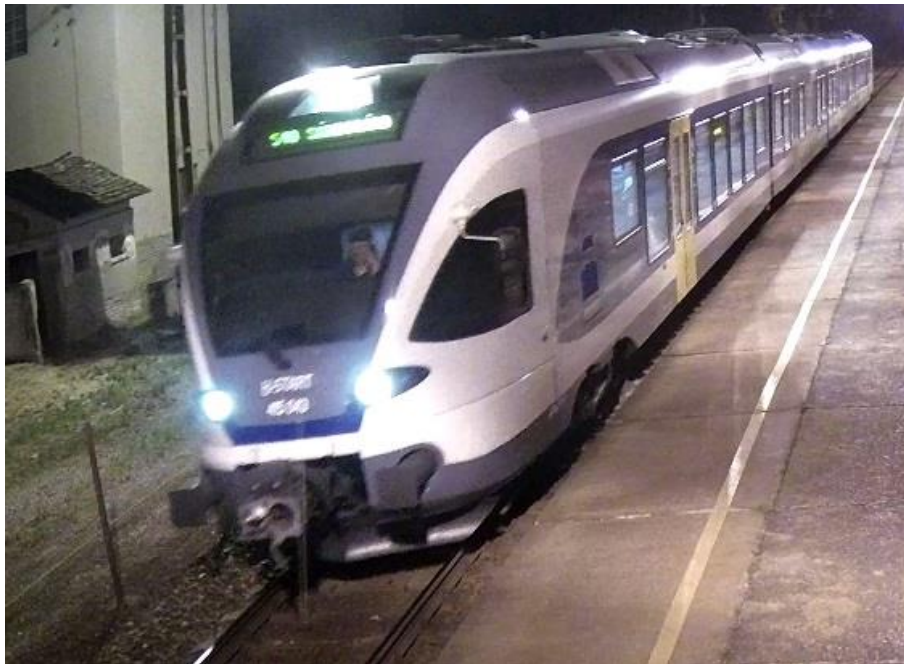
**SUMMARY OF OCCURRENCE № HU-10070**

<i>Grade:</i>	<i>Railway accident</i>
<i>Date and time:</i>	<i>18 June 2021 (09:03)</i>
<i>Location:</i>	<i>Mosonszolnok - Jánossomorja (line)</i>
<i>Occurrence type:</i>	<i>Collision of train with obstacle within the clearance gauge</i>
<i>Movement type:</i>	<i>Regional passenger train</i>
<i>Description:</i>	<i>Train no. 39847 collided with a sleeper-screw driver between Mosonszolnok and Jánossomorja stations. No injuries occurred, because the track workers could manage to escape from the structure gauge in the last moment before the crash.</i>
<i>Consequences:</i>	<i>0 fatality / 0 serious injury Total damage &lt; 150.000 EUR</i>
<i>Parties:</i>	<i>GYSEV Zrt. (IM) GYSEV Zrt. (RU)</i>
<u><i>Direct cause(s):</i></u>	<ul style="list-style-type: none"><li><i>the foreman on watch did not detect the train coming from a sufficient distance and therefore did not warn the workers in time to leave the track clearance and remove the machinery</i></li><li><i>the visible track section length was about a third of the standard stopping distance</i></li><li><i>the safety coverage of the working area was not in accordance with the rules (the watchman had other activities in addition to watching and did not display the "Work in progress on the track!" sign)</i></li></ul>

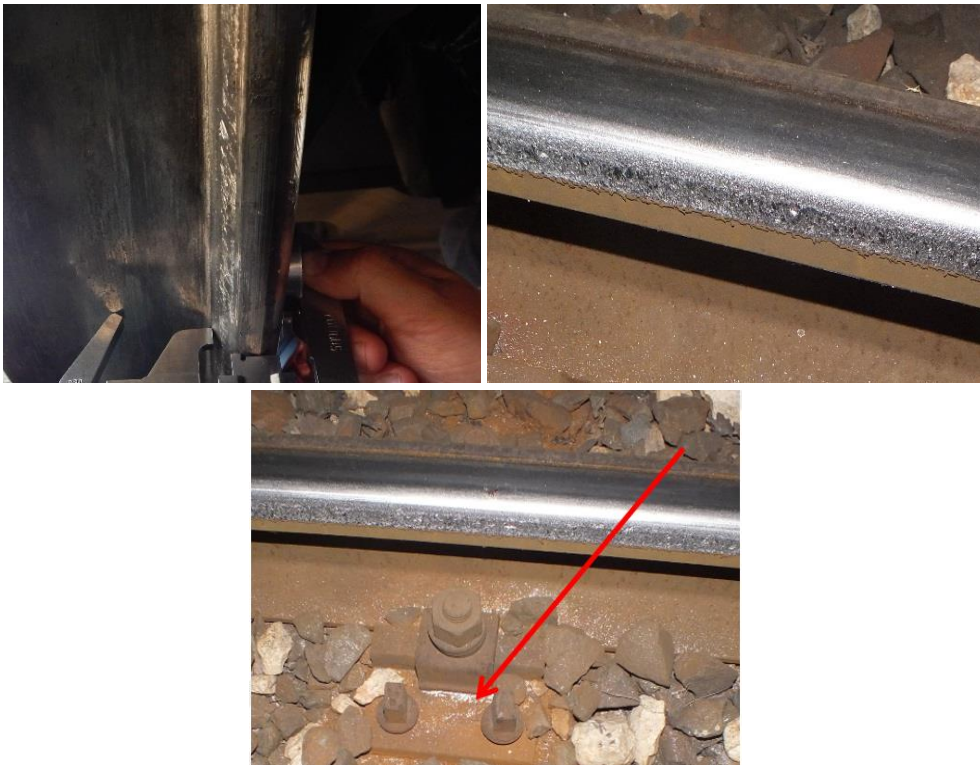
**SUMMARY OF OCCURRENCE № HU-10084**

<i>Grade:</i>	<i>Railway incident</i>
<i>Date and time:</i>	<i>11 July 2021 (14:24)</i>
<i>Location:</i>	<i>Ferencváros (station)</i>
<i>Occurrence type:</i>	<i>Operational event</i>
<i>Movement type:</i>	<i>Freight train and regional passenger train</i>
<i>Description:</i>	<i>Freight train no. 66822 entered to Ferencváros station on a track which was occupied by train no. 3545. The freight train burst open a point and harmed the locked route of the passenger train, before it stopped at the switches.</i>
<i>Consequences:</i>	<i>0 fatality / 0 serious injury No damage (0 EUR)</i>
<i>Parties:</i>	<i>MÁV Zrt. (IM) RCH Zrt. (RU) MÁV-START Zrt. (RU)</i>
<u><i>Direct cause(s):</i></u>	<ul style="list-style-type: none"> <li>• <i>the chief traffic manager made a mistake in identifying the train in front of the E signal, so he called the locomotive driver of the train with the supposed number, who actually was the locomotive driver of a train staying in a different position</i></li> <li>• <i>the instruction identified the train number but not the position of the train</i></li> <li>• <i>the driver accepted the authorisation which lacked the identification of the location</i></li> <li>• <i>the chief traffic manager did not send a subsidiary signal to the home signal</i></li> </ul>

***The NIB recommends reviewing the procedures for issuing instructions of MÁV Zrt., with a view on how it provides the necessary preparation before entry into force, taking into account that the instructions may affect several railway companies.***

***The NIB recommends that the safety management systems of railway undertakings using the national network should review the competence management in order to ensure that their training instructions contain the training requirements set out in Chapter 2.3 of Instruction T.25.***

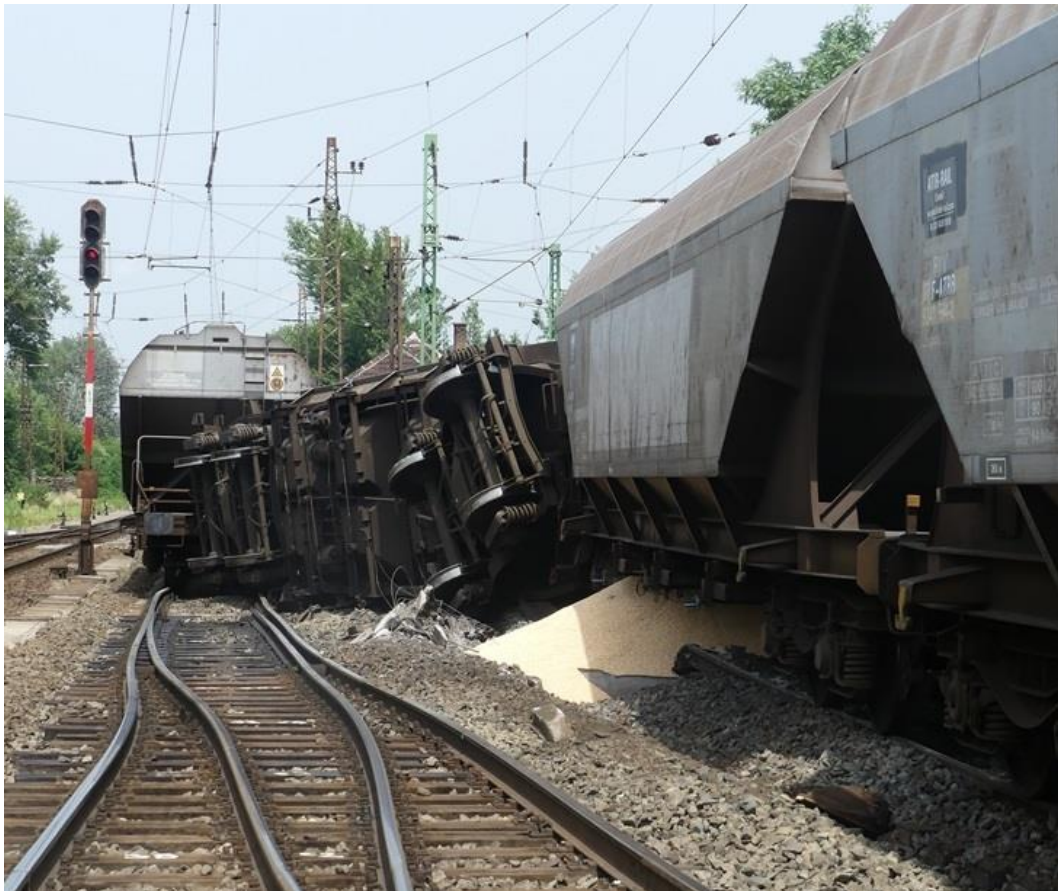
**SUMMARY OF OCCURRENCE № HU-10098**

<i>Grade:</i>	<i>Railway accident</i>
<i>Date and time:</i>	<i>28 July 2021 (15:04)</i>
<i>Location:</i>	<i>Nagykáta (station)</i>
<i>Occurrence type:</i>	<i>Train derailment</i>
<i>Movement type:</i>	<i>Other</i>
<i>Description:</i>	<i>The 4th carriage of service train no. 23613 derailed with one axle while the train was leaving Nagykáta station. No injuries occurred.</i>
<i>Consequences:</i>	<i>0 fatality / 0 serious injury Total damage &lt; 150.000 EUR</i>
<i>Parties:</i>	<i>MÁV Zrt. (IM) MÁV-START Zrt. (RU)</i>
<u><i>Direct cause(s):</i></u>	<ul style="list-style-type: none"> <li><i>the railway track has suffered gauge expansion due to a series of fractures of sleeper screws used for fixing the rails</i></li> <li><i>after the sleeper screws have been weakened by corrosion during their service life, and this had not been detected and corrected by the track supervision</i></li> </ul>
<u><i>Contributory factor(s):</i></u>	<ul style="list-style-type: none"> <li><i>none</i></li> </ul>

<u><i>Underlying cause(s):</i></u>	<ul style="list-style-type: none"> <li><i>the track supervision procedures in place do not allow the fault that led to the accident to be detected in time</i></li> <li><i>the measures necessary for detection and management are still in preparation, despite the fact that the TSB already issued a safety recommendation regarding this area on 9 January 2019</i></li> </ul>
<u><i>Recommendation(s):</i></u>	<i>none</i>

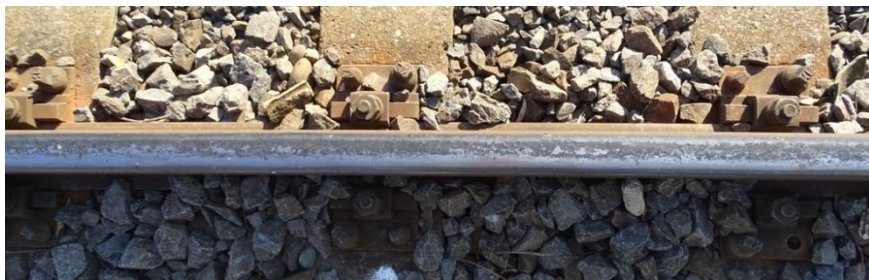
**SUMMARY OF OCCURRENCE № HU-10161**

<i>Grade:</i>	<i>Railway accident</i>
<i>Date and time:</i>	<i>7 Dec 2021 (23:30)</i>
<i>Location:</i>	<i>Szolnok B elágazás (junction)</i>
<i>Occurrence type:</i>	<i>Collision of train with obstacle</i>
<i>Movement type:</i>	<i>Freight train</i>
<i>Description:</i>	<i>Freight train no. 45999 passed signal „K” at danger with permission at Szolnok B elágazás junction, passed the point no. B4 towards a trap siding and crashed into the buffer with earth stabilization. No injuries occurred.</i>
<i>Consequences:</i>	<i>0 fatality / 0 serious injury Total damage 150.000 – 2.000.000 EUR</i>
<i>Parties:</i>	<i>MÁV Zrt. (IM) MVÁ Kft. (RU)</i>
<u><i>Direct cause(s):</i></u>	<ul style="list-style-type: none"> <li><i>the traffic controller at Post VI gave permission by telephone to the locomotive driver of the train No. 45999 to pass the signal at danger, even though he was not sure beyond reasonable doubt which signal the driver and his train were at</i></li> <li><i>the locomotive driver of the train No. 45999 started his train on the basis of the authorisation received by telephone from the traffic officer at Post VI and passed the "K" entry signal at Szolnok B junction at danger, despite the fact that he had received authorisation by telephone to pass not a main signal but a block signal</i></li> </ul>

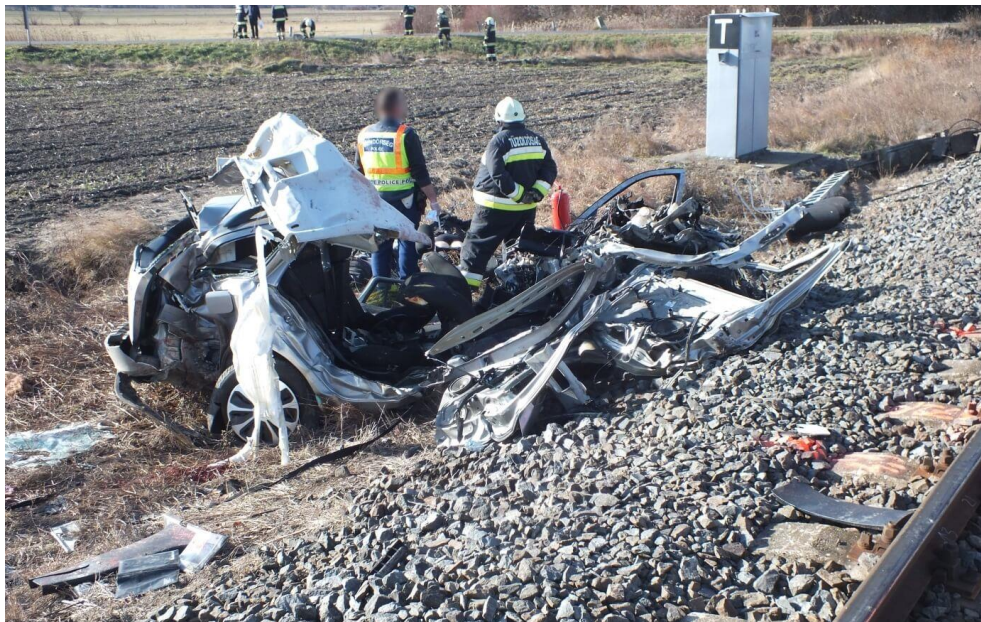
<i>Grade:</i>	<i>Railway accident</i>
<i>Date and time:</i>	<i>1 Jan 2022 (09:50)</i>
<i>Location:</i>	<i>Tapolca - Badacsonytördemic-Szigliget (line)</i>
<i>Occurrence type:</i>	<i>Level crossing accident</i>
<i>Movement type:</i>	<i>Regional passenger train</i>
<i>Description:</i>	<i>The passenger train No. 9797 collided with a car between Badacsonytördemic-Szigliget and Tapolca stations, in the level crossing AS1159 with operating active protection system. Of the 5 people in the car, 4 were killed and 1 suffered serious injuries; no occupant on the train was injured.</i>
<i>Consequences:</i>	<i>4 fatality / 1 serious injury Total damage &lt; 150.000 EUR</i>
<i>Parties:</i>	<i>MÁV Zrt. (IM) MÁV-START Zrt. (RU)</i>
<i><u>Direct cause(s):</u></i>	<ul style="list-style-type: none"><li><i>the driver of the road vehicle failed to stop at the “Warning! Level crossing!” sign, ignoring the red flashing light (“NO GO”) signal, and ran into the crossing at the time when the train arrived</i></li></ul>

<i><u>Contributory factor(s):</u></i>	<ul style="list-style-type: none"><li><i>none</i></li></ul>
<i><u>Underlying cause(s):</u></i>	<ul style="list-style-type: none"><li><i>none</i></li></ul>
<i><u>Recommendation(s):</u></i>	<i>none</i>

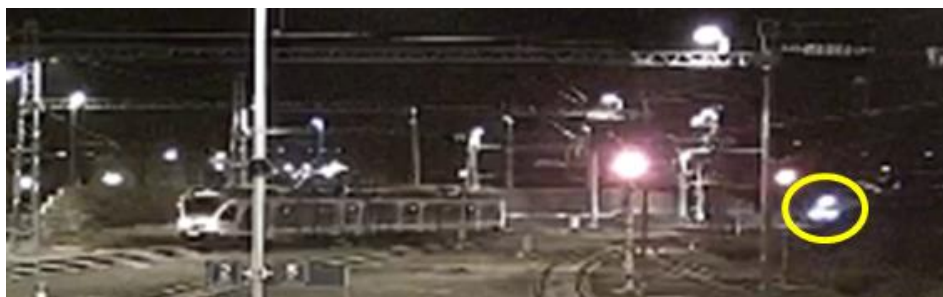
**SUMMARY OF OCCURRENCE № HU-10178**

<i>Grade:</i>	<i>Railway incident</i>
<i>Date and time:</i>	<i>10 Jan 2022 (20:03)</i>
<i>Location:</i>	<i>Gödöllő (station)</i>
<i>Occurrence type:</i>	<i>Signal passed at danger</i>
<i>Movement type:</i>	<i>Locomotive running solo and long distance passenger train</i>
<i>Description:</i>	<i>At Gödöllő station, the train No. 23028 (locomotive running solo) passed the second exit signal at danger without authorization by about 50 metres and stopped at the shunting limit signal between Tracks I and II. The passenger train No. IC658, which was entering Track II of the station, stopped with emergency braking, 125 metre away from the train No. 23028.</i>
<i>Consequences:</i>	<i>0 fatality / 0 serious injury No damage (0 EUR)</i>
<i>Parties:</i>	<i>MÁV Zrt. (IM) MÁV-START Zrt. (RU)</i>
<u><i>Direct cause(s):</i></u>	<ul style="list-style-type: none"> <li>the locomotive driver of the train No. 23028 did not stop at the second exit sign "V1a" at danger because he did not detect it when approaching it or, if he did, he did not become aware of its meaning</li> </ul>

<u><i>Contributory factor(s):</i></u>	<ul style="list-style-type: none"> <li>the locomotive driver of the train No. 23028 misinterpreted, at least in part, the first exit signal aspect "V1" and failed to prepare to stop the train within half the actual stopping distance</li> <li>the locomotive driver of the train No. 23028 was not aware that he had passed a main signal at danger when the train was forced to brake by the train control system, so he started again after the main brake pipe had been filled up</li> <li>the locomotive driver of the train No. 23028 is presumed to have had a temporary loss of concentration below the critical level at the time of the incident, as evidenced by the fact that, at the periodic psychological fitness test ordered after the incident, his age corrected psychological state at the medical examinations was not stable and only partially met the required standards; additionally the misjudgement of the situation by him in his presumed distracted state may have facilitated by environmental factors such as the layout of the station track network and the track alignment</li> </ul>

<u><i>Underlying cause(s):</i></u>	<ul style="list-style-type: none"> <li>psychological testing is not a compulsory part of the periodic medical fitness assessment of locomotive drivers, therefore any age-related mental performance deterioration of employees can be hidden</li> </ul>
<u><i>Recommendation(s):</i></u>	<b>The NIB recommends that the Ministry of Construction and Transport, as the technical preparatory body for transport legislation, to consider proposing an amendment to Government Decree 203/2009 (IX.18.) on the health requirements and medical examination procedure for employees performing railway transport safety-related tasks, so that psychological examinations are included in the periodic medical examinations of railway vehicle drivers (locomotive drivers) with a specified periodicity.</b>

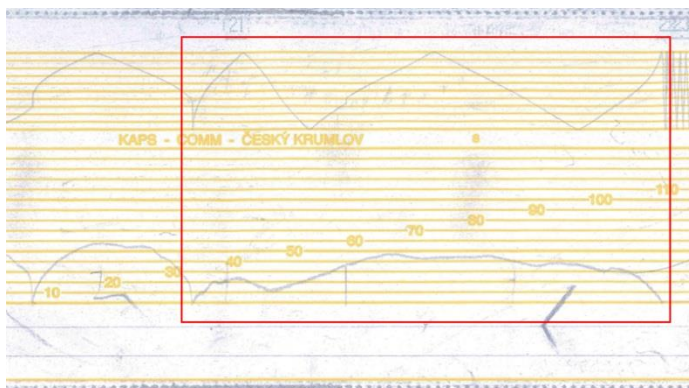
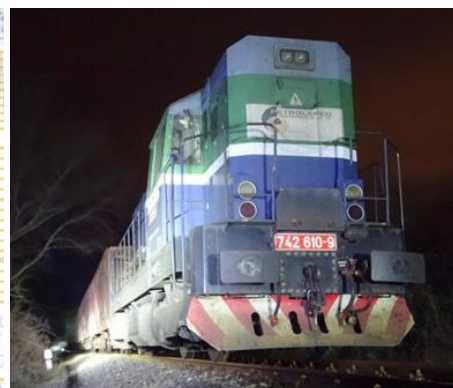
## SUMMARY OF OCCURRENCE № HU-10177

Grade:	Railway incident
Date and time:	10 Jan 2022 (21:32)
Location:	Hidasnémeti (station)
Occurrence type:	Runaway
Movement type:	Freight train
Description:	The freight train No. 47920 (1807 tons), which ran away without crew at Barca station (about 20 km from the Hungarian border in Slovakia), entered the country (Hungary), passed through Hidasnémeti station on an unoccupied track and, and due to the terrain, stopped on the line about 5 km later. There were no injuries during the incident.
Consequences:	0 fatality / 0 serious injury No damage (0 EUR)
Parties:	MÁV Zrt. (IM) PETROLSPED SLOVAKIA (RU)
<u>Direct cause(s):</u>	<ul style="list-style-type: none"> <li>the brake valve of the diesel locomotive, which was forwarded at the end of the train № 47920 closed but engaged, remained in the 'running' position, so during the walk-around check at Barca station (Slovakia), the main brake of the train set was filled up due to the refilling and the air brake got released</li> <li>in Hidasnémeti, the pre-departure brake test of the train № 47920 was unprofessional</li> <li>during the walk-around check at Barca station (Slovakia), the train № 47920 was not secured against running away</li> </ul>

<u>Contributory factor(s):</u>	<ul style="list-style-type: none"> <li>the railway company did not provide the necessary staff to carry out the brake test properly</li> <li>due to language difficulties, it was not possible to notify the Hungarian traffic management of the emergency in time</li> </ul>
<u>Underlying cause(s):</u>	<ul style="list-style-type: none"> <li>the infrastructure manager did not ensure that, in accordance with the local contract in force, a traffic manager with the necessary language skills is assigned to border-crossing traffic management</li> </ul>
<u>Recommendation(s):</u>	<p><b>NIB recommends MÁV Zrt. to review the fulfilment of the expected staff competences in its safety management system to ensure that the language skills of the staff and the applicable language under the border transition contracts are in line.</b></p> <p><b>NIB recommends MÁV Zrt. ensure that the audio recording of the communication equipment (including service mobile phones) used at Hidasnémeti station is properly implemented, including the purpose of making their voice material available. NSA should, where necessary, oblige the infrastructure manager to provide adequate voice recording services.</b></p>

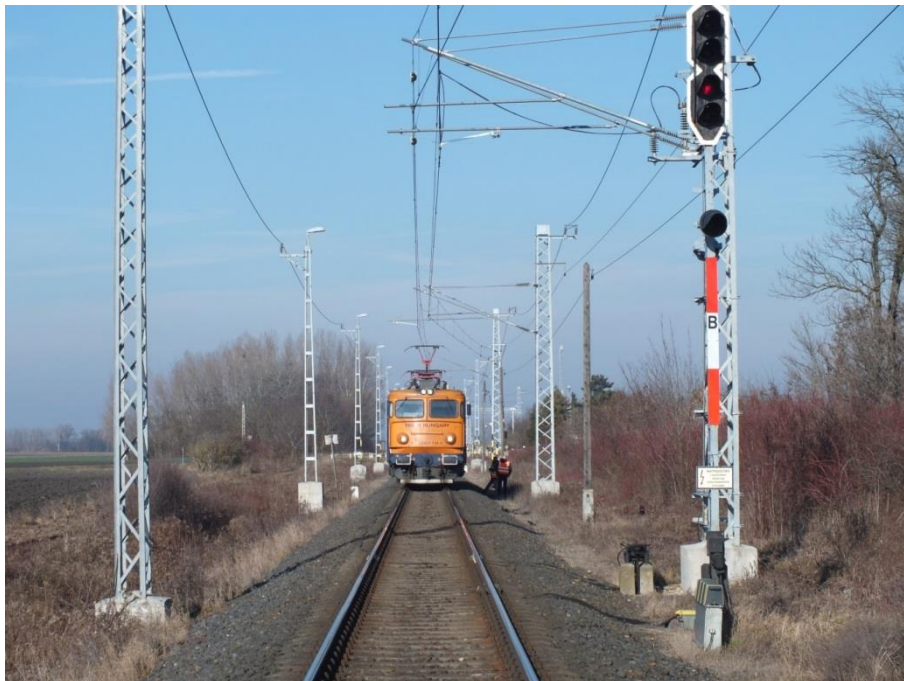
**SUMMARY OF OCCURRENCE № HU-10184**

<i>Grade:</i>	<i>Railway incident</i>
<i>Date and time:</i>	<i>16 Jan 2022 (09:09)</i>
<i>Location:</i>	<i>Bősárkány (station)</i>
<i>Occurrence type:</i>	<i>Signal passed at danger</i>
<i>Movement type:</i>	<i>Locomotive running solo</i>
<i>Description:</i>	<i>At Bősárkány station, the train No. 39880 (locomotive running solo) passed the exit signal at danger without authorization, burst the switch No. 1 open and passed the unmanaged (open) SR1 level crossing, then stopped.</i>
<i>Consequences:</i>	<i>0 fatality / 0 serious injury No damage (0 EUR)</i>
<i>Parties:</i>	<i>GYSEV Zrt. (IM) TRAIN HUNGARY (RU)</i>
<u><i>Direct cause(s):</i></u>	<ul style="list-style-type: none"><li><i>the “IAG” device that operates the servo motor for the tap changer failed, so the locomotive continued traction while the driver applied the brakes</i></li><li><i>the driver had previously started his train despite being informed of the unsafe operation of the tap changer</i></li></ul>

<u><i>Contributory factor(s):</i></u>	<ul style="list-style-type: none"><li><i>he locomotive driver did not realise that there were other options available to him to stop traction, such as the emergency stop switch, the main circuit breaker switch and the pantograph switch</i></li><li><i>the locomotive does not have a main brake pipe pressure switch to prevent traction in the event of inadequate main brake pipe pressure</i></li></ul>
<u><i>Underlying cause(s):</i></u>	<ul style="list-style-type: none"><li><i>the locomotive drivers’ valid knowledge of the vehicle type and their decades of driving experience do not necessarily reflect their confidence in handling vehicles, and knowledge is not always at a skill level</i></li></ul>
<u><i>Recommendation(s):</i></u>	<i>none</i>

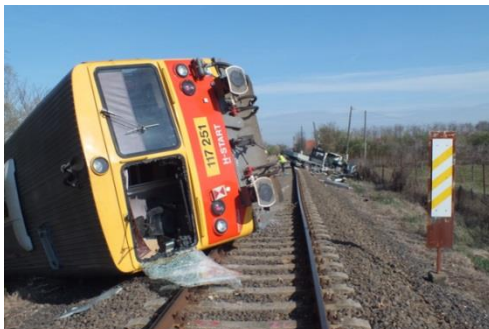
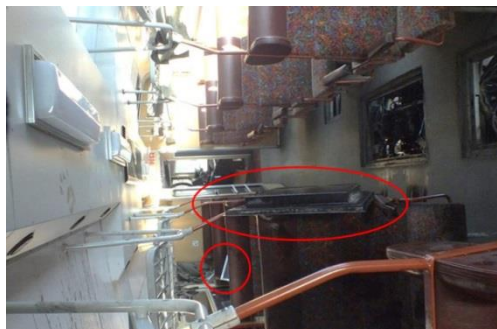
**SUMMARY OF OCCURRENCE № HU-10217**

<i>Grade:</i>	<i>Railway accident</i>
<i>Date and time:</i>	<i>5 April 2022 (06:50)</i>
<i>Location:</i>	<i>Mindszent – Hódmezővásárhelyi Népkert (line)</i>
<i>Occurrence type:</i>	<i>Level crossing accident</i>
<i>Movement type:</i>	<i>Regional passenger train</i>
<i>Description:</i>	<i>Between Mindszent and Hódmezővásárhelyi Népkert stations, the passenger train No. 32610 collided with a van in the level crossing AS187 equipped with warning lights. The DMU of the train derailed and tipped on its side. 5 people in the lorry were killed and 2 seriously injured, while 4 people on board suffered seriously- and 11 more suffered minor injuries.</i>
<i>Consequences:</i>	<i>5 fatality / 6 serious injury Total damage 150.000 – 2.000.000 EUR</i>
<i>Parties:</i>	<i>MÁV Zrt. (IM) MÁV-START Zrt. (RU)</i>
<u><i>Direct cause(s):</i></u>	<ul style="list-style-type: none"> <li>the driver of the road vehicle entered the level crossing despite the flashing red light of the well-functioning warning light system</li> </ul>

<u><i>Contributory factor(s):</i></u>	<ul style="list-style-type: none"> <li>the unfavourable position of the sun made the checking of the warning lights difficult (but not impossible by their design)</li> <li>the unfavourable forces of the collision caused the railway vehicle to derail and turn over</li> <li>parts have been released in the passenger compartment of the overturned railway vehicle, partly due to a design defect and partly due to a maintenance-operation defect</li> </ul>
<u><i>Underlying cause(s):</i></u>	<ul style="list-style-type: none"> <li>the design of the railway vehicle does not allow for rapid evacuation/rescue of passengers from the wreck</li> </ul>
<u><i>Recommendation(s):</i></u>	<p><b>The NIB recommends Csongrád-Csanád County Government Office to review the construction of the railway crossing in section 187 on the Tiszatenyő-Szentes-Hódmezővásárhely railway line and to take the necessary measures to ensure visibility of the railway track as required by law.</b></p> <p><b>The NIB recommends that the technical certificates for the 117 series (Bzmot) motor vehicles be reviewed and, if necessary, amended to ensure that there are no unsecured parts in the passenger compartment that could cause injury to passengers if the vehicle derails or even turns over.</b></p> <p><b>The NIB recommends that the technical approvals of the Series 117 (Bzmot) motor vehicles and their trailers be reviewed and, if necessary, amended to ensure that the vehicles are fitted with the necessary emergency exits (doors and windows that can also be used as emergency exits) and that the vehicle is equipped with the necessary accessories.</b></p>
