*Maritime Administration of  
Latvia*

*Division for Investigation of Maritime Accidents*

***Foundering of Latvian  
f/v BEVERĪNA and loss of 6  
crew members lives in vicinity  
of port of Liepāja (Latvia).***

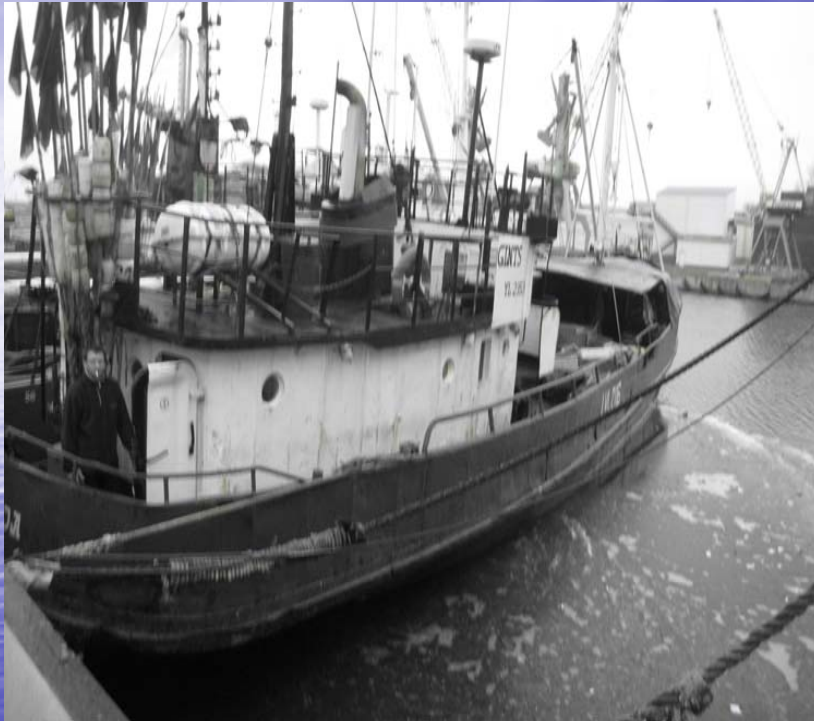
- 02.12.2008 *BEVERĪNA* was on her way back to the port of Liepāja.
- At 1620 (LT) the captain of *BEVERĪNA* reported to Liepāja VTS about the main engine and steering gear failure. MRCC Riga is informed about the situation.
- f/v *GINTS* was ordered to take *BEVERĪNA* on tow.

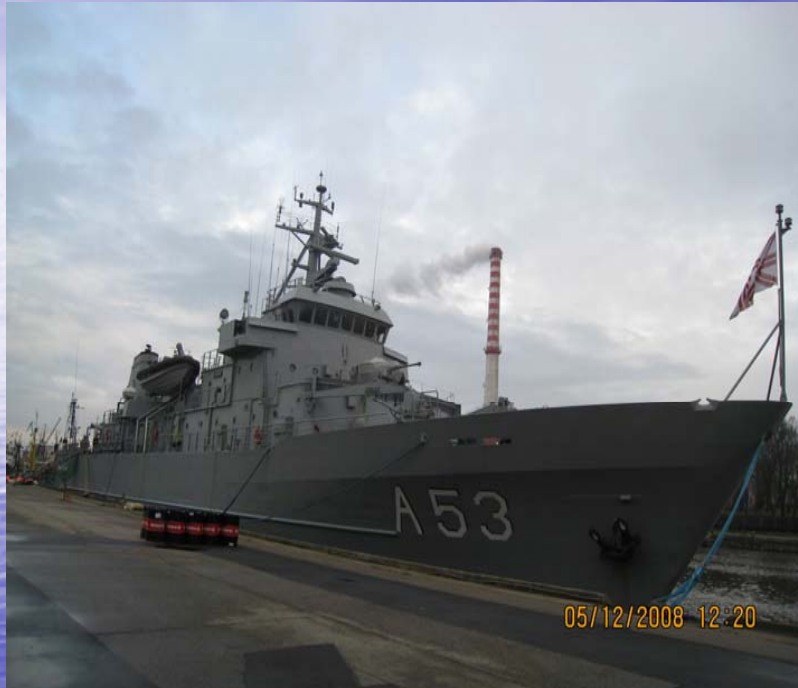
- At 1824 MRCC Riga ordered the coast guard vessel *A-53 VIRSAITIS*, which was nearby the port of Liepāja, to assist *BEVERĪNA*, if necessary.

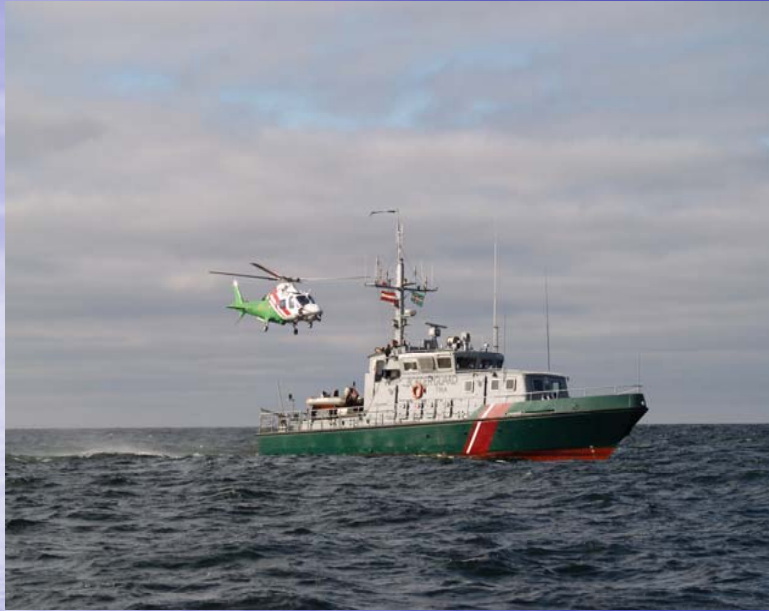
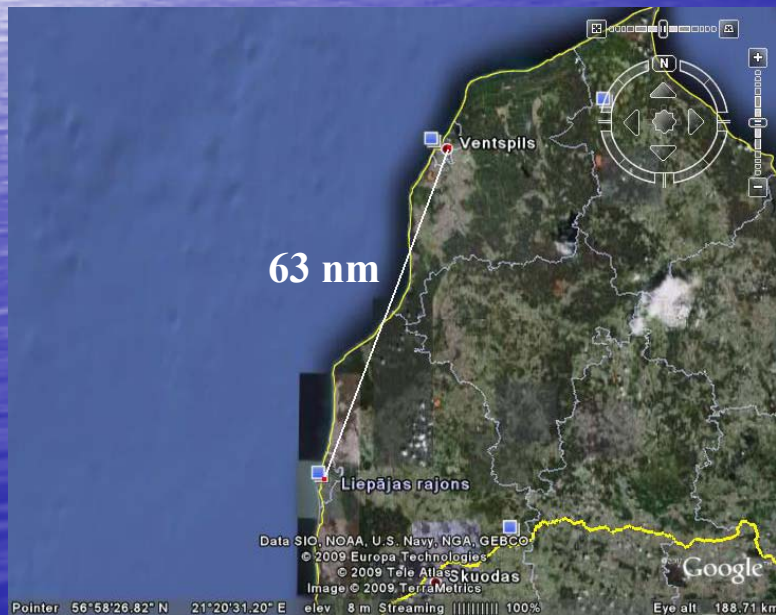
- 2255 border guard vessel *TIIRA* joins the site of accident.
- 2307 *VIRSAITIS* ceases SAR operation due to bad weather.
- 2336 Swedish helicopter arrived at the site of accident.
- 2357 Helicopter departed from site of accident to Ventspils for refueling(it was not possible to take fuel in Liepāja).
- On 3 of December at 0140 helicopter back at site of accident.
- SAR operations continued till 0300, but without any success.

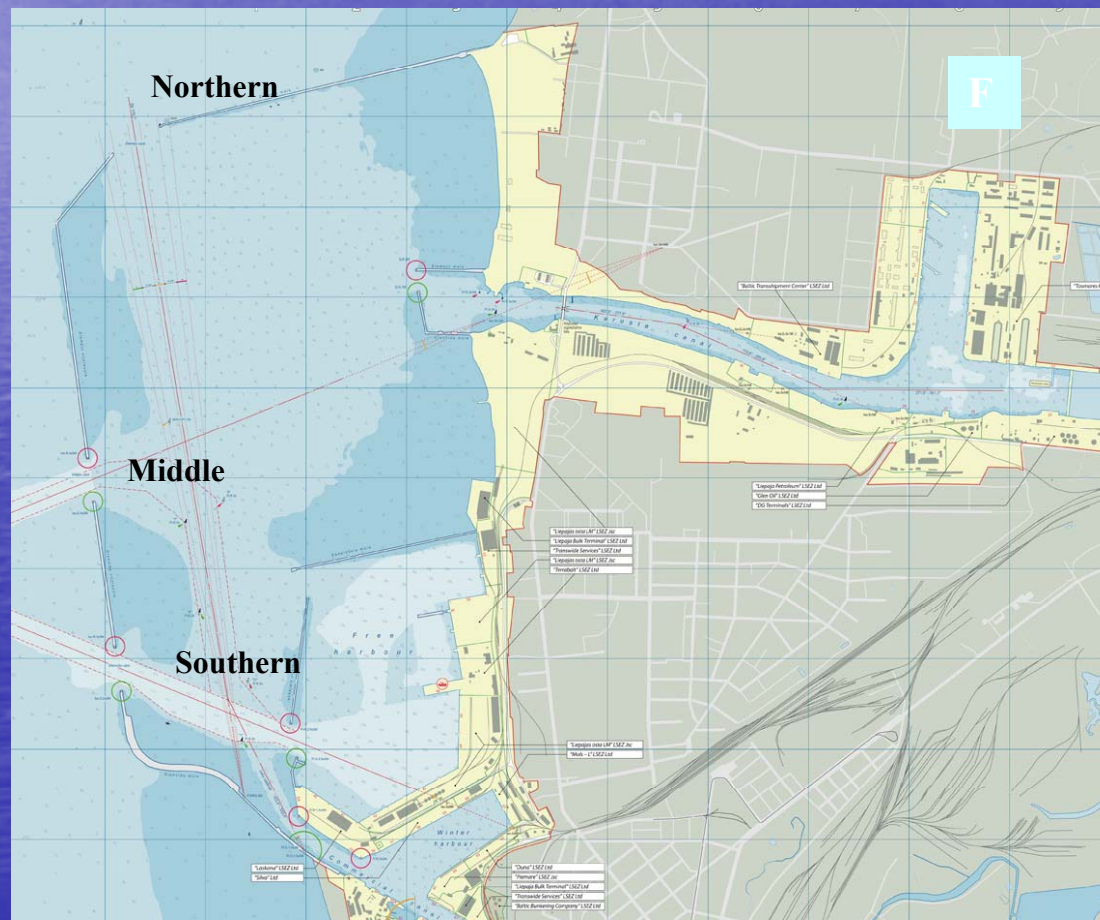
- Considering an advantage of the port of Liepāja, that the entrance into the port is possible through 3 sea gates, Liepāja VTS prohibition to *BEVERĪNA*, which was in emergency situation, to enter the port is doubted.
