MINISTRY FOR
INNOVATION AND TECHNOLOGY
TRANSPORTATION SAFETY BUREAU

FINAL REPORT

Serious incident

Airbus A320

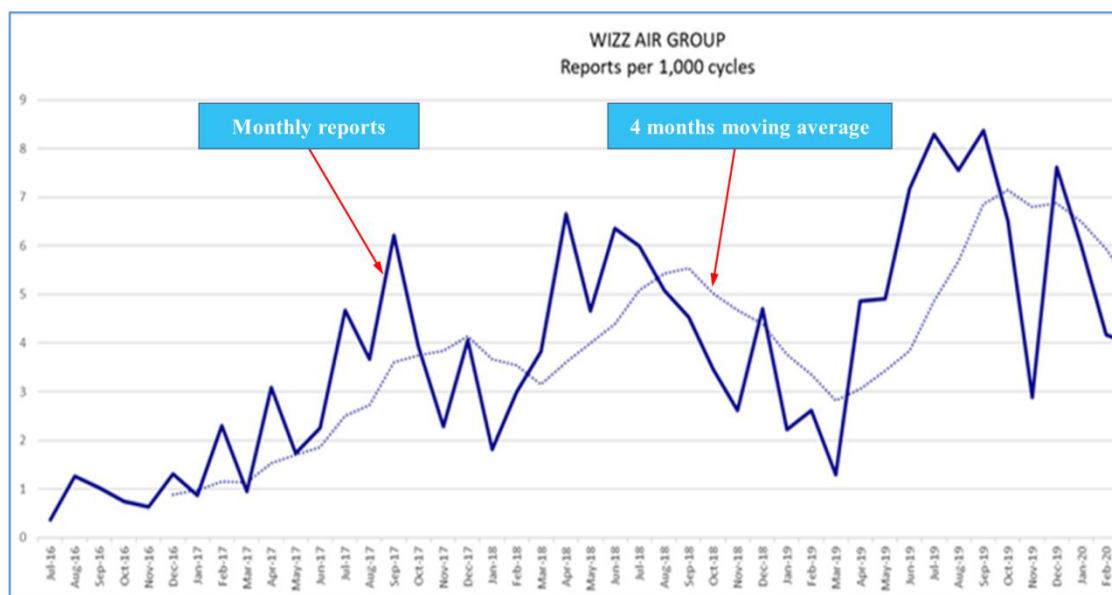
Diagram 1: Monthly number of reports (per 1 000 flights) of fatigue submitted by crewmembers of the airline concerned, (source: Airline)
