2006-069

The control car of a passenger train collided with a concrete mixer lorry between Pécel and Isaszeg stations. The concrete mixer fell onto the rail track as a consequence of a road accident at Nagytartcsa junction.

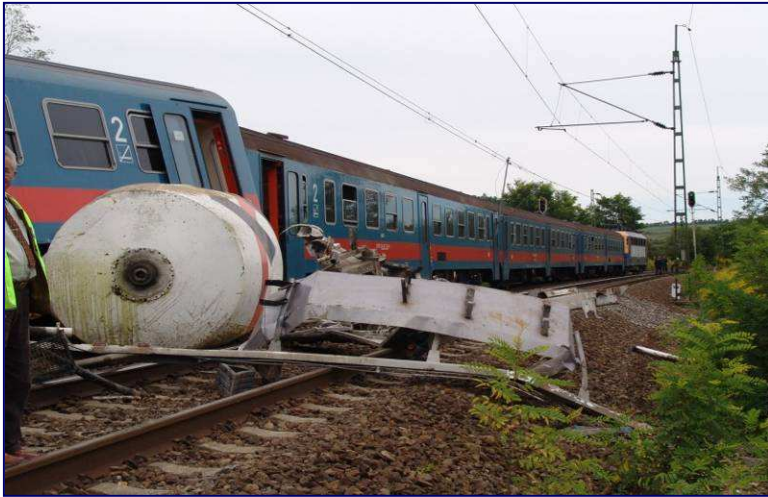
- the driver of the lorry, the chief ticket inspector and a passenger suffered serious and another passenger minor injuries,
- the control car of the train derailed and sustained substantial damage,
- one overhead line mast broke and fell, and the shunting overhead line also broke,
- the left track sustained substantial damage on an approximately 30-metre-distance,
- the lorry was written off,
- the liquid concrete flowing onto the track and the wreckage of the vehicles blocked both rail tracks.

According to the owner of the lorry, the driver must have been unable to turn left in the sharp bend at the junction due to the high speed he was driving with, therefore he chose to turn right, however, he was not able to make that either, so eventually he drove straight on and fell onto the rail track - breaking the roadside barrier - from approximately 3-metre-height.
